Lessons from two fires at Glasgow School of Art

by Simon Kincaid

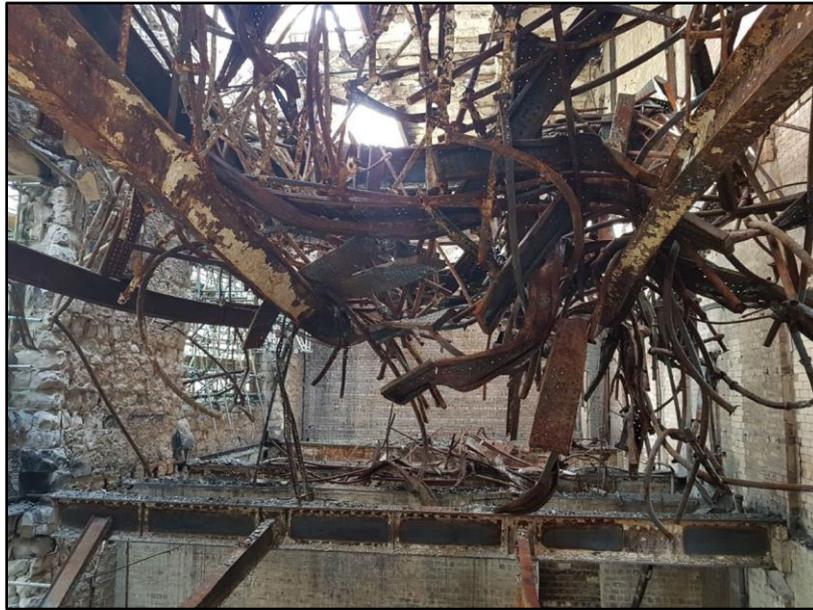
The interior of the Mackintosh Building after the 2018 fire (photo 2019).

Post-fire, the building consists of external masonry walls; internal masonry cross-walls; main connecting steel beams (some badly distorted) and a partial concrete slab at second floor level, this offering some weather protection to the floors below (work has now started to remove some of the most badly damaged elements, prior to their replacement).¹⁹ There was extensive heat damage to the stonework and some exterior walls were found to have moved from position by as much as 100mm in places.²⁰ Most of the superstructure above second floor level was removed due to concerns about stability and the structure was made safe with the use of an extensive support and restraint system, consisting of scaffolding, and lattice and box trusses. All the intricately designed and detailed interiors were lost in the fire, and in most places the interior surfaces are now bare masonry.

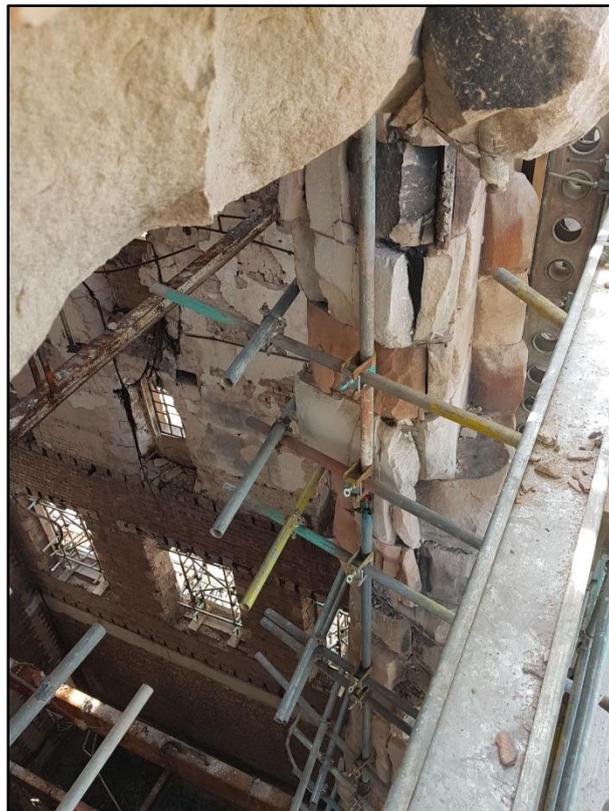
Heat damaged stonework on the Mackintosh Building after the 2018 fire; note also the support/restraint system (photo 2019).
