An investigation into the non-uniform decay of Hardwick Stone

AN INVESTIGATION INTO THE NON-UNIFORM DECAY OF HARDWICK STONE

Robert Brough⁴ & Elizabeth Laycock

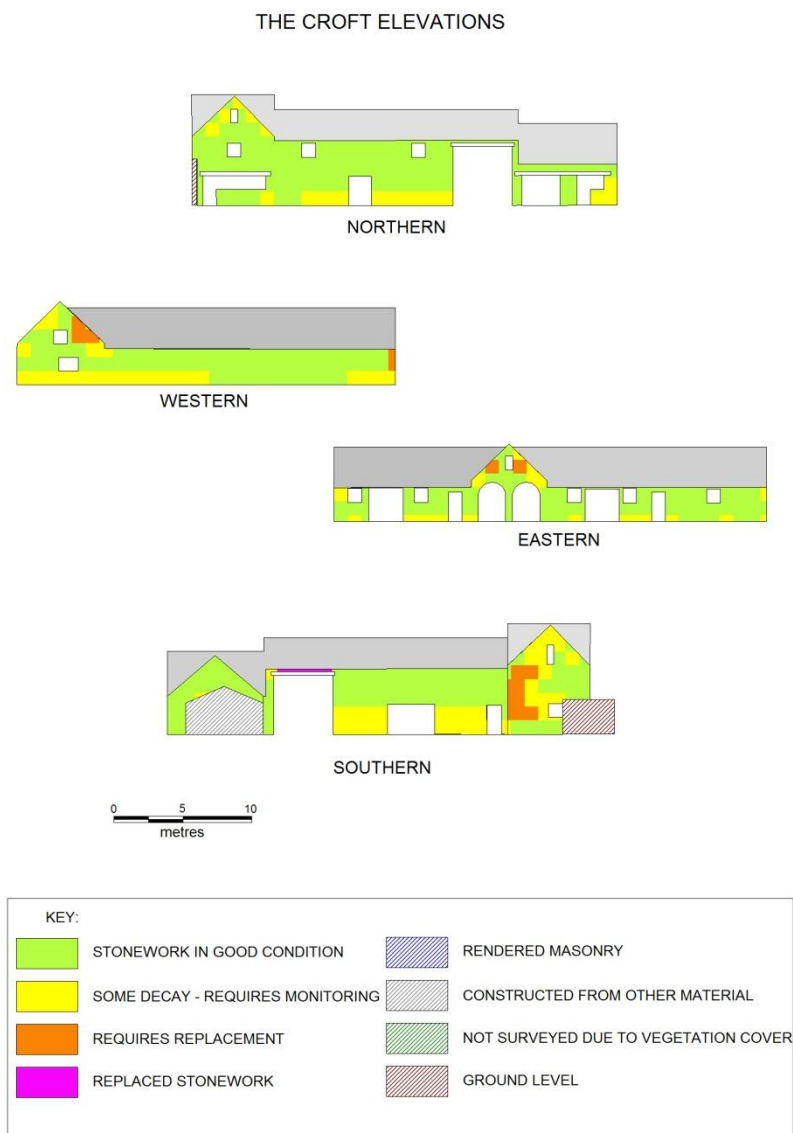
Figure 7: Elevations of The Croft

The elevation with the lowest proportion of stone in good condition is the southern elevation (64%), whereas the highest proportion of stone in good condition was observed on the northern elevation (83%) with an overall average for all elevations of 73%. The southern and western elevations have higher than average figure for stone showing some signs of decay, 28% and 27% respectively. The southern, eastern and western elevations all have some stone requiring replacement, whereas the northern elevation does not. In the case of The Croft Courtyard, both elevations have a low proportion of stone in good condition. The eastern elevation has 44% in good condition, the western elevation fairs slightly better at 52%. The average for these two elevations is 51%. The eastern elevation has a high proportion of stone that is showing some decay (56%), whereas the western elevation has 39% in the same category. The western elevation also has 9% of its stone requiring replacement.

One of the most striking features of this elevation mapping is how the spread of stone showing signs of decay appears to occur high up in the building, towards the southern end of the building which may be attributable to the fact that the southern end is the open end of the courtyard and therefore this part of the building is least protected. Decay at high levels in the elevations can also be seen on the eastern gable of the southern elevation in Figure 7. Another feature of the pattern of stone decay on The Croft is that decay appears to occur on the gables of the buildings parallel to, but offset from, the roof line. This is not shown perfectly by the elevation mapping because the elevations have been split into 1m grids.
