# **Efficacy of Different Materials and Methods of Repair in Highway Bridges**

**P S Mangat, F J O'Flaherty**

School of Construction, Sheffield Hallam University

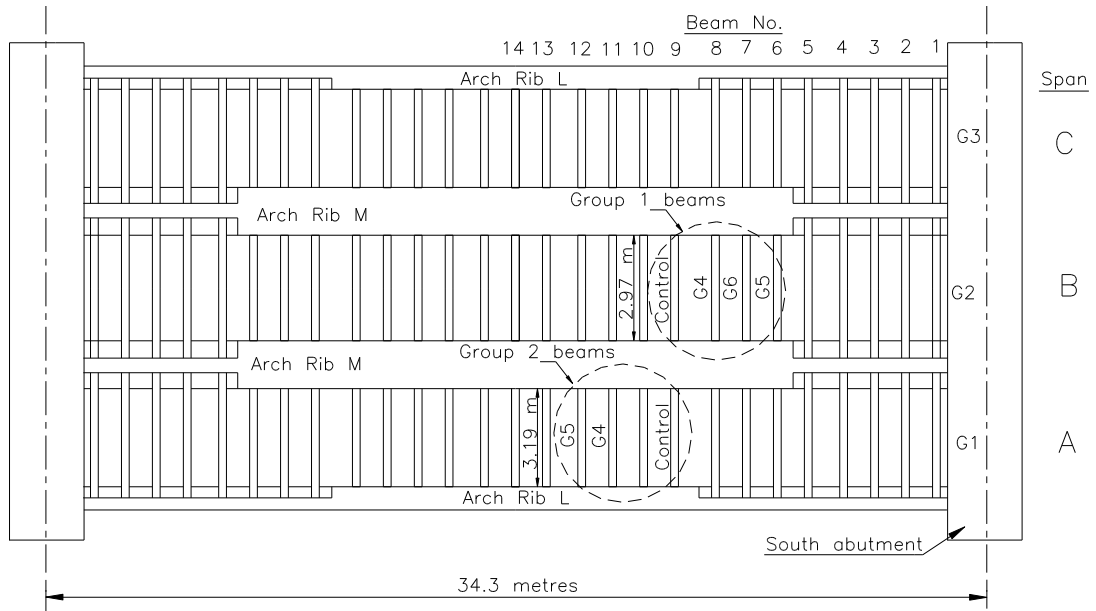
Gunthorpe bridge is a three span reinforced concrete arch bridge spanning the River Trent at Gunthorpe, Nottinghamshire. It was built in 1927 to replace an old iron toll-bridge. Reinforcement corrosion had resulted in high degree of deterioration in the bridge members. Repairs were carried out to the lateral beams spanning between the arch ribs (Figure 1) and to three areas on the South abutment measuring approximately 2.3m x 1.8m. The bridge was repaired in an unpropped state.

Hand applied repairs to the very heavily reinforced lateral deck beams at Gunthorpe bridge (Figure 1), using repair materials of  $E_{rm} < E_{sub}$  (Table 1), resulted in cosmetic repairs. A strain-time plot of the strain gauges attached at different locations of a beam (Figure 2) is shown in Figure 12. The strain-time plots of different beams showed no clear and consistent pattern of strain distribution in the different phases of the repair patch. There was little interaction between the substrate beam and the repair patch; no significant load transfer from the substrate to the repair was evident in the long term.

**Figure 1:** Lateral beams at Gunthorpe Bridge repaired with hand applied materials

The lateral beams were repaired with hand applied patch repairs. Deteriorated concrete was removed along the soffit of the beam to a total depth of 130-140mm (up to 25mm behind the steel reinforcement). The exposed steel was grit blasted and then primed. Vibrating wire gauges (surface and embedment) were attached to the repair patches as shown in Figure 2 to monitor long-term strains. Figure 3 shows the hand applied repair to the beams.

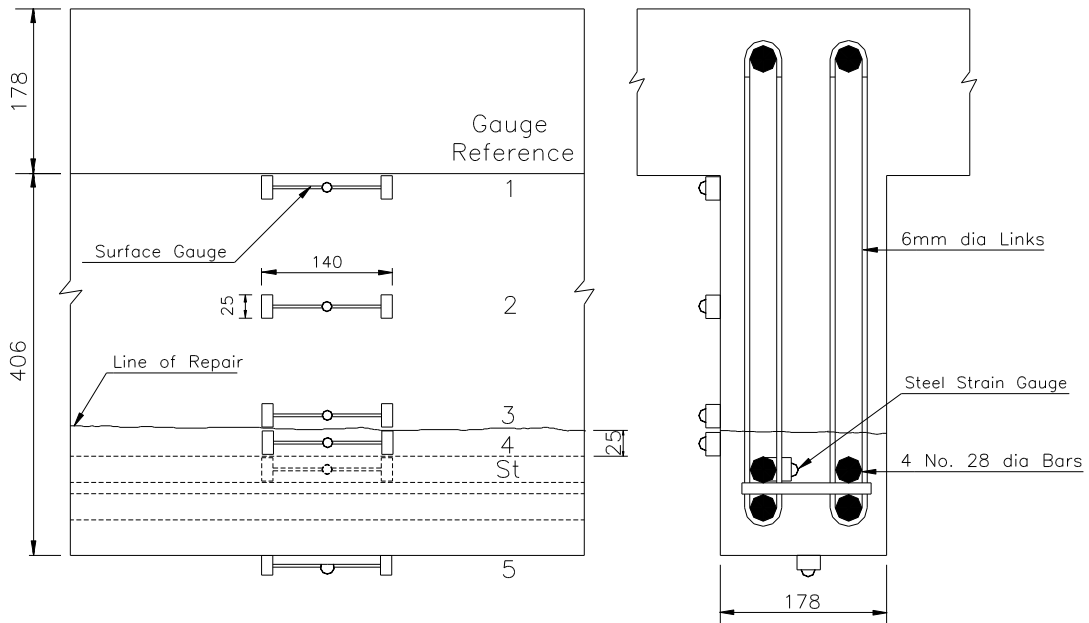
**Figure 2:** Position of vibrating wire strain gauges in the beams at Gunthorpe Bridge

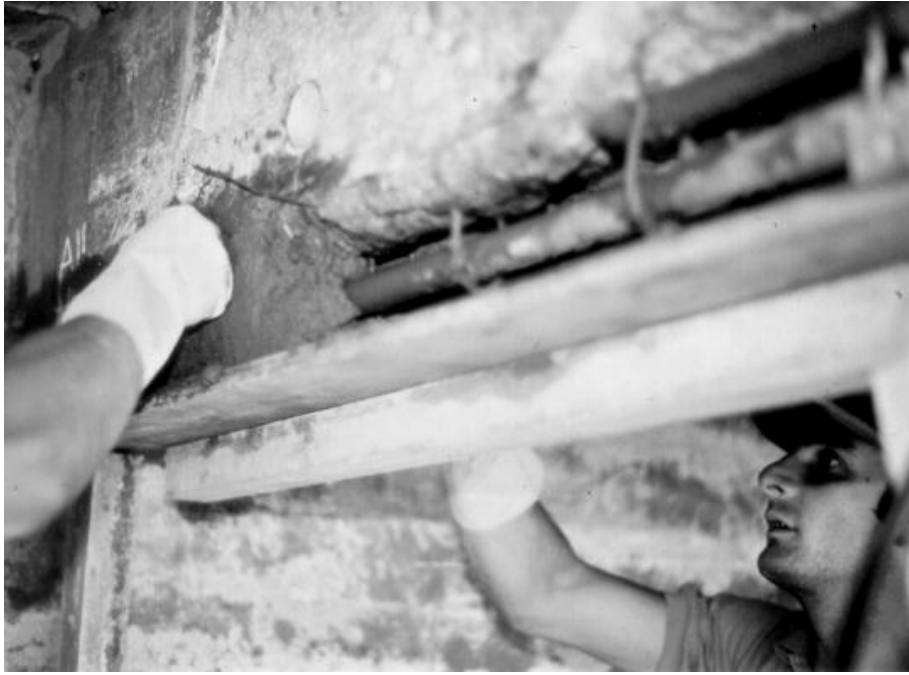
**Figure 3:** Hand applied repairs to beams at Gunthorpe Bridge (unpropped structure)

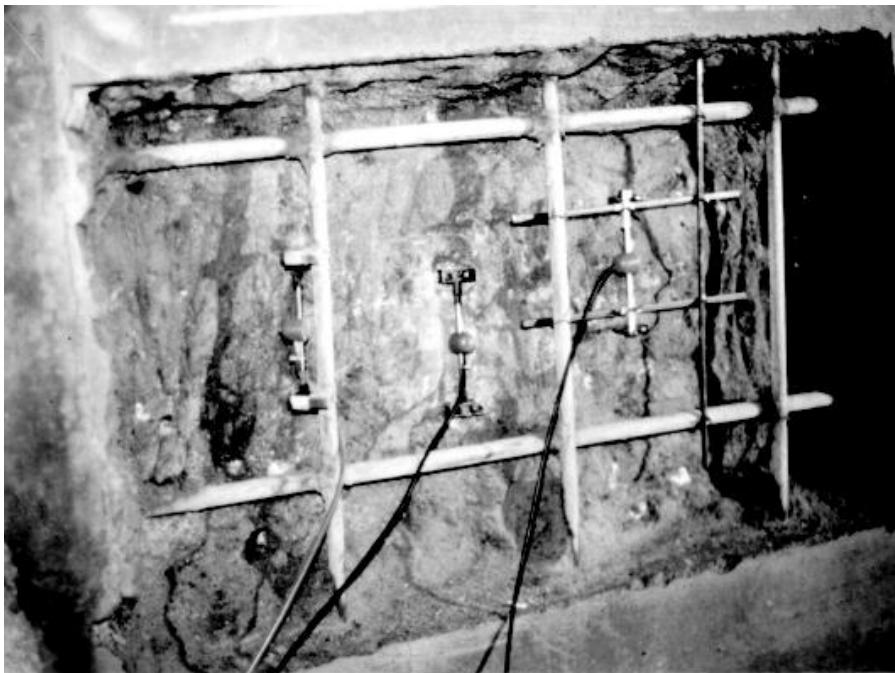
**Figure 4:** Location of vibrating wire strain gauges in the repair patches of bridge abutments

The repair patches to the abutment were applied by spraying, using the dry spray process. The average depth of the repair patch was 140mm. The vibrating wire gauges were attached as shown in Figure 4 - one gauge was attached to the substrate at the interface of repair, one was attached to the longitudinal reinforcement bar and one was embedded in the repair material in the plane of the longitudinal reinforcement bars.

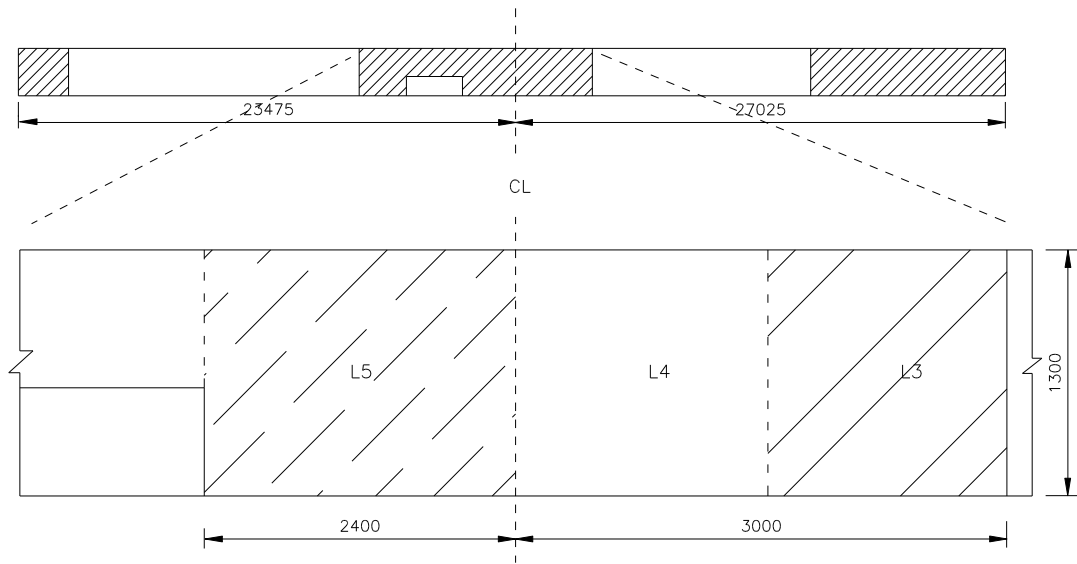
Lawns Lane bridge is a three span reinforced concrete bridge which carries the M1 near Wakefield. It is a 1960's structure which required substantial repairs to the abutments and the North piers. Figure 5 shows the locations of repairs to the North abutment. The repairs were applied to a depth of approximately 140mm using the dry spray process. Vibrating wire gauges were attached as shown in Figure 4. The repairs were carried out in an unpropped state.

**Figure 5:** Location of spray applied repair patches on the north abutment, Lawns Lane Bridge (unpropped structure)

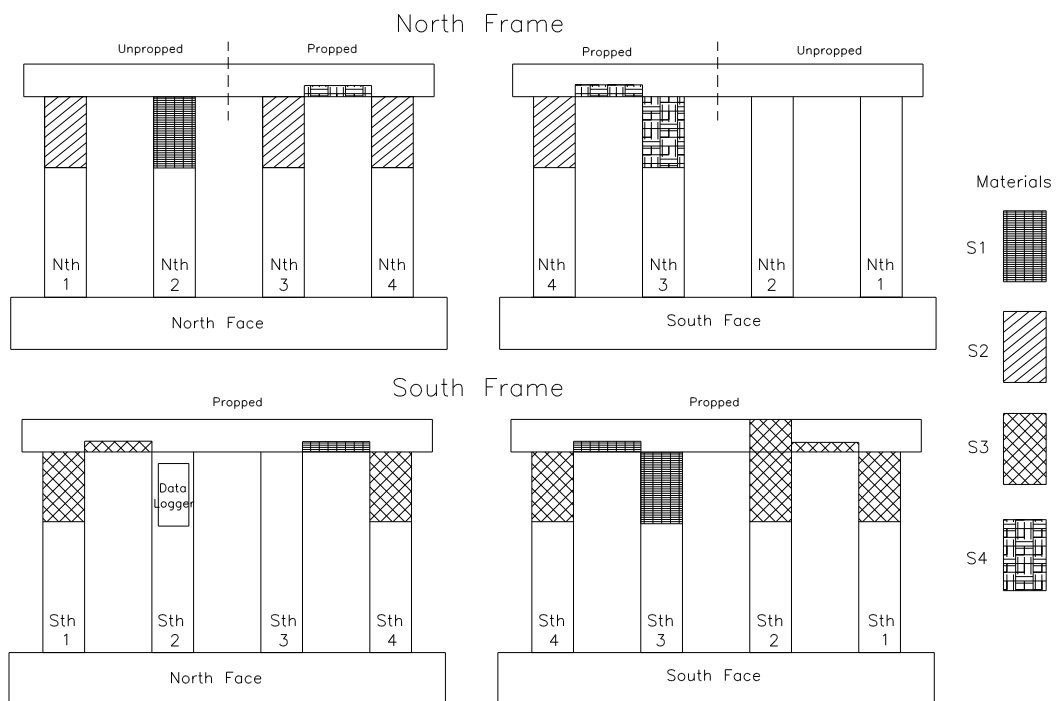
Sutherland Street bridge carries the B6080 over an access road which once linked steel industries in Sheffield. The superstructure consists of an in-situ deck supported by prestressed beams. The substructure consists of reinforced concrete beams and columns in a portal frame configuration. Repairs were carried out to the beams and columns of the portal frame (substructure) as shown in Figure 6. The repairs were applied using the flowing material method of application. Half of the North frame of the bridge was maintained in an unpropped state during the application of repair. The remaining bridge (the South frame and the remaining half of the North frame) was maintained in a propped state during the application of repair. Propping remained in place for approximately 28 days after the application of repair.

**Figure 6:** Location of flowing repairs at Sutherland Street Bridge (propped and unpropped members)

The deteriorated concrete was removed to a depth of 25mm behind the reinforcement. The exposed steel was grit blasted and primed. Plywood shuttering was used for the flowing repairs. The substrate concrete was saturated by filling the shuttering with water and leaving in place overnight. The flowing repair material was poured into the shuttering from a bucket. Compaction was achieved by tapping the shuttering with a wooden hammer as the material was poured. Shuttering was left in place for at least three days after the pour. Vibrating wire strain gauges were attached in a similar manner to the previous bridges on the substrate at the repair interface, on the steel reinforcement and embedded in the repair material in the plane of the reinforcing bars.

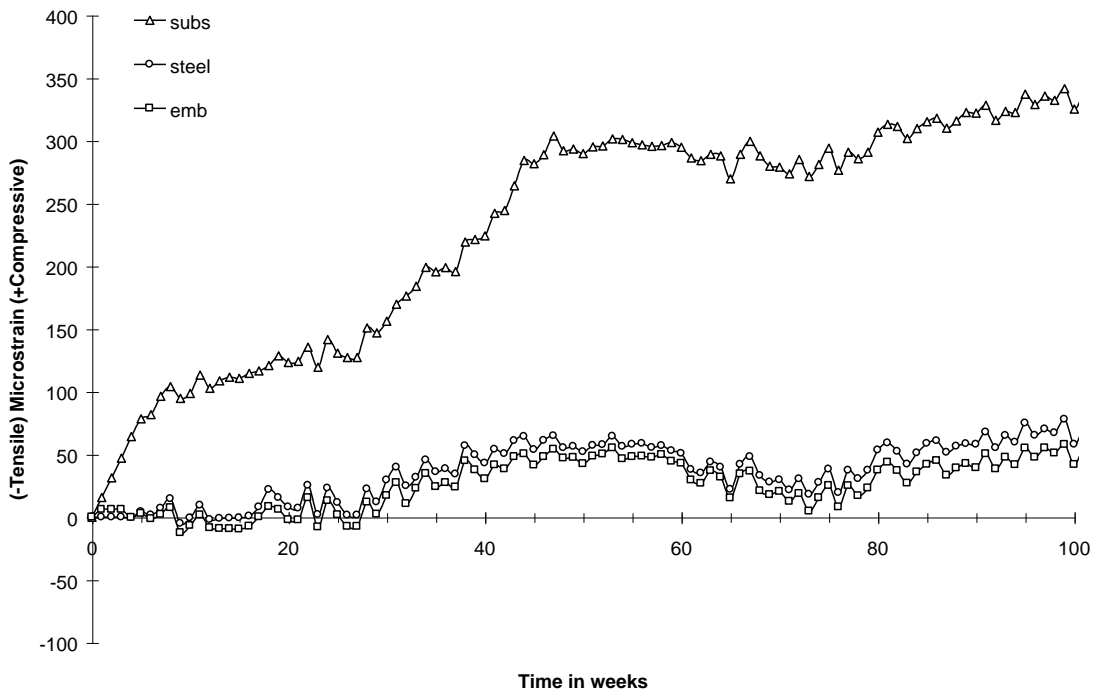
The typical long-term strains monitored in the repair patches on the abutments at Lawns Lane and Gunthorpe bridges are plotted in Figure 7. Repairs were applied to unpropped members. Repair materials of elastic modulus,  $E_{rm}$ , greater than that of the substrate,  $E_{sub}$ , are considered. Strains in the substrate at the repair interface, in the steel reinforcement and in the repair material (in the plane of the longitudinal reinforcement) are plotted. A simplified schematic representation of the strain-time relationship is made in Figure 8 in which the strains monitored by the reinforcement gauge and the embedment gauge in the plane of the reinforcement are averaged. Figure 8 clearly identifies four stages (zones) of strain (and, therefore, stress) transfer. Stage 1 represents the shrinkage strain transfer from the stiffer repair material ( $E_{rm} > E_{sub}$ ) into the substrate concrete at the interface and into the steel reinforcement. The degree of shrinkage transfer is a function of  $E_{rm}/E_{sub}$  and the free shrinkage characteristics of the repair material<sup>(5)</sup>. Zone 2 is a steady state condition of strain (and, therefore, stress) transfer which occurs after the repair material shrinkage stabilises. Zone 3, from week 25 to 47, represents the long-term effects of load redistribution from the substrate structure into the repair patch<sup>(5)</sup>. The long-term load distribution from the substrate is effective in neutralising the tension in the repair material caused by restrained shrinkage.

**Figure 7:** Long-term strain distribution in repair patch.  $E_{rm} > E_{sub}$ . Lawns Lane Bridge abutment. Sprayed repairs

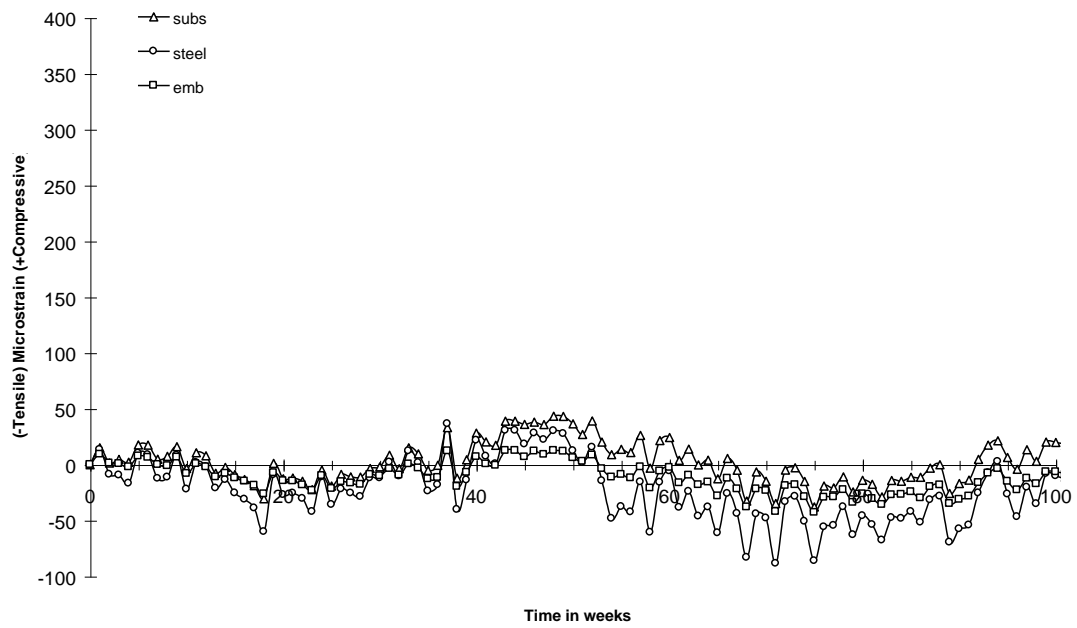
A representative example of long-term strain distribution in repairs with low stiffness materials ( $E_{rm} < E_{sub}$ ) is presented in Figure 9. Spray applied repairs to unpropped bridge abutments are considered. Figure 9 does not identify any of the zones of strain transfer which are evident for high stiffness repair materials ( $E_{rm} > E_{sub}$ ) in Figures 7 and 8. Low stiffness repair materials ( $E_{rm} < E_{sub}$ ) are ineffective in transferring shrinkage strain to the substrate and, therefore, sustain higher degrees of restrained shrinkage tension. Consequently, low stiffness repairs are prone to cracking as evident in Figure 10.

**Figure 9:** Long-term strain distribution in repair patch.  $E_{rm} < E_{sub}$ . Gunthorpe Bridge abutment. Sprayed repair

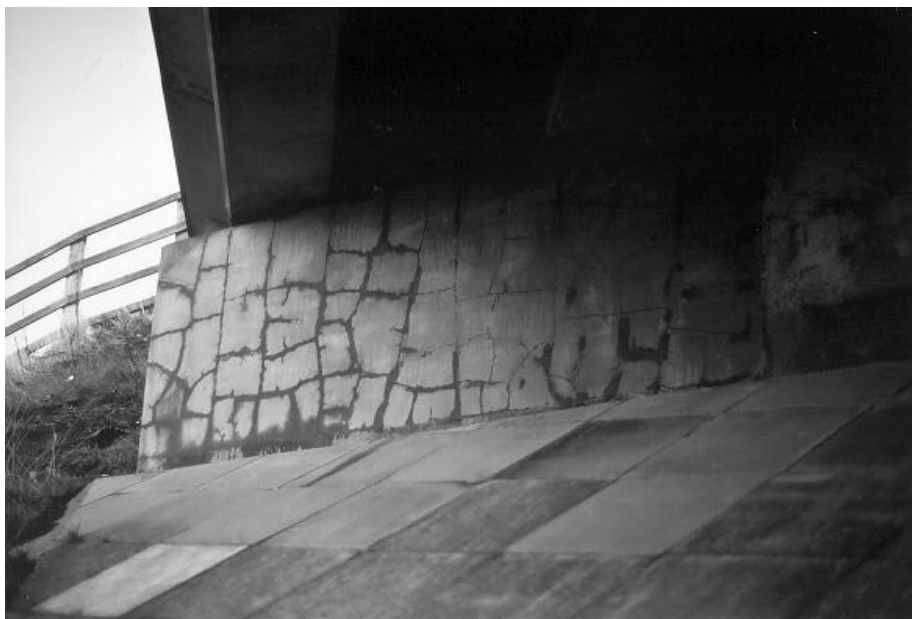
**Figure 10:** Restrained shrinkage cracking in repair patch.  $E_{rm} < E_{sub}$ .

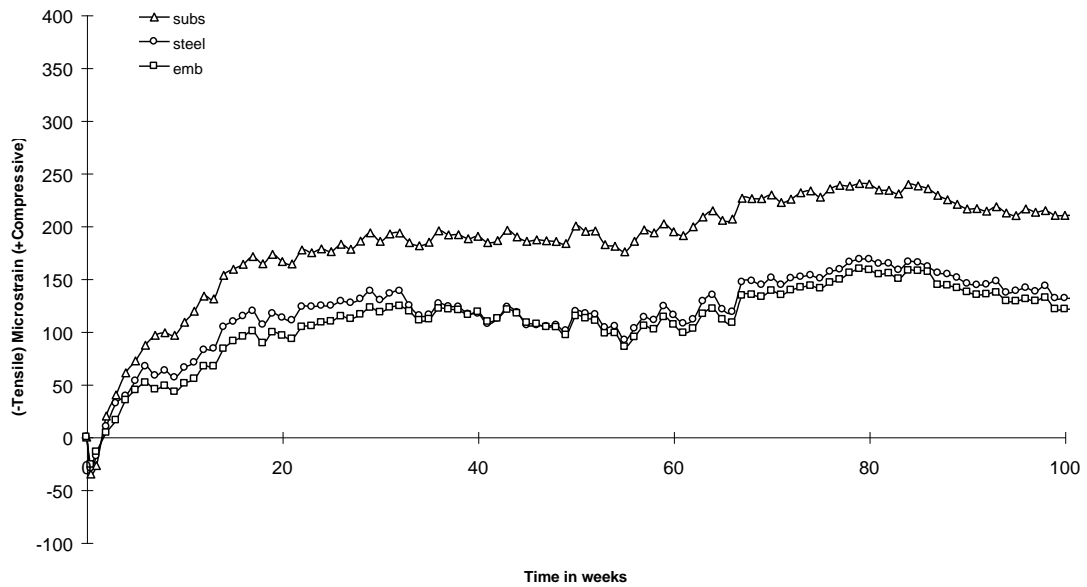
Figure 11 shows the long-term strain distribution in the repair patch of a flowing material applied to an unpropped compression member. The figure shows a well defined shrinkage transfer stage followed by a steady state. A long-term external load redistribution stage is not identified (Zone 3) as in the case of spray applied repairs to unpropped members.

**Figure 11:** Long term strain distribution in repair patch.  $E_{rm} > E_{sub}$ . Sutherland Street Bridge column. Flowing repair.

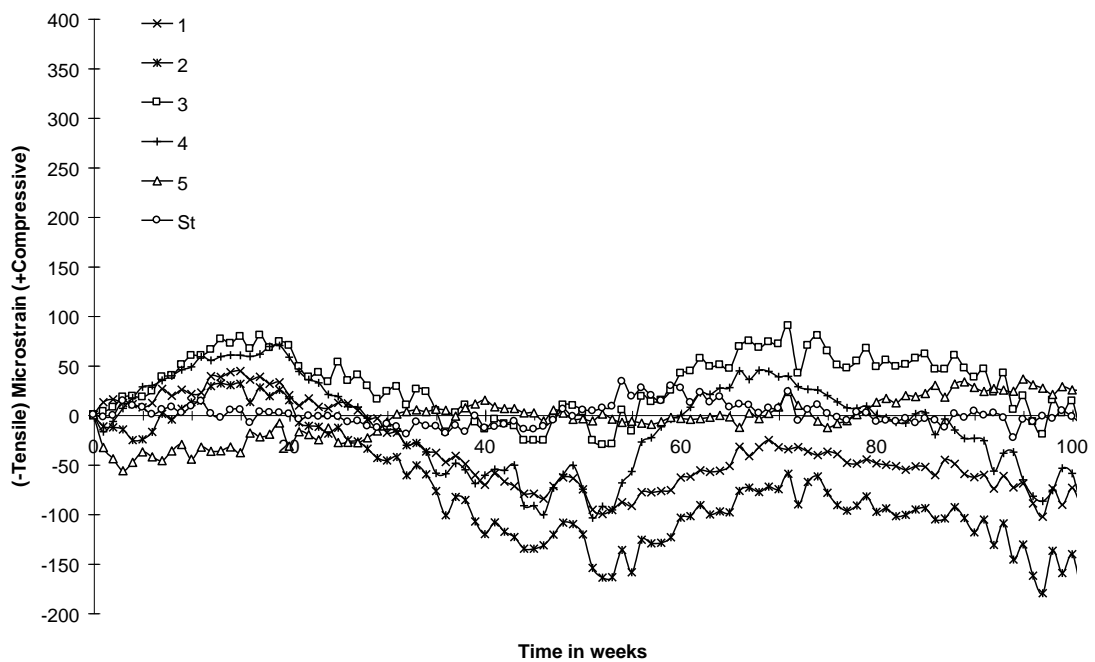
**Figure 12:** Long term strain distribution in the repairs to bridge beams at Gunthorpe Bridge.  $E_{rm} < E_{sub}$ .
