Efficacy of Different Materials and Methods of Repair in Highway Bridges

P S Mangat, F J O'Flaherty

School of Construction, Sheffield Hallam University

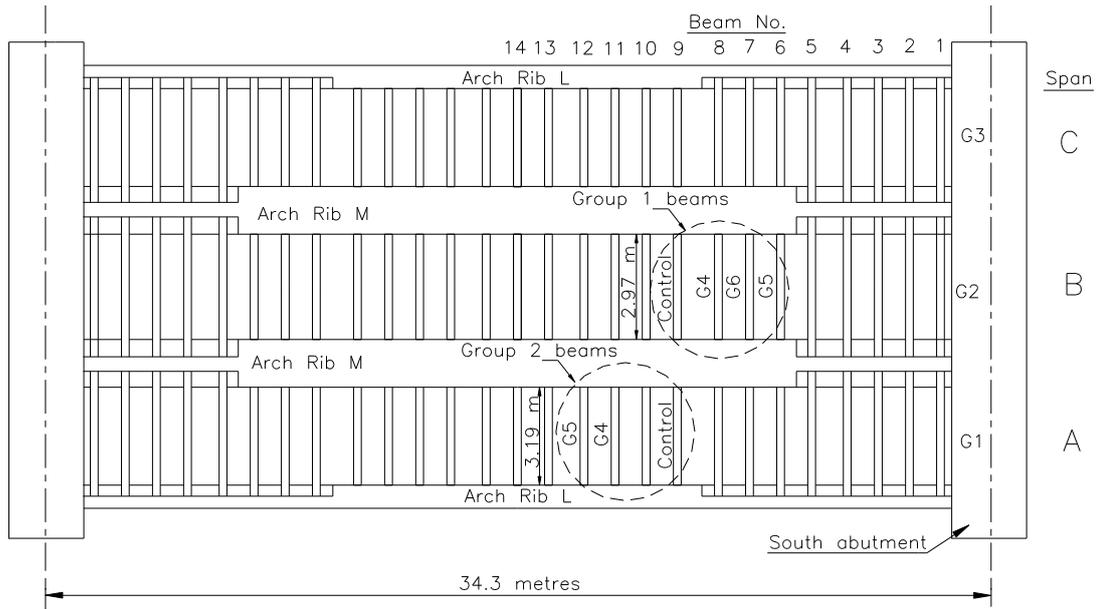
Gunthorpe bridge is a three span reinforced concrete arch bridge spanning the River Trent at Gunthorpe, Nottinghamshire. It was built in 1927 to replace an old iron toll-bridge. Reinforcement corrosion had resulted in high degree of deterioration in the bridge members. Repairs were carried out to the lateral beams spanning between the arch ribs (Figure 1) and to three areas on the South abutment measuring approximately 2.3m x 1.8m. The bridge was repaired in an unpropped state.

Figure 1: Lateral beams at Gunthorpe Bridge repaired with hand applied materials

The lateral beams were repaired with hand applied patch repairs. Deteriorated concrete was removed along the soffit of the beam to a total depth of 130-140mm (up to 25mm behind the steel reinforcement). The exposed steel was grit blasted and then primed. Vibrating wire gauges (surface and embedment) were attached to the repair patches as shown in Figure 2 to monitor long-term strains. Figure 3 shows the hand applied repair to the beams.

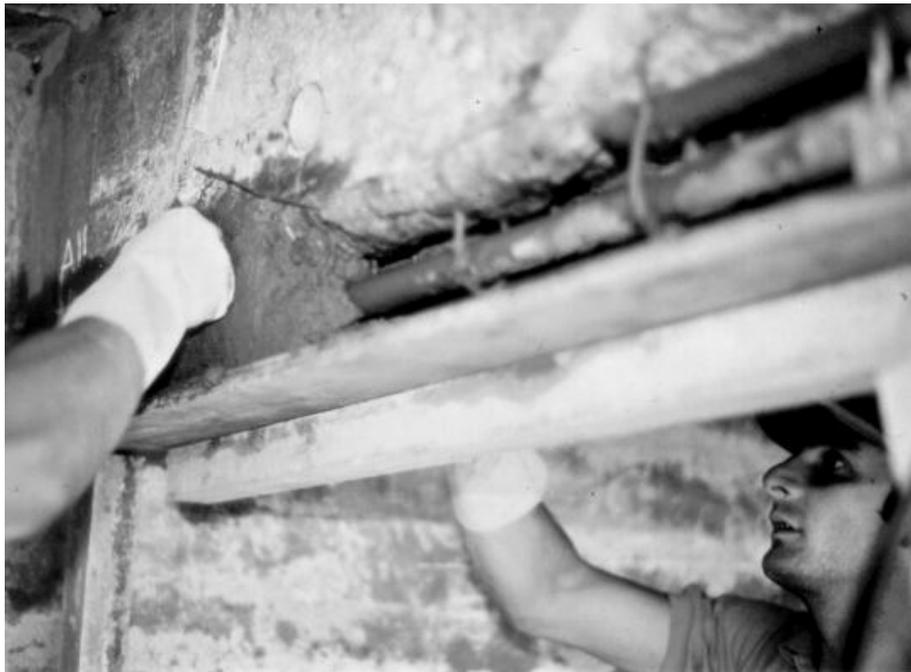
Figure 3: Hand applied repairs to beams at Gunthorpe Bridge (unpropped structure)

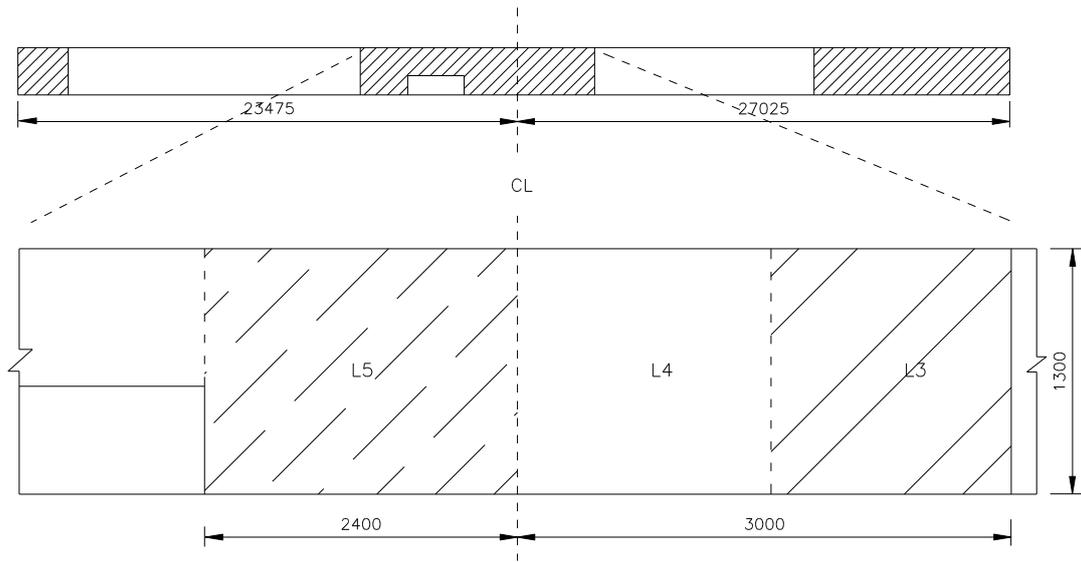
Lawns Lane bridge is a three span reinforced concrete bridge which carries the M1 near Wakefield. It is a 1960's structure which required substantial repairs to the abutments and the North piers. Figure 5 shows the locations of repairs to the North abutment. The repairs were applied to a depth of approximately 140mm using the dry spray process. Vibrating wire gauges were attached as shown in Figure 4. The repairs were carried out in an unpropped state.

Figure 5: Location of spray applied repair patches on the north abutment, Lawns Lane Bridge (unpropped structure)

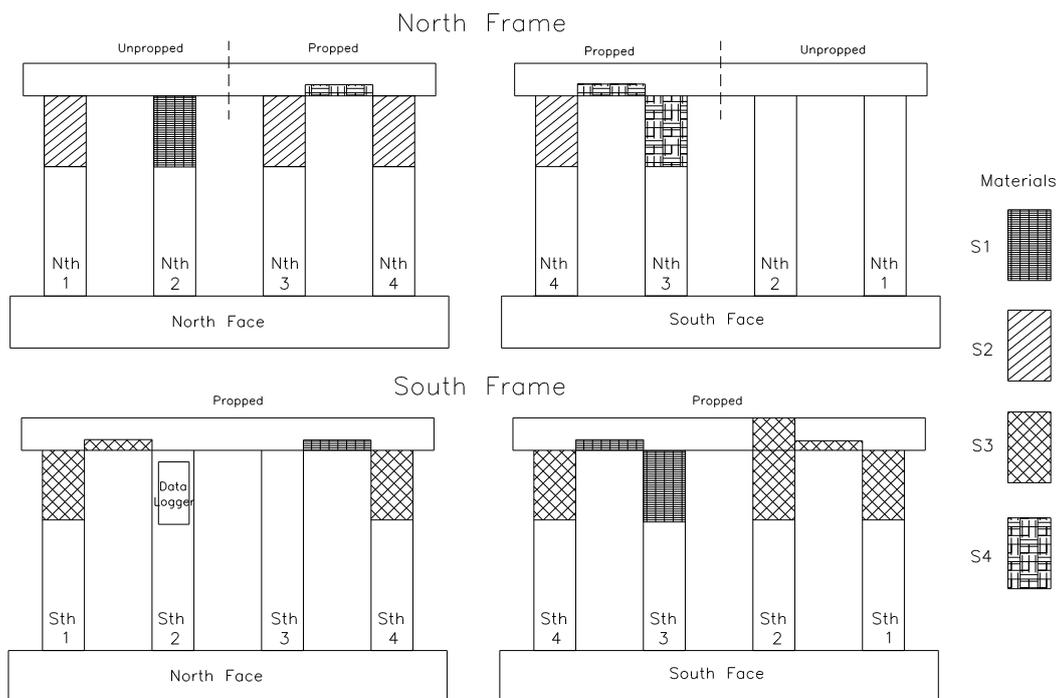
Sutherland Street bridge carries the B6080 over an access road which once linked steel industries in Sheffield. The superstructure consists of an in-situ deck supported by prestressed beams. The substructure consists of reinforced concrete beams and columns in a portal frame configuration. Repairs were carried out to the beams and columns of the portal frame (substructure) as shown in Figure 6. The repairs were applied using the flowing material method of application. Half of the North frame of the bridge was maintained in an unpropped state during the application of repair. The remaining bridge (the South frame and the remaining half of the North frame) was maintained in a propped state during the application of repair. Propping remained in place for approximately 28 days after the application of repair.

Figure 6: Location of flowing repairs at Sutherland Street Bridge (propped and unpropped members)

The deteriorated concrete was removed to a depth of 25mm behind the reinforcement. The exposed steel was grit blasted and primed. Plywood shuttering was used for the flowing repairs. The substrate concrete was saturated by filling the shuttering with water and leaving in place overnight. The flowing repair material was poured into the shuttering from a bucket. Compaction was achieved by tapping the shuttering with a wooden hammer as the material was poured. Shuttering was left in place for at least three days after the pour. Vibrating wire strain gauges were attached in a similar manner to the previous bridges on the substrate at the repair interface, on the steel reinforcement and embedded in the repair material in the plane of the reinforcing bars.

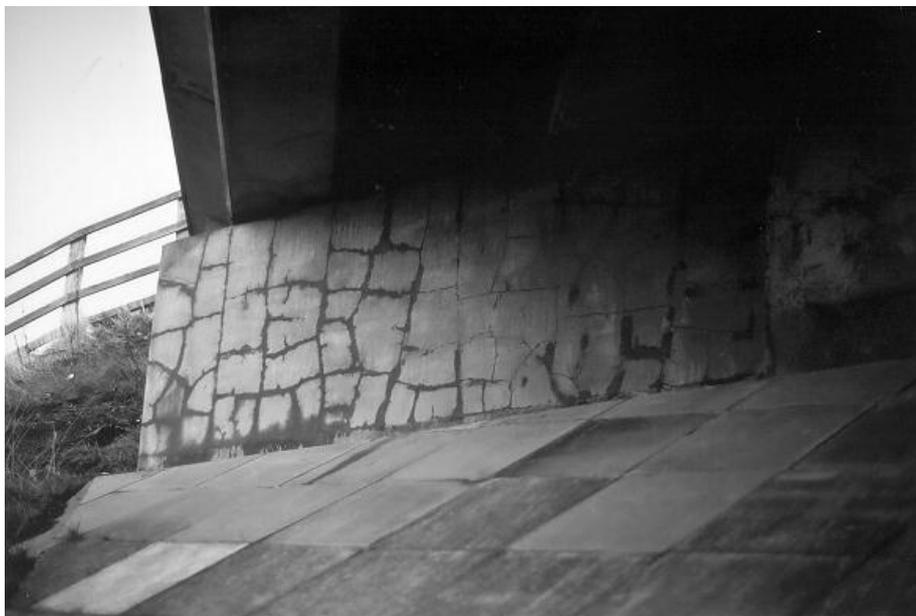
A representative example of long-term strain distribution in repairs with low stiffness materials ($E_{rm} < E_{sub}$) is presented in Figure 9. Spray applied repairs to unpropped bridge abutments are considered. Figure 9 does not identify any of the zones of strain transfer which are evident for high stiffness repair materials ($E_{rm} > E_{sub}$) in Figures 7 and 8. Low stiffness repair materials ($E_{rm} < E_{sub}$) are ineffective in transferring shrinkage strain to the substrate and, therefore, sustain higher degrees of restrained shrinkage tension. Consequently, low stiffness repairs are prone to cracking as evident in Figure 10.

Figure 10: Restrained shrinkage cracking in repair patch. $E_{rm} < E_{sub}$.
