## **Continuous debonding monitoring of a patch repaired helicopter stabilizer: damage assessment and analysis**

# Continuous debonding monitoring of a patch repaired helicopter stabilizer: Damage assessment and analysis

The present work focuses on the structural health monitoring of an aluminium vertical helicopter stabiliser with a pre-introduced crack which was repaired with an adhesively bonded composite patch. The structure was monitored under bending fatigue and its performance was evaluated with Lamb waves, lock-in thermography and ultrasonic testing. Outlier analysis of Lamb waves captured the onset and progress of the damage in the form of patch debonding, enabling the identification of five damage-severity regions. Principal component analysis showed distinctive clusters that corresponded to different damage levels while the application of principal curves on the selected features proved to be an additional damage detection index. Amplitude and phase lock-in images accurately captured the onset and evolution of the damage in the form of patch debonding and honeycomb/skin debonding in agreement with the damage indices obtained from Lamb waves. C-scan further validated th

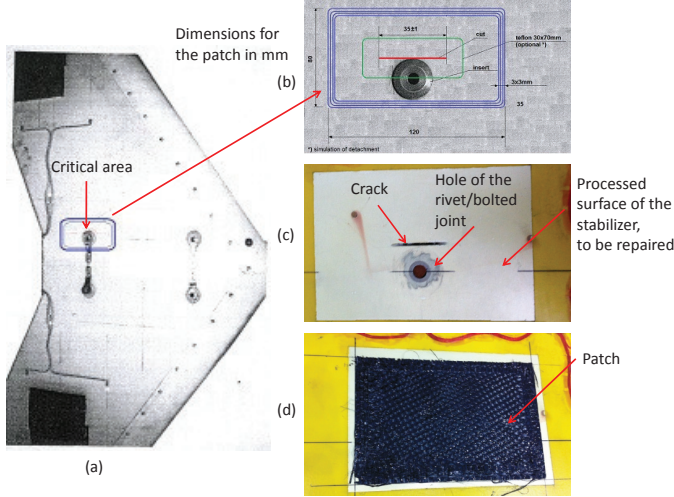
A vertical stabilizer of a helicopter located on the tail boom and manufactured by PZL-Swidnik/AgustaWestland (Poland) was selected as a representative aeronautical structure for repair and non-destructive testing. The panel was of a honeycomb construction, the core of which was made of HexWeb CRIII-5/32-5052-.001N-3.8 and the skin of AL-2024 T3 alloy sheet, of a thickness variation from 0.6 mm to 1.5 mm. Prior to the selection of the area to be repaired, bending fatigue was performed and the most critical region was identified to be around the rivets/bolted joints at the centre of the stabilizer as illustrated in Figure 2(a). An artificially 35 mm crack that would be repaired by a bonded composite patch was introduced, located close to the hole as shown in Figures 2(b), 2(c).

Figure 2: (a) Critical area and proposed location (blue line) for the attachment of the repair patch (b) schematic illustration of the repaired region (c) image of the processed surface of the stabilizer around the crack and the hole before the attachment of the patch (d) final implementation of the patch.<sup>1</sup>

The repair patch consisted of 4 plies AGP 280 (Hexcel 43280S) with a stacking ply sequence  $[90/0]_2$  and total thickness equal to 1.16 mm. First the repaired surface was prepared

using BR127 primer, Figure 2(c), and each ply was impregnated with carbon nanotube (CNT) doped epocast. Each ply was cut to the final dimensions and laid up on the repaired region following a stepwise configuration as outlined in Table 1. Finally, a heating blanket was used for 2 hours at 93°C under vacuum conditions for the curing. The final cured patch is shown in Figure 2(d). A C-scan was performed on the demonstrator prior to testing for evaluation of the bonding quality of the composite patch as shown in Figure 19(a).

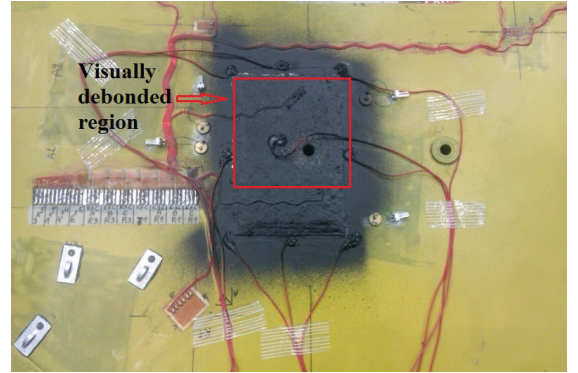
Figure 8: Final debonding after 580,000 cycles of bending fatigue testing.

After 580k fatigue cycles, at the end of the test, a clear debonding could be visually observed as illustrated in Figure

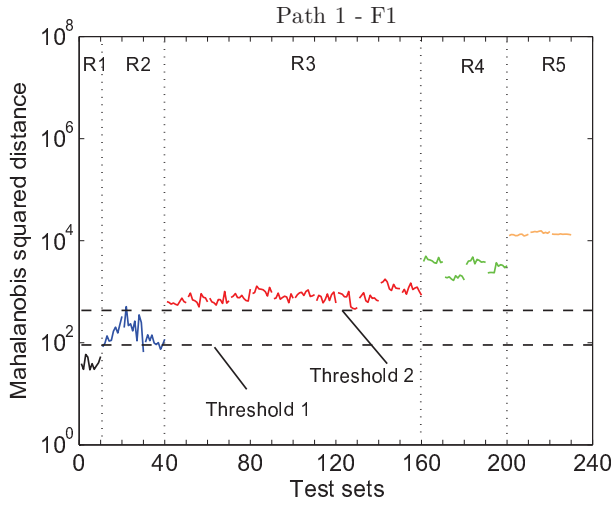
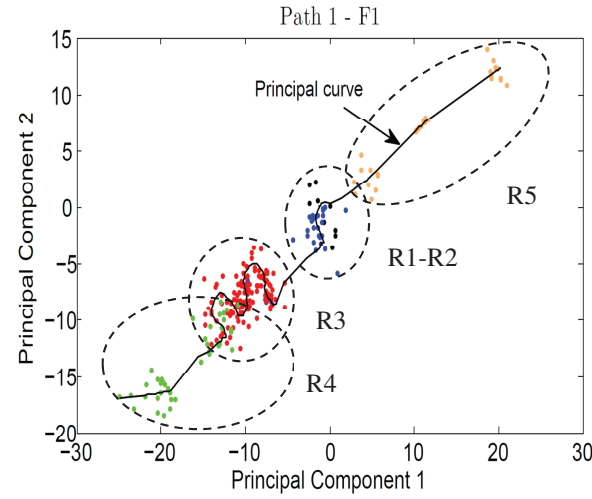
Figure 9: (a) Outlier analysis (OA) and (b) principal component analysis (PCA) for path 1 - feature 1 (F1). Threshold 1 estimated through Monte Carlo technique and Threshold 2 assigned to reflect changes in boundary conditions, outliers above thresholds represent damage, regions R1-R5 show progressive damage increase in the form of increasing Mahalanobis distance OA values and as separate PCA clusters.

Region R3 (15,000– 405,000 cycles) in Figure 9(a) is only slightly flagged above the thresholds but without any considerable deviation. However, there is a certain increasing tendency which suggests that damage has started accumulating in the monitored area (path 1). Region R4 (405,000 – 480,000 cycles) shows a higher deviation from the thresholds than region R3 while the region R5 (480,000–580,000 cycles) clearly cor-

responds to a stage where significant damage has developed. Feature 1 (F1), shown in Figure 9(a), which corresponds to the part of the waveform that has been captured by the sensor without interacting with any other features/boundaries, shows more distinctive differences than feature 2 (F2), shown in Figure 10(a). However feature 2 (F2) exhibits higher values of deviation from the normal condition (higher Mahalanobis squared distance) (areas R3–R5).

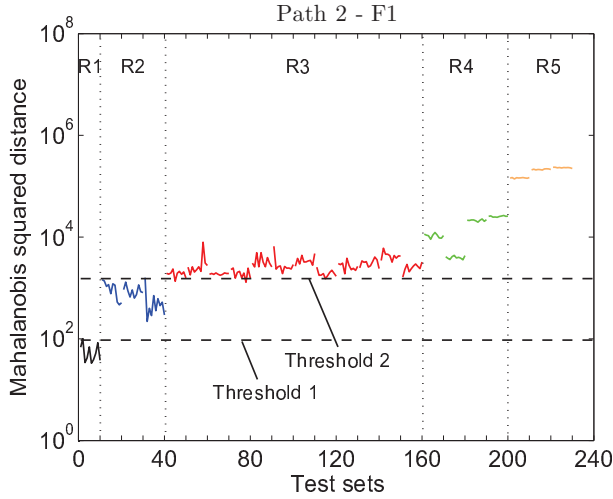
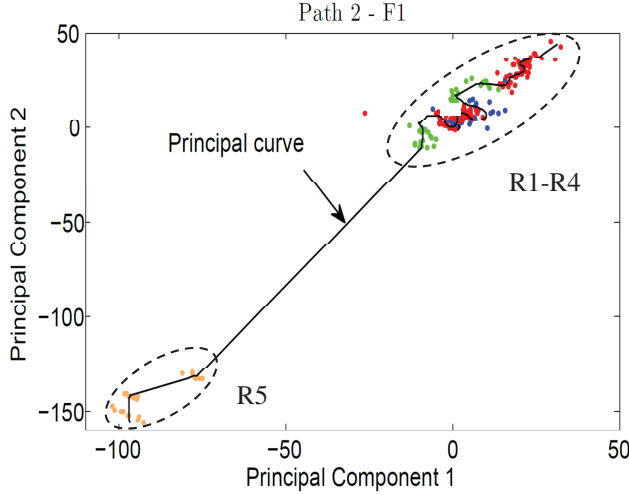
Figure 11: (a) Outlier analysis (OA) and (b) principal component analysis (PCA) for path 2 - feature 1 (F1). Threshold 1 estimated through Monte Carlo technique and threshold 2 assigned to reflect changes in boundary conditions, outliers above thresholds represent damage, regions R1-R5 show progressive damage increase in the form of increasing Mahalanobis distance OA values and as separate PCA clusters (R1-R4 and R5).

Figures 11 and 12 illustrate the same results but for path 2. The y-axis is scaled in the same way as for path 1 for comparison purposes. The first observation is that the same regions (R1-R5) can be assigned in the OA figures, which indicate the level of deviation from the baseline reference (pristine condition) and from the assigned thresholds as shown in Figures 11(a) and 12(a). One difference is that region R4 starts one set of data later (e.g. 170 test sets) for the second feature (F2) compared to F1 for the same path and also compared to both features F1 and F2 for path 1. Furthermore, PCA exhibits quite mixed clusters, from which only the region R5 can be separated for the F1, as shown in Figures 11(b) and 12(b).

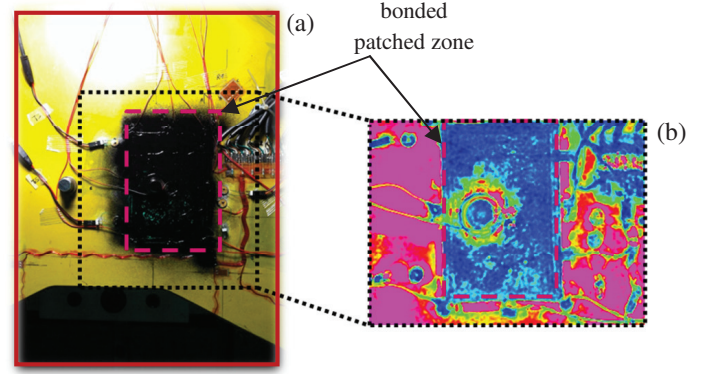
Figure 16: (a) Monitored area, (b) representative thermographic image.<sup>1</sup>

Starting with the first lock-in amplitude image in 16b, the applied bonded patch is clearly identified. As may be observed next to the bonded patch, the piezoelectric sensors for Lamb wave monitoring may be discerned. The rivet/bolted joint thermal imprint is also clearly visible. Moreover, a relatively small high amplitude or stress concentration area around the rivet was acquired. The rest of the patched area does not exhibit any significant variations, suggesting a uniform temperature and stress distribution all over the bonded zone. At this stage, the arti-

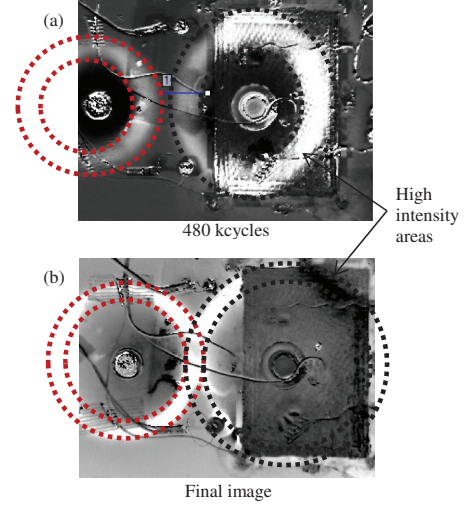
Figures 18a and 18b depict a comparative evaluation between a lock-in image at 480kcycles and the one acquired at the final stage. The stress concentrations around the bolted joints of Figure 18a form patterns possessing a radial symmetry. These circular patterns indicate high amplitude areas/stress concentrations both in the unrepaired and the repaired rivet sites. Mechanically-induced stresses around the patched joint can be distinguished, due to the fact that the patch remains bonded on the substrate. However, this is not the case in the final recorded

Figure 18: Lock-in phase images at (a) 480kcycles and (b) 561kcycles (final stage).

image (Figure 18b). After the almost complete separation of the patch, the suggested high amplitude /stress concentration areas were not detected on the patched zone. To further elucidate the above statements, circles showing the presence (or absence) of stress concentration areas around the bolted joints were drawn (Figures 18a and 18b). The centers of the drawn circles correspond to the position of the rivets (unpatched-left side and patched-right side).

Moreover, the juxtaposition of images in Figure 18 denotes that the diameters of the figurative high amplitude /stress concentration circles around the rivets have increased. This suggests that apart from the degradation of the patch /substrate interface, a second deterioration mechanism may be present; as the interrogated vertical stabilizer is a sandwich structure, it is highly probable that the local stress concentration also invoked the failure of the interface between the honeycomb and the aluminum skin. Ultrasonic imaging verified this hypothesis.

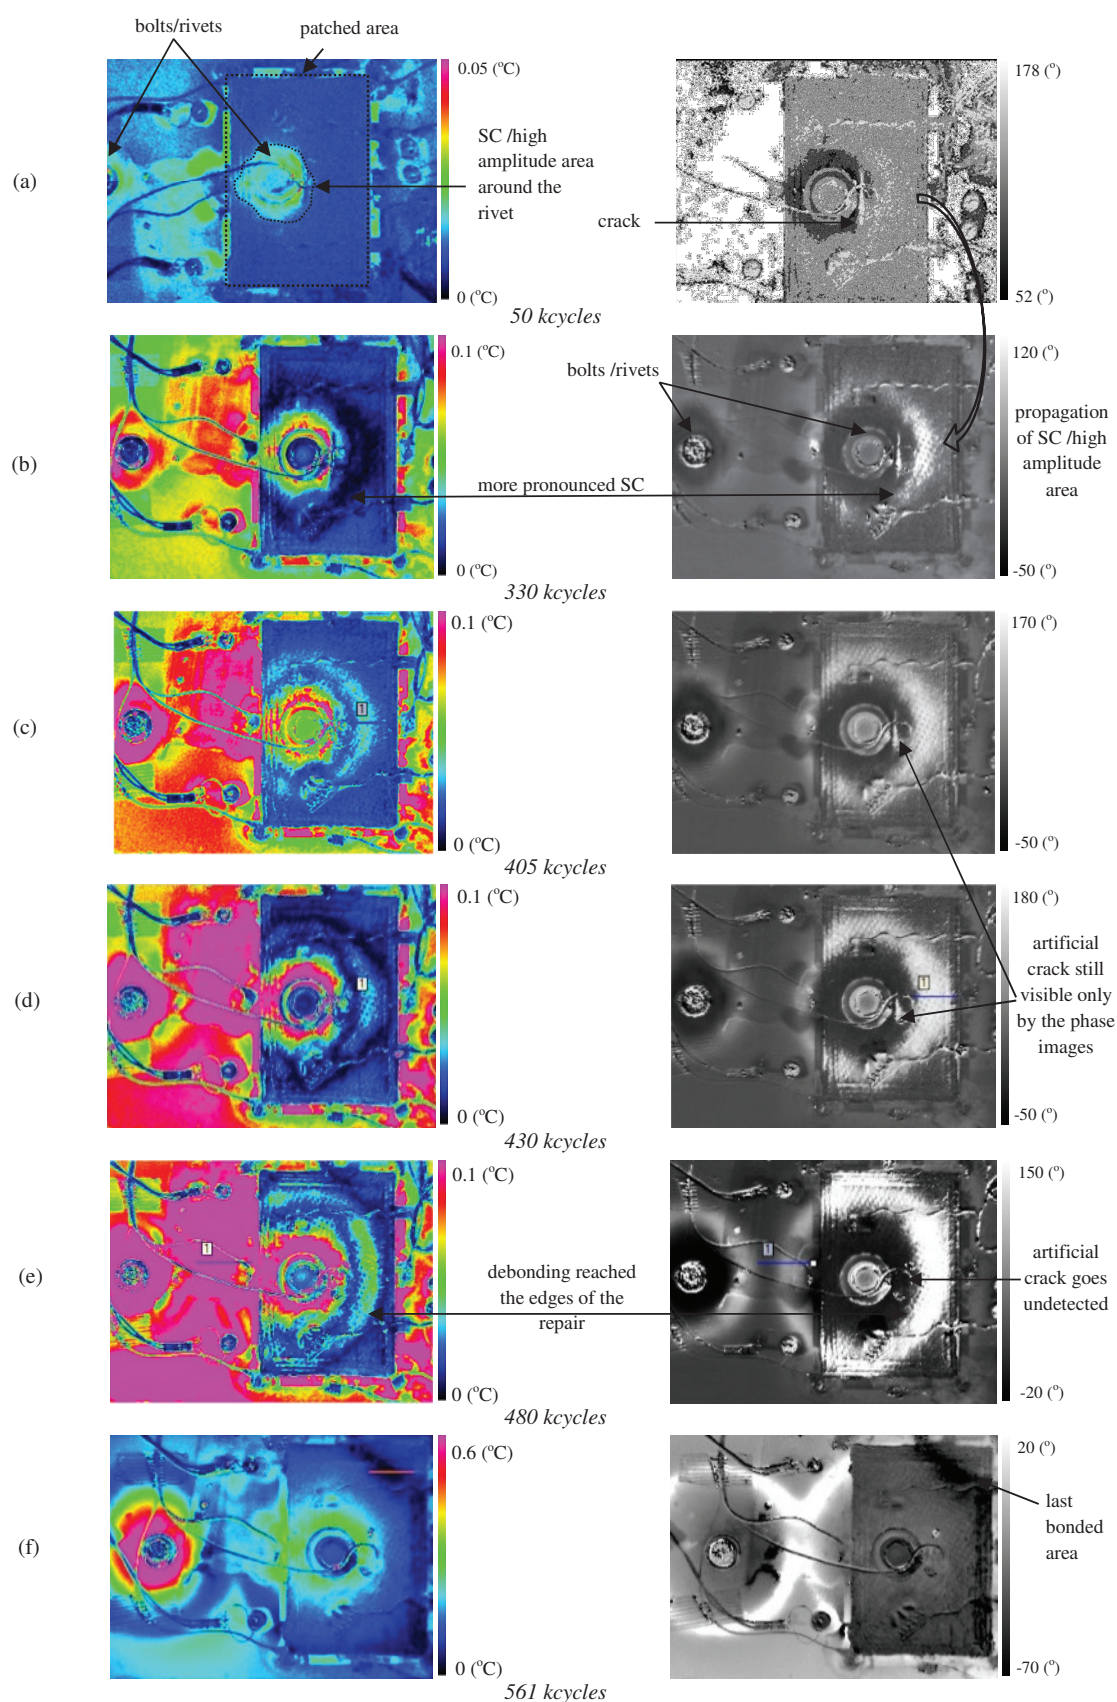
Figure 17: Amplitude (left-hand side) and phase (right-hand side) images.

cially induced crack is not discernible, suggesting that the patch eliminates locally induced stress concentrations. At 50 kcycles, the phase and amplitude gradients become significant and in both lock-in (magnitude and phase) images (Figure 17a) the crack was visible. In the phase image, the full length of the crack can be seen. This is not the case for the amplitude image, probably because the surface topology inhibits the observation of internal defects. As the load level increased, stress concentrations around the rivet became more pronounced. The relative phase and amplitude gradients increased, suggesting a substantial increase of the stress concentration in the region surrounding the rivet. At 330 kcycles (Figure 17b) a dark region was detected in the amplitude image. The same region was clearly presented with bright color by the phase one. With the increase in load level and fatigue progression this behavior became more prominent with the enlargement of the dark region shown in the amplitude imprint as well as its gradual shifting towards the horizontal axis of the image (Figure 17c). At 430 kcycles (Figure 17d) the dark region on the amplitude image reached the right edge of the patch. This is verified by the phase image (430 kcycles), which shows an extended bright area which propagates to the tapered right edge of the patch.

This gradual radial propagation of stress concentration areas with the same profile was noted, as fatigue loading continued. At 480 kcycles (Figure 17e), the area with increased stress concentration caused by the bolted joint, reached the left (as indicated on the image) edge of the patch. The same behavior consistently continued up to the final loading step of the fatigue testing (Figure 17f) at 561 kcycles. At the acquired last lock-in images (Figure 17f), only a small dark region is presented on the right upper corner of the patch. This was considered as the last bonded area of the patch. For this reason, it was decided to stop the test process and verify this observation with c-scanning of the patched area. The verification with ultrasonic imaging would assure the effectiveness of the thermographic method on monitoring damage initiation and propagation during service.

A closer examination of the whole lock-in image sequence denotes that besides stress concentration around the patched rivet, circularly-shaped high intensity areas were recorded around the patch-free rivet. It is noteworthy, that as the last recorded lock-in images indicate, the mechanical stresses /high amplitude areas have diminished from the patched rivet. This observation suggests the following (and probably complementary effects): i) complete stress relaxation on the patched area and ii) complete failure of the patch /substrate interface. The latter inhibits the visibility of high amplitude areas /stress concentrations around bolted joint which are clearly identified around the un-patched rivet area (Figure 17f).

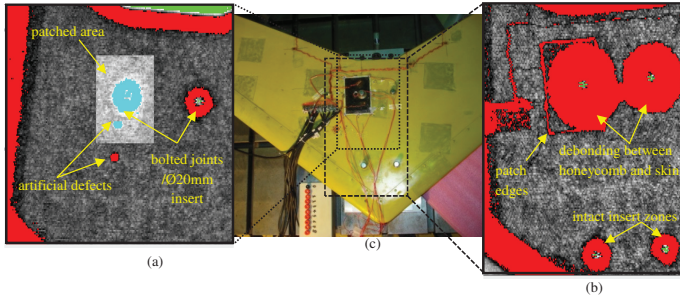
As is shown in Figure 19a where the C-scan of the repaired stabilizer prior to testing is shown, the rectangle-shaped CFRP patch can be seen upon the  $\varnothing 20\text{mm}$  insert. The patched and unpatched cylindrical insert, where the rivets are fixed are well discerned and, in addition, two artificially induced flaws (simulating manufacturing defects) were also visible. On the contrary, in the post-testing C-scan imaging, the patch goes totally undetected. Only the edges of the patch can be seen, at the very same external areas where sealant tape was placed to prevent from water penetration after immersion in the C-scan tank.

Together with the edges of the patch, the debonded honeycomb /skin interface is well verified with ultrasonics. Fatigue mechanical testing led to the detachment of the internal core of the stabilizer from the aluminum skin, at the very same areas where the cylindrical inserts of the rivet /bolted joints are located. Figure 20 shows an overlapping of an optical, the final phase and the post-testing C-scan image. The areas around

Figure 19: Ultrasonic images of the stabilizer (a) prior and (b) post testing, (c) repaired wing stabilizer.<sup>1</sup>

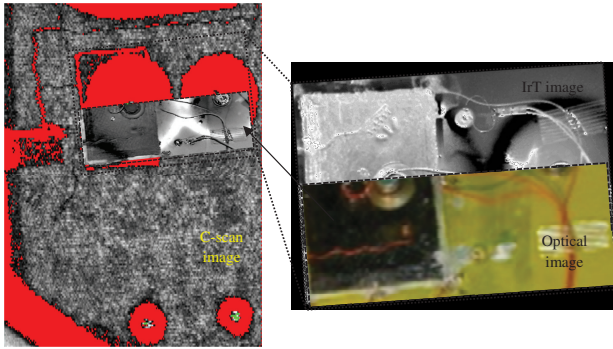
Figure 20: Overlapping of ultrasonic, optical and thermographic images.<sup>1</sup>

the inserts /rivets which exhibited high amplitude areas/stress concentrations can be identified and correlated both via the ultrasonic and thermal imaging. It is also worth mentioning that the area in the vicinity of the other two bolted joints remained intact after the test procedure (discernible in the C-scan image and Figure 19b).
