Continuous debonding monitoring of a patch repaired helicopter stabilizer: damage assessment and analysis

PAVLOPOULOU, S., GRAMMATIKOS, S.A., KORDATOS, E. Z., WORDEN, K.,
PAIPETIS, A.S., MATIKAS, T.E. and SOUTIS, C. (2015). Continuous debonding
monitoring of a patch repaired helicopter stabilizer: damage assessment and
analysis. *Composite Structures*, 127, 231-244. [Article]

S. Pavlopoulou^{a,*}, S. Grammatikos^b, E. Z. Kordatos^c, K. Worden^d, A. Paipetis^e, T. Matikas^e, C. Soutis^a

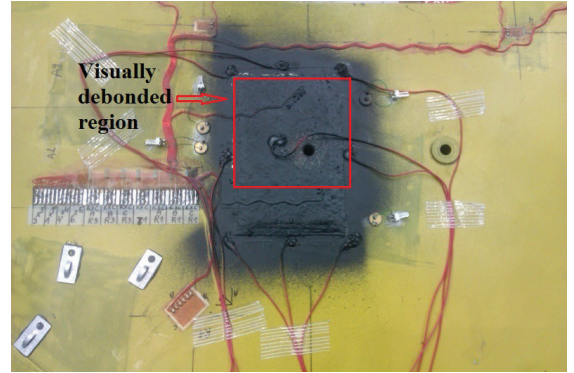
Figure 8: Final debonding after 580,000 cycles of bending fatigue testing.

After 580k fatigue cycles, at the end of the test, a clear debonding could be visually observed as illustrated in Figure

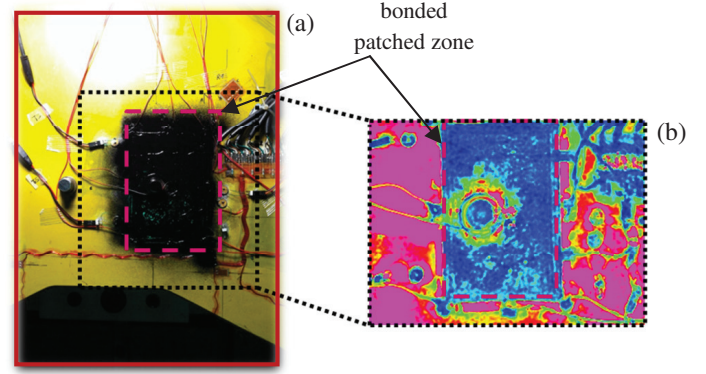
Figure 16: (a) Monitored area, (b) representative thermographic image.¹

Starting with the first lock-in amplitude image in 16b, the applied bonded patch is clearly identified. As may be observed next to the bonded patch, the piezoelectric sensors for Lamb wave monitoring may be discerned. The rivet/bolted joint thermal imprint is also clearly visible. Moreover, a relatively small high amplitude or stress concentration area around the rivet was acquired. The rest of the patched area does not exhibit any significant variations, suggesting a uniform temperature and stress distribution all over the bonded zone. At this stage, the arti-

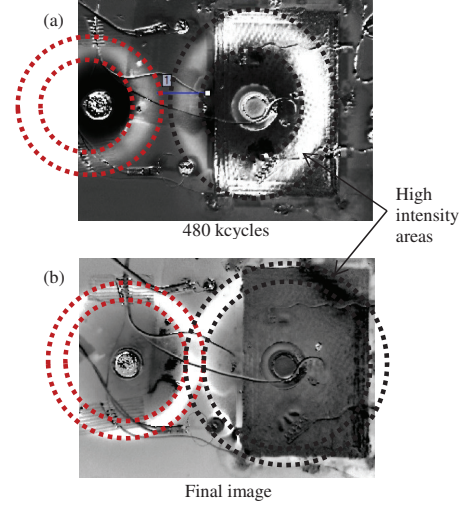
Figures 18a and 18b depict a comparative evaluation between a lock-in image at 480kcycles and the one acquired at the final stage. The stress concentrations around the bolted joints of Figure 18a form patterns possessing a radial symmetry. These circular patterns indicate high amplitude areas/stress concentrations both in the unrepaired and the repaired rivet sites. Mechanically-induced stresses around the patched joint can be distinguished, due to the fact that the patch remains bonded on the substrate. However, this is not the case in the final recorded

Figure 18: Lock-in phase images at (a) 480kcycles and (b) 561kcycles (final stage).

image (Figure 18b). After the almost complete separation of the patch, the suggested high amplitude /stress concentration areas were not detected on the patched zone. To further elucidate the above statements, circles showing the presence (or absence) of stress concentration areas around the bolted joints were drawn (Figures 18a and 18b). The centers of the drawn circles correspond to the position of the rivets (unpatched-left side and patched-right side).

Moreover, the juxtaposition of images in Figure 18 denotes that the diameters of the figurative high amplitude /stress concentration circles around the rivets have increased. This suggests that apart from the degradation of the patch /substrate interface, a second deterioration mechanism may be present; as the interrogated vertical stabilizer is a sandwich structure, it is highly probable that the local stress concentration also invoked the failure of the interface between the honeycomb and the aluminum skin. Ultrasonic imaging verified this hypothesis.

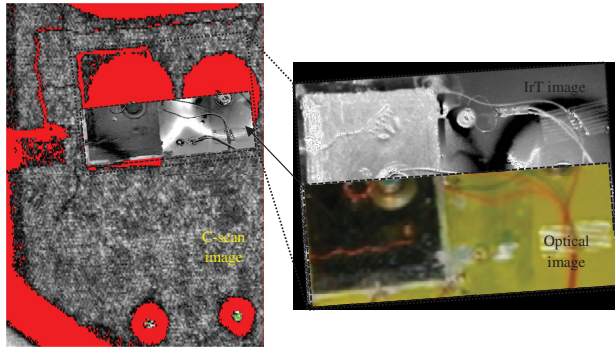
Figure 20: Overlapping of ultrasonic, optical and thermographic images.¹

the inserts /rivets which exhibited high amplitude areas/stress concentrations can be identified and correlated both via the ultrasonic and thermal imaging. It is also worth mentioning that the area in the vicinity of the other two bolted joints remained intact after the test procedure (discernible in the C-scan image and Figure 19b).
