Case Study: Wear Mechanisms of NiCrVMo-steel
and CrB-steel Scrap Shear Blades

Case Study: Wear Mechanisms of NiCrVMo-steel and CrB-steel Scrap Shear Blades

Abstract

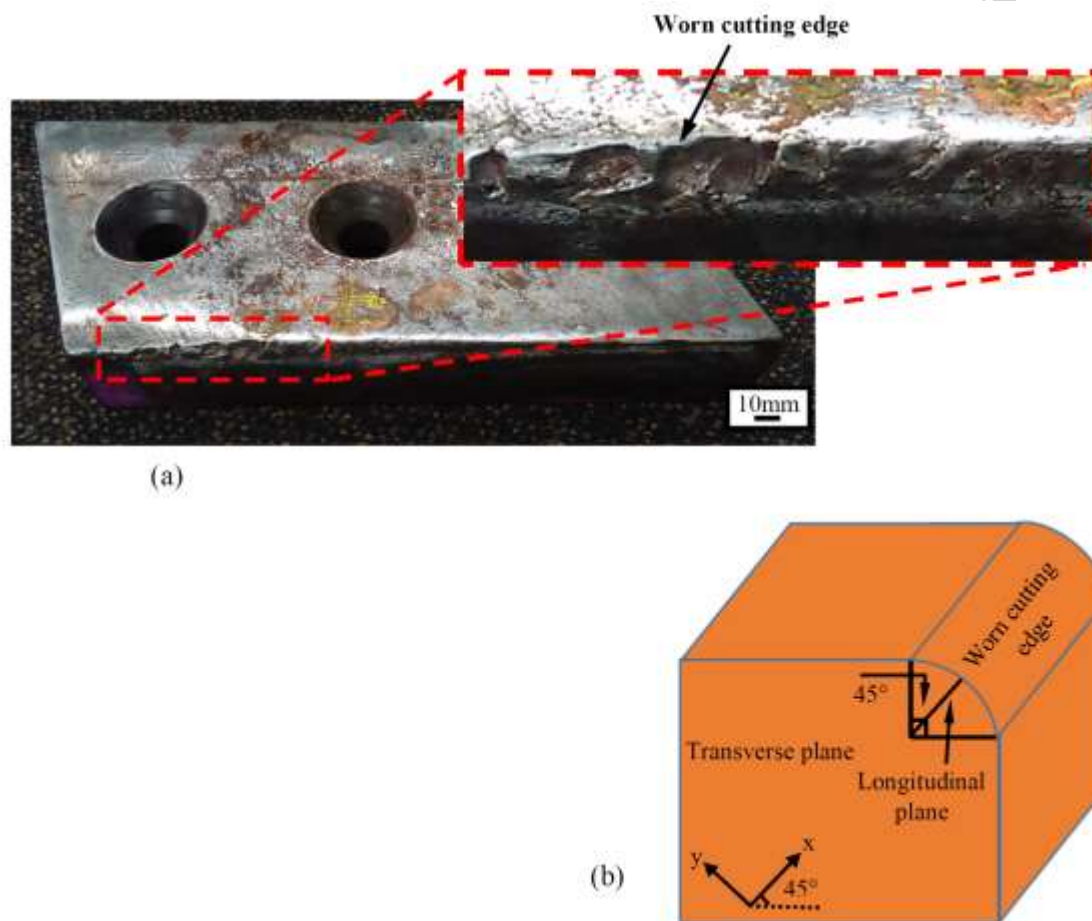
Fig. 1, (a) A typical worn blade, (b) Schematic illustration of worn edges and the direction of transverse and longitudinal planes for characterisation.

Visual inspections of worn blades showed that the wear was mainly related to sharp cutting edges so that curve shaped edges were formed due to wear (e.g. Fig. 1). The curve shaped edges (i.e. worn edges) had a radius of about 8.0 to 11.5 mm which consisted of local dents. The dents were occasionally observed in CrB blades, whereas a high frequency of them appeared in NiCrVMo blades.

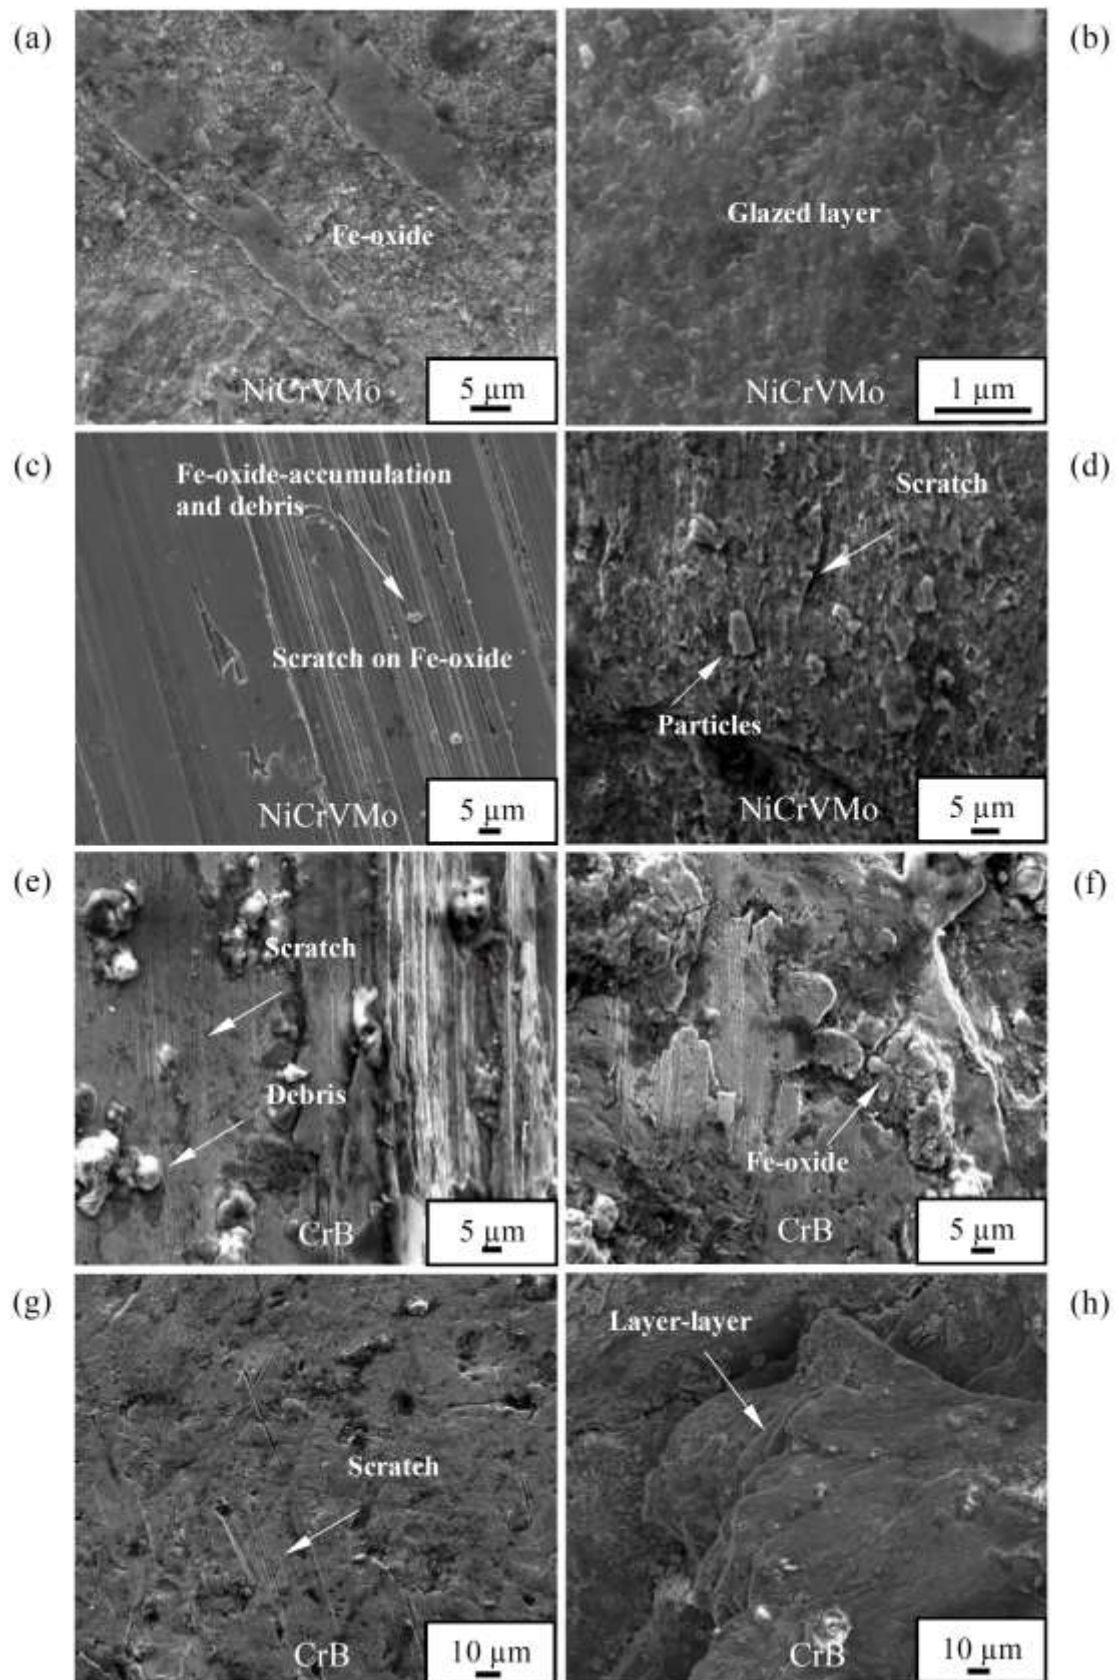
Figs. 5 and 6 show SEM micrographs corresponding to the topmost surface of worn cutting edges in both blades. Smooth worn areas with wear tracks (scratches) were frequently observed in both blades, indicating an adhesive/abrasive wear. Further SEM (SE and BSE)-EDS analysis revealed the presence of Fe-oxide accumulated debris/particles and a non-continuous tribo-oxide layer on these regions of both blades, suggesting an oxidation wear (e.g. Fig. 6). It is clear that the presence of debris/particles on the surface could enhance an abrasion wear during scrap shearing process.

Figs. 5 (h) and 6 (e) indicate typical layer-layer features and fracture regions on the topmost surface of worn areas in studied blades. Microscopy observations suggested different frequencies of these features in two blades so that a higher frequency of fracture regions appeared in NiCrVMo blades, while CrB blades usually showed layer-layer features. Further SEM observations assisted by tilting along transverse direction of these features revealed the presence of initiated cracks from the topmost surface through subsurface deformed/elongated and/or white etching areas. Clearly, these features are associated with spalling and this will be further clarified in section 3.4.

Fig. 5, SEM micrographs corresponding to the topmost surface of worn cutting edges in NiCrVMo and CrB blades.

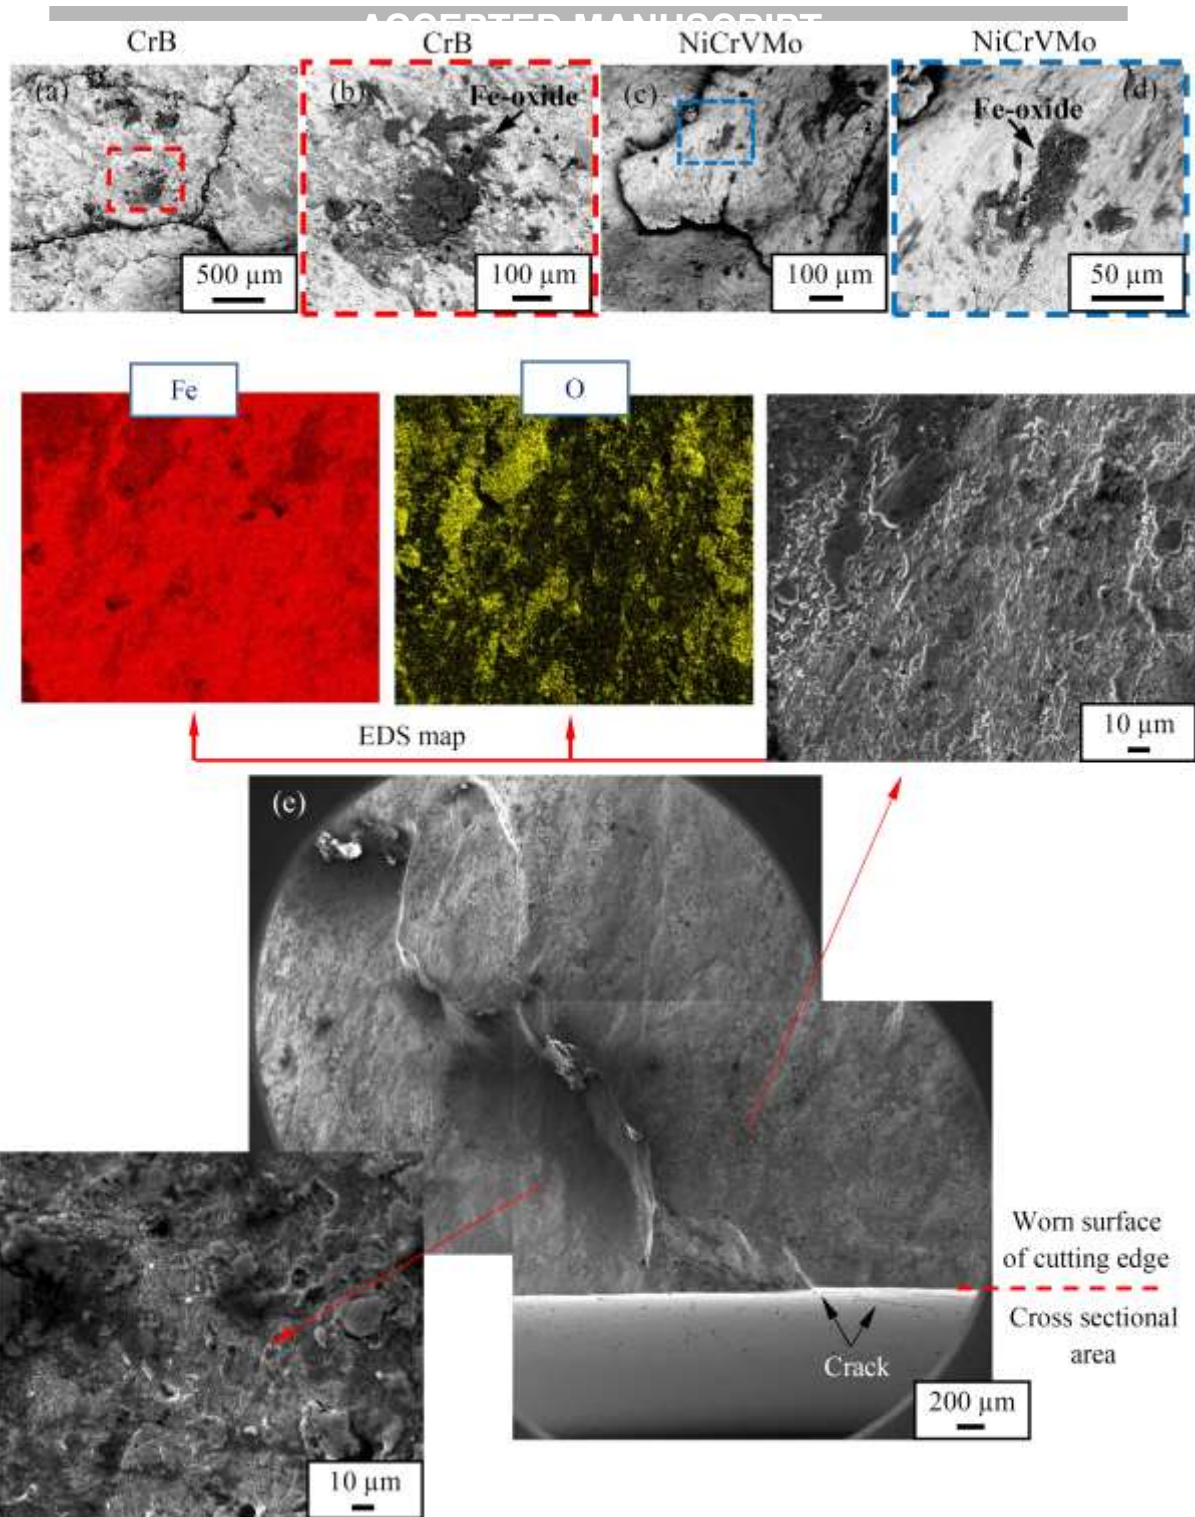
Fig. 6, SEM micrographs corresponding to the top surface of worn cutting edges, (a) to (d) BSE images, (e) Selected SE images and corresponding EDS map, showing the presence of oxygen rich areas (NiCrVMo blade).

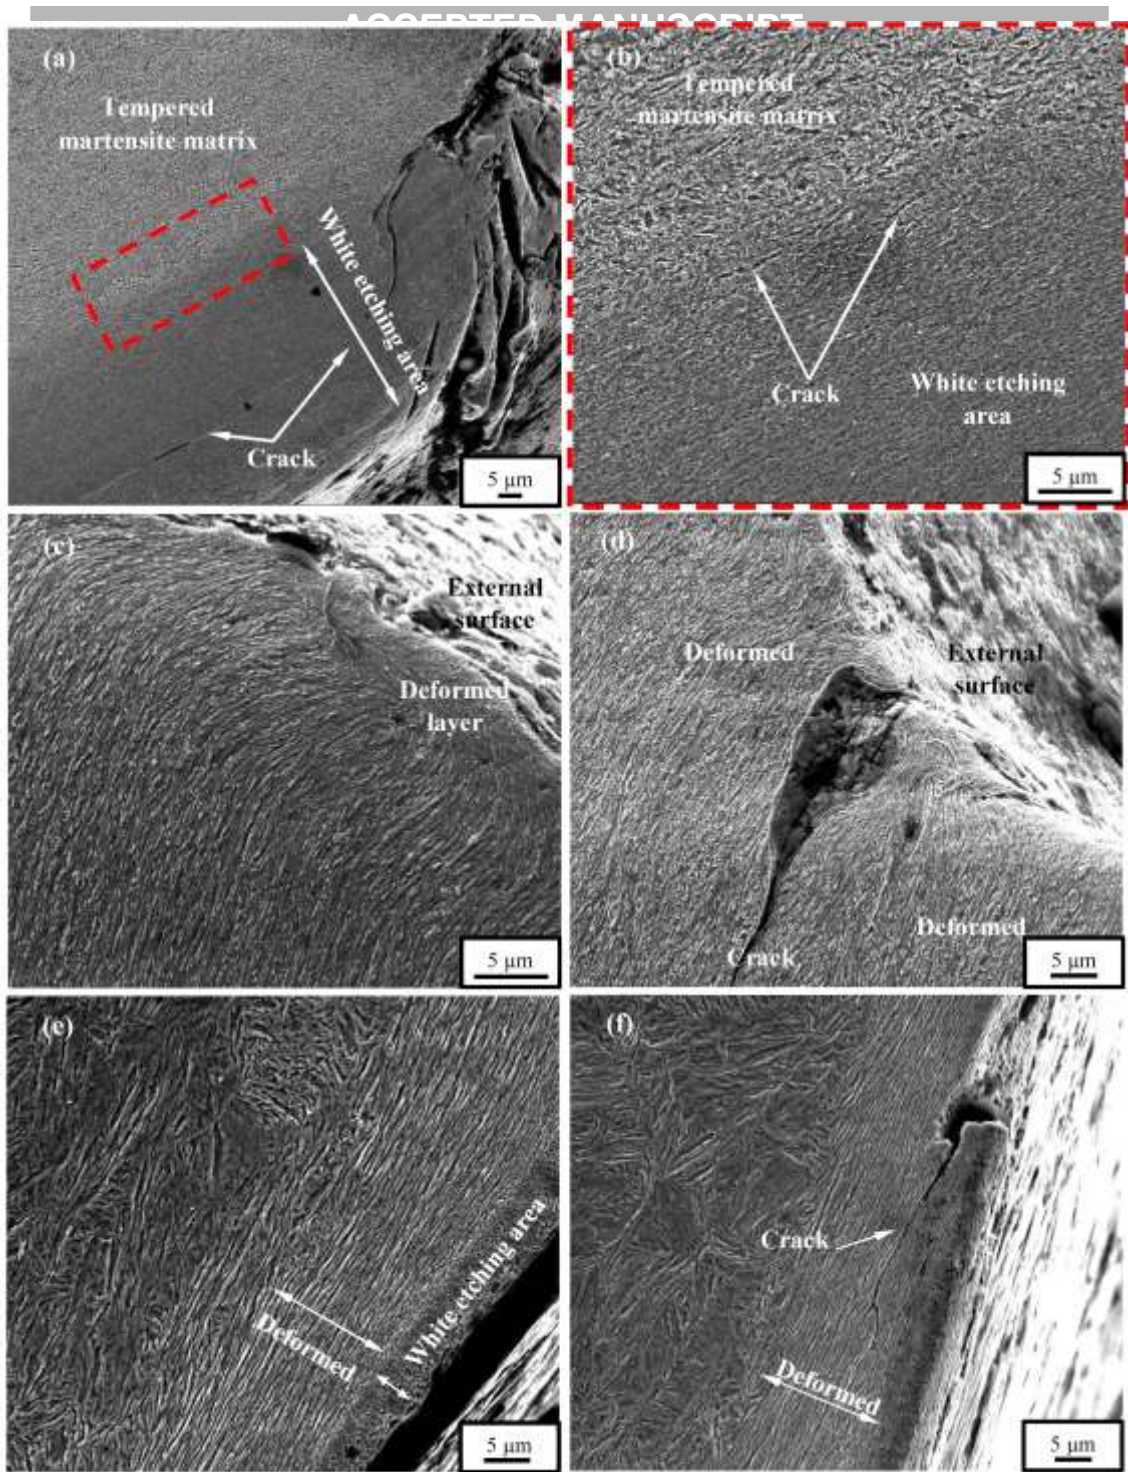
In Fig. 8, a few selected SEM cross-sectional images show typical damages at the surface layers of worn blades. Both examined blades showed a plastically deformed/elongated layer on the worn surface. The microscopy observations indicated that this layer is non-continuous so that they were appeared locally at different regions of samples. However, the results suggested a larger frequency of these areas at worn cutting edges of CrB blades compared to NiCrVMo blades.

Fig. 8, SEM micrographs, showing tribolayer and elongated/deformed areas below worn cutting edges, (a) to (d) NiCrVMo blade, (e) and (f) CrB blade.

The first type of spalling took place within the depths of severely deformed layer (e.g. Fig. 8 (f)). In fact, shear deformation increases due to wear is accompanied by a dislocation pile-up in the subsurface [32]. Therefore, further sliding of mating surfaces likely caused a micro-crack initiation and propagation under a combined tensile and shear mode in deformed regions until the final fracture [33]. It has been also reported that cracks can be formed under impact loadings in subsurface features of worn surfaces [34]. A cyclic loading at high strain amplitudes on contact areas of cutting edges during shearing process could lead to surface fracture. It can be thus inferred that the surface spalling due to delamination wear could primarily result from repetitive sliding/impact loadings during shearing process.

The second type of spalling happened due to the formation of white etching bands, where the white etching bands could be either in the outmost worn surface (e.g. Fig. 8 (a)) or in the subsurface (Fig. 9). As pointed out earlier in section 3.5, these regions have a considerably higher hardness compared to the matrix. The observed difference between the hardness of matrix and white etching areas leads to a higher stress concentration in these areas. Presumably, a repeatedly striking/sliding during shearing process could result in crack initiation and propagation and consequently cause surface spalling. Our results evidenced the presence of cracks through subsurface white etching areas demonstrated that this mechanism significantly contributed in the formation of deep cracks and consequently material removal, especially in NiCrVMo blades. It is thus clear that the material removal from surface was considerably accelerated by white etching areas. Similarly, Zhang et al. showed that surface and subsurface white etching areas in a tempered-martensitic structure of low

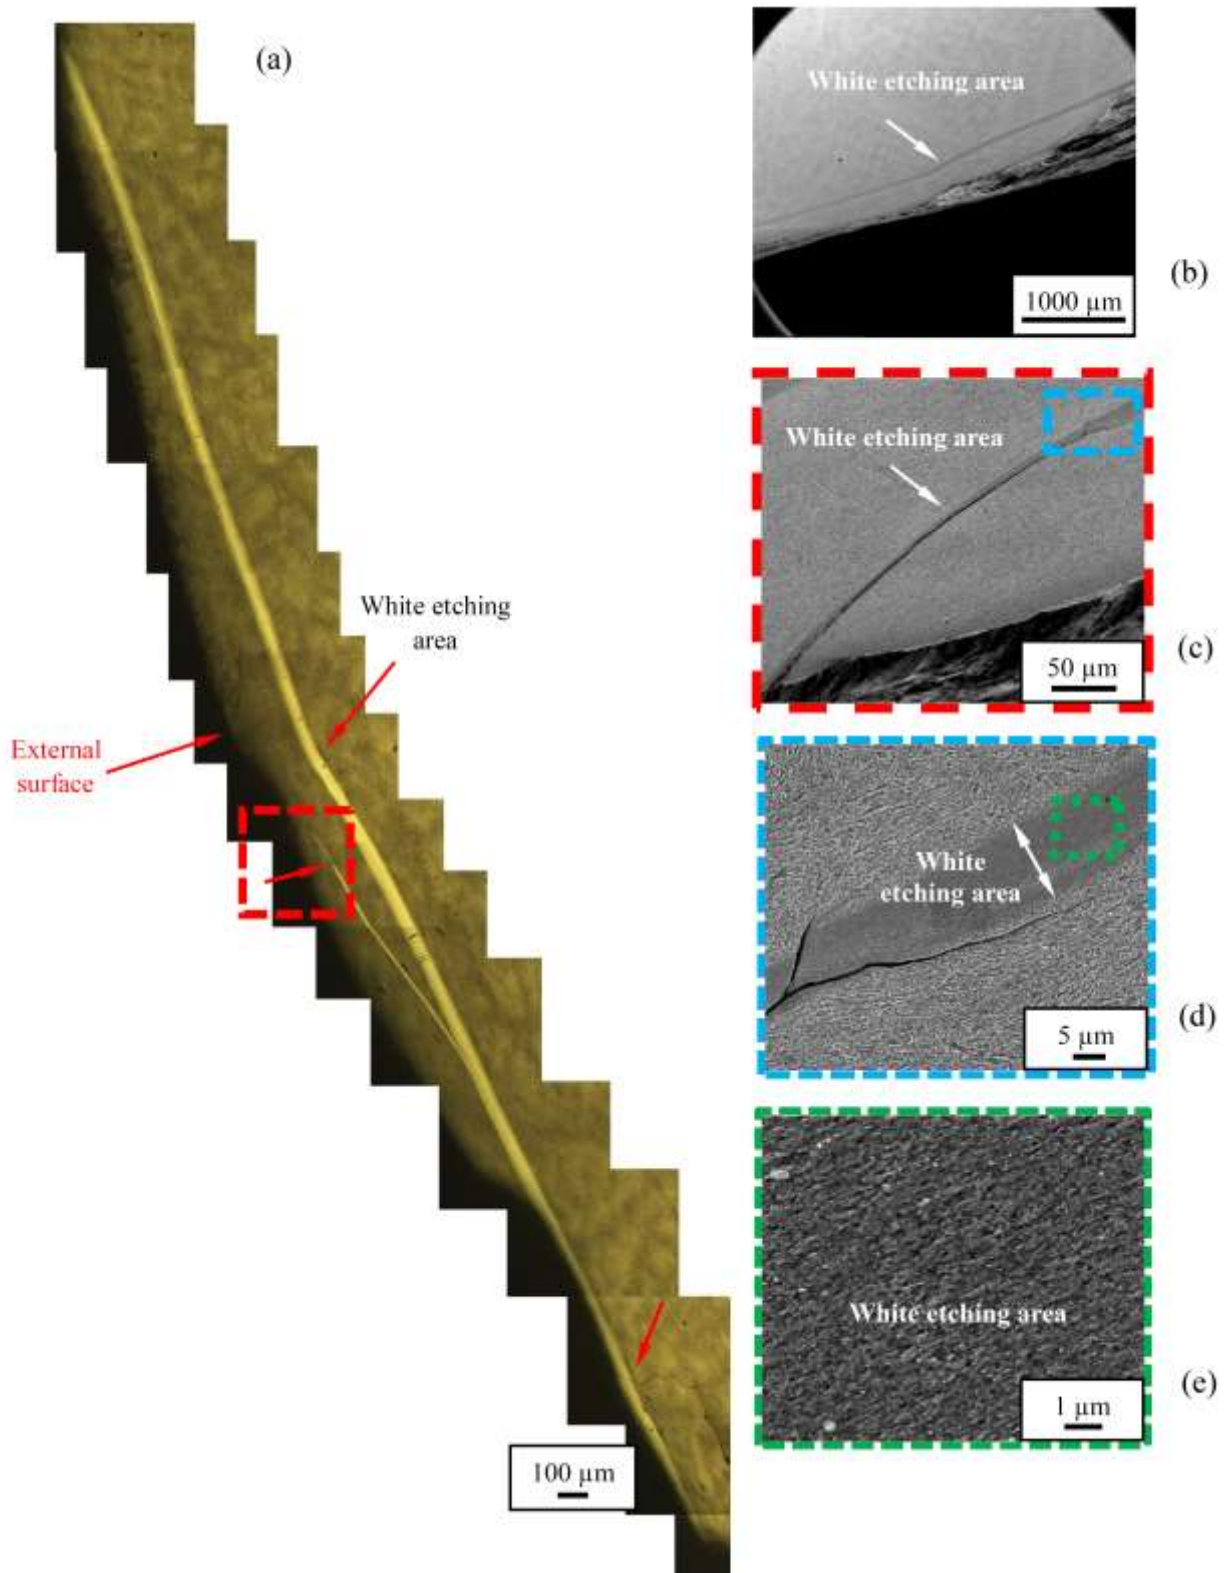
White etching layers/areas were not only found on the worn cutting edge surface, but also in subsurface regions (Figs. 8 and 9). Nevertheless, white etching areas on the worn cutting edge surface and subsurface were hardly observed in CrB blades, while they frequently appeared in NiCrVMo blades, especially in subsurface areas (e.g. at a depth of about 200 μm beneath the worn blade surface). In many places, the white etching layers were found to co-exist with parallel or inclined cracks that these cracks are associated with surface spalling. Such spalling within the depth of white-etching layer is shown broadly in Figs. 8 (a), and more precisely in Fig. 9, where the thickness of spalling particles is in sub-mm scale.

SEM observations also showed arrested cracks in the NiCrVMo steel matrix that had been deflected from subsurface white etching areas (Fig. 9 (d)). It is evident that white etching areas with a thickness of about 10-30 μm precede crack initiation and propagation. Additionally, microscopy analysis did not demonstrate a considerable growth and coalescence of such cracks through the matrix. It is clear that the tempered martensite matrix of NiCrVMo-steel blades could effectively retard crack propagation during wear.

Fig. 9, (a) Optical micrograph of an etched sample, showing the presence of subsurface white etching areas in a NiCrVMo blade, (b) to (e) SEM micrographs corresponding to the white etching area in (a).

Moreover, the formation of white etching layers at certain depths below the surface suggested a mechanism that could enhance a subsurface severe localised deformation (Fig. 9). Such behaviour reflects the applied loading circumstances. In fact, worn edges was subjected to repeated impact and compressive loads so that the blade exhibited low rate of progressive wear caused by abrasive and adhesive wear. As a result, a maximum shear stress was caused at a certain depth for a period of repeated loading. In other words, repeated strong impacting is a major loading characteristic. Also, the lower toughness of NiCrVMo steel (i.e. ~10J) during high strain impact/compressive loading conditions could enhance localised severe deformations along shear bands, resulted in subsurface white etching layers formation [54]. This is in agreement with the findings of other researchers who also reported that white etching layers can be extensively formed in low toughness tempered-martensite steels during dynamic compressive deformations [55]. They showed that a lower absorbed compressive deformation could be responsible for the formation of white etching (adiabatic shear) layers.

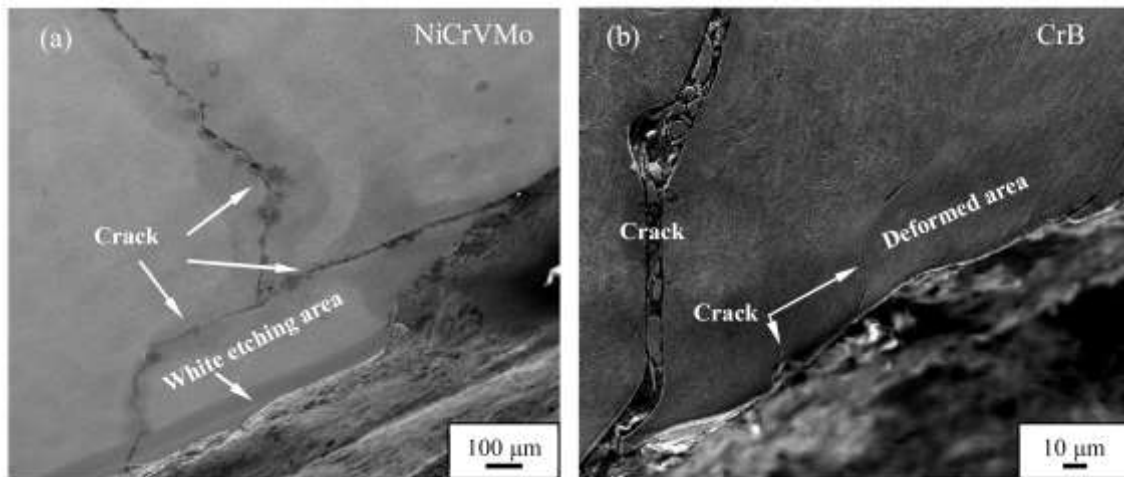
Fig. 10 shows cracks almost perpendicular to the worn surface that have penetrated deeply up to several millimetres (e.g. 1 to 3 mm) into both blades. These cracks were mainly initiated from

severely deformed areas or white etching layers that could have led to the generation of spalling and delamination wear particles. Some cracks were even opened to have some external solids inserted inside. Such cracks could have been produced after the blade was repeatedly subjected to severe impact loads. Further microhardness measurements indicated that the surrounded regions of crack tips had a lower hardness compared with the matrix (e.g. ~46 HRC). However, comparative SEM-EDS analysis of these areas and matrix did not show any significant difference in their microstructure and chemical composition.

Fig. 10, SEM micrographs corresponding to worn areas, showing propagated cracks from deformed and white etching areas through the material.

The third type of spalling was caused by deep cracks almost normal to the outermost surface of worn cutting edges, frequently surrounded by a relatively lower hardness region (Fig. 10). These cracks were mainly initiated from severely deformed layers or surface white etching areas. It is thought that localised deformations and frictional temperature increases might soften the material which encouraged the crack tip growth through materials [35]. However, these cracks could result in large wear particles and left macro-scale dents on the worn cutting edge.

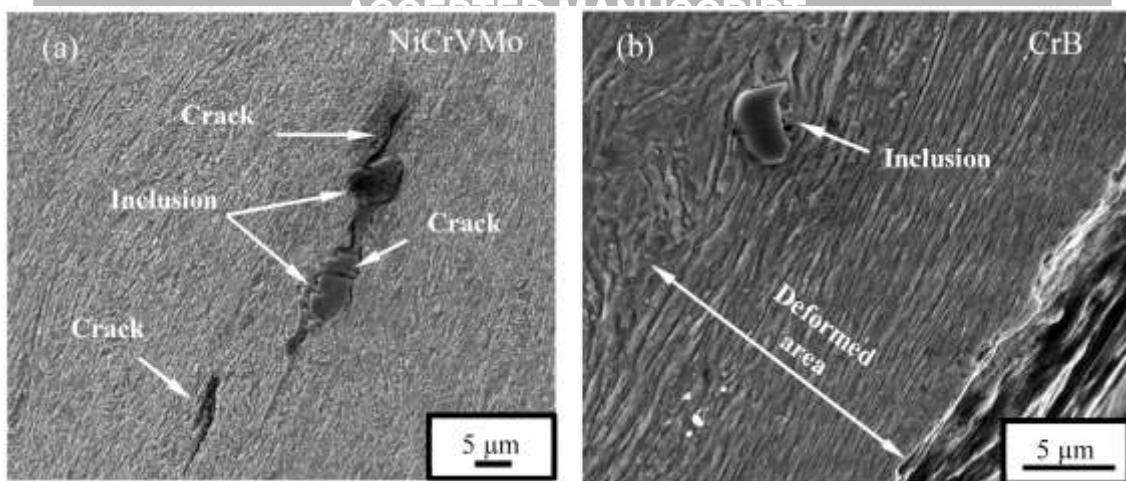
The behaviour of non-metallic inclusions in the wear failure was also examined carefully. Two typical cross-sectional micrographs containing such inclusions are shown in Fig. 11, exhibiting the presence of inclusions in deformed areas just below worn surface. The inclusion in Fig. 11 (a) has been determined to be rich in Mn-S-V using SEM-EDS. Several short cracks were found both inside the inclusion and along its boundary to the matrix. The cracks were enveloped inside the inclusion itself, i.e. without any lateral propagation into the adjacent matrix. This behaviour was observed in almost all of inclusions regardless their morphology and size in NiCrVMo blades. It has been established in the literature that large and incoherent particles/inclusions necessitate a lower amount of subsurface deformation for crack initiation [20,21,22,23]. However, SEM analysis rarely showed initiated cracks from inclusions in CrB blades (e.g. Fig. 11 (b)).

Fig. 11, SEM micrographs, showing non-metallic inclusions in subsurface deformed areas, (a) NiCrVMo blade, (b) CrB blade.

Small propagated cracks from interfaces of non-metallic inclusions through the matrix were extensively observed only in NiCrVMo blades. In fact, mobile dislocations generated by the applied loads during shearing process can be blocked and piled up by inclusions [20,36,37]. Presumably, this is stronger than the cohesive strength of matrix and inclusion, and could enhance void/crack formations. Although there is no available data on the coherency of inclusions in this study, it is thought that the stronger cohesion between inclusions and matrix was likely the reason for the absence of cracks in CrB blades. Cracks were also observed through inclusions (e.g. V-Mn-S rich inclusions) in NiCrVMo blades (e.g. Fig. 11 (a)). Perhaps dislocation pile-up stresses can break hard particles which form small cracks [37]. However, our results did not show any large propagated cracks inside the matrix, suggesting that non-metallic inclusions did not contribute to wear in studied blades.

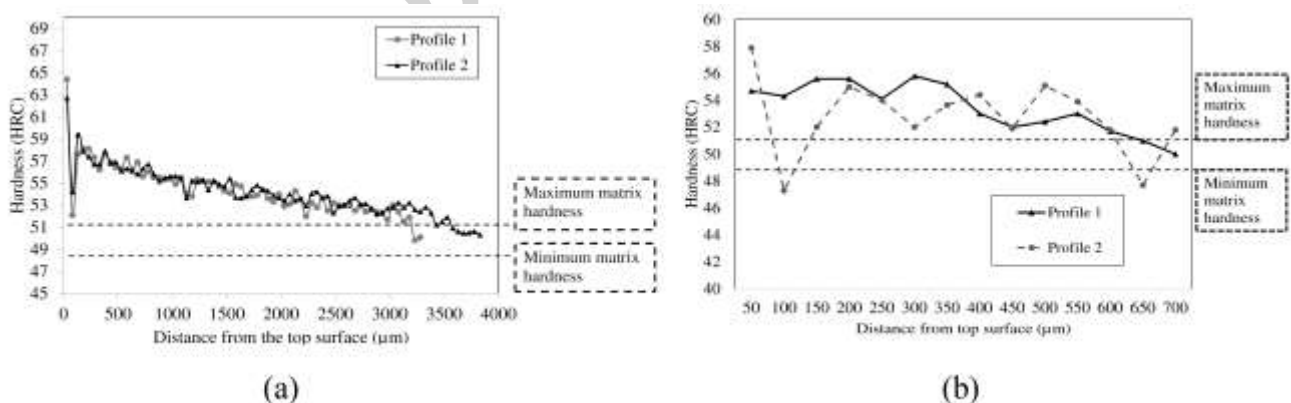
Using SEM and microhardness testing, the evolution of microstructure and hardness property from the worn surface to various depths were characterised. Fig. 12 shows the trend of hardness variations from the topmost surface of worn cutting edges along cross sectional area of both blades (see Fig. 1). The hardness values in NiCrVMo blade are related to white etching free areas, whereas in CrB blade the results include white etching (on topmost surface) and severely deformed layers. The results of NiCrVMo blades suggested a higher hardness values up to about 550 μm below the surface (average hardness of ~53HRC). Similarly, the microhardness analysis of CrB blades showed a gradual reduction from the topmost surface, i.e. up to ~4000 μm below the surface. Moreover, the hardness results of severely deformed (elongated) layer showed locally lower hardness compared to other areas.

Fig. 12, Hardness profile through the transverse direction planes below worn cutting edges (see Fig. 1), (a) CrB blade, (b) NiCrVMo blade.

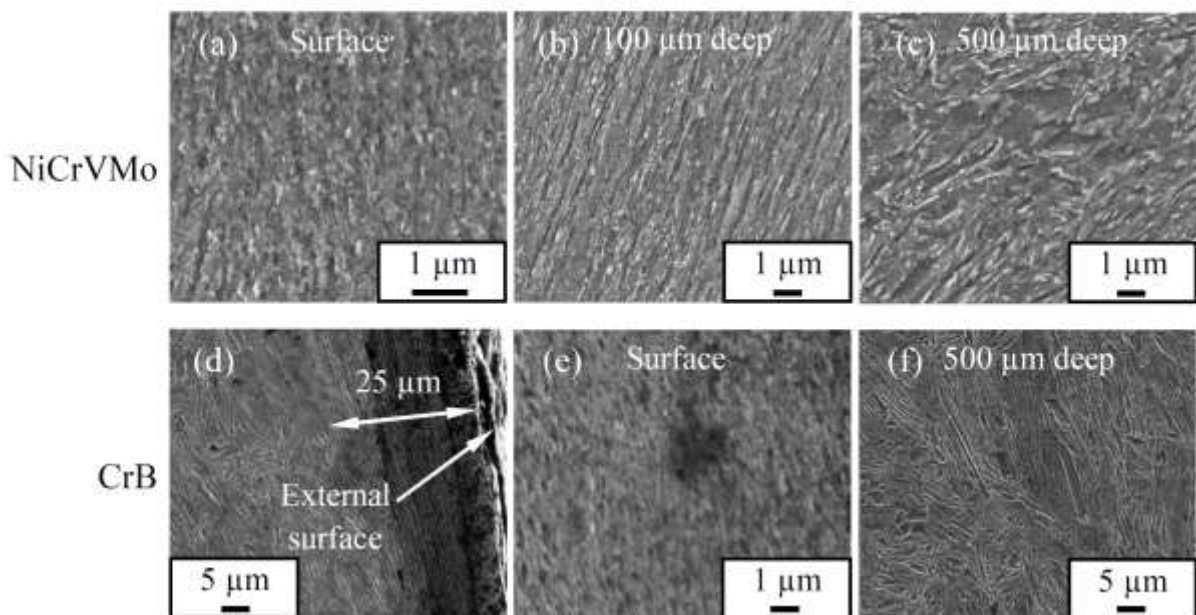
Fig. 13 shows selected SEM images taken at various depths (from a worn surface) of the NiCrVMo and CrB worn blade samples. The plastic deformation has been found to be non-uniform so that most of the imaged areas exhibit preferentially elongated microstructure along the orientation of the worn surface, whereas the less- or non-deformed structures appear in a few islands in deeper areas. The relative fraction of elongated region and its continuity increase towards the worn surface before entering the top layer of severely deformed microstructure. In the SEM imaged area, such deformed layer exhibited a thickness of maximum $\sim 100\ \mu\text{m}$, e.g. Figs. 13 (b) and (d). In the top layer, the entire volume shows a fibre-like microstructure with its elongation parallel to the worn surface. Note that most delamination cracks have been found to generate in such elongated layers, like the one shown in Fig. 8 (f). When the elongated layer was imaged at the best resolution of the FEG-SEM (Figs. 13 (a) and (b)), one can find that the microstructure has been completely replaced by the fibre-like distribution of extremely fine grains. In particular, most of the carbide precipitates exhibit nodular shape and sizes in nano scale. Moreover, microstructural observations and microhardness profiles below the elongated layer suggested that a steady state compressive deformation occurred and the hardness of both steels gradually decreased with distance increases from the topmost surface (Figs. 13 (c) and (f)).

Fig. 13, Selected SEM micrographs, showing the variation of microstructure at different depths below the topmost worn surface, (a) to (c) NiCrVMo blade, (d) to (f) CrB blade.

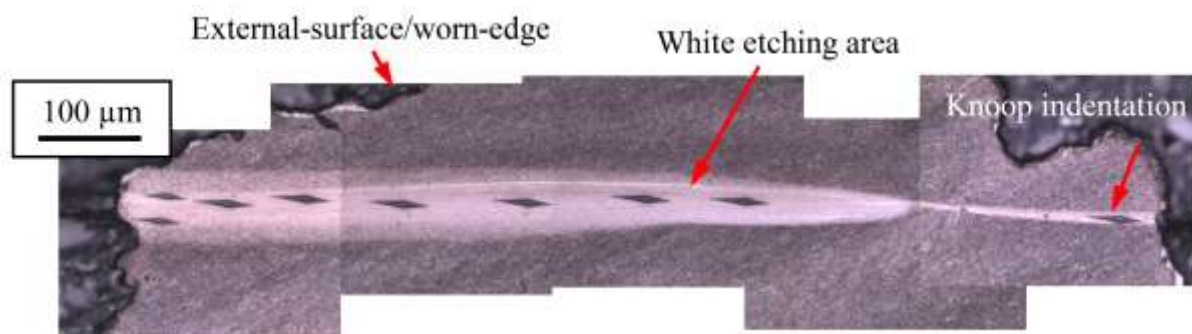
Microhardness measurements of surface/subsurface white etching areas showed a hardness of ~30 to 75% higher than the tempered-martensite matrix in NiCrVMo blades (i.e. ~65 to 88 HRC) (e.g. Fig. 14). Similarly, the hardness of white etching areas in CrB blade was ~25% higher than the martensitic matrix (i.e. ~62 to 65 HRC).

Fig. 14, Selected optical micrograph, showing the position of Knoop-microhardness indentations in a subsurface white etching area in the NiCrVMo blade.
