Spalling failure mechanism of a railway turnout made from carbide-free bainitic steel

LUO, Quanshun <<http://orcid.org/0000-0003-4102-2129>>, KITCHEN, Matthew, FARMILO, Nick, LI, Jianbin, LI, Wenbo and LI, Yanzheng

To be presented in 25th Int. Conf. Wear of Materials, Elsevier, Sitges, Spain, 13-17 April 2025

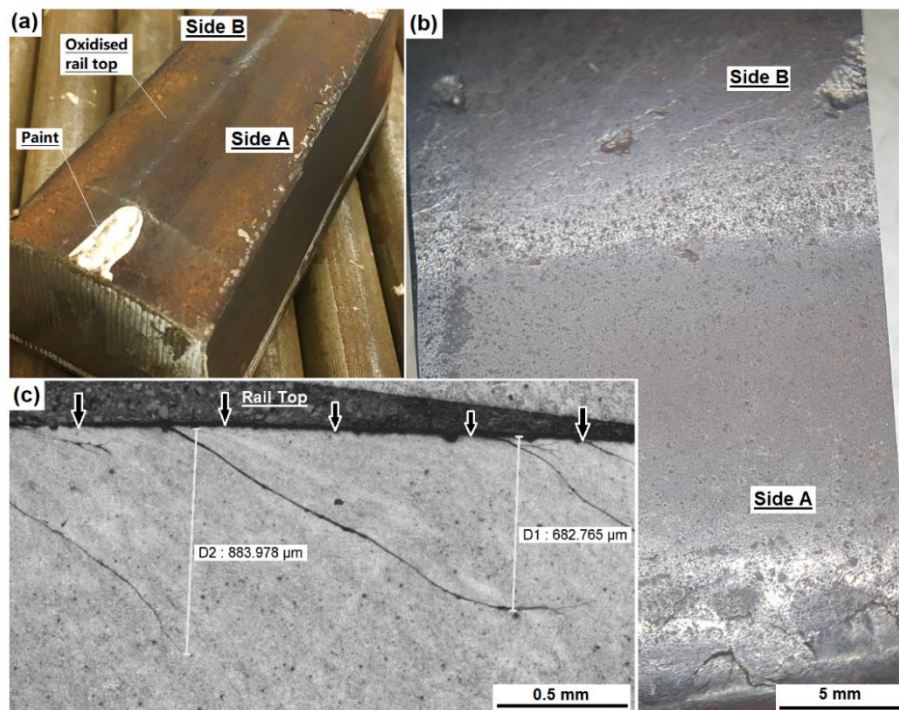
Several small pieces were cut transversely from the rest part of the longitudinal piece using an abrasive wheel cutter under water-based cooling, for cross-sectional analysis. These samples were prepared following a procedure of mounting in Bakelite, manual grinding on abrasive papers, and metallographic polishing to a mirror finish. The samples for microstructure observations were etched using a 2% nital etchant. Figure 1c shows an example of optical microscopy (OPM) observations of the etched cross-sections, where the surface cracks were seen to have propagated to a depth up to 0.9 mm.

Figure 1 The turnout to be analysed: (a) a photo of the rail top piece as well as several cylindrical bars machined from the bulk turnout; (b) a photo of the electrolytically clean rail top showing large spalling pits; (c) an optical microscopic image of the etched transverse cross-section showing propagation of cracks from the rail top to certain depths. The black arrows in (c) show the position of the rail top.

The spalling wear failure of the investigated turnout was found to include both thin delamination sheets and thick spalling pieces, as shown in Figure 1 and Figure 5. The formation of the small and thin delamination sheets revealed surface embrittlement following the accumulation of plastic deformation and subsequent work hardening of the rail top. The plastic deformation was evidenced by the nano-scale refined laminar-layered microstructure, as shown in Figures 11, 12 and 15. Such severe plastic deformation contributed to the measurement of ultrahigh microhardness along with the formation of a gradient hardness profile from the worn surface to certain depth, as shown in Figures 9 and 10. Crack nucleation and subsequent propagation were found to take place within the severely deformed and embrittled surface layer. In addition, the current work also revealed the formation of high compressive residual stresses in the worn surface. Such in-plane compressive stress is known to trigger a tensile stress perpendicular to the worn surface, which may have also contributed to the crack propagation.

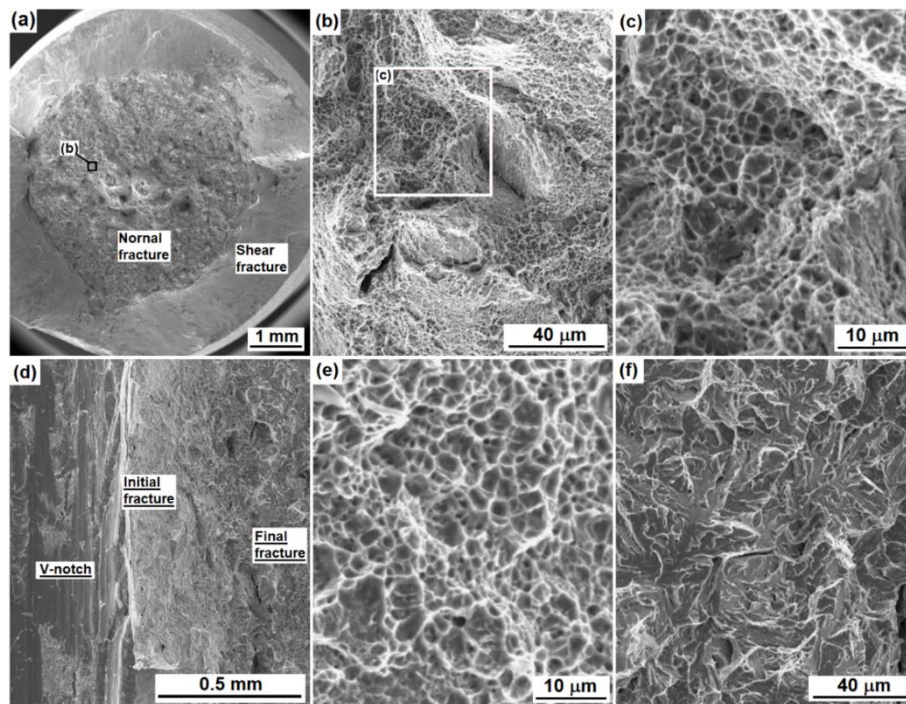
Figure 2 shows SEM observations of the obtained tensile and impact fractures. Under both testing conditions the steel exhibited microvoid coalescence features, typical of ductile fracture. The tensile fracture in Figure 2a shows fracture normal to the axis in the core part and shear fracture in the outer edge. Further higher magnification observations of the tensile fracture suggest voids-

Figure 2 SEM fractographic analyses of tensile and impact samples: (a-c) tensile fracture at various magnifications; (d) V-notch impact fracture at low magnification; (e) voids-type ductile fracture in initial fracture area; and (f) quasi-cleavage fracture in final fracture.

type ductile fracture, as shown in Figures 2b and 2c. Figure 2d is a low-magnification view of an impact fracture section, where the deformation grooves in the left-hand side show the machined V-type notch. The fracture initially exhibited the ductile voids-type mode, as shown in Figure 2e, followed by a transition to the less-ductile quasi-cleavage mode, as shown in 2f.

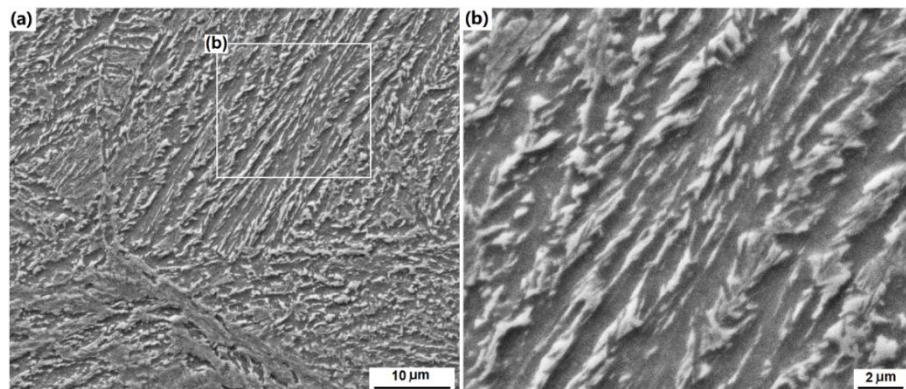
Figure 3 SEM images showing the bulk microstructure of the turnout: (a) the bainitic ferrite matrix and uniform distribution of retained austenite (in bright contrast); and (b) an enlarged image showing lath-like bainitic ferrite and inter-lath austenite.

Figure 3 shows the microstructure of the bulk bainitic steel about approximately 10 mm beneath the rail top. The steel exhibited a dual-phase microstructure of bainitic ferrite and retained austenite without appearance of any carbide. The inhibition of carbide precipitation should be attributed to the role of silicon as reported by many other researchers [2, 5, 24, 25]. Lath-like bainitic ferrite dominated the microstructure whereas retained austenite showed a morphology of either inter-lath films or blocks.

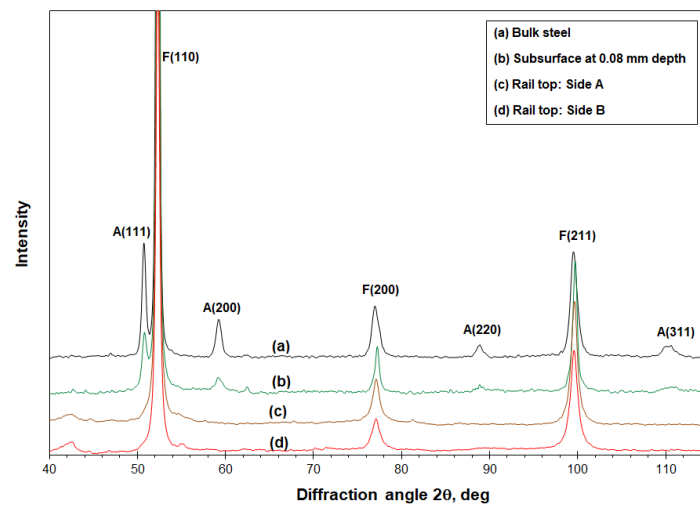
Figure 4 X-ray diffraction curves acquired at various locations: the bulk steel 10 mm beneath the rail top, subsurface at a depth of 0.08 mm, and rail tops on Side A and Side B (from top to bottom).

The diffraction peaks acquired in the bulk steel denote austenite free from plastic deformation, corresponding to a low hardness of HV_{0.1} 4.4 GPa. In contrast, the subsurface area shows decreased diffraction intensity of the austenite peaks. Accordingly, the microhardness measured at the depth of 0.08 mm has increased to HV_{0.1} 5.9 GPa. It is indicated in Figure 5 that significant strain hardening took place up to a depth of 1.4 mm. More interestingly, the uppermost worn surface showed no austenite peak at all, suggesting that the amount of retained austenite had become too small to be detected in the XRD acquisition. Furthermore, the maximum hardness was measured in areas where cracking was observed, however in areas that were free from cracks the hardness was lower. The increased hardness and decreased austenite at the rail top suggest that there was deformation induced transformation of the austenite to ferritic structure.

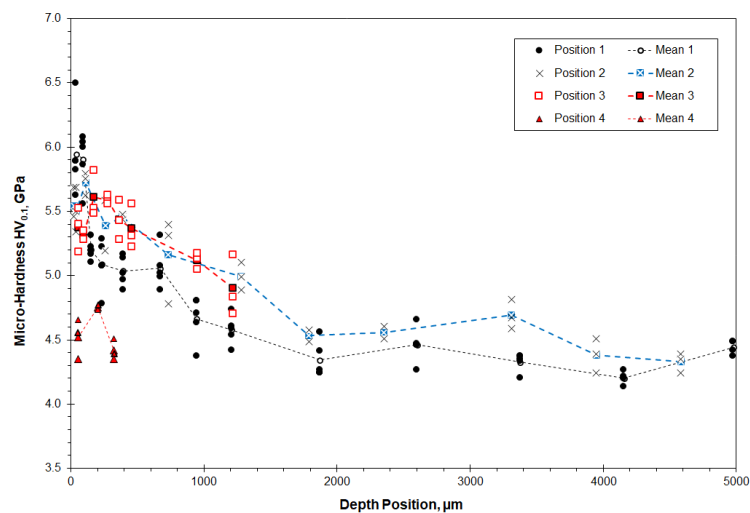
Figure 5 Microhardness plotted versus depth positions of the worn turnout: Position 1 and Position 3 refer to two areas exhibiting severe plastic deformation and cracking; Position 2 refers to an area exhibiting severe deformation but free from cracking; and Position 4 is a place exhibiting only mild plastic deformation and no subsurface cracking.

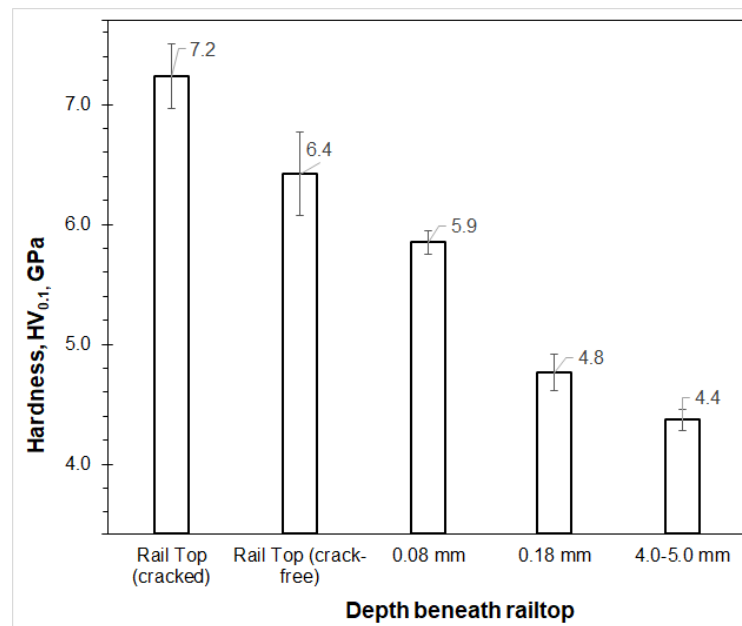
Figure 6 Microhardness property measured at various depths of the worn turnout.

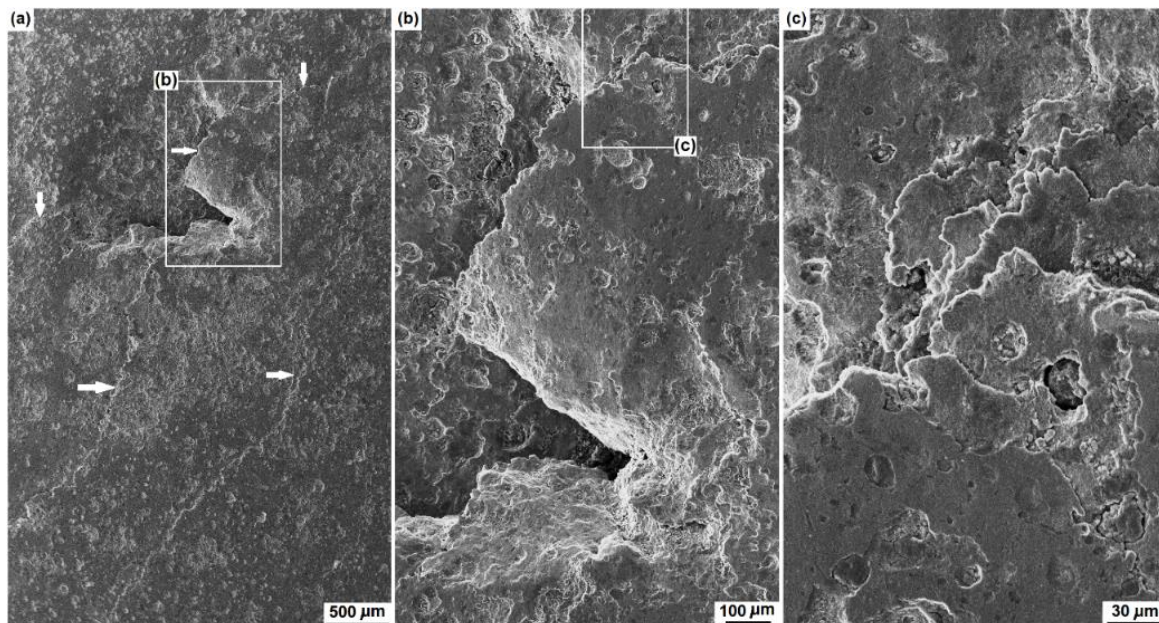
SEM observations were carried out on the rail top of the turnout, as shown in Figure 7. Figure 7a is an overview, where the rail top was found to be full of delamination pits. Several shear edges were marked by white arrows, indicating spalling wear. Macro-scale spalling pits are shown in Figure 7a and were observed at higher magnifications, as shown in Figures 7b and 7c. These features indicate brittle delamination of small fragments.

The shear edges in Figure 7a were related to subsurface cracks as shown in Figure 1c. To clarify this, the arc-shape rail top was flat-ground and polished at a low-angle inclined metallographic cross-section, followed by etching with 2% nital to show the subsurface microstructure within a very small depth range. Figure 8 shows selected results of SEM observations. In Figure 8a, the worn rail top shows a layered structure from the oxidised rail top (marked 'I'), an etching-resistant featureless top layer (marked 'II') and the severely deformed bainitic microstructure containing inter-granular cracks (marked 'III'). Further observation at a higher magnification, as shown in Figure 8c, revealed more details of the different regions at a better spatial resolution. The fine features in most of the imaged areas revealed the binary bainitic ferrite and retained austenite. EDX analyses of typical areas are shown in Figure 9, where the four spectra refer to the regions marked in Figure 8c. Spectrum 1 confirms the metallic nature of the bainitic matrix. However, the matrix had completely lost its regular lath-like morphology of the bulk steel (Figure 3) by exhibiting severely deformed shapes. Spectra 2 and 4 were acquired from the contaminants, indicating that the subsurface cracks and surface spalling pits had accommodated corrosion products as indicated by the higher O and C contents.

Figure 7 SEM images taken on the worn rail top surface: (a) A low-magnification overview of the relatively smooth worn surface and a spalling site. (b) A high-magnification view from the spalling edge. (c) A further high magnification view of the spalling failure showing brittle fragments on the facet worn surface.

The formation of thick spalling pieces was completed in three steps. Firstly, cracks were nucleated in the rolling/sliding worn surface of the rail top along with the formation of small spalling pits, as shown in Figure 7. The second step is very important as it shows that the cracks grew inside and followed the deformation induced laminar structure to gradually increasing depths, as shown in Figure 14. The severe deformation played a decisive role in promoting the crack propagation due to strain hardening and embrittlement, increased residual stresses and the laminated microstructure. Combined stresses arising from the applied cyclic rolling loads and residual stresses made the cracks propagate into the non-deformed matrix after propagating through the deformed and hardened surface layer, as shown in Figure 16. Finally, the cracks turned growing approximately parallel to the rail top, as shown in Figure 1c. Coalescence of these cracks eventually led to the formation of thick spalling pieces.

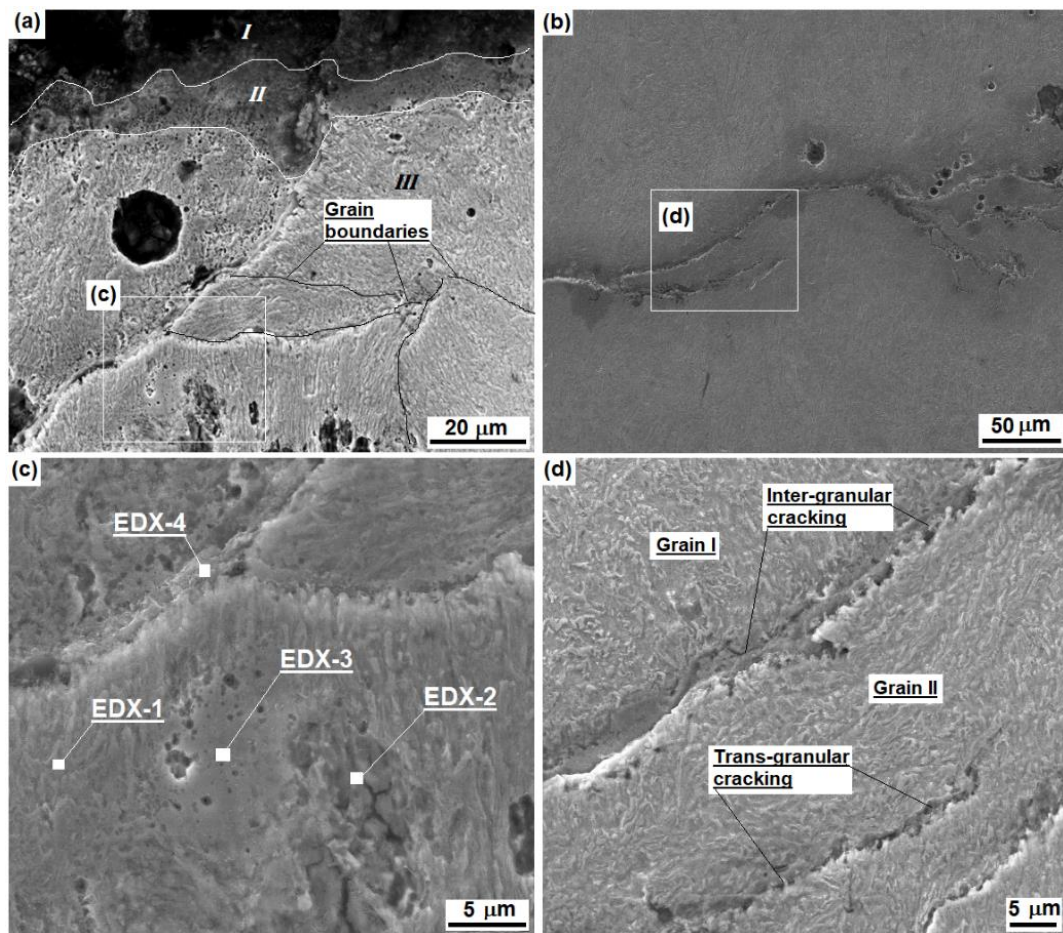
Figures 8b and 8d show microstructure of the turnout at a depth of approximately 50-80 μm beneath the rail top. The morphology of the bainitic ferrite and retained austenite had become significantly disordered as compared to the bulk steel, by comparing between Figures 8d and 3b. Such disordered morphology is an evidence of severe plastic deformation. In addition, inter-granular and trans-granular cracks can be seen to have propagated to such depths, whereas the cracks were filled with corrosion products similar to those observed in Figures 8a and 8c. By comparing the morphology of the bainitic structures shown in Figures 3b, 8c and 8d, it has been demonstrated that the turnout had accumulated depth-dependent plastic deformation.

Moreover, special attention was paid to a feature-less smooth area in Figure 8c. Firstly, the feature-less smooth area is not a part of the oxidised top layer because that the acquired EDX spectroscopy is consistent to the bainitic matrix, essentially free from oxygen (comparing Spectrum 3 and Spectrum 1 in Figure 9). Secondly, the area was feature-less in the SEM imaging as compared to the severely disordered bainite-austenite dual-phase matrix in the adjacent zone. Such feature-less structures were not found in any further depth, such as in the depth of 50 - 80 μm as shown in Figure 8b and 8d. Instead, the feature-less morphology was consistent to the top layer as marked 'II' in Figure 8a. These chemical and morphological features are similar to the so-called 'white-etching layer' or 'white-etching area' as described in literature [6, 8, 10, 11]. Its formation can be explained by that the repeated plastic deformation was extremely severe to have resulted in the regular dual-phase structure to change gradually to a nano-crystalline or quasi-amorphous layer at the outmost rail top.

Figure 8 SEM images showing the rail top after metallographic polishing and etching: (a & c) Low-angle inclined cross-sectional observations. (b & d) Severely deformed bainitic microstructure and inter-granular and trans-granular cracks at a depth of approximately 50-80 μm beneath the rail top. The marks 'I', 'II' and 'III' in (a) denote the surface oxide, the etching-resistant rail top and etched bainitic microstructure respectively.

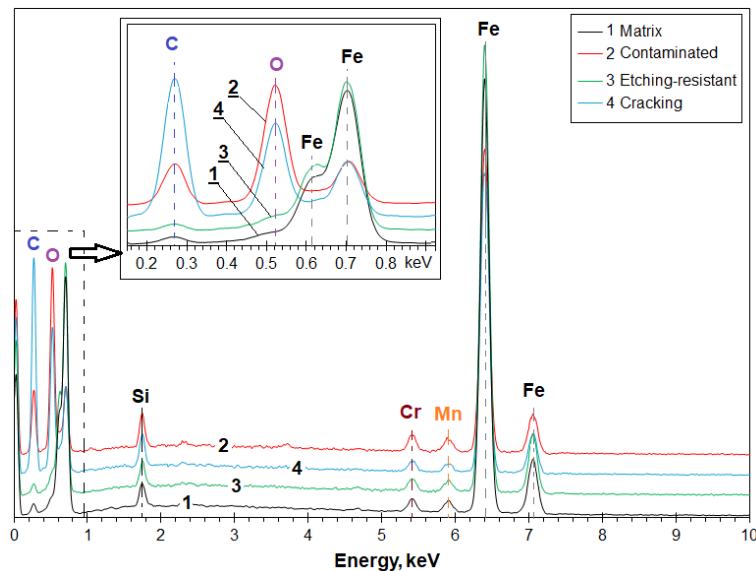
Figure 9 Energy dispersive X-ray spectra of the rail top subsurface. The spectra were acquired at the positions marked in Figure 8c.

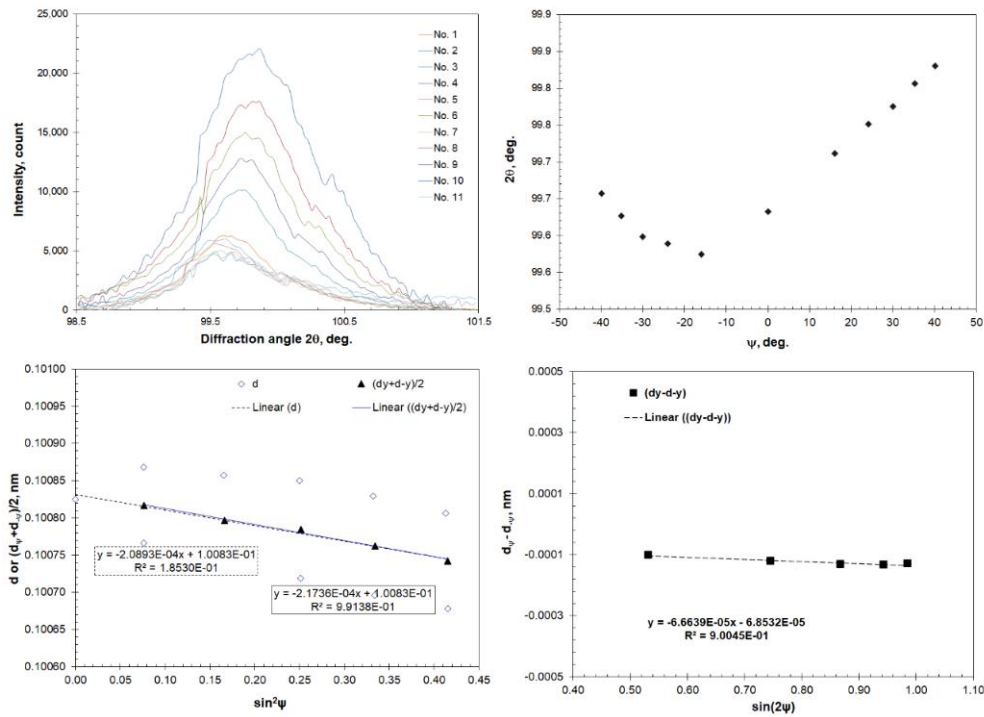
Figure 10 shows an example of XRD measurements of residual stresses on both sides of the rail top. The results of residual stress measurements are summarised in Table 3. Residual stresses were primarily in the form of compressive normal stresses as compared to the marginal residual shear stresses. The residual stresses were predominately along the transverse direction of 300 - 410 MPa, but much lower than the yield strength of the bainitic steel and not as severe as those measured on a failed austenitic turnout, i.e., 504 MPa and 648 MPa as reported elsewhere [9]. Nevertheless, the detection of residual compressive stresses provided further evidence of severe plastic deformation accumulated on the rail top.

Figure 10 An example of XRD residual stress measurement performed on the rail top: (a) The F(211) diffraction peaks acquired at various off-axis angles (ψ). (2) The measured peak position (2θ) plotted versus off-axis angles (ψ). (c) Linear regressions to calculate normal stress σ . (d) Linear regression to calculate residual shear stress τ .

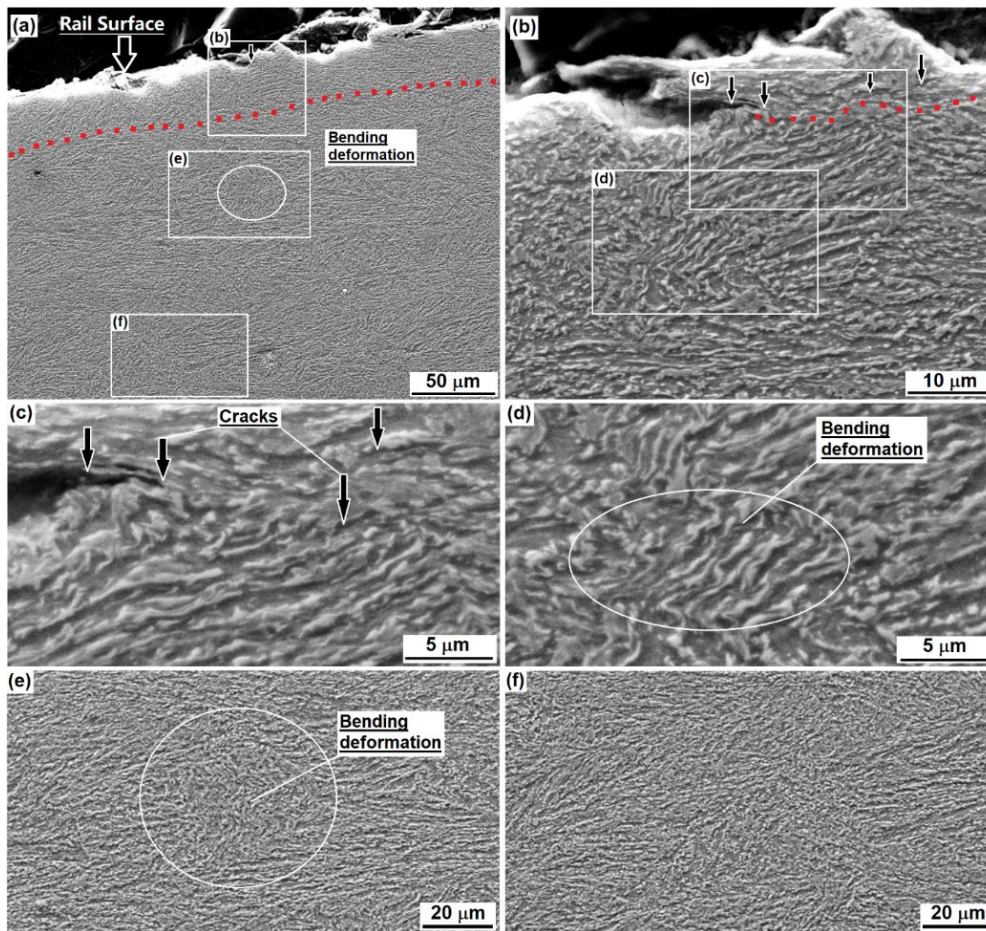
Figure 11a is an overall view of cross-sectional microstructure from the rail top to a depth of 0.22 mm. The most significant deformation took place at the rail top in a depth of approximately 0.05 mm, as indicated by the red dash line. Figure 11b shows further details at a higher magnification, in which the remarkably interrupted microstructure reveals severe plastic deformation. Figures 11c and 11d show further details of the deformed microstructure at the specified depths. In Figure 11c, the upmost microstructure above the dash line had become extremely fine and disordered, including several small cracks as labelled by the black arrows. Further propagation of these cracks would generate a new delamination fragment. Figure 11d shows a high-magnification image at a depth range of 0.02 - 0.04 mm, where the plastic deformation is typically evidenced by the deformed morphology of the austenite (in brighter contrast). In Figure 11e, the bending deformation at a depth of 0.06 - 0.11 mm is recognised only in the marked area whereas the microstructure surrounding that area retains the ordinary bainitic morphology. In the areas of further increased depths, the microstructure exhibits no remarkable morphological variation, as shown in Figure 11f.

Figure 11 Cross-sectional SEM images showing gradient deformation beneath the rail surface: (a) a low-magnification overview from top to a depth of 0.22 mm. (b) Depth range 0 - 0.05 mm. (c) Depth range 0.01 - 0.02 mm. (d) Depth range 0.02 - 0.04 mm. (e) Depth range 0.06 - 0.11 mm. (f) Depth range 0.16 - 0.21 mm.

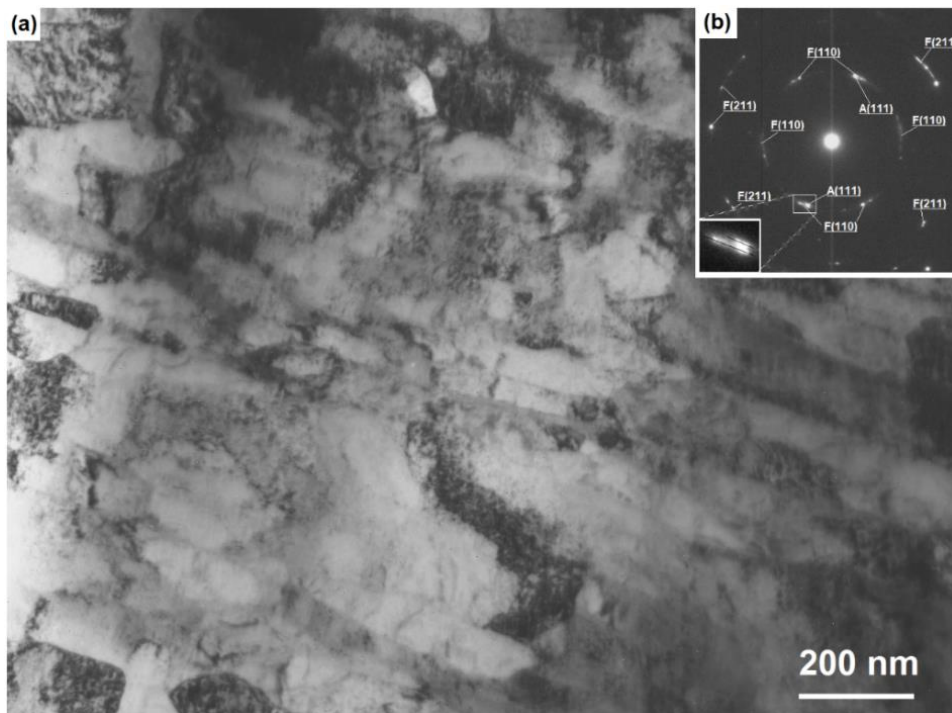
Figure 12 shows TEM characterisation of a subsurface region close to the top edge. The bright field image in Figure 12a indicates nano-scale lamellar morphology parallel to the worn top surface. The thickness of the lamellar grains was measured to be in the range of 55 ± 18 nm. The nano-laminates show sub-structures of dislocation cells with domain dimensions of 40 ± 9 nm. Figure 12b is a selected area diffraction pattern acquired in the observed area. The pattern suggests predominantly bainitic ferrite as well as a trace appearance of retained austenite. In particular, the joint-presence of ferrite and austenite patterns, F(110) and A(111), is shown in the insert. The two patterns are very close to each other because of the similar lattice spacings, i.e., 0.208 nm for A(111) and 0.203 nm for F(110) providing a very small lattice mismatch of 2.5%. Nevertheless, the SAD analysis suggested distinct presence of retained austenite.

Figure 12 High-resolution observation of the extremely deformed microstructure of the rail top. (a) A bright field TEM image showing the laminated microstructure. (b) A selected diffraction pattern taken in the observed area confirming weak presence of retained austenite along with the majority of bainitic ferrite.

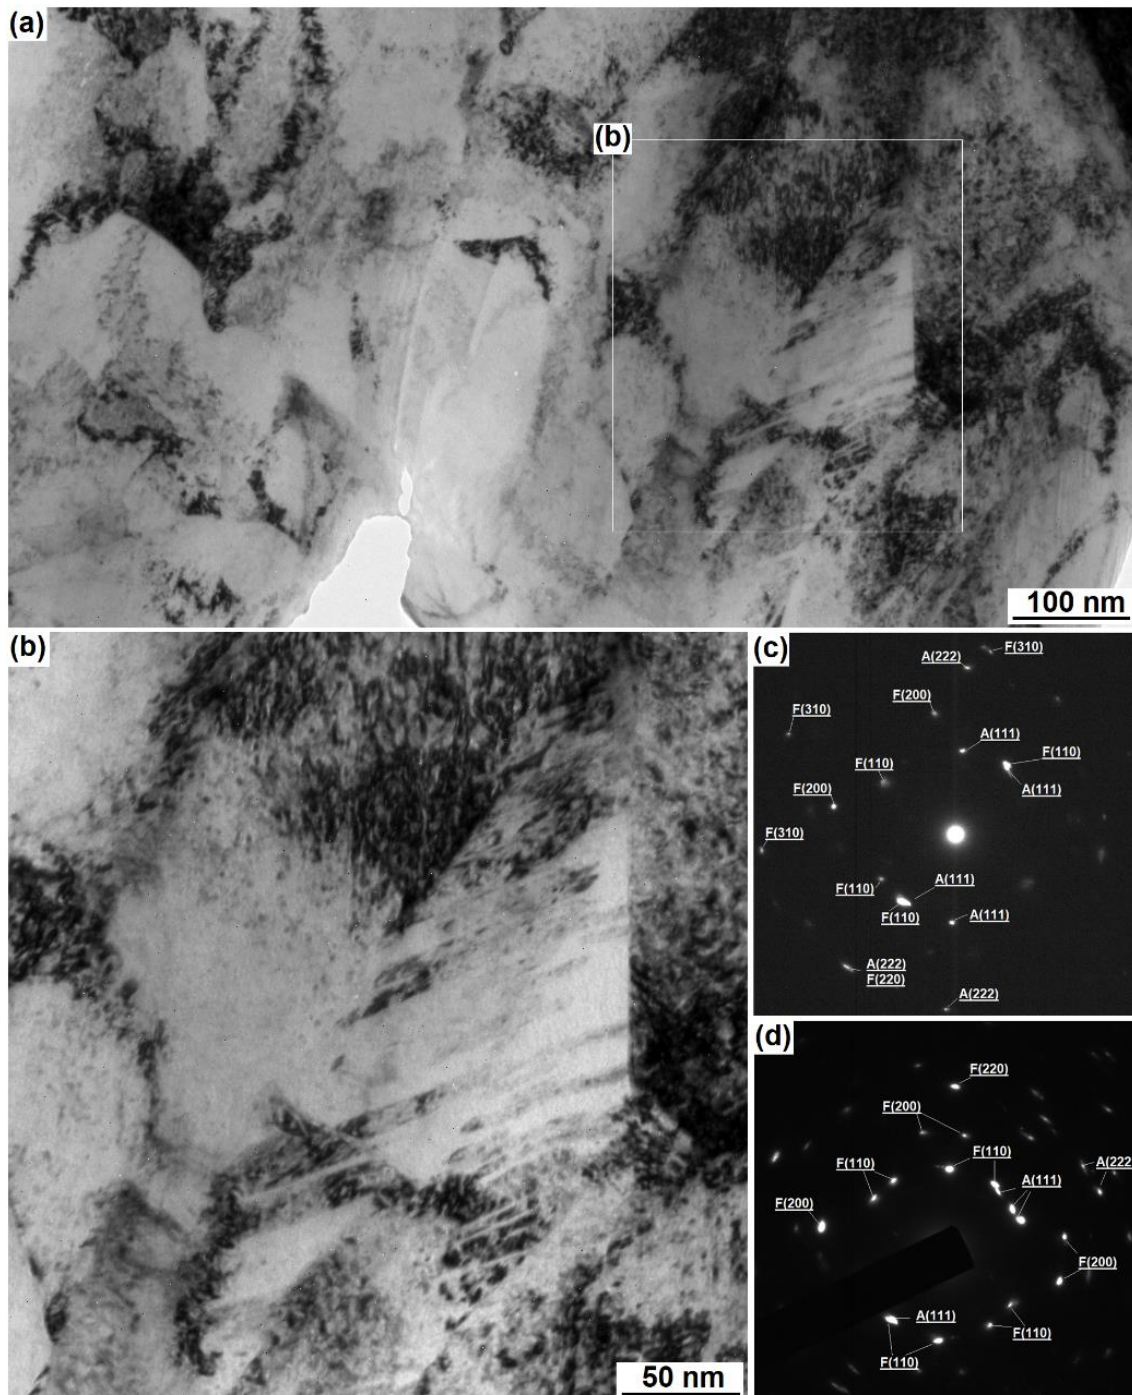
Figure 13 shows TEM observations and related diffraction analysis in a subsurface zone approximately 20 μm beneath the worn surface. This area exhibited equiaxial morphology with grain sizes of 229 ± 61 nm. Interestingly, several acicular sub-structures were observed in one of the grain in the imaged area, as highlighted in Figure 13a and further imaged in Figure 13b at a higher magnification. The acicular grains were 61 ± 16 nm in length and 8 ± 2 nm in width. These could be recognised as deformation-induced martensites transformed following a shear mode. SAD patterns obtained in this area show co-existence of austenite and bainitic ferrite. Such acicular-shape martensites were repeatedly observed in this region but not in the regions showing nano-laminar structures. The preferential presence of acicular sub-structures may imply that shearing transformation of martensite took place in austenite grains which have relatively coarse grain sizes.

Figure 13 High-resolution observation of deformation induced austenite-to-martensite transformation in close vicinity to the laminated zone. (a-b) Bright field TEM images showing martensite laths formed in an austenite grain. (c-d) Selected diffraction patterns indicating co-existence of ferritic and austenitic phases.

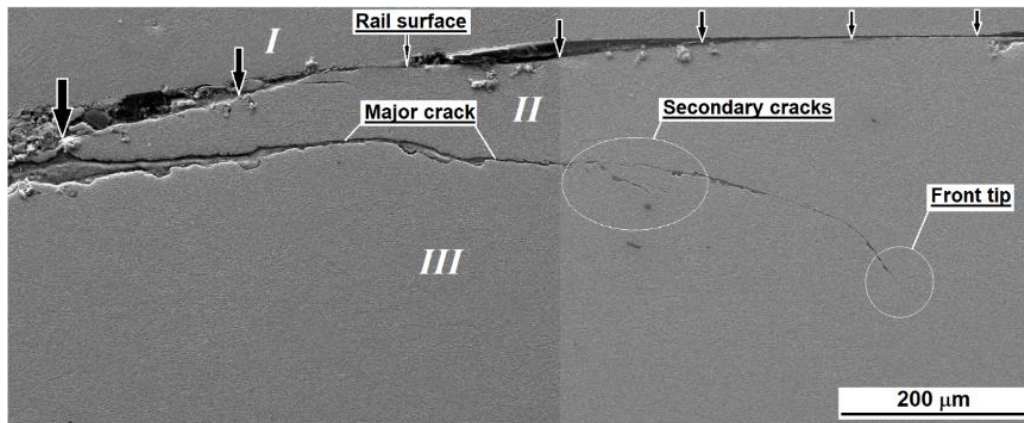
Figure 14 is spliced low-magnification images, which are separately presented also in Figures 15a and 16a, showing a subsurface crack from its open end on the worn rail top to the growth front. A major crack can be seen to have initiated from the rail surface and propagated to a total length of 970 μm and to a depth of 273 μm below the worn rail top. It grew initially at a low inclined angle of approximately 12° to a depth of 112 μm , and gradually turned to a higher angle of 49.6° before being terminated the maximum depth.

Figure 14 Spliced low-magnification SEM images showing a major spalling crack developed in the deformed depth below the worn rail top surface. The region marked 'I' is a counterpart piece protecting the worn surface from any damage in metallographic grinding and polishing. The labels 'II' and 'III' indicate subsurface regions of the turnout above and beneath a crack. The arrows indicate the rail top.

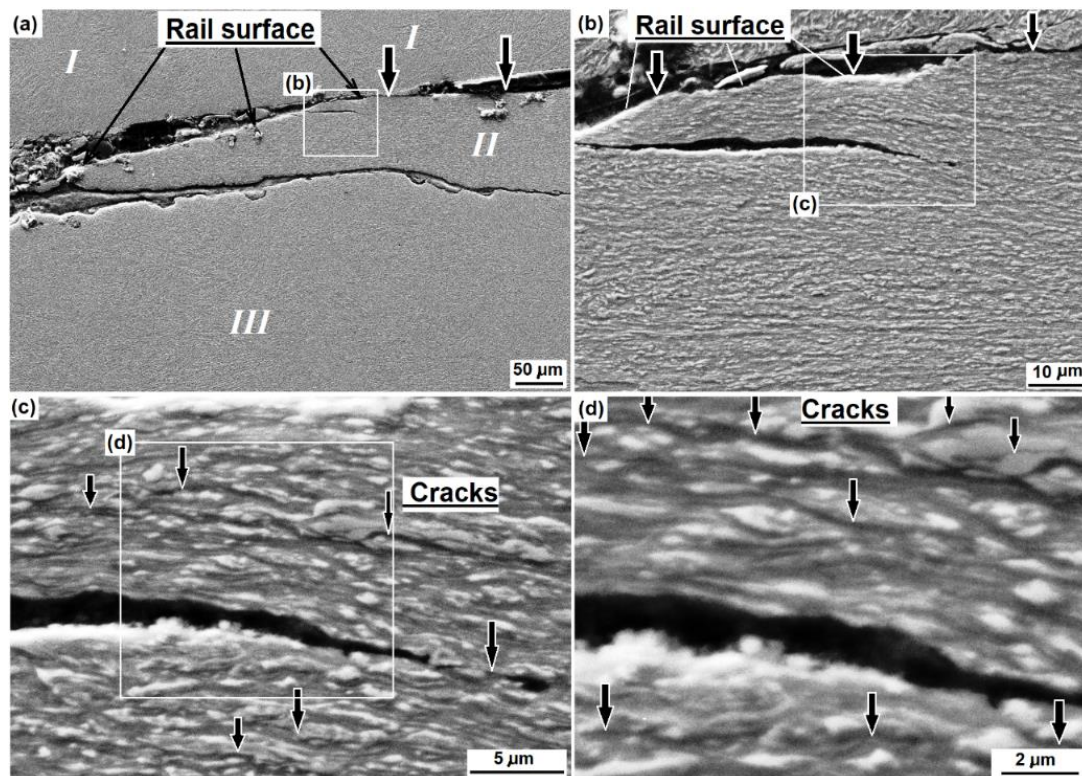
Figure 15 Cross-sectional SEM images showing surface cracking and severely deformed bainitic microstructure. (a) A low-magnification overview of surface cracking following a low inclining angle. (b - d) Further observations of the small crack nucleation-propagation in the depth within the extremely severe deformation region highlighted by the black arrows.

Figure 15a shows the initial growth of the crack to a depth of 112 μm . A small crack, highlighted in Figure 15a and presented at higher magnification in Figure 15b, was found to have nucleated within the severe plastic deformation region a depth of 19 μm . The crack had grown to a length of 75 μm at a shallow angle of 15° with respect to the rail top. Note that the crack propagation followed exactly the lamellar orientation, more detailed and higher resolutions images of this region are found in Figures 15c and 15d. Several short

cracks were found within the laminar structure. The crack propagation can be seen to follow the lamina orientation regardless of the bainitic ferrite (having grey contrast), austenite (having bright contrast) or the ferrite-austenite interface.

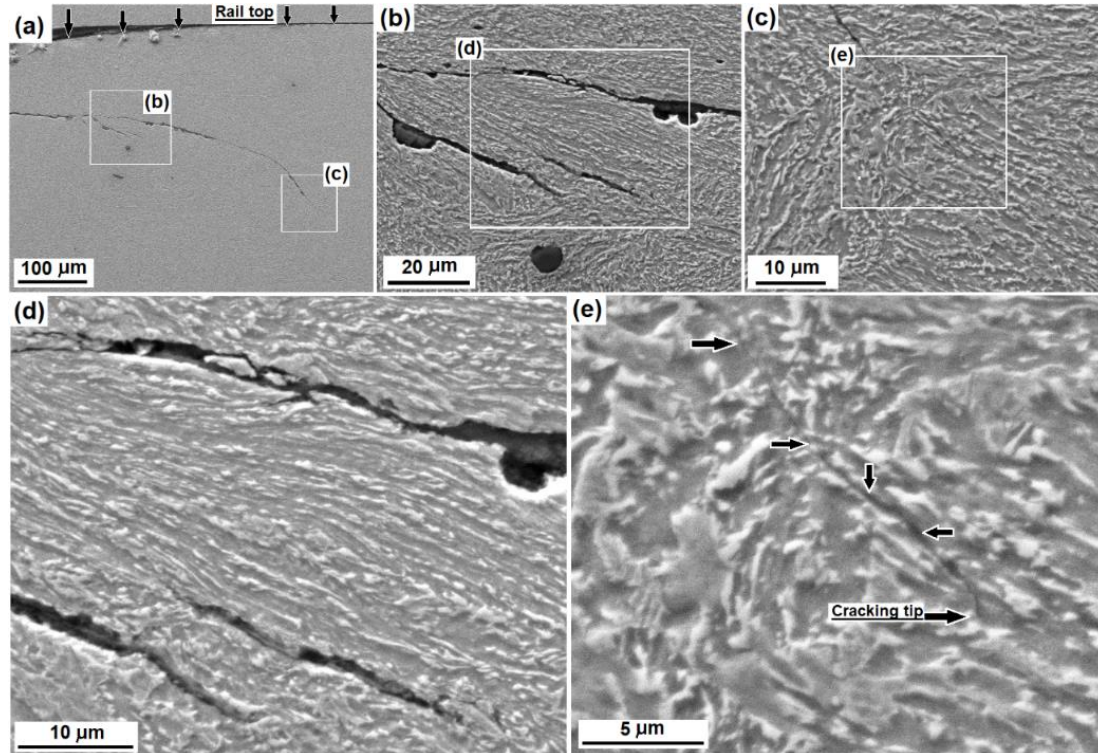
Figure 16a shows the final section of the major crack adjacent to Figure 15a, in which two selected areas were observed separately at higher magnifications to show details of the deformed microstructure in Figures 16 b-e. The crack follows exactly the lamina orientation in the severely deformed area, as shown in Figures 16b and 16d. Eventually the crack grew into the non-deformed bainitic microstructure at a higher inclination angle. In Figure 16e, it is indicated that the crack propagation was either in the bainitic ferrite or austenite without any preference.

Figure 16 Cross-sectional SEM images showing cracking and deformation beneath the rail surface. (a) A low-magnification view of the section showing a subsurface crack under propagation. (b & d) More details of the cracks and deformed bainitic microstructure. (c & e) The less deformed bainitic microstructure at the front of crack propagation. The black arrows in (e) highlight the crack propagation within the microstructure.
