AN INVESTIGATION INTO THE NON-UNIFORM DECAY OF HARDWICK STONE

Robert Brough⁴ & Elizabeth Laycock

Hardwick stone as used on the vernacular Hardwick Estate buildings decays in a non-uniform way. Typically stones at Hardwick decay cavernously leaving the mortar matrix behind. Levels of decay can vary dramatically from stone to stone with one stone showing advanced decay whilst adjoining stones are relatively intact. Ten sample buildings giving a total of 1587m² of elevations and with a good geographical spread across the estate were surveyed. Ratings were assigned according to condition. It was shown with 95% confidence that the weathering on the western elevations is significantly worse than that seen on the eastern elevations of the sample buildings. Northern elevations had high levels of stonework in good condition, while western elevations had the lowest. The prevailing wind direction on the Estate is west to north-west. The difference in levels of decay below 1 metre and above 1 metre has been shown to be significant at the 95% confidence level with a slight correlation between levels of stone decay and building height (above sea level). The survey also highlighted stone decay

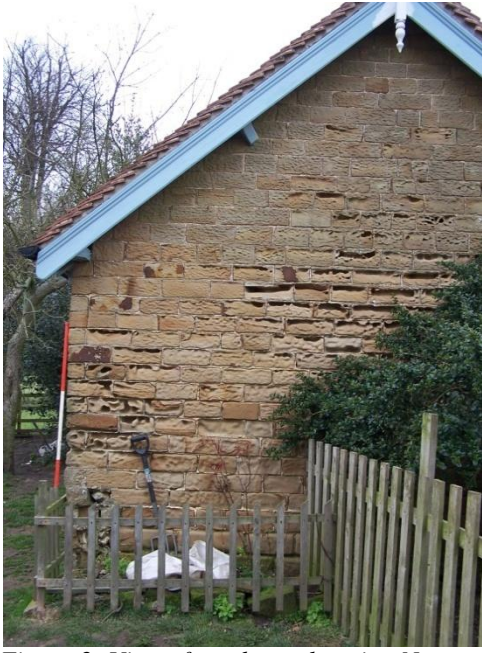
The southern elevation has the lowest proportion of stone in good condition (36%). The eastern elevation has the highest proportion of stone in good condition (69%). The average for all elevations is 55%. The northern elevation has the highest proportion of stone showing signs of decay (42%). The eastern elevation has the lowest proportion of stone in this category (24%).

Figure 2: View of southern elevation Norwood Piggeries

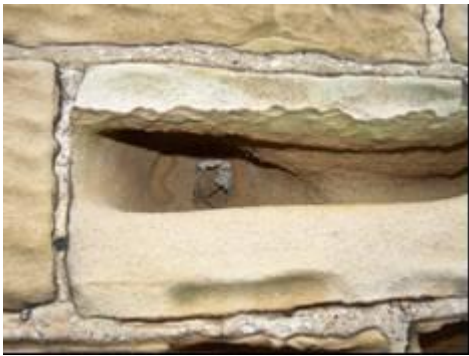
Figure 3: Example of cavernous weathering, southern elevation Norwood Piggeries

Figure 33 is a detailed photograph of one of the stones exhibiting cavernous decay in the southern elevation of Norwood Piggeries. In this photograph it is possible to see that the cavern passes right through the stone and it is possible to see mortar and the rubble core behind.

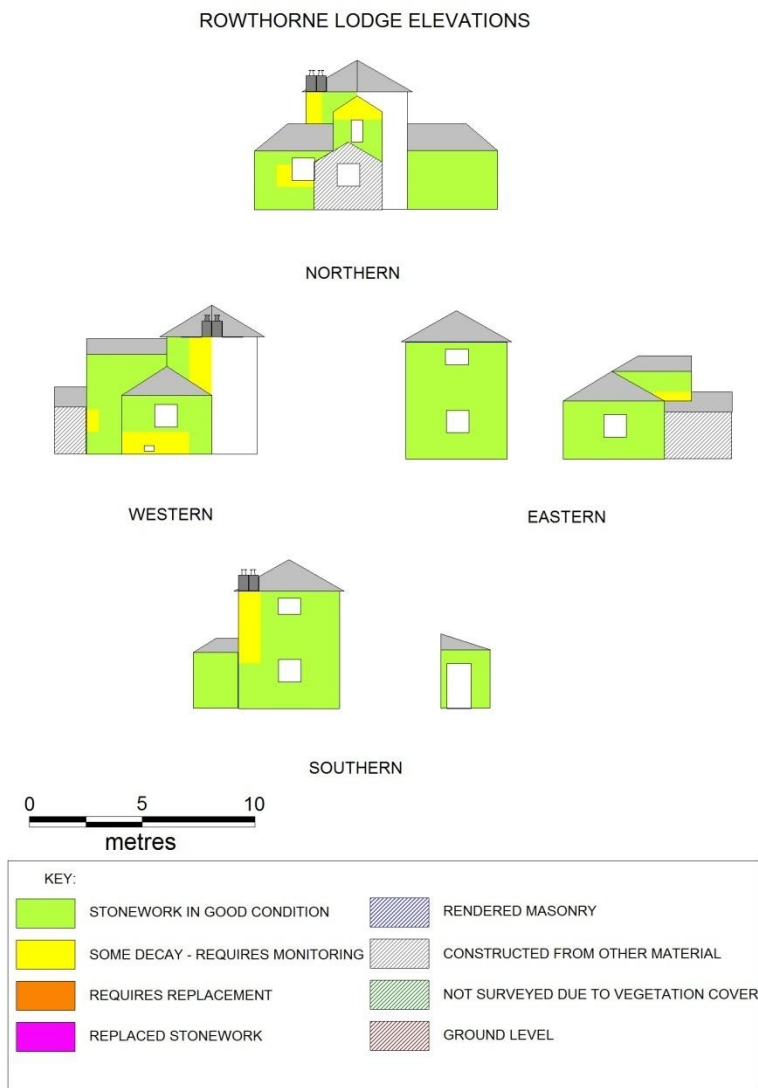
Figure 4: Elevations of Rowthorne Lodge

The western elevation has the lowest proportion of stone in good condition (74.5%). The eastern elevation has the highest proportion of stone in good condition (98%). The average

proportion of stone in good condition for all elevations is 88%. Apart from the flues the other locations where there is stonework showing signs of decay are on the northern gable, around the cill on the northern elevation and mainly at low level on the western elevation.

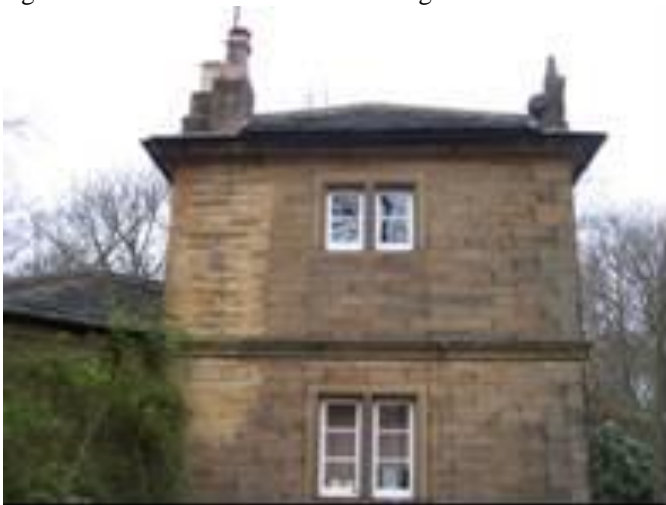
The National Trust vernacular building survey for Rowthorne Lodge states that it was constructed in approximately 1827 (National Trust Vernacular Building Survey - Rowthorne Lodge, 1997, p.1). The central protruding section of north elevation has been extended at ground floor level at some point and is not built with Hardwick Stone. This building, although small, was finished to quite a high standard. It is generally in good condition, and there is no stonework in the worst two categories i.e. needs replacing or has been replaced. The stone showing some signs of decay on upper levels follows the path of the flues due to combustion by-products. The roofs have a slight overhang, this is more pronounced on the roof over the central two-storey section. Figure 54&5 show how the exterior stone decay appears to follow the path of the flue.

Figure 5: Stone decay along route of flue

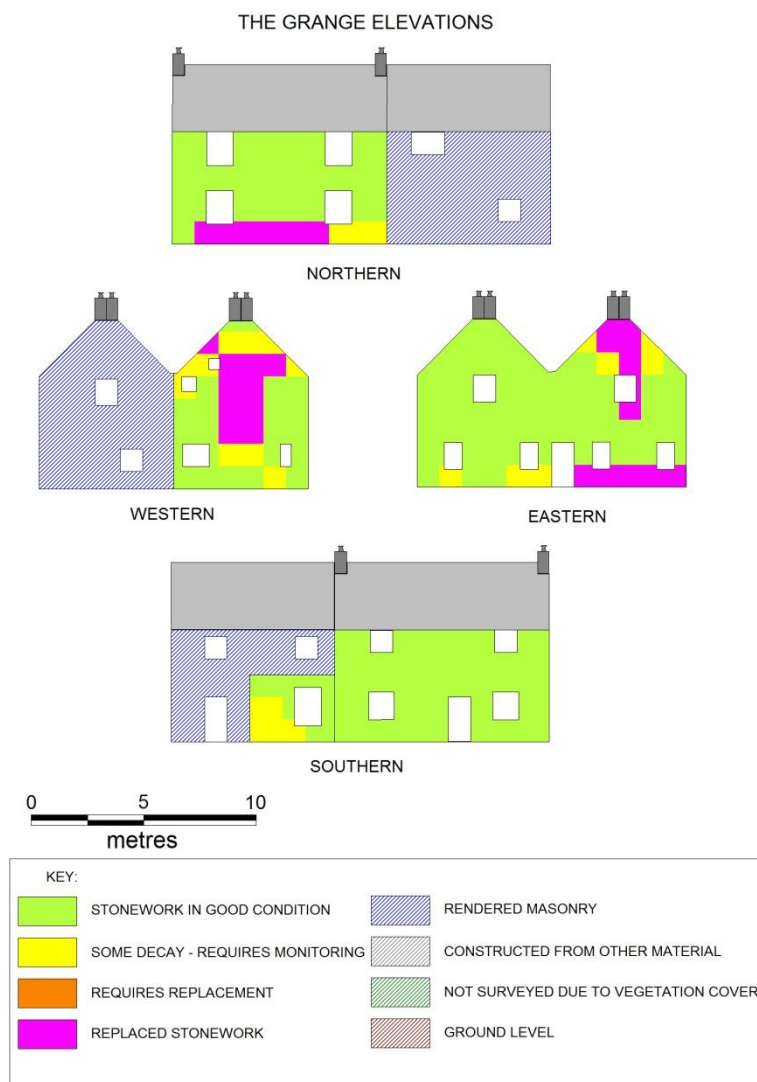
Figure 6: Elevations of The Grange

The elevation with the highest proportion of stone in good condition is the southern elevation (92%), the western elevation has the lowest proportion of stone in good condition at 52%, with an average over all the elevations of 77%. The western elevation has the highest proportion of stone that is showing signs of decay (22%) and also the highest proportion of stone that has been replaced (26%).

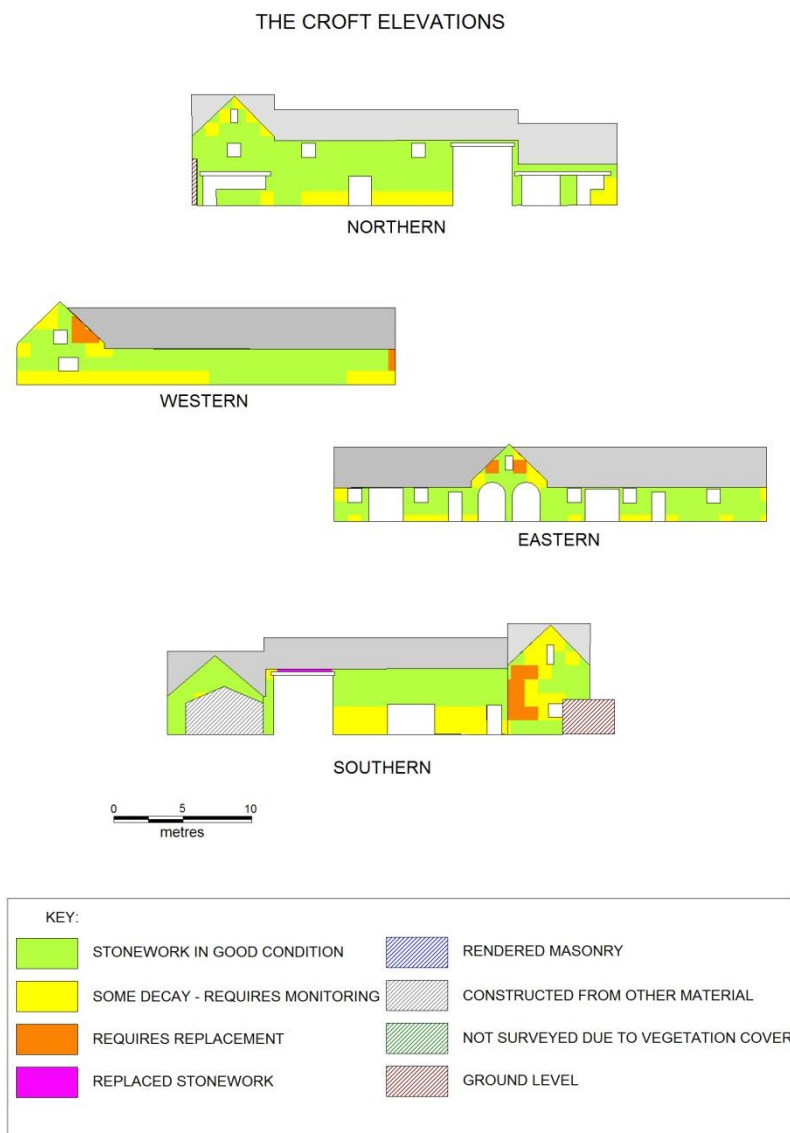
Figure 7: Elevations of The Croft

The elevation with the lowest proportion of stone in good condition is the southern elevation (64%), whereas the highest proportion of stone in good condition was observed on the northern elevation (83%) with an overall average for all elevations of 73%. The southern and western elevations have higher than average figure for stone showing some signs of decay, 28% and 27% respectively. The southern, eastern and western elevations all have some stone requiring replacement, whereas the northern elevation does not. In the case of The Croft Courtyard, both elevations have a low proportion of stone in good condition. The eastern elevation has 44% in good condition, the western elevation fairs slightly better at 52%. The average for these two elevations is 51%. The eastern elevation has a high proportion of stone that is showing some decay (56%), whereas the western elevation has 39% in the same category. The western elevation also has 9% of its stone requiring replacement.

One of the most striking features of this elevation mapping is how the spread of stone showing signs of decay appears to occur high up in the building, towards the southern end of the building which may be attributable to the fact that the southern end is the open end of the courtyard and therefore this part of the building is least protected. Decay at high levels in the elevations can also be seen on the eastern gable of the southern elevation in Figure 7. Another feature of the pattern of stone decay on The Croft is that decay appears to occur on the gables of the buildings parallel to, but offset from, the roof line. This is not shown perfectly by the elevation mapping because the elevations have been split into 1m grids.

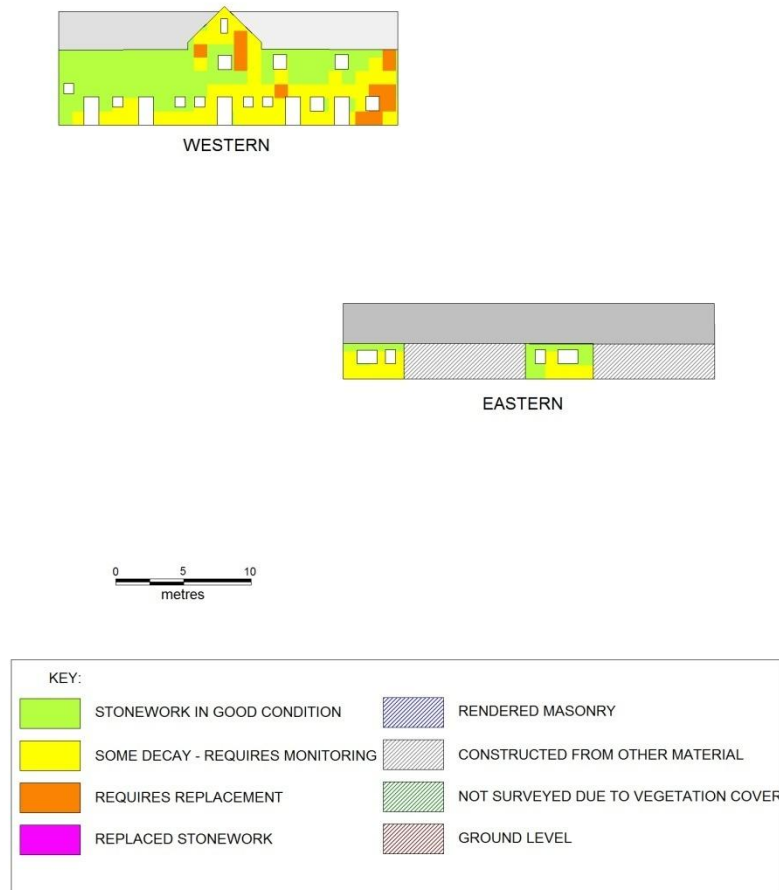
Figure 8: Elevations of The Croft Courtyard

The roofs of the Croft building are dual pitch covered with stone slates. They do not overhang any of the elevations to any significant degree. There are multiple openings to the elevations performing a variety of functions. The condition of the stonework in the elevations varies. The elevation in worst condition is the western elevation of The Croft Courtyard.

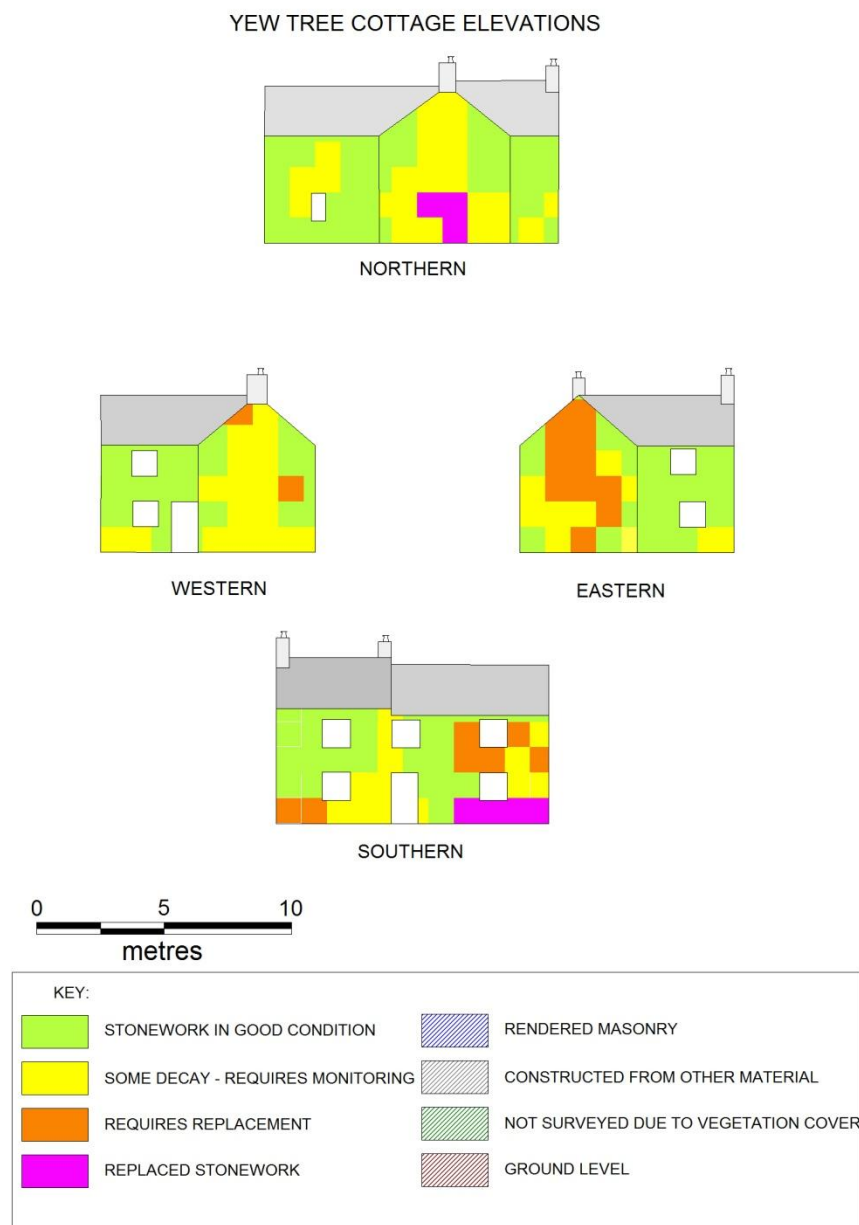
Figure 10: Elevations of Yew Tree Cottage

The proportions of stone in good condition is low for all elevations, the worst elevation being the southern elevation (48%) and the best being the northern elevation (55%). The western elevation has 50% of stone in good condition and a further 45% showing signs of decay. This leaves 5% requiring replacement. The eastern elevation has the lowest proportion of stone showing signs of decay (23%), but has the highest proportion of stone requiring replacement (27%). The southern elevation has the highest proportion of stone that has been replaced (9%).
