**Transmission electron microscopy and energy dispersive X-ray spectroscopy on the worn surface of nano-structured TiAlN/VN multilayer coating**

LUO, Q. and HOVSEPIAN, P. E. (2006). Transmission electron microscopy and energy dispersive X-ray spectroscopy on the worn surface of nano-structured TiAlN/VN multilayer coating. *Thin Solid Films*, 497 (1-2), 203-209.

## **Abstract**

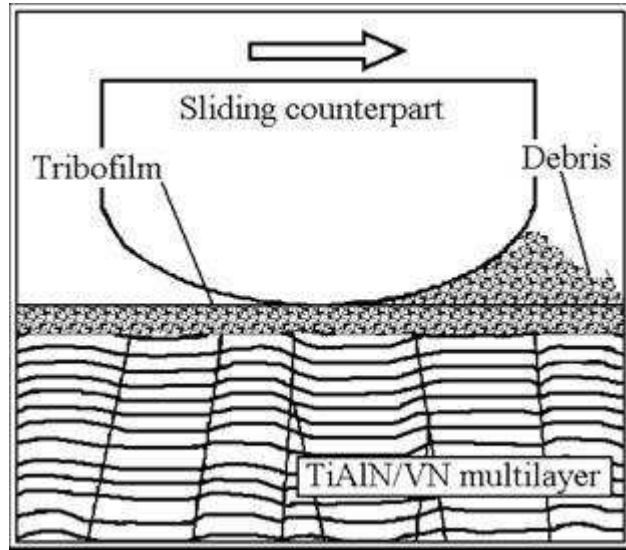
Figure 6

A schematic diagram (Fig. 6) can be drawn to show the formation of tribofilm. As soon as wear debris is generated, it is involved in the sliding wear by forming a tribofilm between the contacting surfaces. The tribofilm reported in this study neither has a crystalline structure as compared to the annealing induced oxides of TiAlN/VN [13, 14], nor contains crystalline V<sub>2</sub>O<sub>5</sub> as reported in previous Raman microscopy study [10]. However, it really resulted in a three-body system: the counterpart, tribofilm and the coating. In particular, the amorphous structure revealed that the tribofilm would have experienced severe shear straining in each pass of the pin-on-disc contact and therefore, it was the shearing resistance of the multi-component oxide film which

**Fig. 6** Schematic graph showing the formation of tribofilm and its influence on the wear of coating.
