21st European Conference on Fracture, ECF21, 20-24 June 2016, Catania, Italy

Applications of Residual Stress in Combatting Fatigue and Fracture

M N James ^{a, b*}, D G Hattingh ^b, D Asquith ^c, M Newby ^d and P Doubell ^d

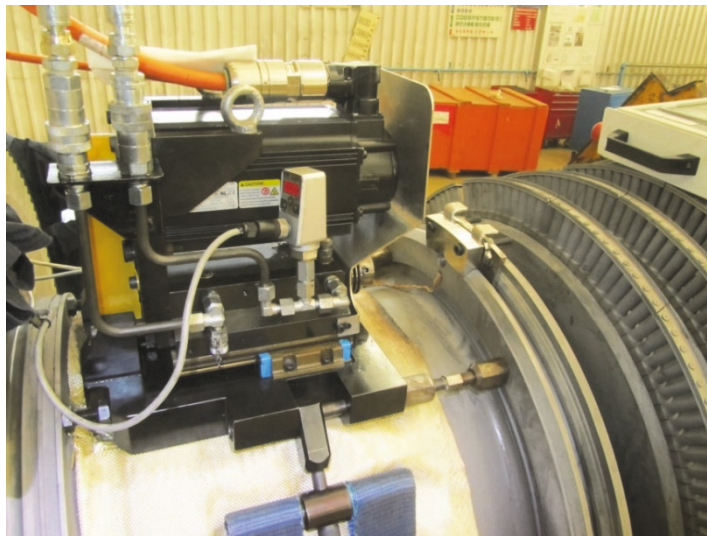
Figure 1. Illustration of the bespoke FTHP platform in position on a stream turbine rotor. It uses the registered WeldCore® process and is capable of extracting an annular metallurgical sample through the thickness of the blade attachment t-slot wall, repairing and re-drilling the hole in a single sequence of operations.

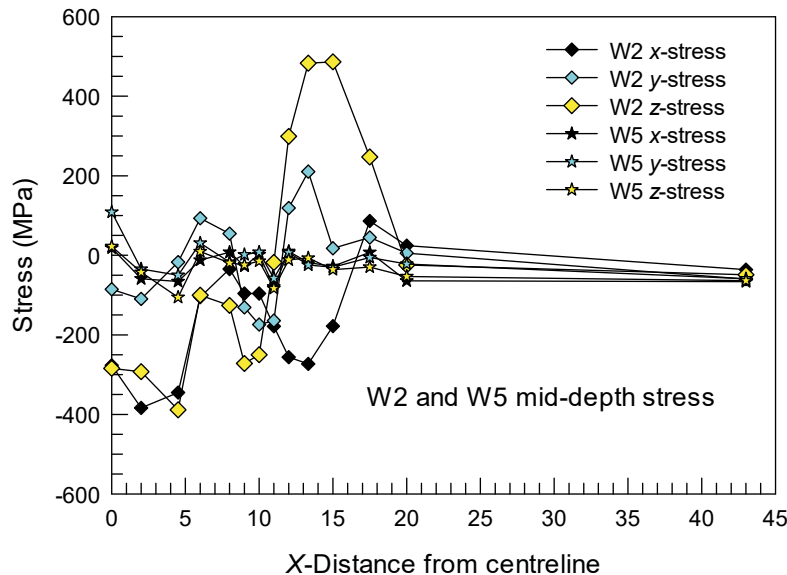
Figure 4. Comparison between the mid-depth values of residual stress in all three coordinate directions for specimens W2 (as-welded and undrilled) and W5. The edge of the original hole in the blade would have been at the $x = 4$ mm position.

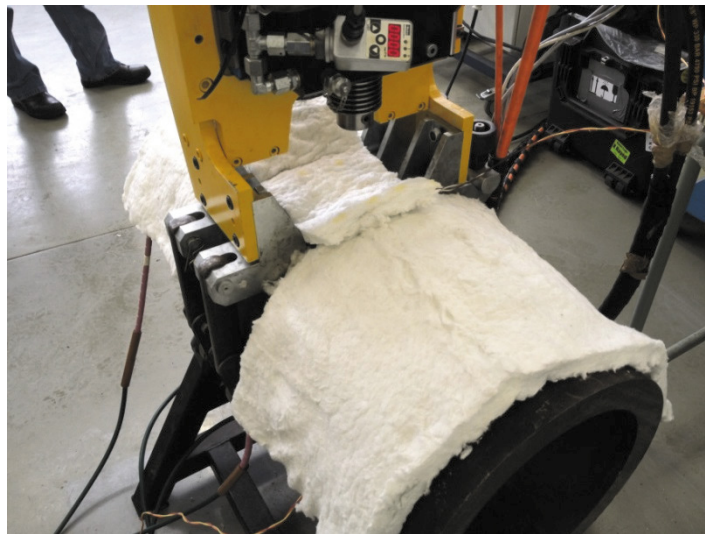
Figure 6. FTHP processing platform in-situ on a section of thick walled steam pipe. The pads are for preheating the pipe to approximately 200°C prior to commencing the WeldCore® process.

The sequence of events in the WeldCore® creep sampling process is shown in Figure 5 and the FTHP platform is shown in position attached to a piece of steam pipe in Figure 6. In the original planning for this experiment, specimens were prepared from two locations spaced at 90° intervals around the circumference of the pipe. At each position one as-welded specimen and one specimen that had been subjected to localised post-weld induction heat treatment were prepared. In the beamtime available in Experiment 1-02-128 it became necessary to concentrate the residual stress measurement effort on a single as-welded specimen (1A) and on a single specimen (2B) that had been welded and subjected to in-situ PWHT by induction heating (see Figure 7); these specimens were cut from circumferential positions 90° apart and a direct point-based comparison between the residual stresses before and after PWHT is therefore not possible. Nonetheless the residual stresses in the pipe would be expected to be similar

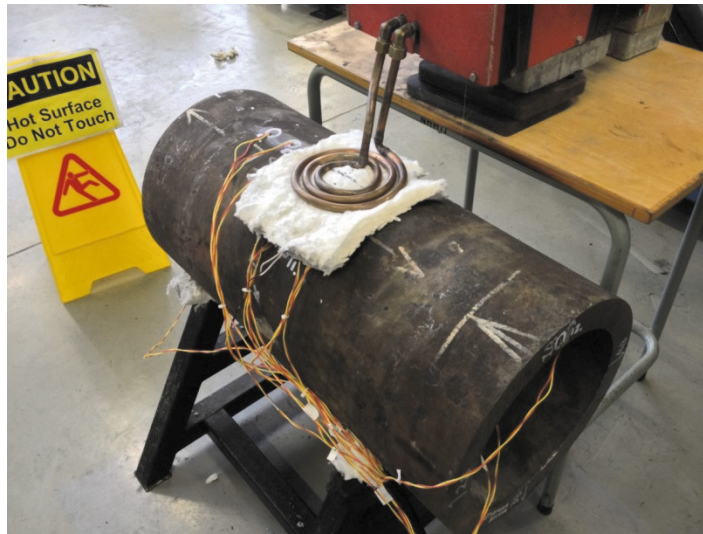
Figure 7. Induction heat treatment of the pipe after completion of the WeldCore® process.

at the two circumferential positions. Full details of the FTHP process are given in Table 1 and the consumable tool was manufactured from BS EN 10216 Grade 10CrMo9-10 (Material number 1.7380). The PWHT was limited to a maximum surface temperature of 800°C and induction heating was continued until the inner surface of the pipe reached 650°C which was then maintained for a minimum of 15 minutes. Cooling took place in still air conditions in the laboratory.
