## **The upgrading of fire safety in historic buildings**

KINCAID, Simon (2018). The upgrading of fire safety in historic buildings. *Historic Environment: Policy & Practice*, 9 (1), 3-20. [Article]

# The upgrading of fire safety in historic buildings

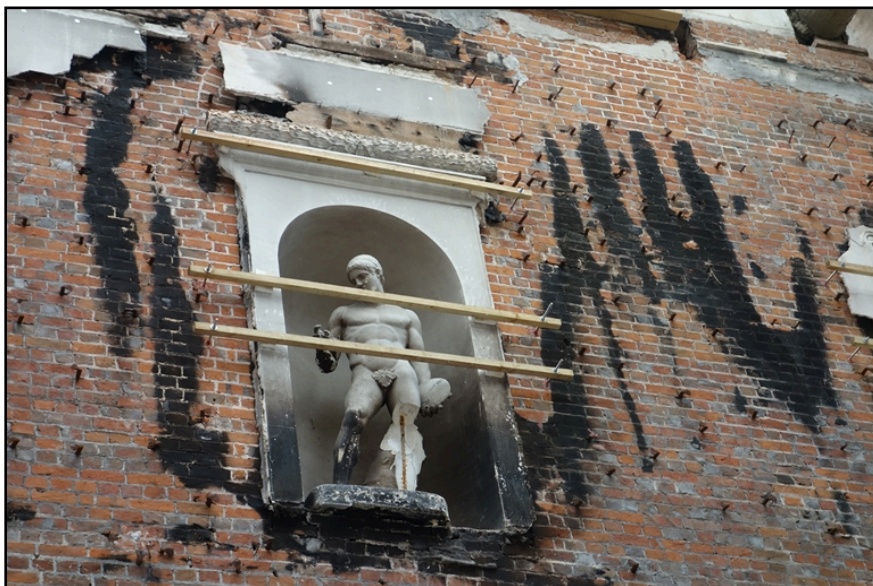
After the fire at Clandon Park in Surrey. Little is left of Giacomo Leoni's great Marble Hall from the 1730s; considered to be his masterpiece and described as one of the great rooms of early Georgian England<sup>1</sup>.

Voids may be vertical in nature and may be the result of phases of construction or alterations, or may relate to old flues, ducts or shafts<sup>48</sup>. Initial fire spread at Clandon Park was via a lift shaft; the fire getting into this because of a lack of fire stopping above the electrical distribution board cupboard where the fire started, and able to spread to each floor of the building by this route<sup>49</sup>. Voids may also be horizontal in nature and at Windsor Castle, fire spread was reportedly assisted by the presence of a ‘large, uninterrupted, high level ceiling void running the entire length (65 metres) of the St. George’s Hall’<sup>50</sup>. Voids between floors are common; at Chatsworth, some of these are reported to be storey-height in size<sup>51</sup>.
