**A study on the failure of steel chains in rotary cement kilns**

AL-MOUSSAWI, M. A. M. (2018). A study on the failure of steel chains in rotary cement kilns. *Metallography, Microstructure, and Analysis*, 7 (2), 153-167.

# A Study on the Failure of Steel Chains in Rotary Cement Kilns

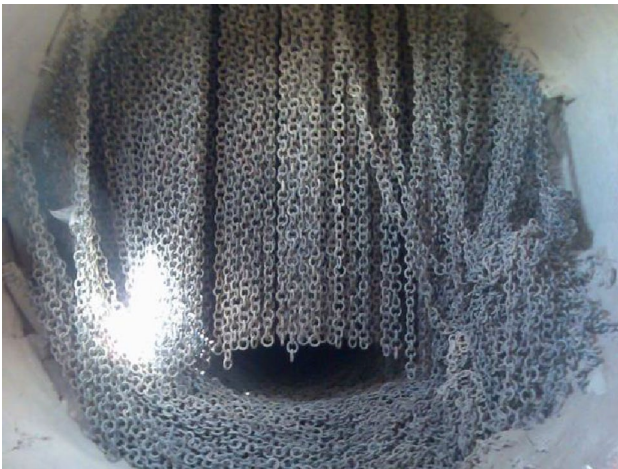
**Fig. 2** A real image of chains curtain inside rotary cement kiln at *Kufa cement plant*. Courtesy of *Kufa cement plant* (image no. CK-005)

Chains in wet and long-dry rotary cement kilns usually work as a removal of the moisture from the raw cement materials (mud), and it is also cleaning the kiln shell by transporting materials, crushing the mud rings, reducing the dust amount, and reducing the kiln exit gas temperature. Figure 1 shows a sketch to the rotary cement kiln including the chain locations (called also curtains) and the process of cement manufacturing [1]. The raw material enters the rotary cement (wet feed) with a temperature of 40 °C, while it discharges from the kiln with a temperature of 200 °C. The gas enters the kiln with a temperature usually ranged from 700 to 760 °C and exits with a temperature of 180 °C. These ranges of temperatures input and exit are controlled by the chains; any issues in the chains including failure due to breakage during the kiln operation can affect the product (clinker) quality and may result in air pollution. Figure 2 is a real

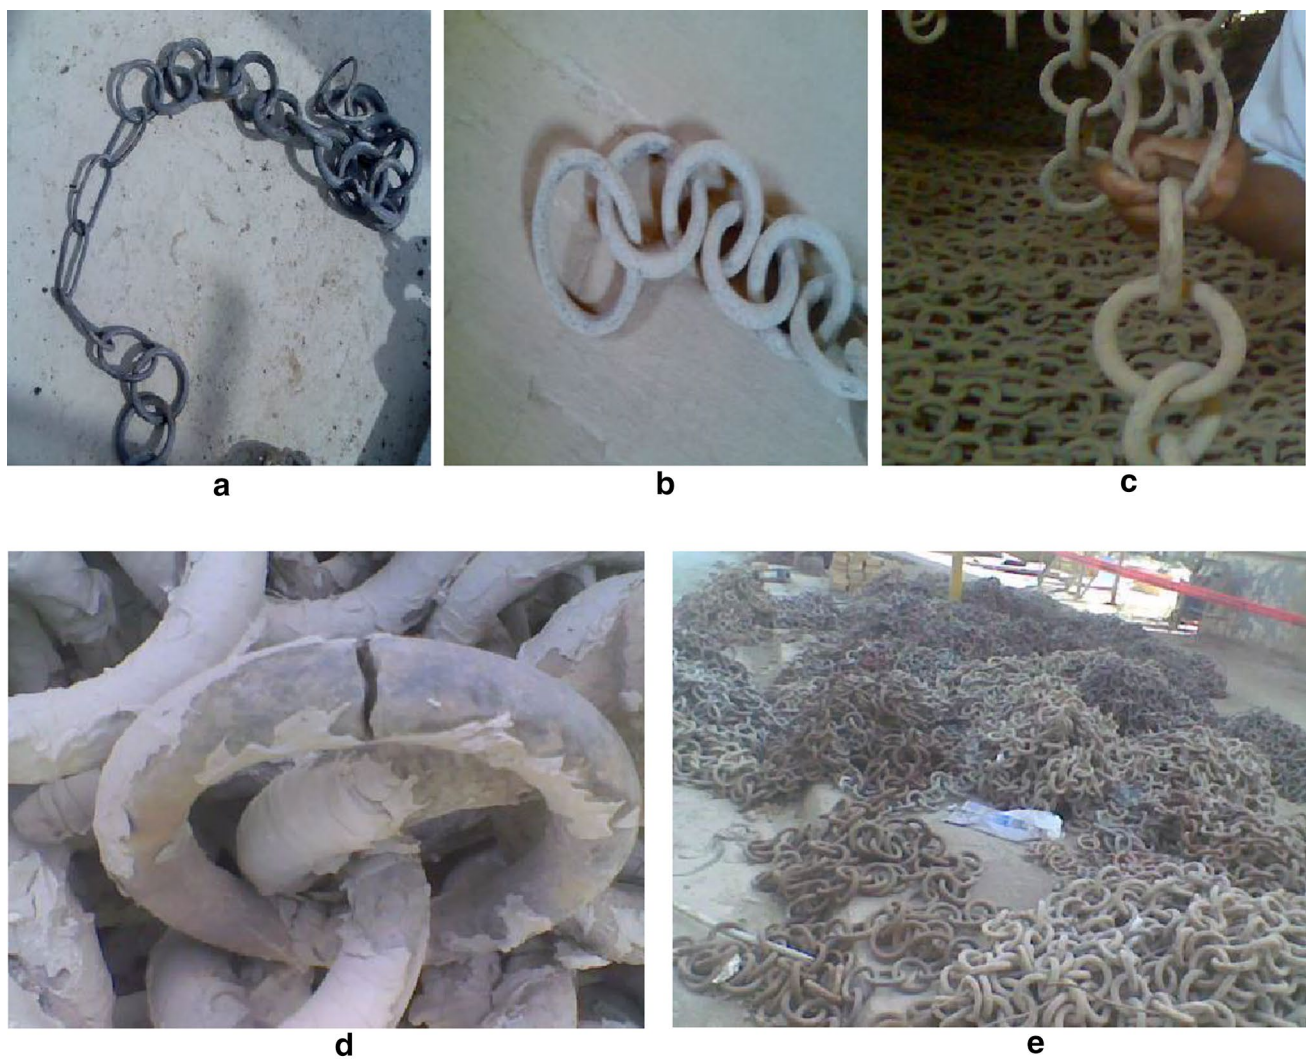
**Fig. 6** Different types of chains failure, (a) reduction in thickness and deformation (St37 grade), (b) oval deformation in the first ring, 1.4742 (AISI F10). (c) Reduction in thickness, oval, and twisting deformation in the first ring 1.4742 (AISI F10). (d) Brittle cracking

(DIN 1.4892 105MA) and (e) different types of failed chains dropped outside the cement kiln. Courtesy of Kufa cement plant (image no. CK-007-CK011)
