**A study of transfer films formed on the  
surface of automotive friction couples.**

A thesis submitted in partial fulfilment of the requirements of  
Sheffield Hallam University  
for the degree of Master of Philosophy

Collaborating Organisations:	Plasma Coatings Ltd.
	Ferodo Ltd.
	B.B.A. Friction Ltd.

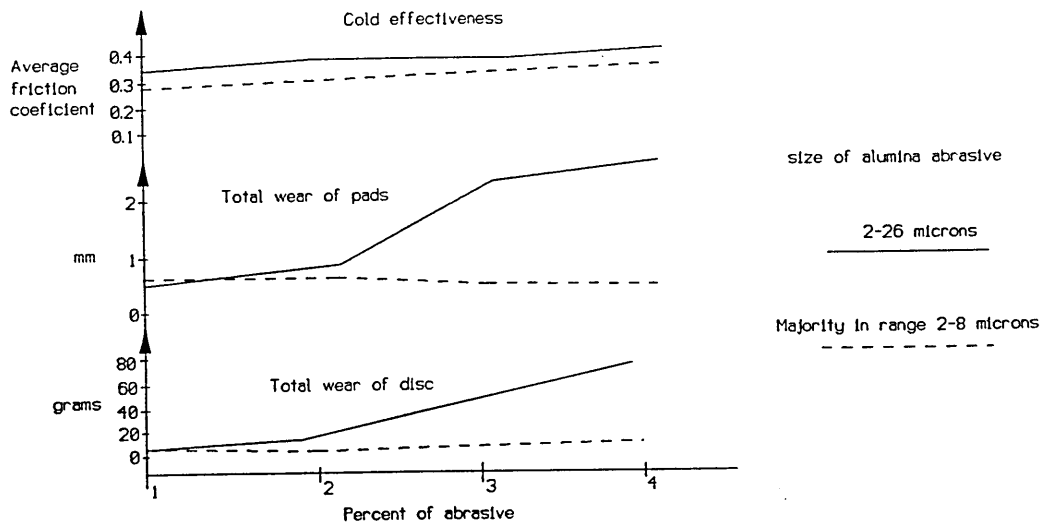
Figure 2.3.2. Abrasive concentration effects on wear. (duplicated from Crosa *et al*).

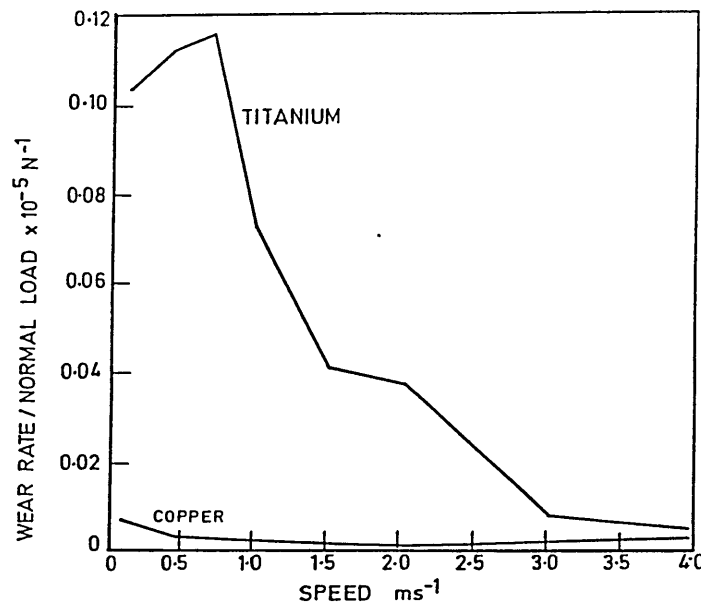
Figure 2.5.3. Abrasion of titanium and copper. [Duplicated from ref. 36]

In many cases it has been observed that harder materials have a greater wear rate than softer materials. Biswas [36] showed how the wear of copper against aluminium oxide abrasives was substantially lower than for titanium, a much harder metal. The difference in wear is a result of the strain rate response of the metals. For hard materials a very high strain rate is observed on the surface promoting easy shear and fracture resulting in loss of material. The strain rate within the softer copper is much weaker and instabilities are transmitted into the substrate. As a result plastic deformation tends to occur as opposed to fracture. Increasing the temperature of the titanium allows instabilities to be transmitted away from the uppermost surface and thus the wear rate approaches that of copper as shown in figure 5.2.3.
