Cathodic Protection of Corroded Pre-stressed Tendons

A thesis submitted in partial fulfilment of the requirements of
Sheffield Hallam University
for the degree of Doctor of Philosophy

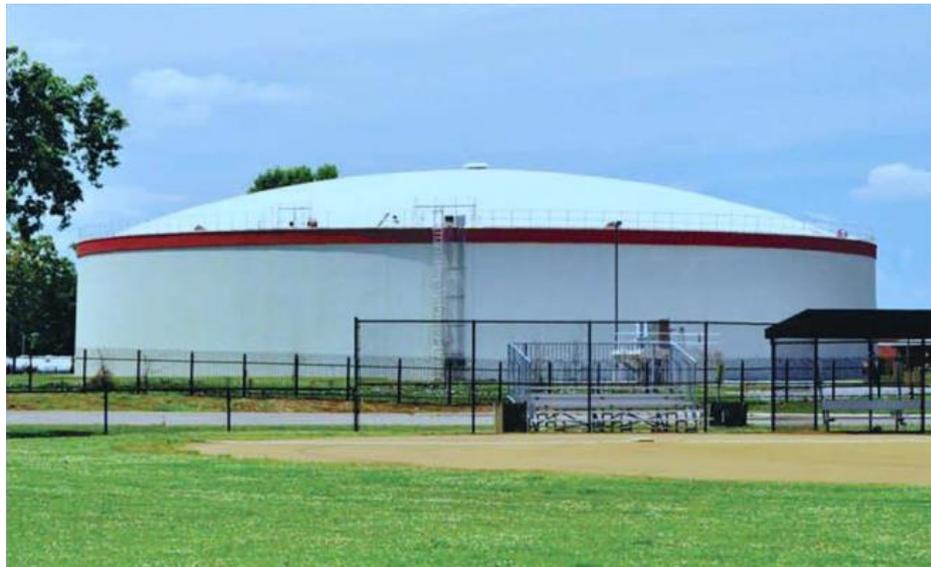
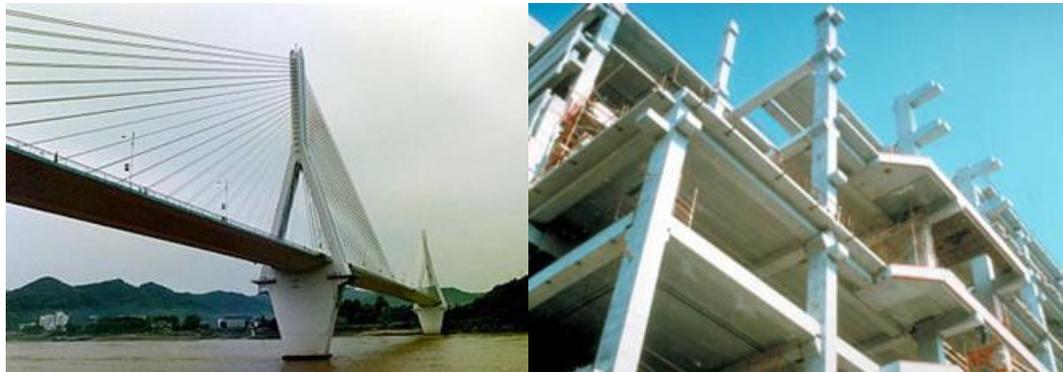
Figure 1.1 Some of the applications of pre-stress concrete structures

Due to the compression of concrete in pre-stressed concrete structures, cracking is better controlled as well as allowing a reduction of the cross-sectional area of a member, thus offering an extended range of options for many types of structures including bridges and buildings. Pre-stressed concrete tanks are used in water treatment and distribution systems, waste water collection and treatment systems and storm water management. Other applications include liquefied natural gas (LNG) containment structures and bunds, large industrial process tanks and bulk storage tanks (Figure 1.1)

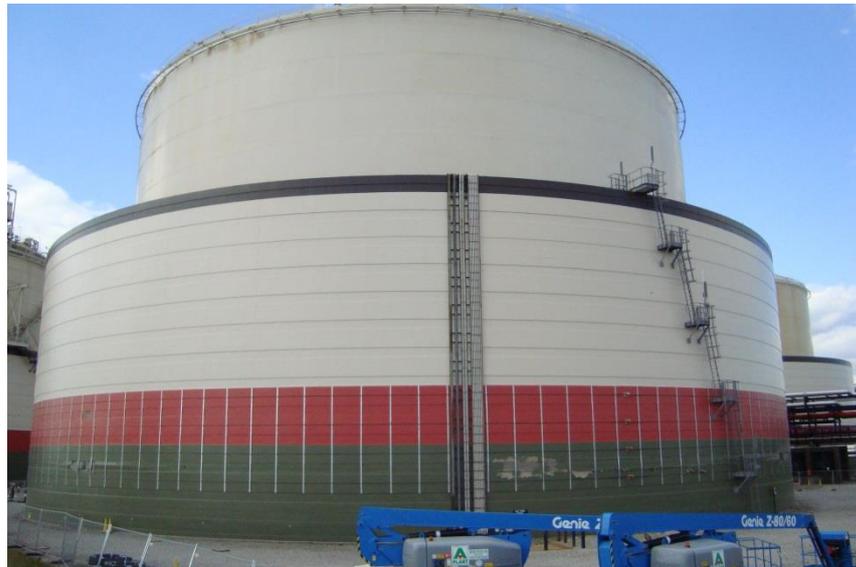
Figure 1.2 LNG bund wall

A particular type of structure which will benefit from the research are bund walls. These provide secondary containment in the event of a rupture of holding tanks (Figure 1.2). These are constructed using the 'Preload' system, where high tensile tendons are wound under tension around the walls to provide support to the structure. The tendons are then sprayed with gunite to provide a durable, smooth finish.

The bund walls can be up to 20m high and 60m-70m in diameter. Circumferential bands are equispaced throughout its height and recessed some 80 mm into the outer face of a 500 mm thick wall. Each band can be 500 mm deep in elevation and, depending on its position, can contain between 240 and 380 small diameter galvanized steel wires each stressed to 1.5 metric tonnes [3].

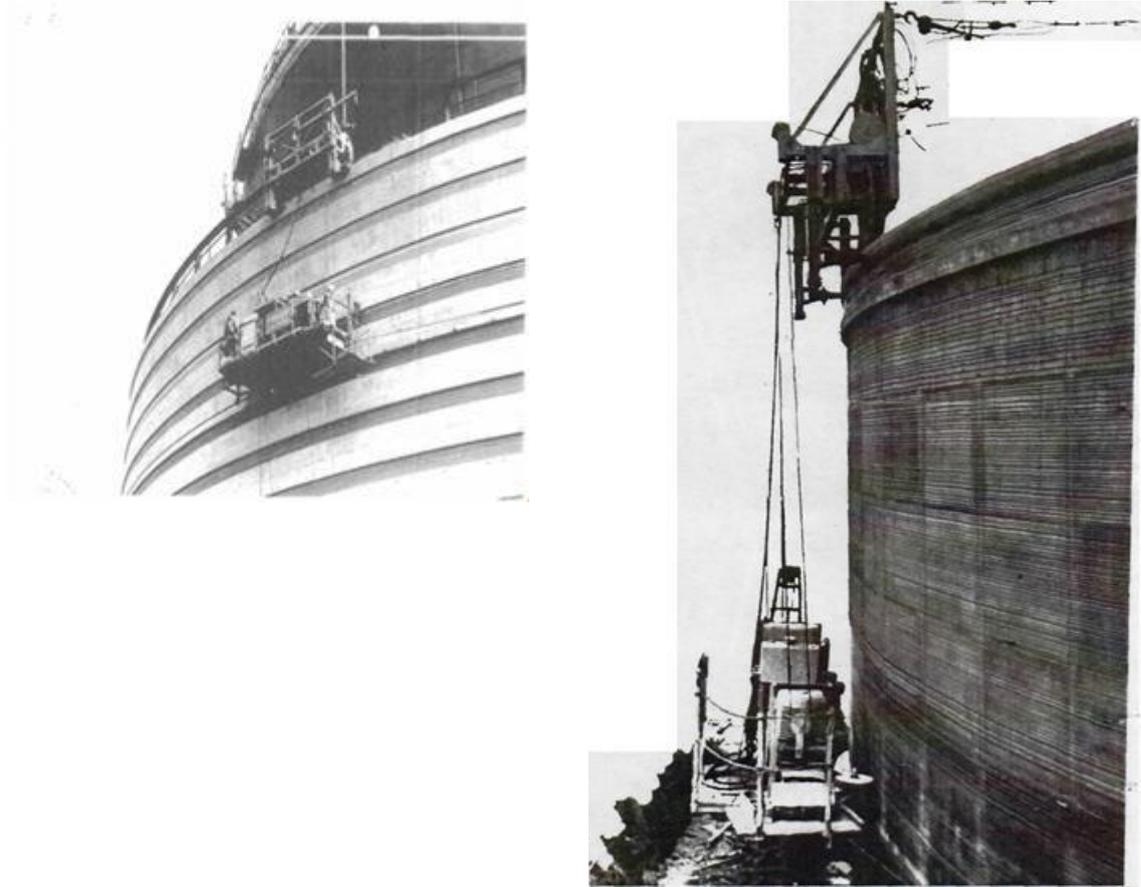
Figure 1.3 Preload system of bund wall

The basis of the Preload system of design and construction of pre-stressed concrete circular structures is the Preload stressing machine or wire winder, developed around 1943 for the purpose of applying large quantities of stressed high tensile steel wire to circular structures in a rapid and efficient manner (Figure 1.3).

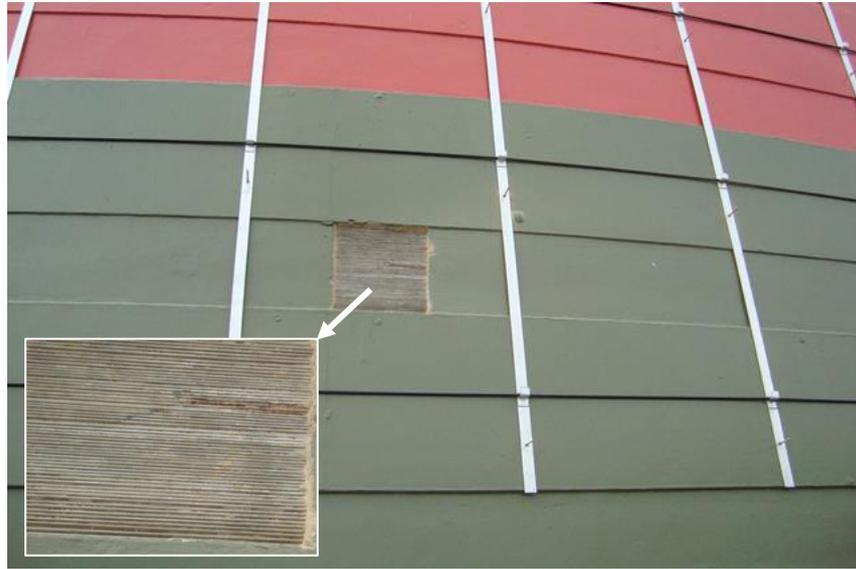
Figure 1.4 Corrosion on preloaded tendon in a bund Wall

The United Kingdom, along with many other nations, is now facing growing concerns with regard to the safety of these structures. Corrosion of the wire tendons has become an issue (Figure 1.4) and an assessment of their residual strength, in addition to proposing new methods for strengthening and increasing their service life, is required.

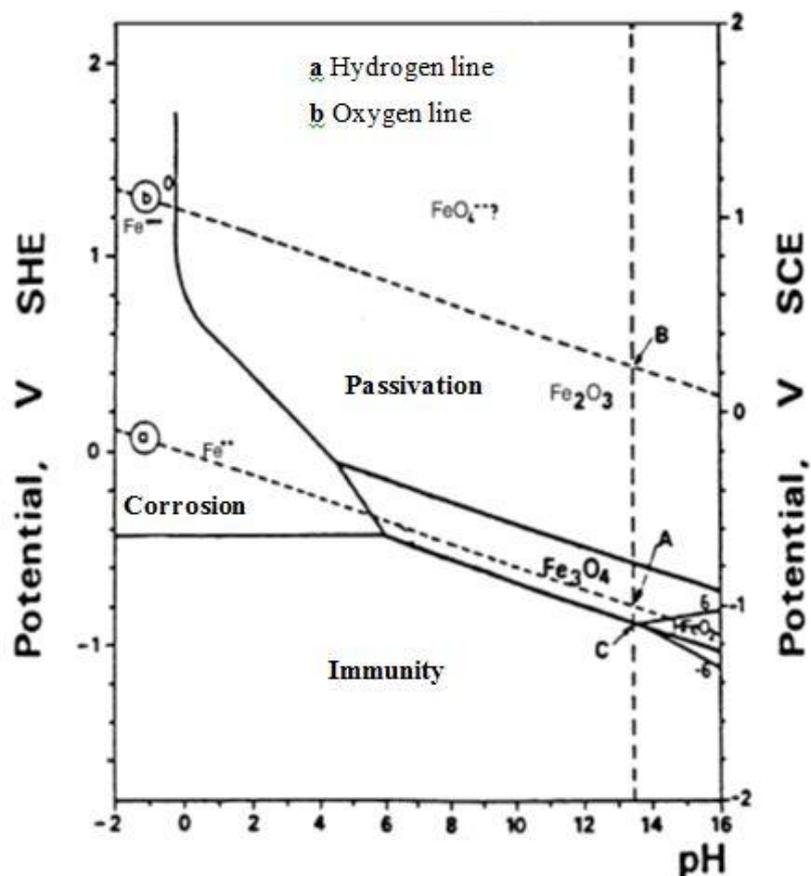
Figure 2.6 Potential-pH equilibrium diagram of iron in aqueous solutions [32]

While the electrical resistance of the concrete is one of the factors controlling how fast corrosion can occur (i.e. the reaction kinetics), the parameters determining whether or not corrosion is actually possible (the reaction thermodynamics) are the pH of the concrete pore solution and the electrochemical potential existing at the steel surface. One can determine theoretically whether or not the reactions are thermodynamically possible and values of E as a function of pH for which the above reactions are in equilibrium can easily be calculated and are available in graphical form as illustrated in Figure 2.6 [32].

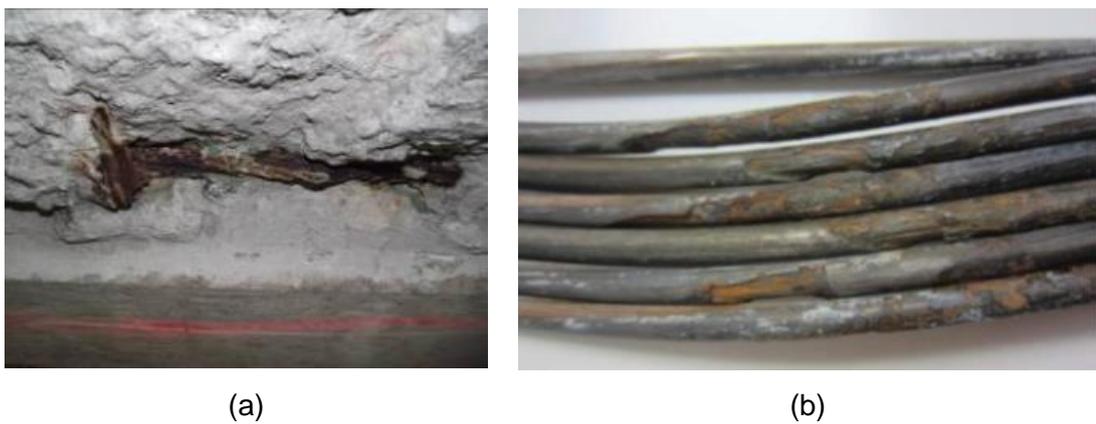
Figure 2.7 (a) Corrosion of Pre-stressing Wires [35] (b) Corroded wires of a strand from a simulated tendon [36]

For many pre-stressed structures exposed to marine environment and de-icing salts, attack by chloride ion is the chief factor that causes corrosion of steel bars. Durability failures of pre-stressed structures caused by chloride contamination are happening continuously all over the world [33]. Offshore structures, piers, dams, docks or harbours are also attacked by chlorides from seawater especially in the tidal, splash and spray water zones [34]. Figure 2.7 and Figure 2.8 show the corrosion of pre-stressed steel wires.

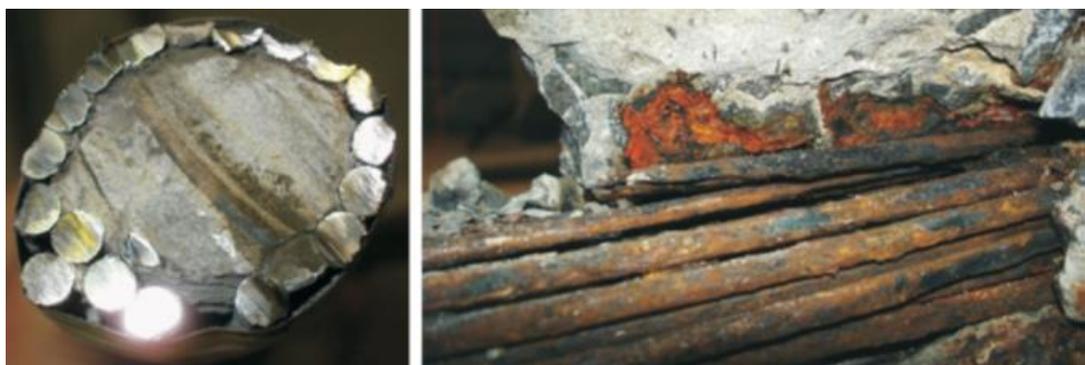
Figure 2.8 Severe corrosion and minimal rust staining on pre-stressing wires [37]

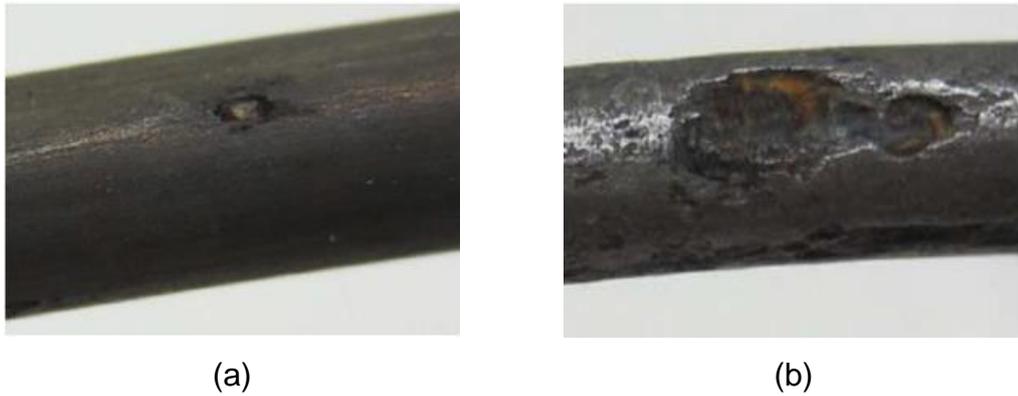
Figure 2.9 Pitted PT wires with (a) grout [Cl⁻] 0.80 wt% cement, pit depth 0.12 mm, and no physical grout deficiency and (b) grout [Cl⁻] 2.00 wt% cement, pit depth 0.46 mm and a grout void [36]

Pitting corrosion of steel usually is readily recognised. Individual shallow pits, and in later stages, deep and sometimes connected pits can be seen with the eye. Pitting corrosion starts when the passive oxide film breaks down in a chloride-rich environment. Once the passive film is breached, an electrochemical cell becomes active. Iron goes into solution in the more anodic bottom of the pit, diffuses toward the top, and oxidizes to iron oxide. The concentration of the iron chloride solution in a pit can increase as the pit deepens. Pitting can penetrate deep into the steel, creating a situation where the steel could fail [38].

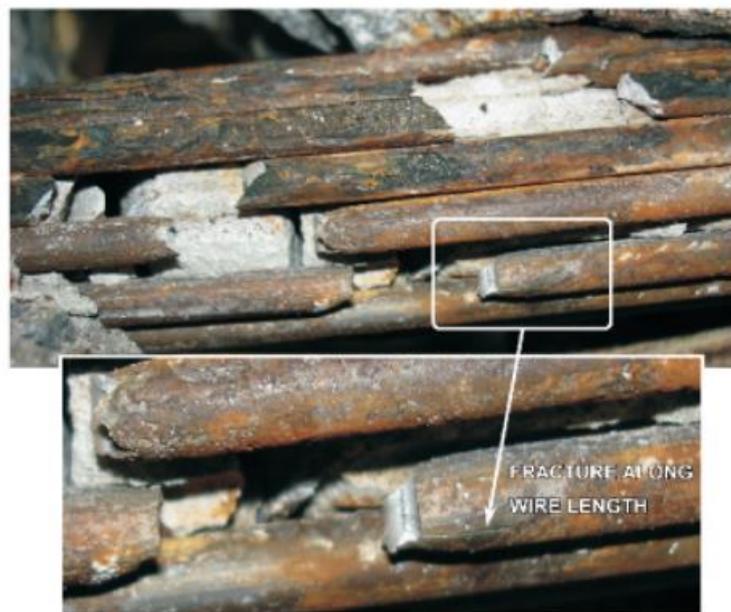
Figure 2.13 Brittle fracture of pre-stressing wire [37]

In sensitive steels the hydrogen under the effect of mechanical stresses can create pre-cracks in critical structural areas such as grain boundaries. These cracks may grow and result in material fracture. Special conditions have to exist to activate the formation of adsorbable hydrogen atoms [42]. SCC and the

subsequent failure of steel (Figure 2.13) and construction may occur if the protection is not guaranteed from the beginning as a result of poor workmanship, or it is lost because of deterioration of the construction in the course of the time, or the pre-stressing reinforcement is pre-damaged during handling. Also, an application of unsuitable materials for pre-stressing steel, injection mortar or concrete can alone or in combination with other factors favour SCC.

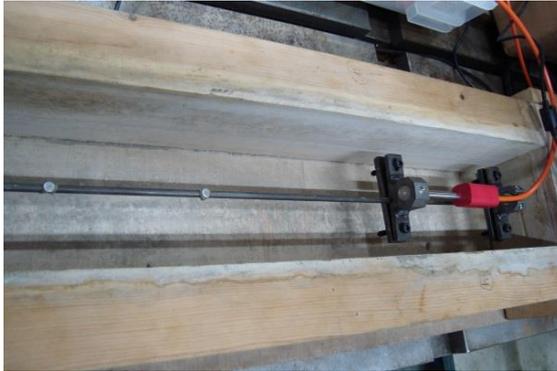
(a) Placing DEMEC pins (100mm) and VW strain gauge (89mm) on the tendon

A number of tests were carried out in order to identify suitable strain gauges that can work within the range of the target stress of the tendon. Two different DEMEC mechanical strain gauges of 100mm and 200mm length were used along with two vibrating wire (VW) strain gauges 89mm and 150mm length as shown in Figure 3.1 (a) and (b).

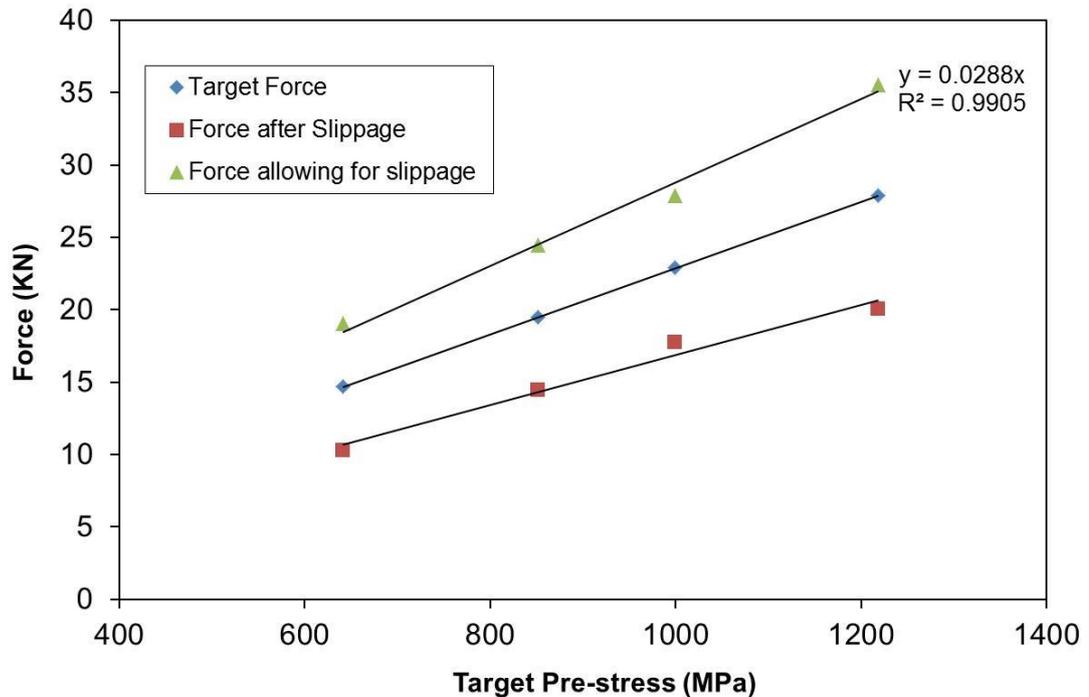
Figure 3.2 Slippage compensation with increasing applied pre-tensioning force

Figure 3.2 shows the required applied force to reach the target stress and its slippage. This slippage is increment with the increase of applied pre-tensioning forces. The force, F, allowing for slippage can be obtained from the equation $F=0.0288 \sigma$ shown on Figure 3.2. The target stress 600, 800, 1000 and 1200 MPa corresponds to allowable forces for slippage of 17.28, 23.04, 28.80 and 34.56 kN.

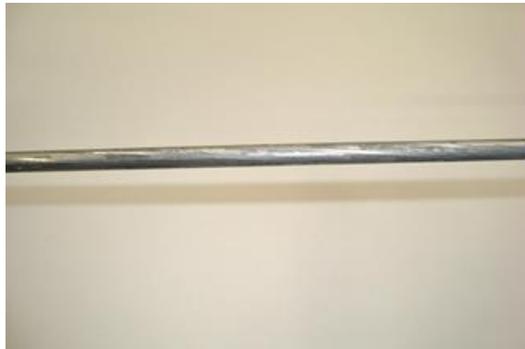
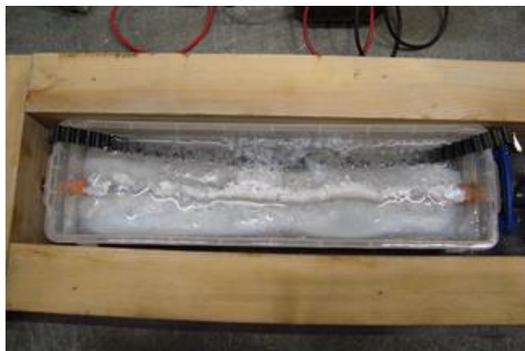
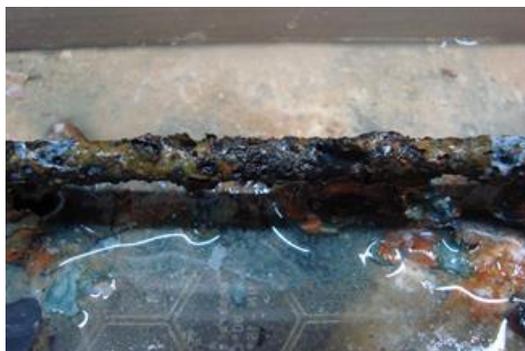
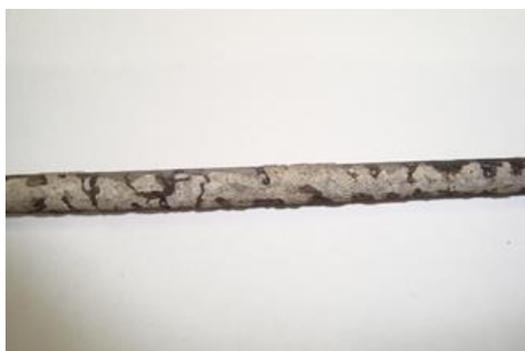
(a) Before start of corrosion

(b) After one day of corrosion, tendon covered by white zinc corrosion products

(c) After completion of corrosion (degree of corrosion: Stage II) and before removing corrosion substance of ferrous rust

(d) After completion of corrosion and removing corrosion substance

Figure 3.3 Appearance of tendon throughout the corrosion period

Figure 3.3 (a) and (b) shows the appearance over time of the galvanized tendon after completion of corrosion and before inducing the ICCP. The galvanized steel tendon after one day exposed to corrosion was covered with a white zinc corrosion product [Figure 3.3 (b)] and ferrous rust was spread widely in the specimens after completion of corrosion on day 3 [Figure 3.3 (c)]. Figure 3.4 and Figure 3.5 show a reduction in service stress of the ungalvanised tendon over the entire test period for target pre-stresses Low and High levels respectively. At Stage I degree of corrosion, stage I losses are very similar, while there is a greater difference in loss of pre-stress due to stage II corrosion. This indicates that the loss in service stress is more dependent on the degree of

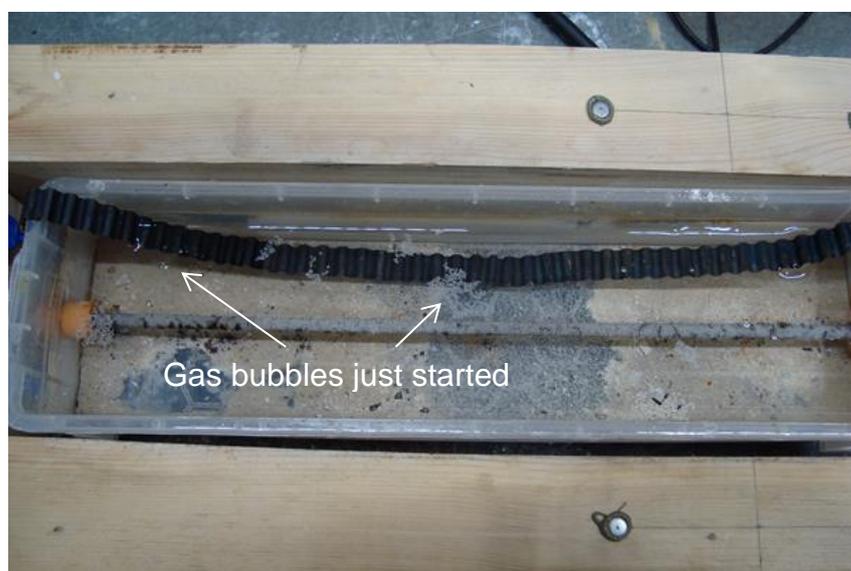
Figure 3.6 Hydrogen just being generated on tendon S-G-H-II-1

A test was initially conducted on one pre-stressed galvanised tendon (S-G-H-II) to evaluate its operation (Figure 3.6) and Table 3.7 shows the tendon parameters. Table 3.4 and Table 3.7 provide details of the test.

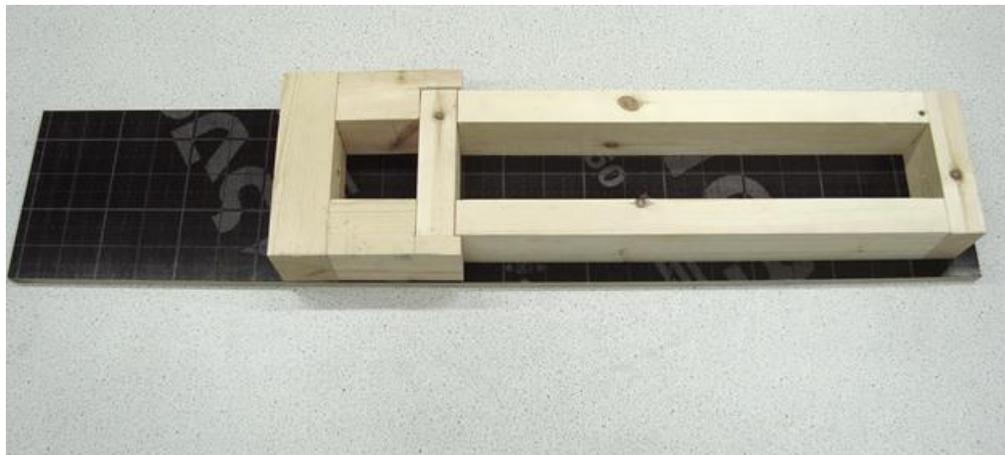
Figure 4.1 Timber mould on a wisa-form base

A total of 12 timber moulds/pre-stress beds were designed, manufactured and developed as shown in Figure 4.1. The timber mould was fastened to a plywood or wisa-form base and was used:

- pre-load the tendon
- provide formwork for the cast gunite/mortar or space for the solution in a plastic tray
- conduct accelerated corrosion
- conduct cathodic protection

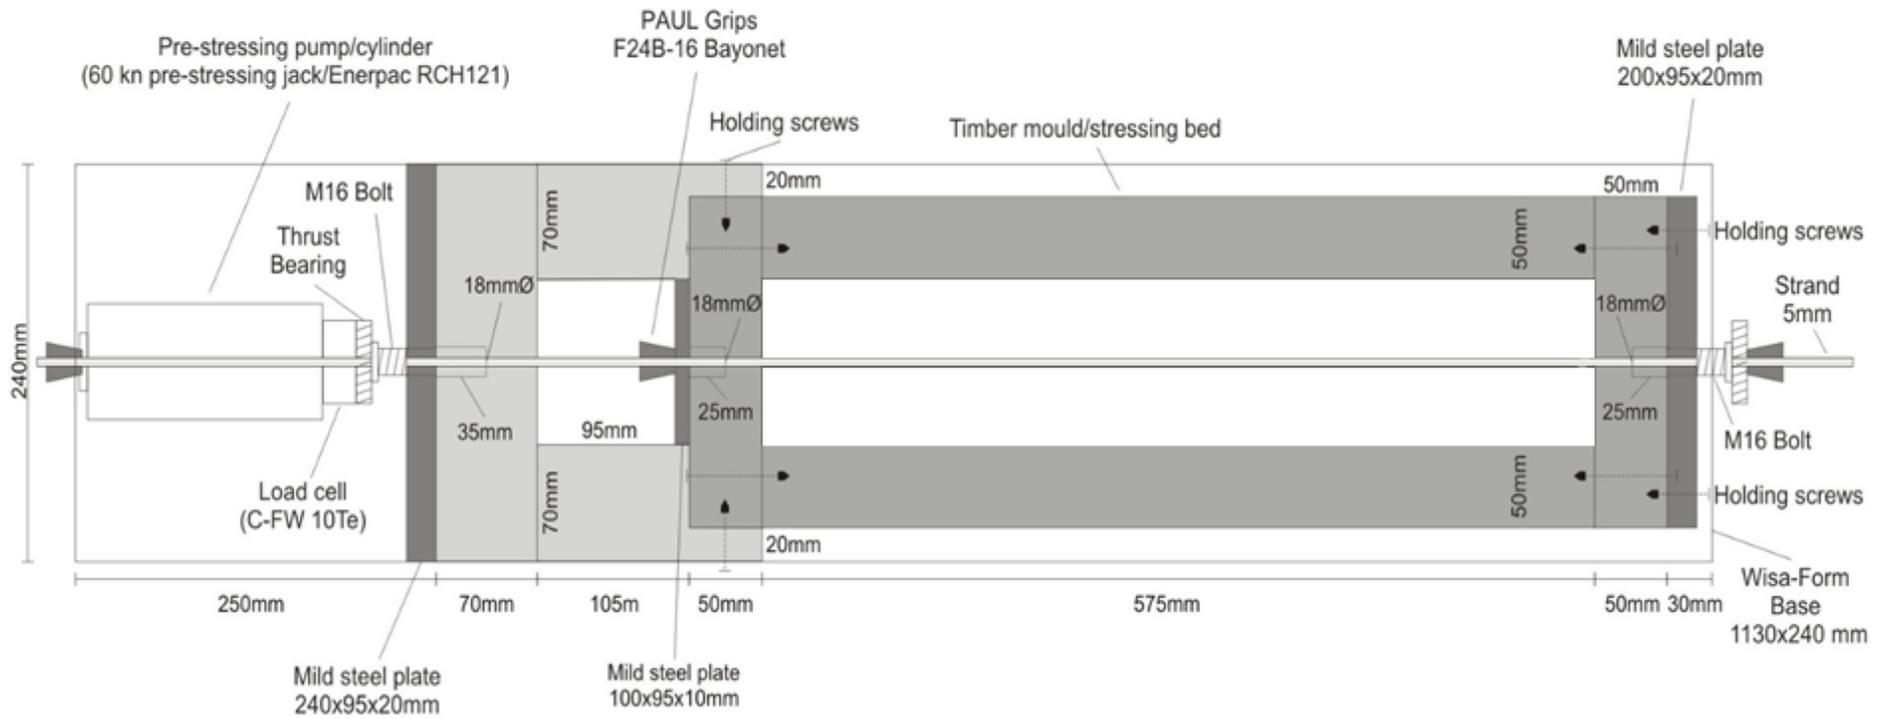
Figure 4.2 Pre-stressing set-up

- drilled M16 mild steel bolts at either end, through which the tendons passed, and threaded into the end plates to facilitate releasing of the pre-load
- a thrust bearing inserted at the bolt head at the loading end to prevent damage to the tendon/mortar bond during the release of load
- a data logger to record and log the strain readings from the strain gauges

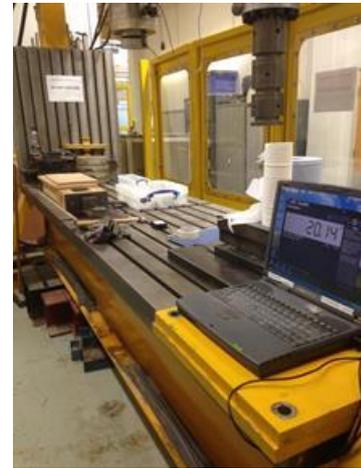
(b) Pre-stressing in progress

Figure 4.5 Trial test using load cell to determine the losses

The target stress was exceeded by approximately 5 MPa to allow for the losses, based on trials conducted with the load cell in place and monitoring the drop-off in load (Figure 4.5 (a) and (b)). The preliminary work enabled the target pre-stress to be more accurately determined due to a better understanding of slippage losses within this pre-stressing system (Section 3.7.1)

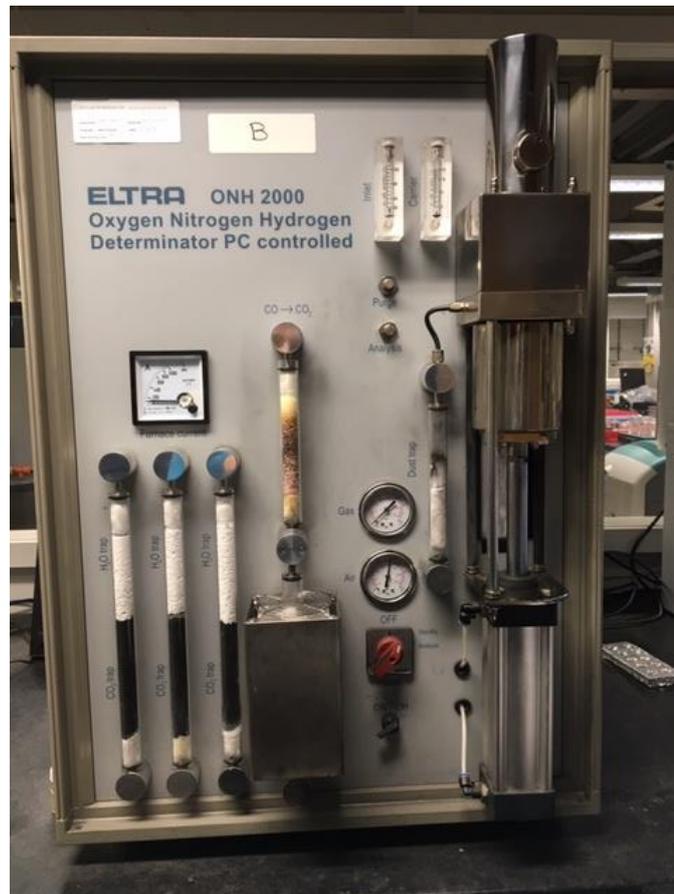
Figure 4.11 Hydrogen test machine

The inert gas fusion and thermal conductivity methods are widely used for quantitative determination of hydrogen (H) in metals. A portion of sample is heated to 3000°C in an electrode furnace. Firstly, the sample is placed in a gas inert environment (He) and current is passed through the graphite crucible producing enough heat to melt the sample. The different gases produced are separated in the separation column and H₂ is measured by a thermal conductivity cell by comparing the conductivity of a pure inert gas with the sample conductivity (Figure 4.11)

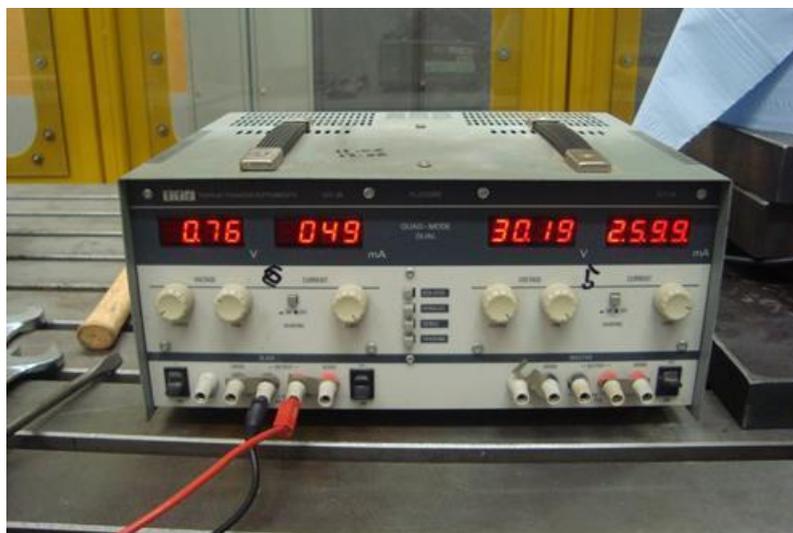
Figure 4.12 DC Multi-Channel Power Supply

A DC power supply system (Figure 4.12), has been used to accelerate corrosion on the tendon and apply ICCP. The positive terminal is connected to the anode (tendon) and negative to the cathode for corrosion. This is reversed for the ICCP, the tendon is the cathode and the MMO titanium the anode.

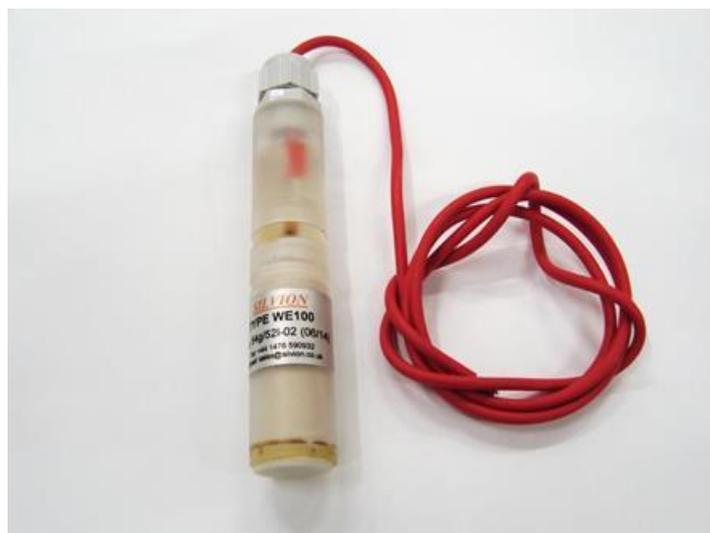
Figure 4.13 Reference electrode

In this research, reference electrode types Silver/Silver Chloride Ag/AgCl/ 0.5M KCl Type WE100 (Figure 4.13) were used to measure the potential of the tendon in both solution and mortar. It was inserted in the solution or applied to the mortar face. It was supplied by Silvion Limited, UK.

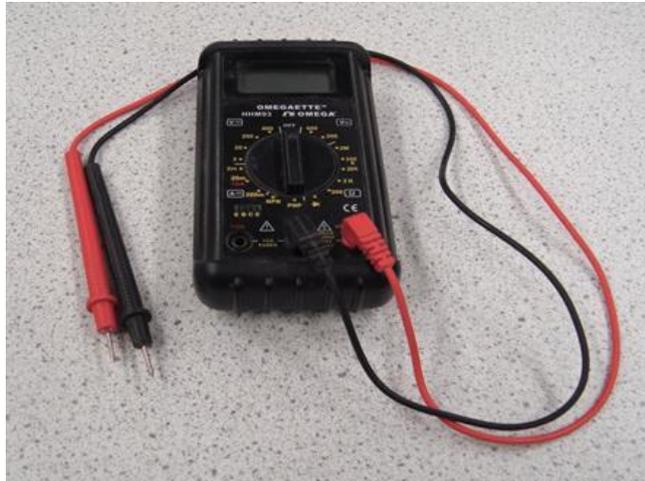
Figure 4.14 Digital voltmeter

The digital voltmeter (DVM) used in the investigation (Figure 4.14) has high input impedance so that current flowing through the reference electrode does not cause disturbance or affect its potential. It is manufactured by Omegaette.

The voltmeter has a different range of resolution. The potential drop along the cable from the reinforcing steel to the voltmeter was less than 0.1 mV when measured between two previously calibrated reference electrodes.

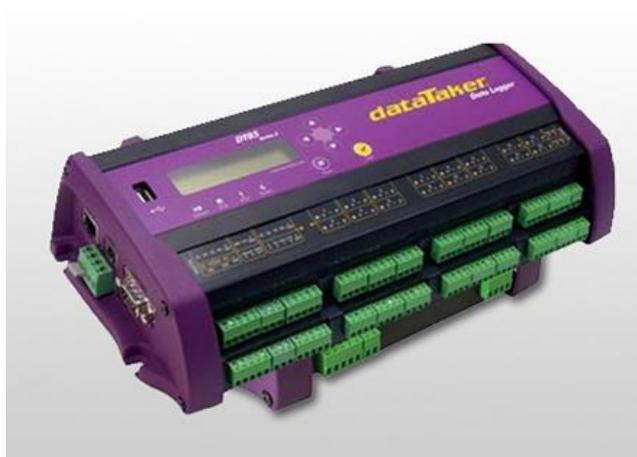
Figure 4.15 Data logger Type 85D

A dataTaker DT85 is used to record the test results. The dataTaker DT85's dual channel configuration allows up to 32 isolated channel inputs to be used in many combinations (Figure 4.15).

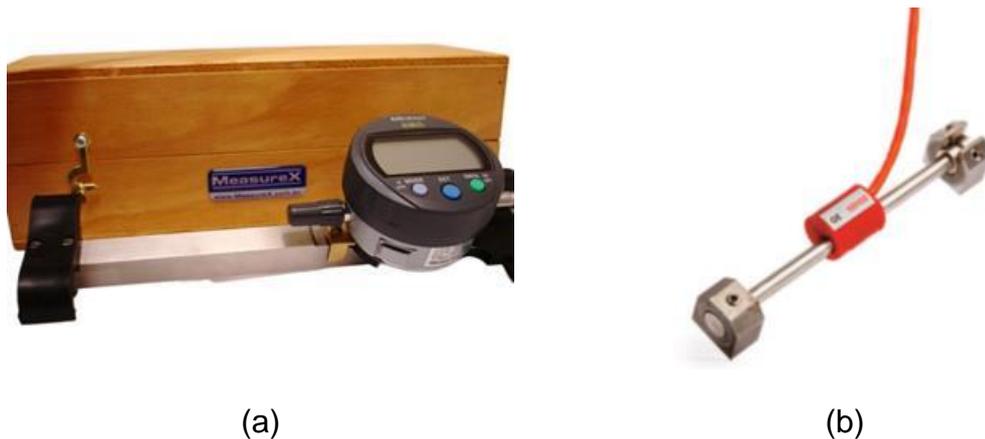
Figure 4.16 (a) Demec digital strain gauge, (b) Digital vibrating wire strain gauge

Different strain gauges were used to measure the strain in the pre-stressing system during the tensioning process. A digital DEMEC with 300mm gauge length was used to measure the strain (compression) in the timber pre-stressing moulds during tensioning of the tendon. This would enable any losses in pre-stress to be attributed to the tendon and not a contraction of the mould. Two types of vibrating wires gauges were used and supplied by Geosense to continuously measure the strain in the tendon in the stressed state. Strain gauge with a gauge length of 89mm and a strain range of 3000 microstrain was used where lower strains were expected (low level of pre-stress). Where higher strains were expected (High level of pre-stress), a vibrating wire strain gauge with a gauge length of 150mm was used, this had a capacity of 6000 microstrain ($\mu\epsilon$) (Figure 4.16). Specifications of both 89mm and 150mm strain gauges are given in Table 4.5.

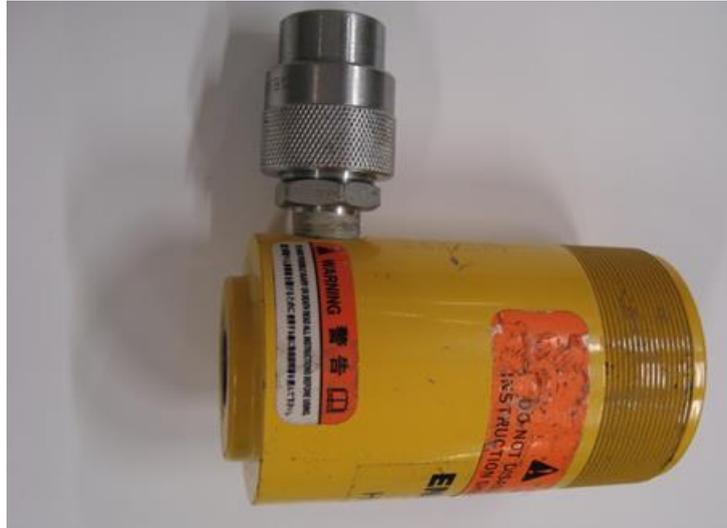
Figure 4.17 Hydraulic hollow cylinder Jack

A hydraulic jack RCH-121 with 12 tons capacity was supplied by Apex Hydraulic in the UK. It was used to apply different pre-determined tensioning loads to the tendons. It has a hollow centre allowing the tendon to pass through it, thereby enabling a load to be applied. A hand-pump was used to pressurise the cylinder (Figure 4.17).

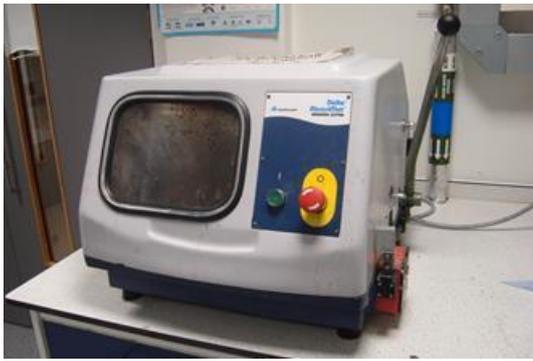
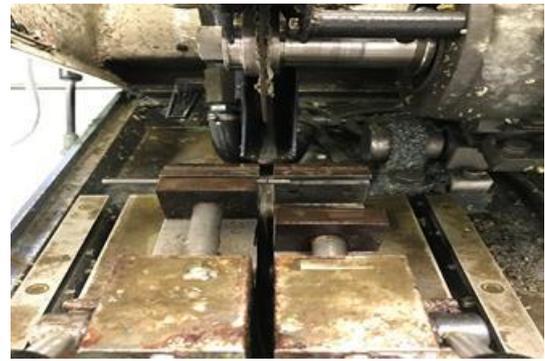
(a) Cutting machine

(b) Cutting sample of tendon

Figure 4.20 Cutting SEM samples

Figure 4.20 (a) and (b) shows the cutting of the sample to fit with the sample holder and the SEM's chamber using the cutting machine type Delta Abrasimet made by Buehler.

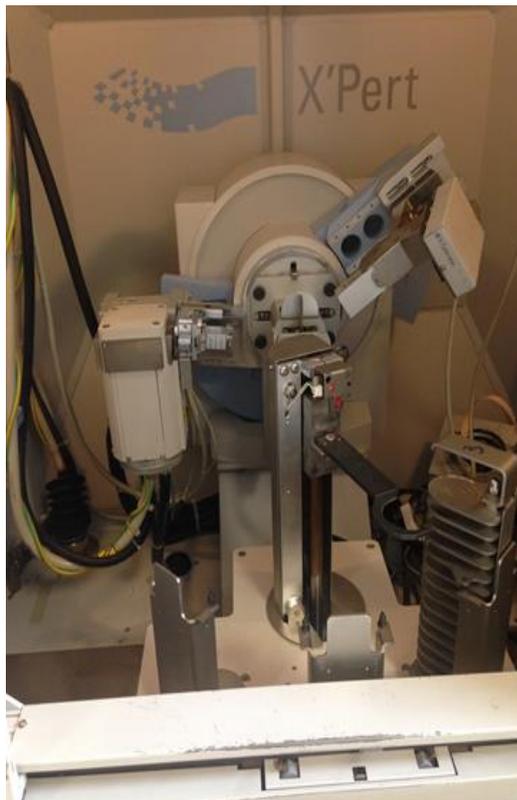
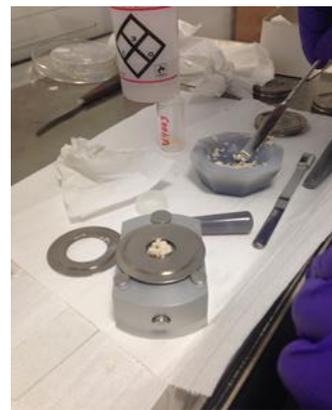
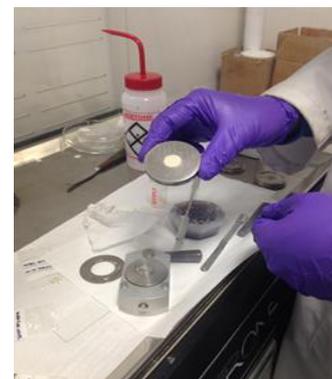
(a) XRD Instrument

(b) Sample preparation

Figure 4.22 X-Ray Diffraction (XRD)

Sedimentation due to the reaction occurring during application of accelerated corrosion within the solution electrolyte on galvanised and ungalvanised specimens were investigated using the XRD as presented in Figure 4.22 (a) and (b). In addition, corrosion products on galvanised and ungalvanised specimens were investigated also using the XRD. This investigation applied when completing corrosion and ICCP tests, samples of corrosion products were taken and investigated.

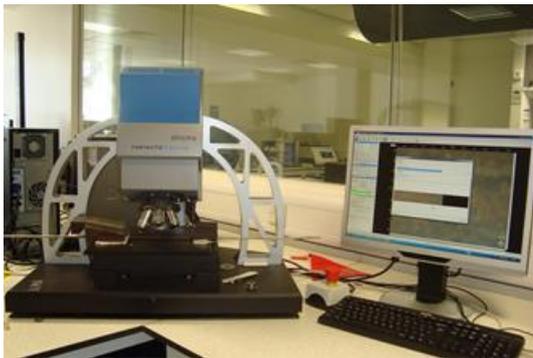
Figure 4.23 Infinite Focus Measurement (IFM) (a), taking image (b)

Using a 3D micro coordinate measurement machine by Alicona, surface images before and after removing the corrosion products were taken. Surface integrity analysis is performed using Infinite Focus Microscope (IFM) Figure 4.23 (a) and (b). The Infinite Focus Microscope (IFM) is an optical 3D measurement device which allows the acquisition of datasets at a high depth of focus. First a stack of n images from the lowest to the highest plane of the surface features is acquired. Then the positions in the stack are determined where each image

point is best in focus. This leads to an overall sharp image and to a reconstruction of the surface, where a height value exists for each point on a ground plane. The IFM method allows capturing images with a lateral resolution down to 400 nm and a vertical resolution down to 20 nm [89]. The IFM 3.5 software version was used for the measurements. With a high magnification X50, roughness of the surface on both galvanised and ungalvanized tendons were measured. Corrosion pit widths were measured and comparisons with different stages of corrosion were made.

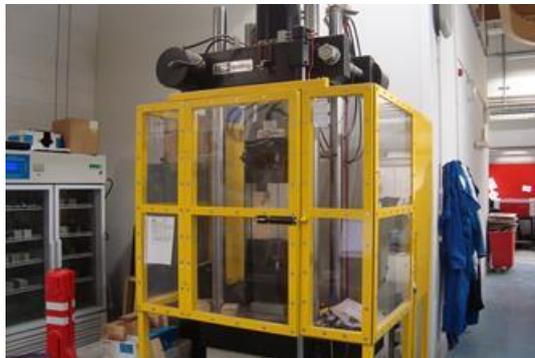
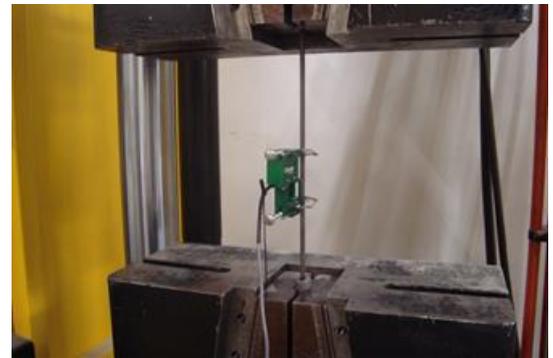
(a) Tensile test machine

(b) Extensometer

Figure 4.24 Tensile test machine ESH600 and extensometer

The test sample is securely held by top and bottom grips attached to the tensile or universal testing machine. During the tension test, the grips are moved apart at a constant rate to pull and stretch the specimen. The force on the specimen and its displacement is continuously monitored and plotted on a stress-strain curve until failure.

strain curve was shown on the computer screen as a visual representation. Figure 4.24 shows both shield ESH600 tensile machine and extensometer used to conduct the tensile test.

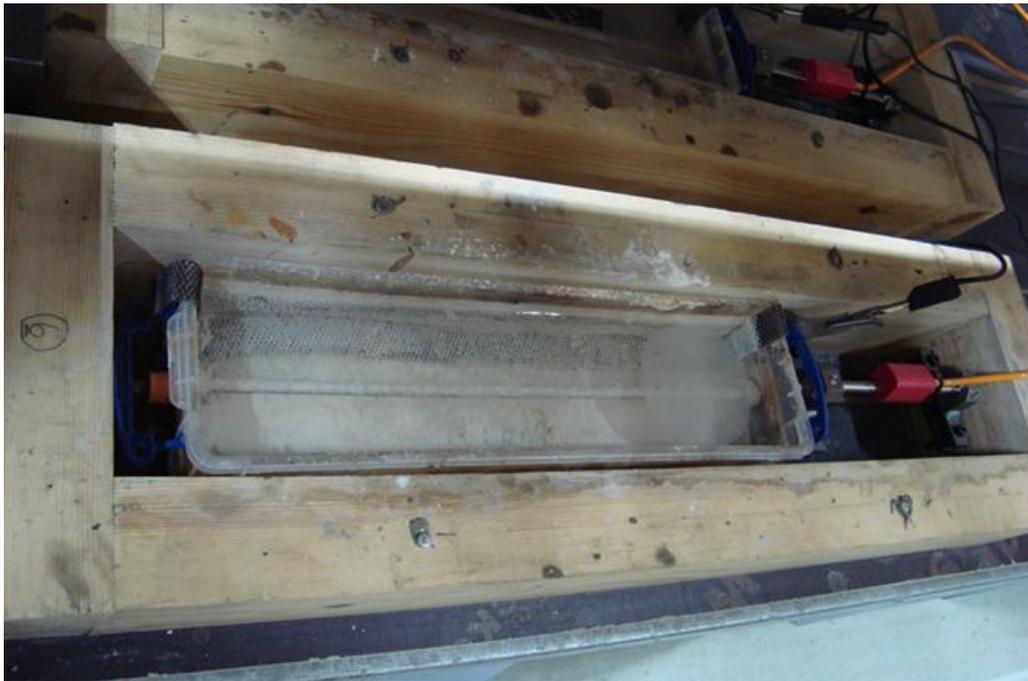
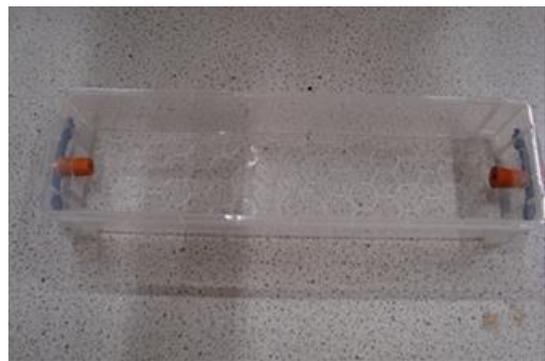
Plastic box in a prestressing timber mould with test ongoing

Drilled Plastic box ready to use

Figure 5.1 Test set-up for saline electrolyte

For the purpose of the test, batch one, plastic boxes with internal dimensions 320 mm length, 80 mm width and 60 mm depth were employed to contain the saline solution. Two holes were made in each end face of the box to allow the tendon to pass through with tight fitting bungs to prevent any leakage as shown in Figure 5.1. The saline solution consisted of water and 5 % by weight sodium chloride (NaCl) in order to promote the corrosion of the tendon.

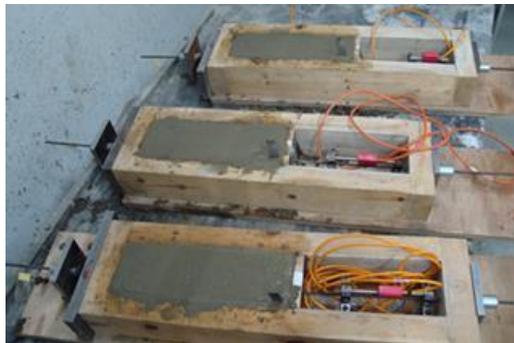
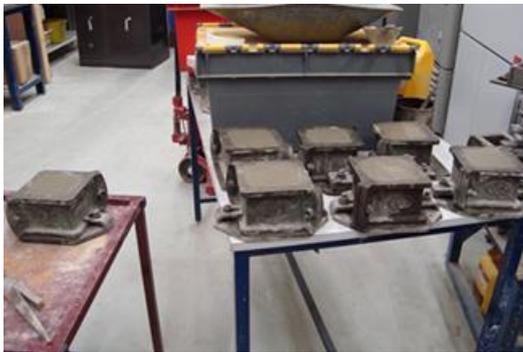
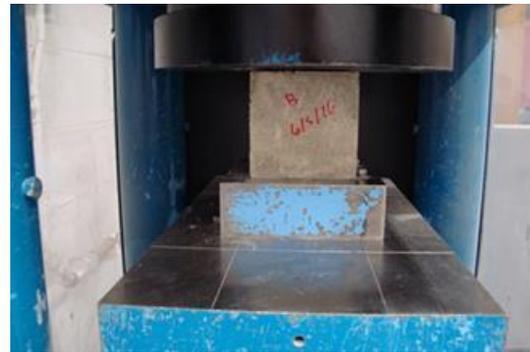
(a) Casting the mortar in the mould

(c) Casting cubes

(d) Testing cubes

Figure 5.3 Casting the mortar and testing the cubes

for a further 27 days (28 days in total). Cube specimens were cast for each mix and tested for compressive strength in accordance with BS EN 12390-3: 2009. Cubes were tested at 1, 14, and 28 days age as shown in Figure 5.3.

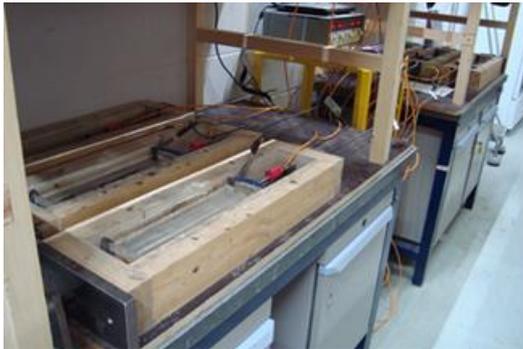
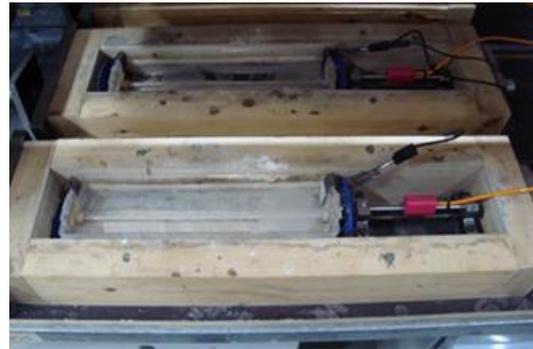
Specimens generating hydrogen during accelerated corrosion

Figure 5.7 Batch 1 specimens under accelerated corrosion

corrosion. MMO Ti mesh was connected to the negative terminal of a D.C power supply, working as the cathode, while the pre-stressed tendon was connected to the positive terminal of D.C power supply and corroded. The corrosion process took place in a plastic box containing 3.5% NaCl solution by weight. The solution level in the box was adjusted to ensure adequate submersion of the tendon, but to also allow sufficient oxygen availability for the corrosion processes to occur freely on the anodic tendon. Figure 5.7 shows Batch 1 under accelerated corrosion.

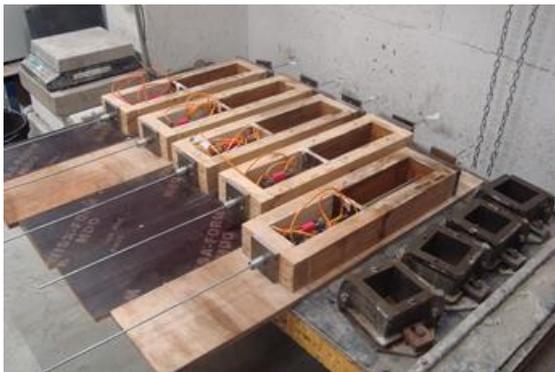
(a) Pre-stressing moulds and cubes ready for casting

Figure 5.8 Specimens and cubes ready for casting

After pre-stressing stage, the moulds were cast with mortar as shown in Figure 5.8 (a) & (b).

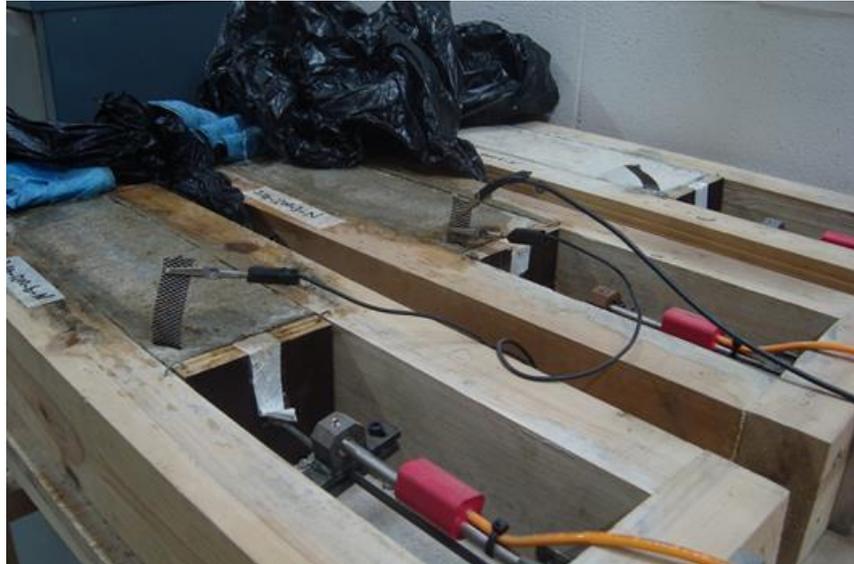
Figure 5.10 Set of specimens under accelerated corrosion - Batch 2

The duration of corrosion was calculated by Faraday's Law (Section 5.5). Three different stages of corrosion were selected Stage I (0-1 % control), Stage II (2-4 %) and Stage III (4-7 %). For all specimens, the applied current was fixed (54.28 mA, Equation 5.8) and corrosion period was adjusted (Equation 5.5) to give the required degree of corrosion (e.g. 20.23 hours for 1 %, 60.90 hours for 3 % and 121.81 hours for 6 %) Figure 5.10.

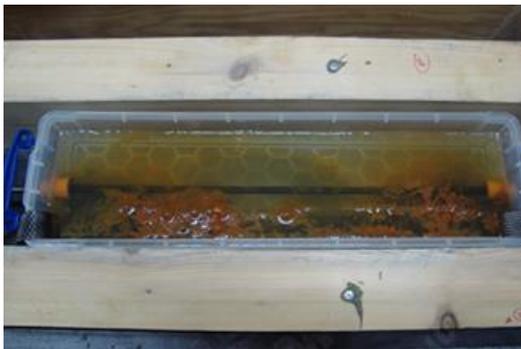
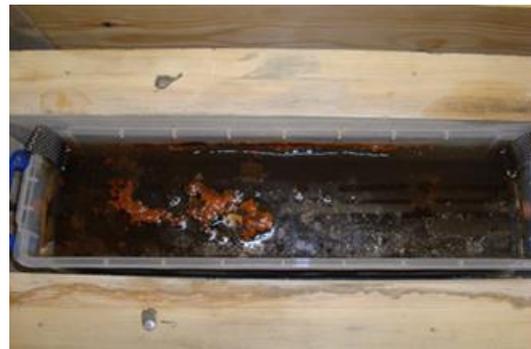
(a) Yellow to brown rust colour in the solution

(b) Dark brown and black colour in the solution

Figure 5.12 Corrosion of the tendons in the saline solution and colour changes

Figure 5.11 shows Batch 1 specimen under accelerated corrosion and each sample was monitored daily during the test in terms of changes in applied service stress via the VWSG data logger and visual inspection for any change in the saline solution. The first sign of corrosion was yellow/brown (rust) staining on the surface of solution which was observed after a few hours (Figure 5.12 (a)). It was also observed after 24 hours that the colour of the corrosion on the solution surface changed first to a darker brown then to black (Figure 5.12 (b)). It was also observed that hydrogen on titanium was generated, as would be expected due to hydrolysis of water. Regarding the pre-stress in the tendon, it was observed that it reduced during the corrosion process; the next section will show this in more detail. Having achieved the required degree of corrosion, cathodic protection (CP) was applied to specimens and monitored. Upon completion of the CP, the tendons were removed and reweighed to determine the weight loss and hence, the actual degree of corrosion.

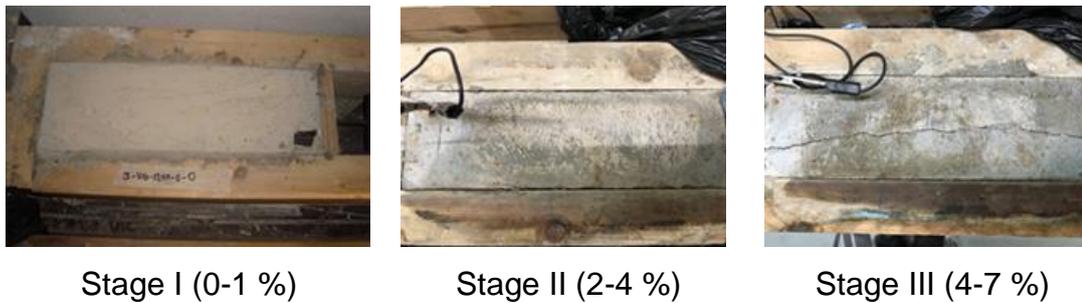
Figure 5.13 Cracks at each stage of corrosion during accelerated corrosion process

The progress of corrosion of each sample was monitored daily. As accelerated corrosion was induced in the tendons, most specimens in batches 2, 3, 4 and 5 a longitudinal crack was observed on the surface of the mortar where the stage III of corrosion was applied. It was observed that longitudinal cracks appeared on the surface of mortar along the pre-stressed tendon (Figure 5.13).

These cracks were located along the tendon. Table 5.5 shows the maximum crack width associated with each stage of corrosion, measured to the nearest 0.05 mm by means of a crack-measuring microscope. There is no cracking up to Stage II (2-4 %), while a clearly visible crack occurred when the degree of corrosion increased Stage III (4-7 %), indicating that a threshold stage had been passed.
