Cathodic Protection of Corroded Pre-stressed Tendons

A thesis submitted in partial fulfilment of the requirements of
Sheffield Hallam University
for the degree of Doctor of Philosophy

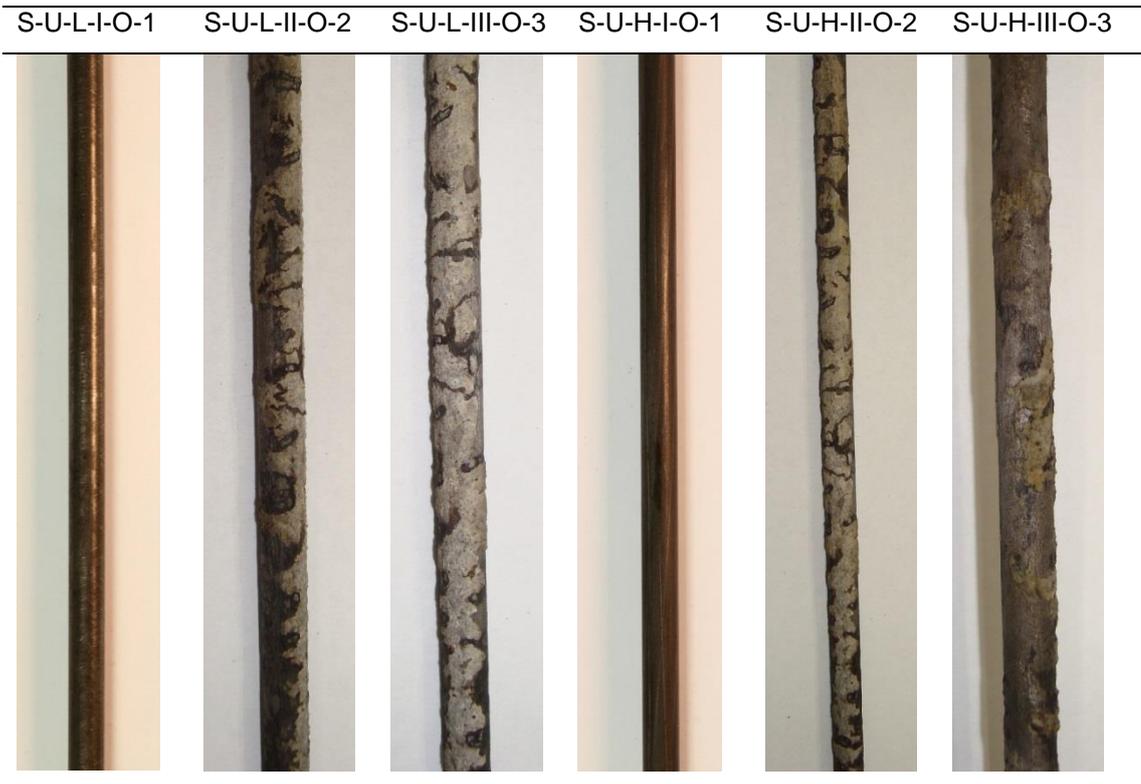
Figure 5.15 Surface of tendon after corrosion - Batch 1

After drying in the laboratory air, any remaining corrosion products were removed using a fine glass fibre brush. The surface of the corroded tendon was then examined to analyse the extent and type of corrosion. The corroded surface of the tendon after cleaning is shown in Figure 5.15 to Figure 5.18, images were taken by digital camera (Canon EOS 5D Mark2).

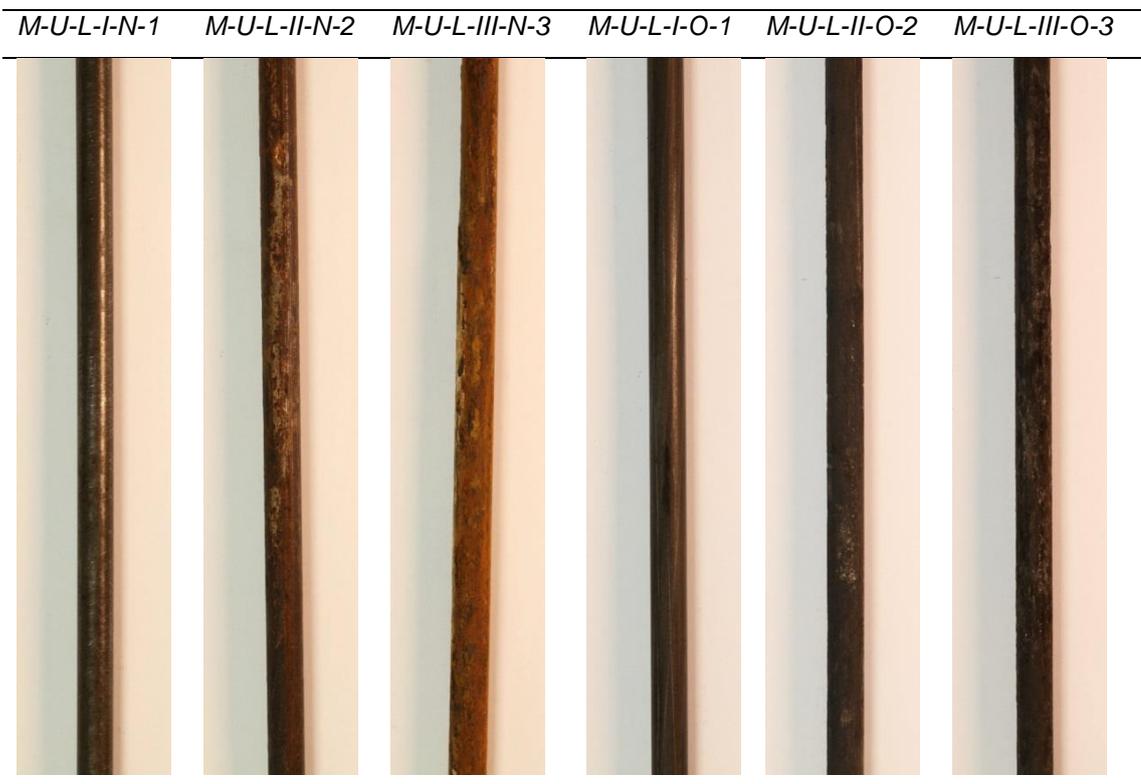
Figure 5.16 Surface of tendon after corrosion - Batch 2

The visual inspection of the tendon surface condition indicates that localised corrosion appeared more clearly defined at higher degrees of pre-corrosion than for the lower degrees of pre-corrosion, as described in Table 5.6.

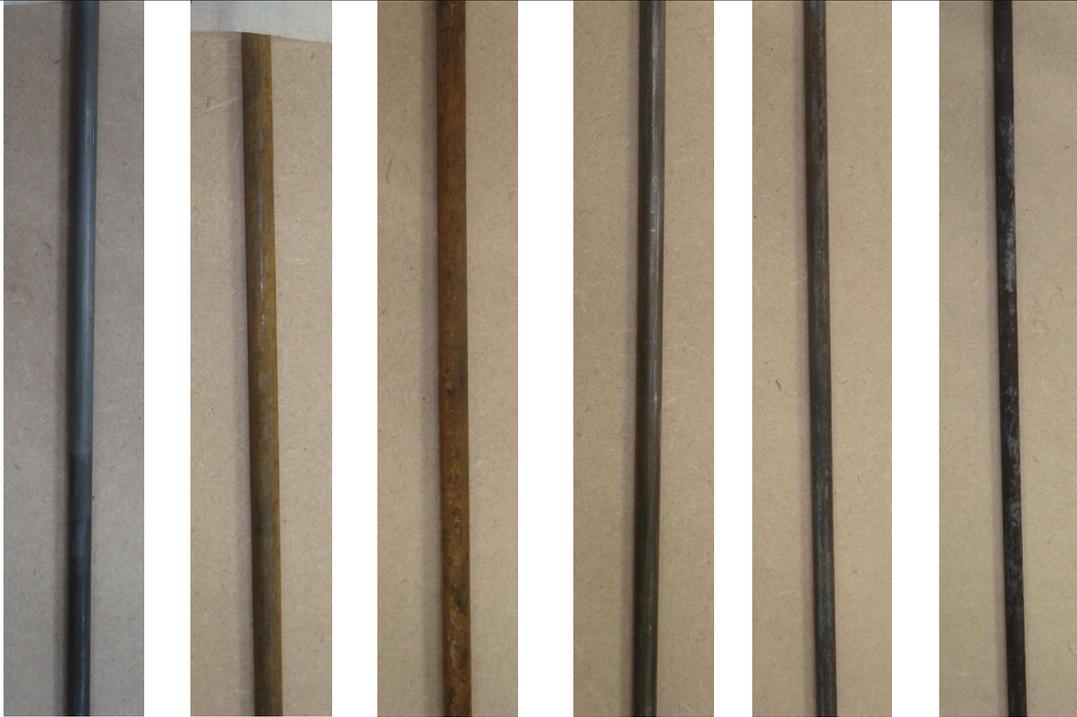
Figure 5.17 Surface of tendon after corrosion - Batch 3

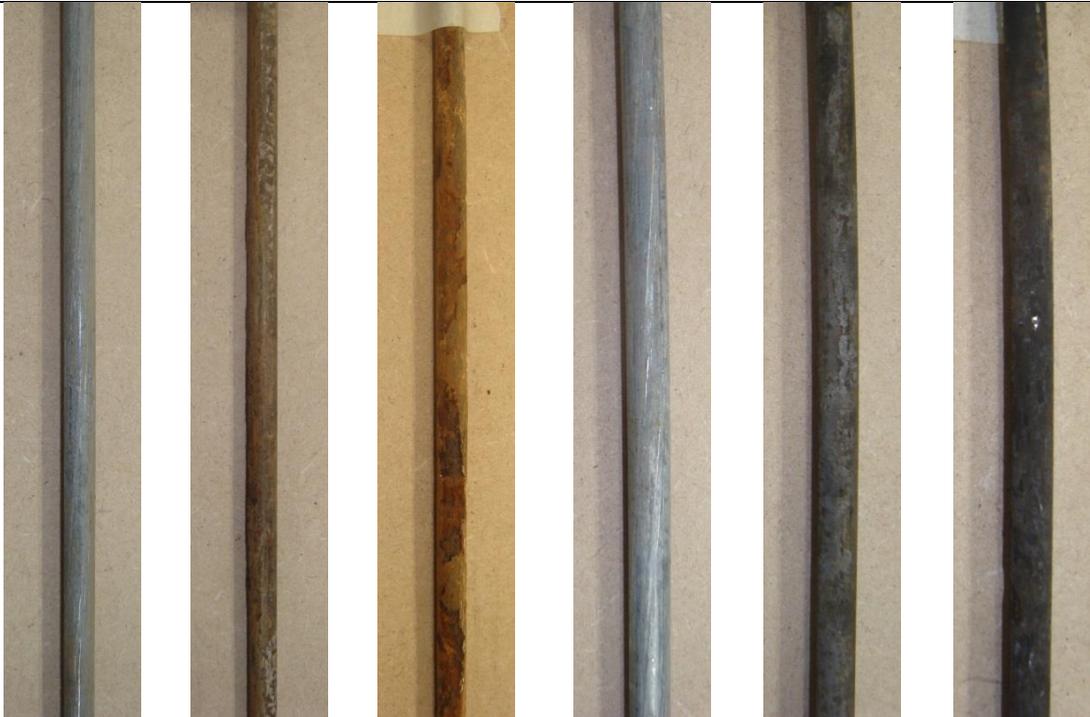
Figure 5.18 Surface of tendon after corrosion - Batch 4

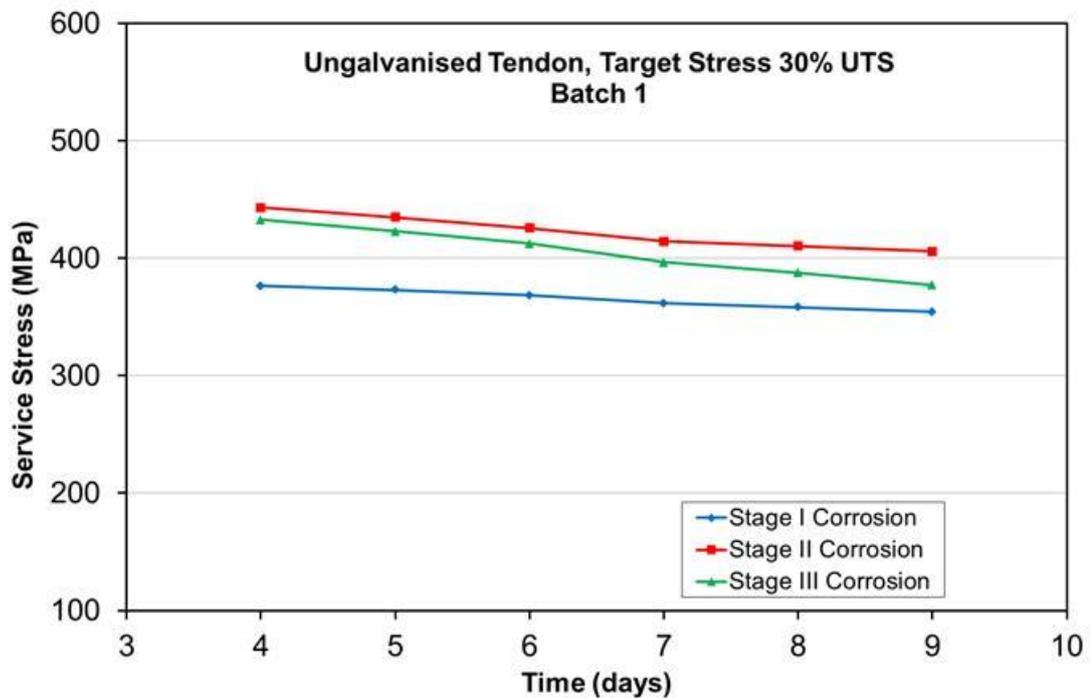
Figure 5.20 Gross loss in tendon pre-stress over corrosion period (30% UTS)

Figure 5.20 compares the loss in pre-stress of the tendons with the different degrees of corrosion, Stage I (0-1 %), Stage II (2-4 %) and Stage III (4-7 %) at the low pre-stress level (300-400 N/mm², approximately 30% Ultimate Tensile Strength of the tendon, UTS). Figure 5.21 shows the net loss in pre-stress due to corrosion of Stage II and Stage III where the loss in pre-stress from the control Stage I specimen is subtracted from the corroded specimens with the same level of pre-stress, 30% UTS.

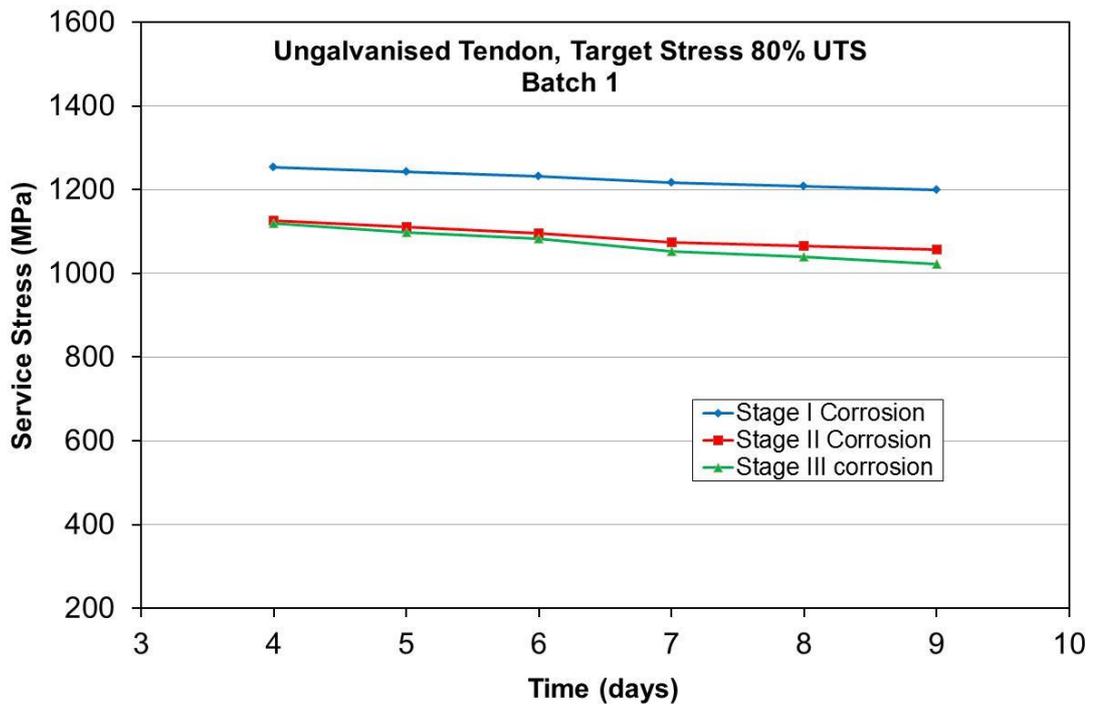
Figure 5.22 Gross loss in tendon pre-stress over corrosion time (80% UTS)

Similarly for the target pre-stress, High Level (800-1200MPa), Figure 5.22 compares the loss in pre-stress of the tendons with the different degree of corrosion, Stage I, Stage II and Stage III over the corrosion period.

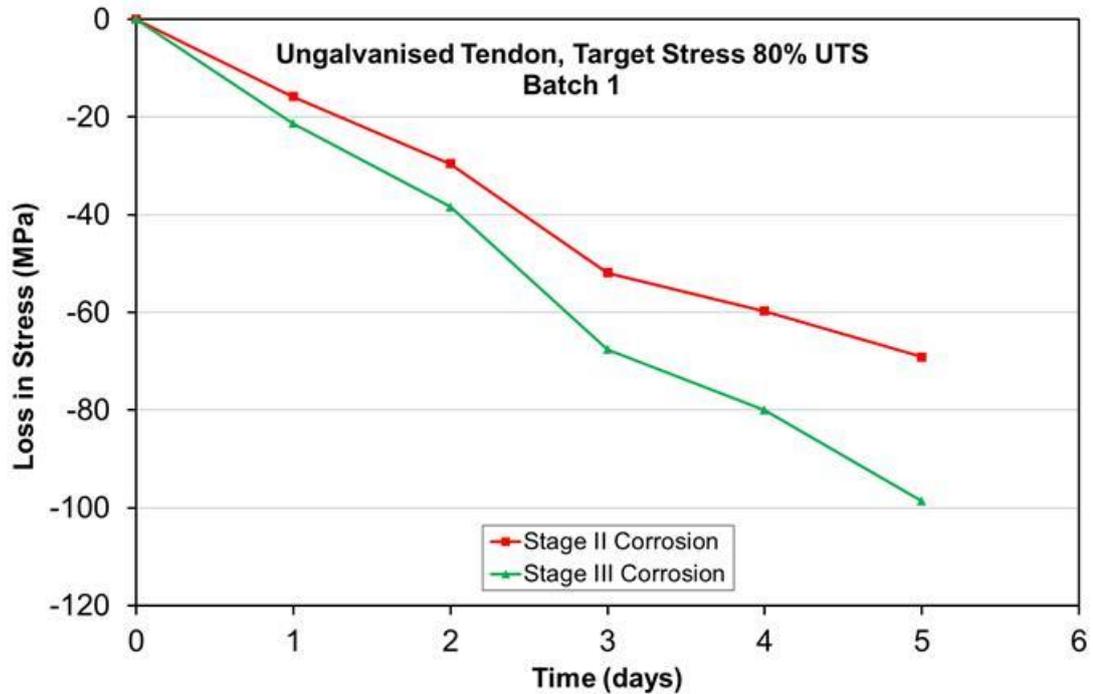
Figure 5.23 Net loss in tendon pre-stress over corrosion period (80% UTS)

Figure 5.23 shows the net loss in pre-stress due to corrosion Stage II and Stage III. Again, the net losses in pre-stress are obtained by subtracting the control (Stage I) stress from the stress measured during the corrosion phase.

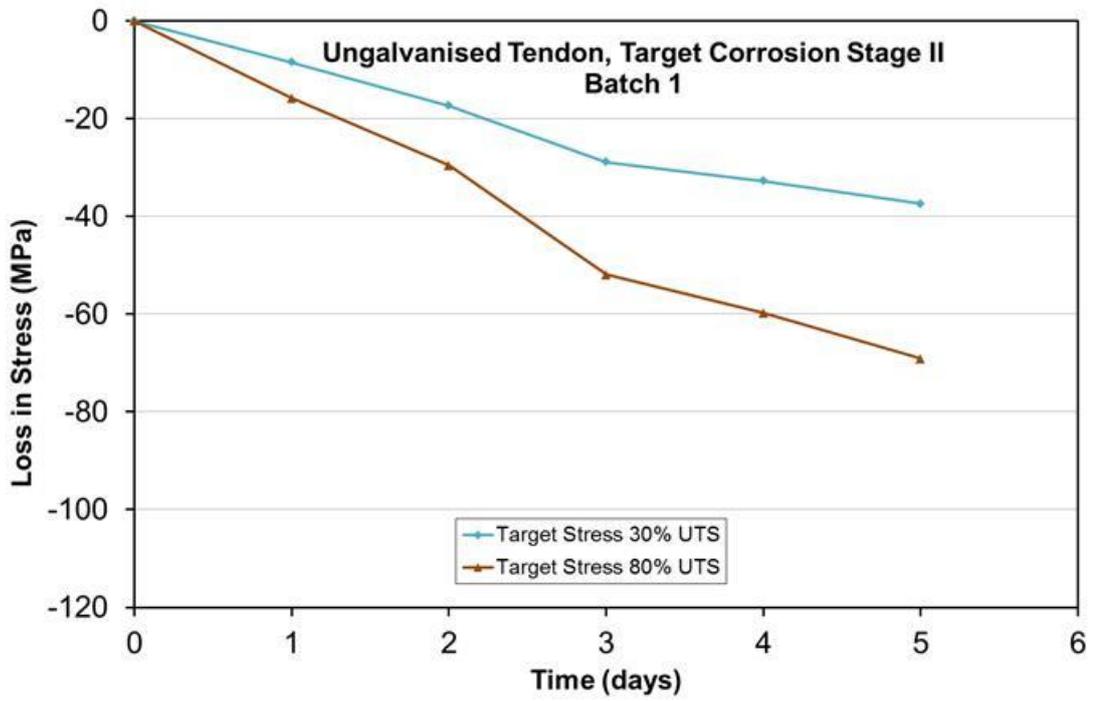
Figure 5.24 Loss in pre-stress due to corrosion Stage II

Figure 5.24 shows losses in pre-stress in tendons with target pre-stress of 30% UTS and 80% UTS. At Stage II degree of corrosion, Stage II losses are very similar, while Figure 5.25 indicates that there is a greater difference in loss of pre-stress due corrosion Stage III. This indicates that the loss in pre-stress is more dependent on the degree of corrosion and less dependent on the initial pre-stress in the tendon.

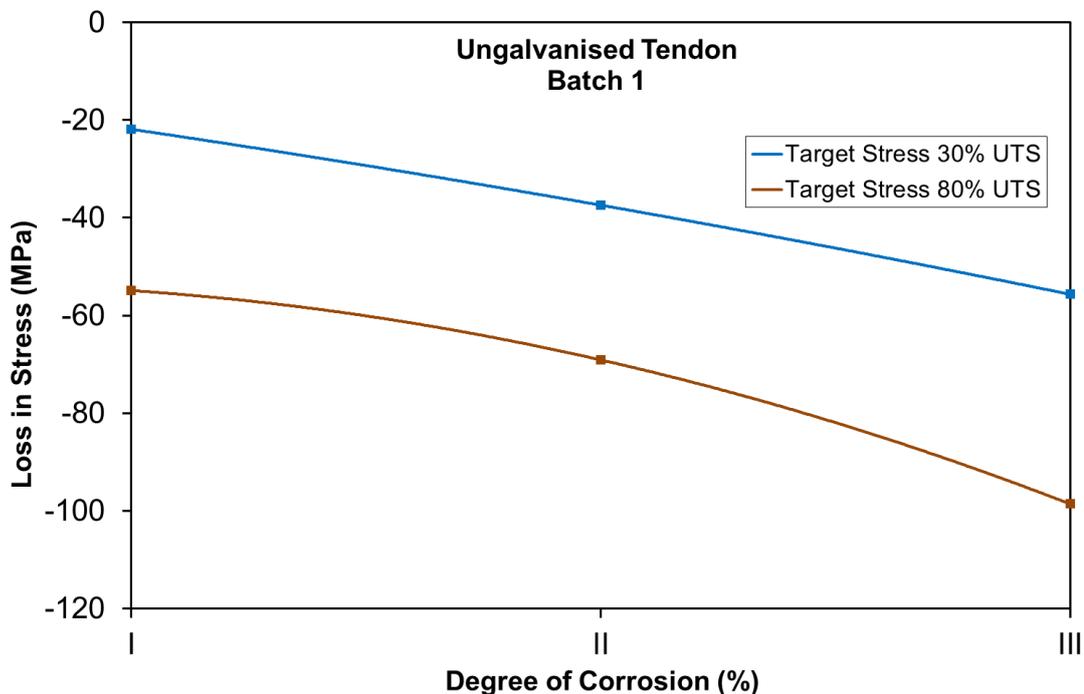
Figure 5.26 Relationship between degree of corrosion and different levels of pre-stress

The results shown in Table 5.14 are plotted in Figure 5.26. It is apparent that as the degree of corrosion increases from Stage II through to Stage III, there is an increase in loss of pre-stress for both the highly stressed tendon (80% UTS) and the tendons exhibiting a pre-stress of 30% UTS. However, the decrease in loss in stress is slightly more pronounced for the 80% UTS specimens. This indicates that tendons subjected to higher degrees of corrosion will suffer higher losses which should be accounted for at the design stage as an additional loss. The tendons exposed to Stage I corrosion, although not subjected to corrosion, do suffer a reduction in pre-stress, perhaps as a result of compression in the timber moulds or relaxation (this has been accounted for in the net losses in Stage II and III).

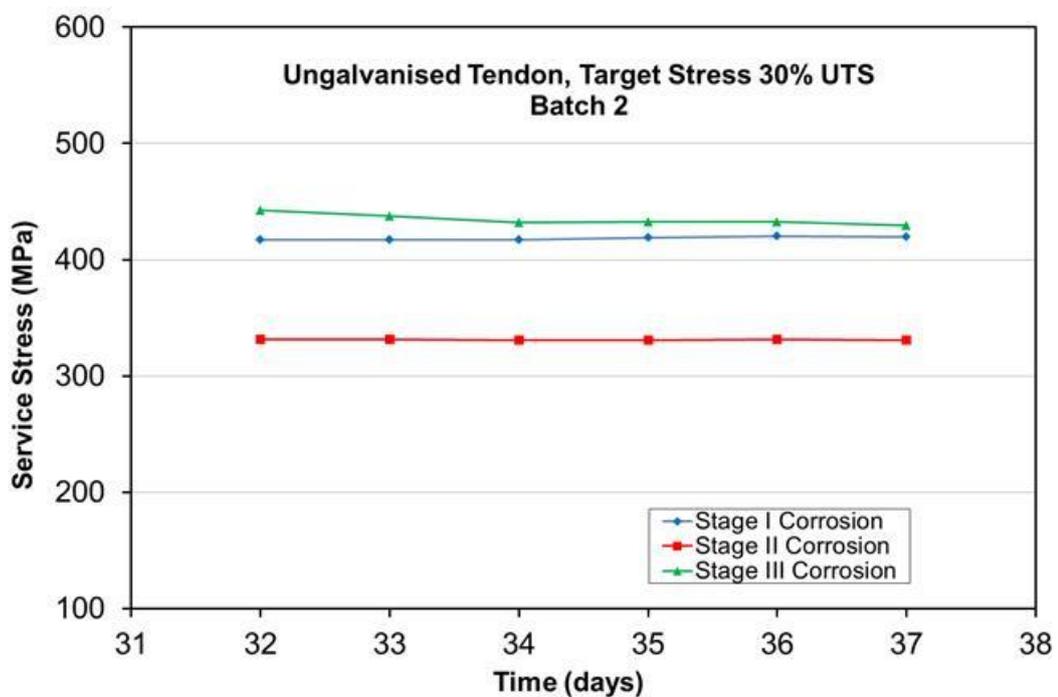
Figure 5.27 Gross loss in tendon pre-stress during corrosion period (30% UTS)
- Batch 2

In this section, results of Batch 2 and Batch 3 are presented together as these two batches have the same parameters in terms of tendon type and corrosion criteria. The data presented in Table 5.13 are shown graphically in Figure 5.27 to Figure 5.33 to better understand the performance of the tendons. Figure 5.27 compares the gross loss in pre-stress of the tendons with the different degrees of corrosion, Stage I (0-1 %), Stage II (2-4 %) and Stage III (4-7 %) at a low level of applied pre-stress (300-400 N/mm²), 30% Ultimate Tensile Strength (UTS). Similarly, Figure 5.28 shows the gross loss in pre-stress due to corrosion of Stages I, II and III for Batch 3.

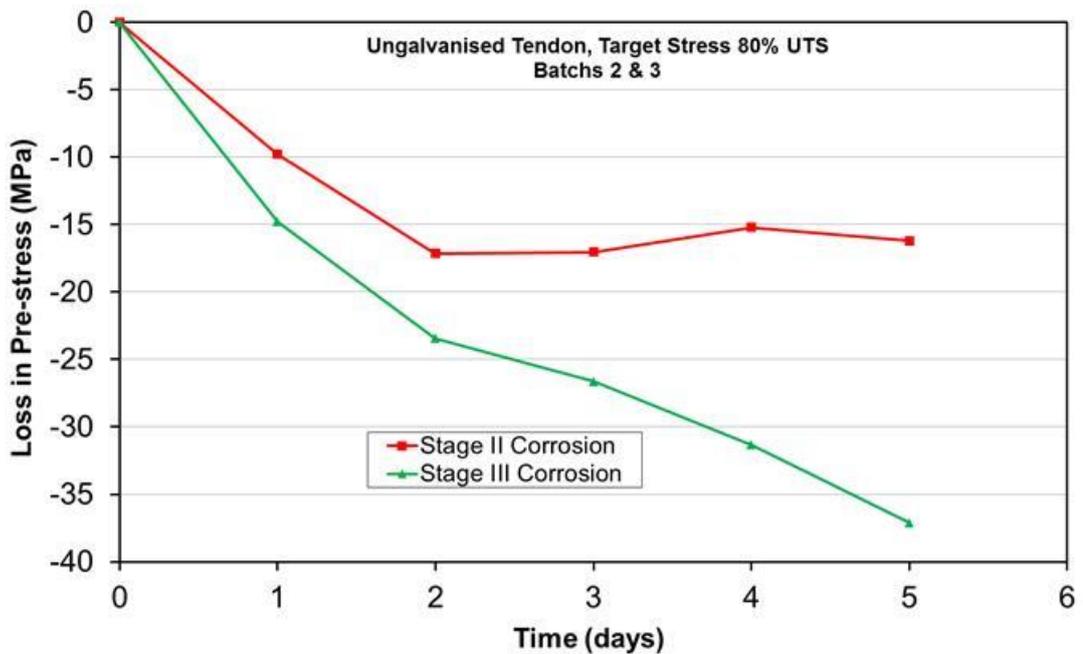
Figure 5.31 Average loss in tendon pre-stress during corrosion period (80% UTS) - Batch 2 & 3

Figure 5.31 shows the average loss in pre-stress due to corrosion Stages II and Stage III (Batches 2 & 3) for target stress 80% UTS.

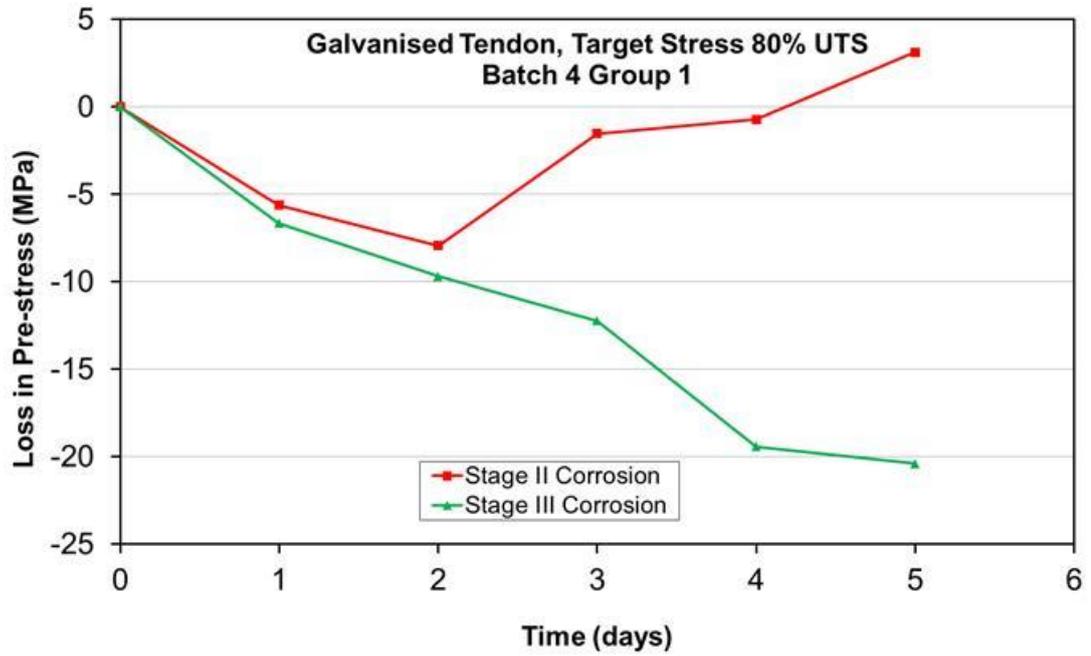
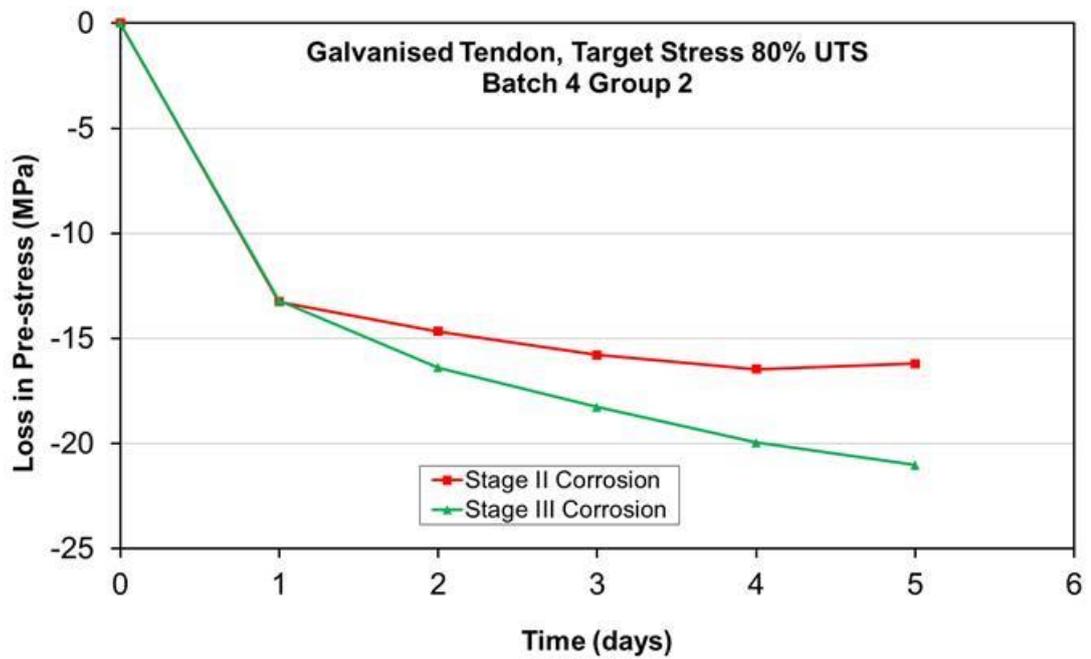
Figure 5.37 and Figure 5.38 show the net loss in pre-stress due to corrosion of Stage II and Stage III (Batches 2 & 3) for target stress 80% UTS for Groups 1 and 2 respectively.

Figure 5.37 Net loss in tendon pre-stress during corrosion period (80% UTS) -
Batch 4, Group 1

Figure 5.38 Net loss in tendon pre-stress during corrosion period (80% UTS) -
Batch 4, Group 2

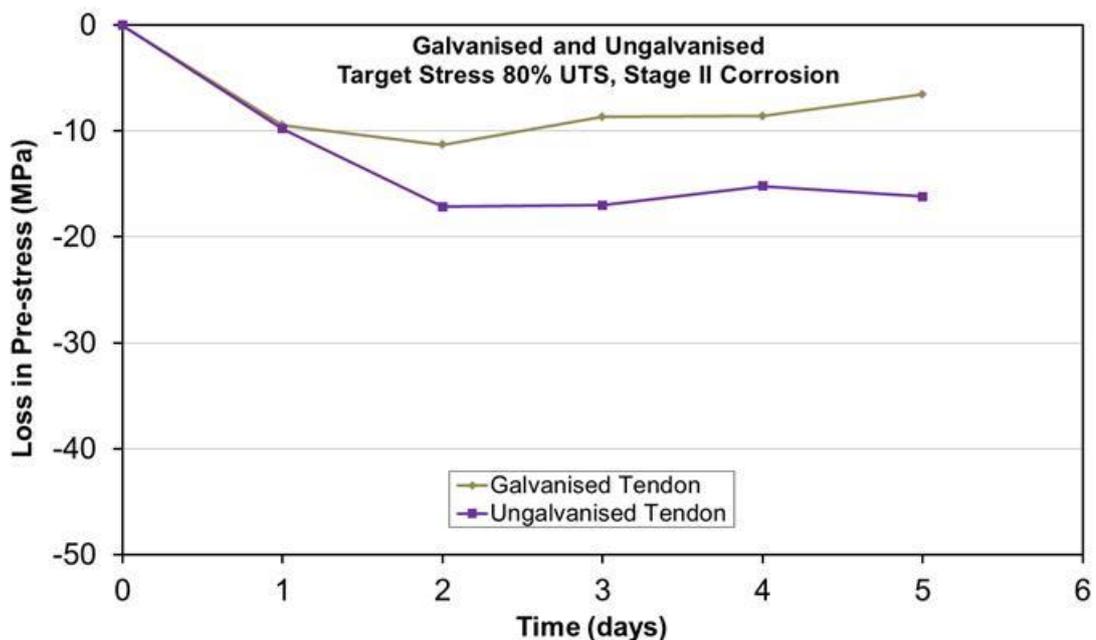
Figure 5.40 Net loss in galvanised and ungalvanised tendon pre-stress during corrosion period (Stage II)

From the above results of the loss in pre-stress over the corrosion test period for both galvanised and ungalvanised with the High Level of pre-stress, Figure 5.40 and Figure 5.41 show a comparison in the reduction in pre-stress of the ungalvanised and galvanised tendons with the different degree of corrosion Stage II and Stage III respectively. The loss in stress for both galvanised and ungalvanised with Stage I degree of corrosion exhibited a negligible change in pre-stress, therefore can be omitted. Both Figure 5.40 and Figure 5.41 show that the decline of ungalvanised pre-stress profile is more pronounced than the galvanised pre-stress profile. It can be seen that the loss in pre-stress in the ungalvanised tendons in both corrosion Stages II and III decline more than the loss in stress profile of the galvanised tendons. It is also noticeable that the different losses in pre-stress in galvanised and ungalvanised tendons with target stress 80 % UTS at Stage II degree of corrosion are broadly similar, while Figure 5.41 indicates that there is a large difference in loss of pre-stress resulting from Stage III corrosion. This indicates that the loss in pre-stress is more dependent on the degree of corrosion and less dependent on the initial pre-stress in the tendon.

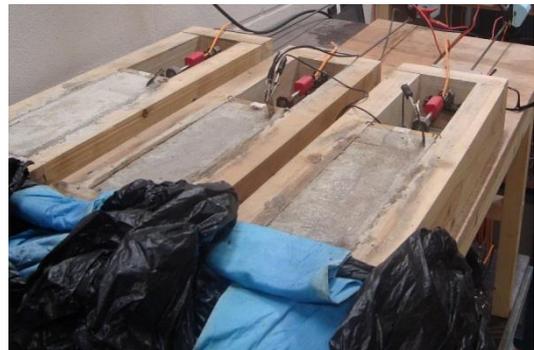
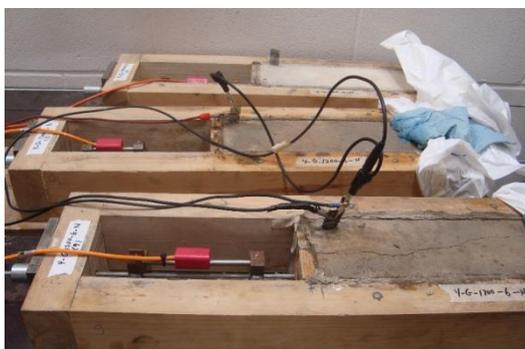
(b) Normal protection with low level of pre-stressed tendons

(c) Normal protection with high level of pre-stresses tendons

Figure 6.3 Setup of specimens under application of ICCP-Normal protection

An ICCP system for reinforced mortar has been established for analysing the distribution of protective potential and current. In this study, the DC power supply was a CPI manual power system, supplied by Cathodic Protection International Aps. The ICCP system was operated in the Construction Materials Laboratory, which ensured a stable environment of average 20°C and humidity of 60% \pm 5% (Figure 6.3) (a-c). Following installation of all the components of the ICCP, each system was connected to the power and monitoring equipment and powered up. In general there are two methods of controlling ICCP systems. One is that the output voltage is kept constant and the current is allowed to alter

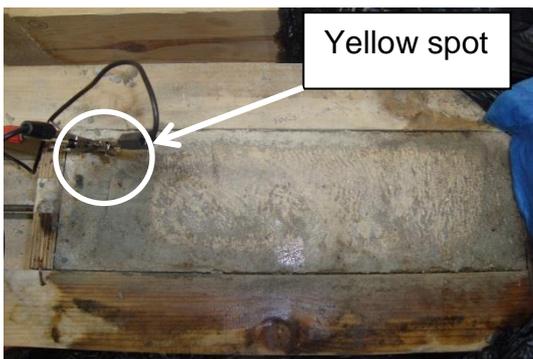
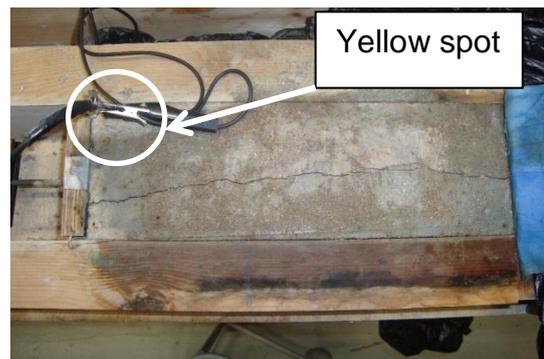
(b) Specimen M-U-L-II-N-2

(c) Specimen M-U-L-III-N-3

Figure 6.5 Yellow spots on the mortar surface for ungalvanised tendons with Low Level of pre-stress

of anode location as shown in Figure 6.5 (a-c) and Figure 6.6 (a-c). At the time corresponding to a current of 13mA applied to the MMO mesh anode, a gaseous and yellow liquid deposit appeared around the mesh. Concrete Society Technical Report No. 73 states that due to the electrochemical reactions, acid and oxygen is generated during operation at the surface of anodic commonly used for the cathodic protection of reinforced concrete. It has been stated that some anodes may also generate chloride depending on the environment [48]. Therefore, the yellow discharge observed at the MMO Ti anode and concrete interface is believed to result from acid generation [120]. In the case of the galvanised tendons (Batch 4), there was no sign of yellow spots (Figure 6.7).

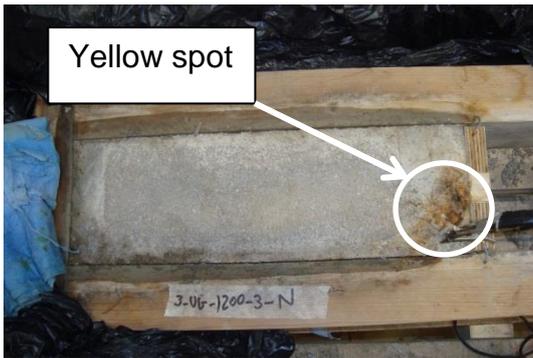
(b) Specimen M-UG-H-II-N-2

Figure 6.6 Yellow spots on the mortar surface for ungalvanised tendons with High Level of pre-stress

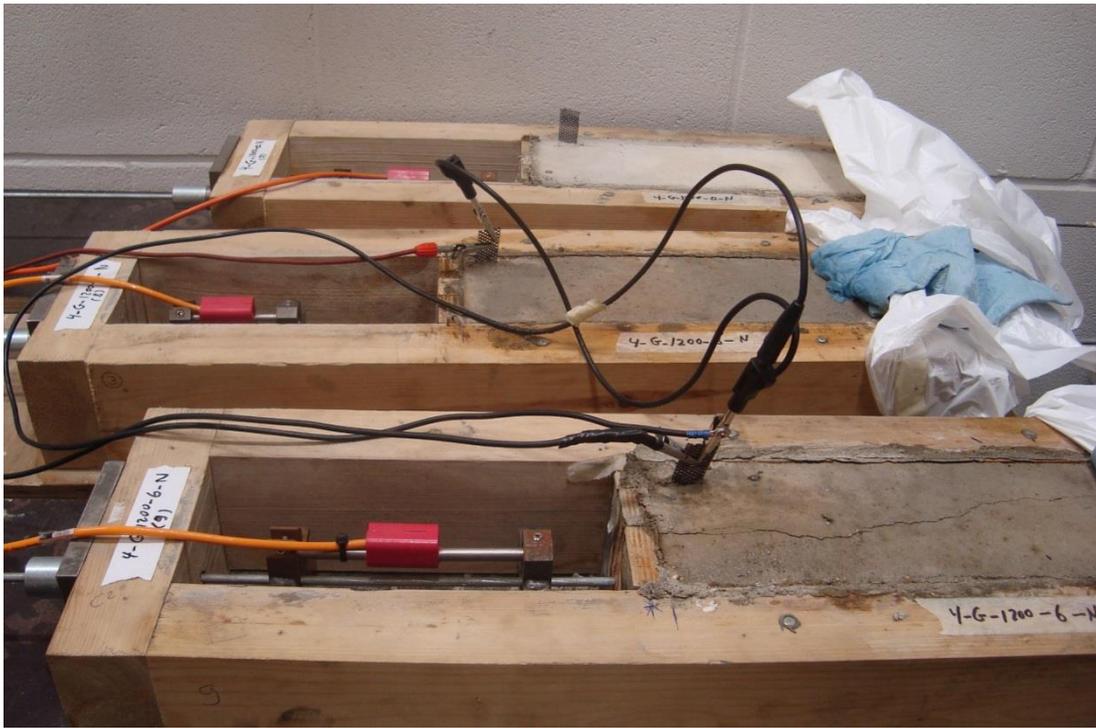
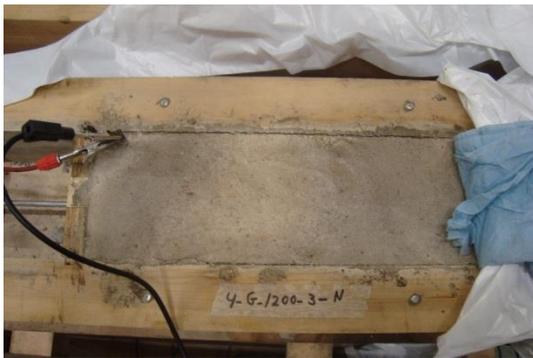
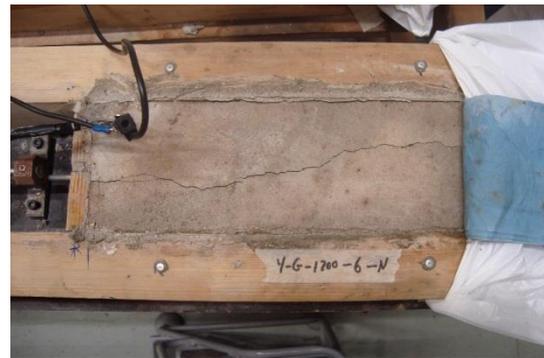
(a) General view

(b) Specimen M-G-H-II-N-2

(c) Specimen M-G-H-III-N-3

Figure 6.7 No yellow spots on the mortar surface for galvanised tendons with High Level of pre-stress

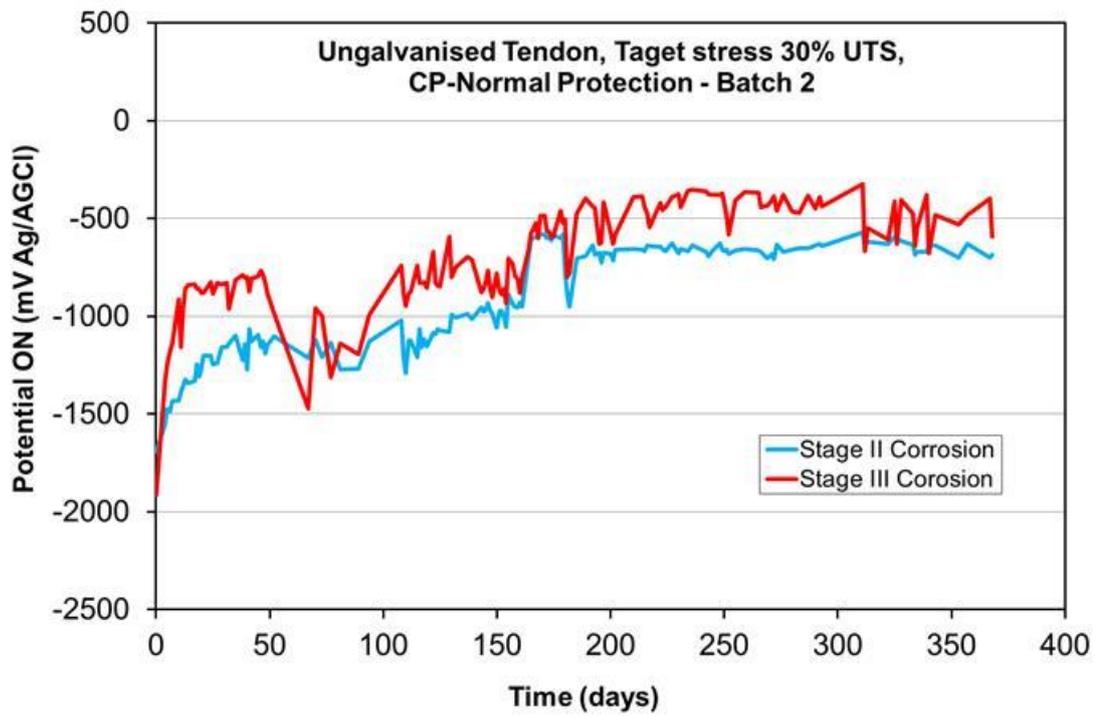
Figure 6.11 "ON" potential of ungalvanised tendons during applying ICCP- Normal Protection, 30% UTS

The power supply was switched on and the voltage adjusted until the steel potential reached the target negative potential -650 to -750mV for ICCP-N, then the "E_{on}" potentials were recorded as shown in Figure 6.11 and Figure 6.12 for ungalvanised tendons with Low Level and High Level of pre-stress respectively. As can be seen from these two figures, the potential started highly negative then decreased before stabilising at approximately 1000mV below the steel potential. This drop is due to the resistance of the mortar decreasing and also the cathode (pre-stressed tendon) becoming charged with more electrons. Figure 6.13 shows the 'ON' potential with time for galvanised tendons with High Level of pre-stress tendons. As can be seen, the initial potential is much more negative than for the ungalvanised due to the resistance of the galvanised tendons.

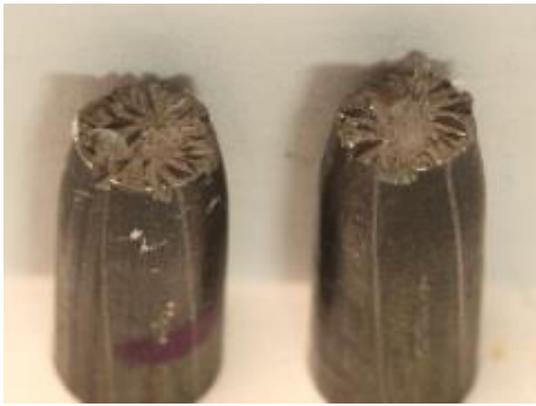
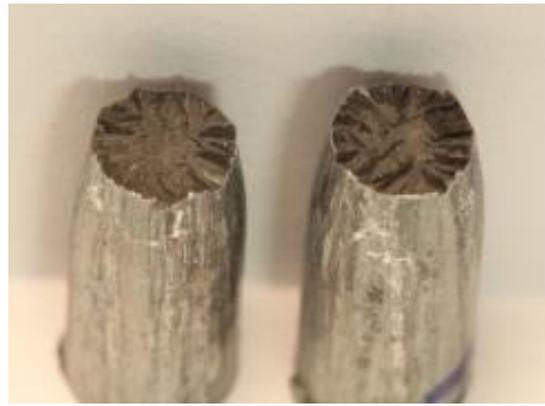
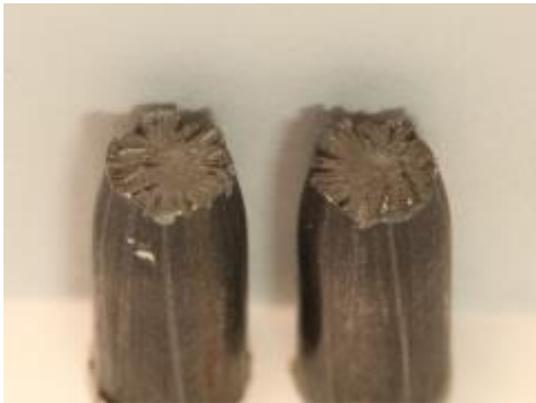
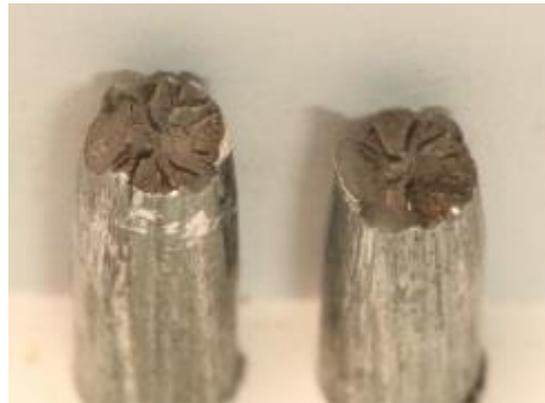
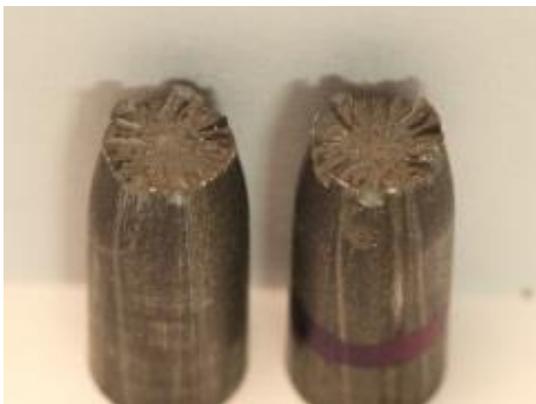
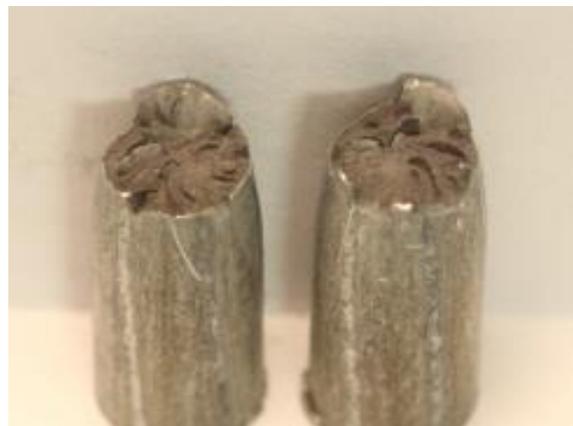
After completing the tensile tests, all mechanical properties were recorded and images of the fracture modes were obtained as shown in Figure 6.27 (a-f). These images show a cup-cone failure mode which is characteristic of ductile steel.

Figure 6.27 Fracture modes for ungalvanised and galvanised as-received tendons

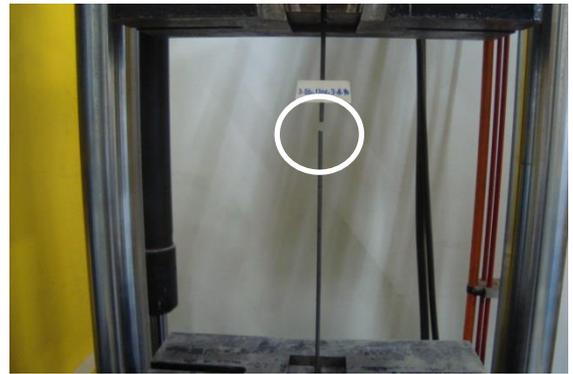
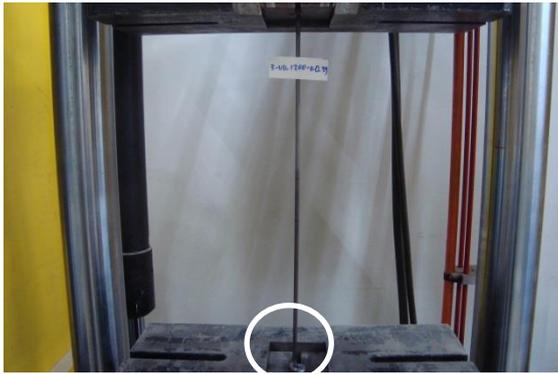
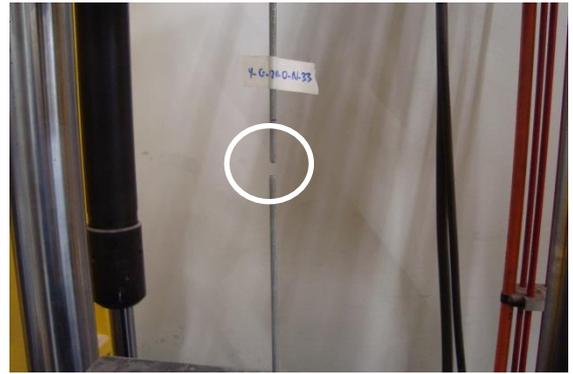
(b) Upper middle failure

(c) Bottom edge failure

(d) Middle failure

Figure 6.28 Location of failure mode

Figure 6.28 (a-d) shows the different location of the tendon failures and was named Bottom Edge (close or at the grip), Upper middle (between top grip and the middle), Lower middle (between bottom edge and the middle) and Middle (within the gauge length).

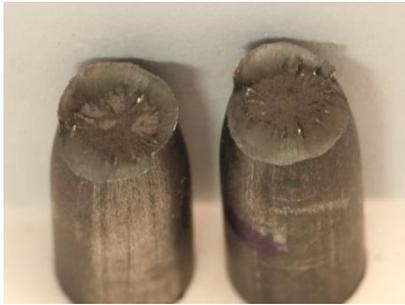
(a) M-U-L-I-N-1
Fracture cup-cone type

Figure 6.42 SEM images for ungalvanised tendon (M-U-L-I-N-1), 30% UTS

For the Batch 2, ungalvanised tendons with Low level of pre-stress as shown in Figure 6.42 (a-c), Figure 6.43 (a-c) and Figure 6.44 9 (a-c) all samples at different corrosion stages show cup-cone character and necking. Under powerful magnification, the dimples are present in the microstructure which indicates that the fracture surfaces were purely ductile.

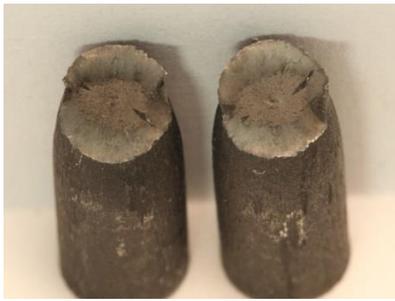
(a) M-U-L-II-N-2
Fracture with cup-cone type

Figure 6.43 SEM images for ungalvanised tendon (M-U-L-I-N-2), 30% UTS

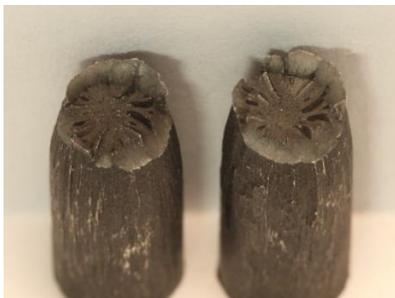
(a) M-U-L-III-N-3
Fracture with partial cup-cone type

Figure 6.44 SEM images for ungalvanised tendon (M-U-L-III-N-3), 30% UTS

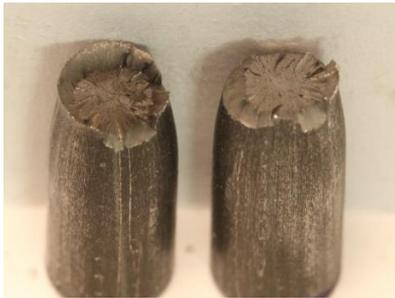
(a) M-U-H-I-N-1
Fracture cup-cone type

Figure 6.45 SEM images for ungalvanised tendon (M-U-H-I-N-1), 80% UTS

For Batch 2, ungalvanised with High Level of pre-stress, as shown in Figure 6.45 (a), Figure 6.46 (a) and Figure 6.47 (a) all fractures are cup-cone type. The microstructures show both small dimples and large, deep dimples (identified by red arrows) for specimen M-U-H-II-N-2 (Figure 6.46 (c)) and specimen SM-U-H-III-N-3 (Figure 6.47 (c)) and coalescence and connection of dimples on the fracture surface (red dashed area).

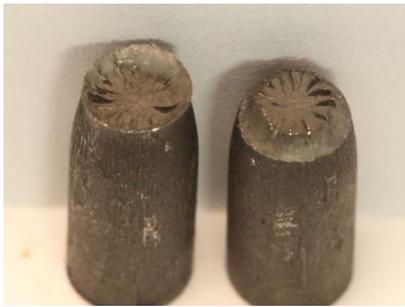
(a) M-U-H-II-N-2
Fracture cup-cone type

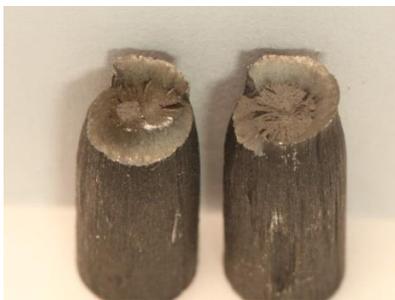
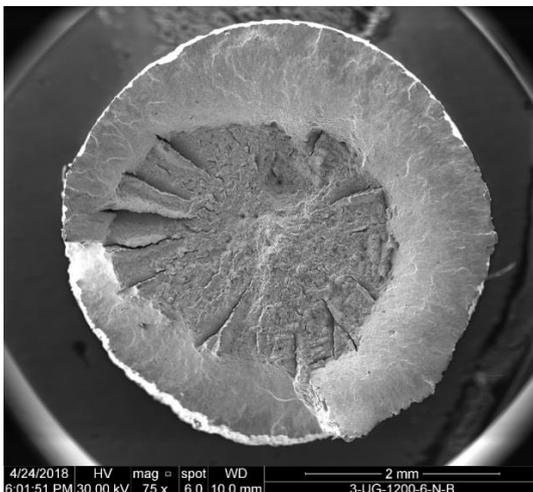
(a) M-U-H-III-N-3
Fracture with partial cup-cone type

(b) The whole fracture surface

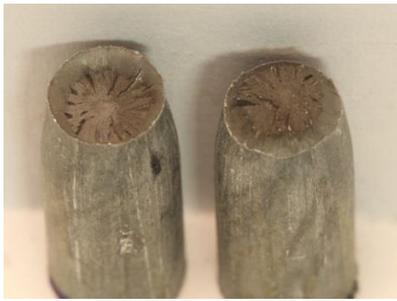
(a) M-G-H-I-N-1
Fracture cup-cone type

Figure 6.49 SEM images for galvanised tendon (M-G-H-I-N-1), 80% UTS

For Batch 4, galvanised tendons with High Level of pre-stress, as shown in Figure 6.49, Figure 6.50 and Figure 6.51, the fracture modes for specimens M-G-H-I-N-1 (Figure 6.49 (a-c)) and M-G-H-II-N-2 (Figure 6.50 (a-c)) are cup-cone in character while specimen M-G-H-III-N-3 (Figure 6.51 (a)) exhibited brittle and shear (identified by white arrow) type fracture mode (Figure 6.51 (b) [127]). The microstructures show dimples in all of them and in addition specimen M-G-H-III-N-3 (Figure 6.51 (c)) shows a mixture of ductile (identified by yellow circle) and brittle (identified by red boxes) modes of fracture [125], [127].

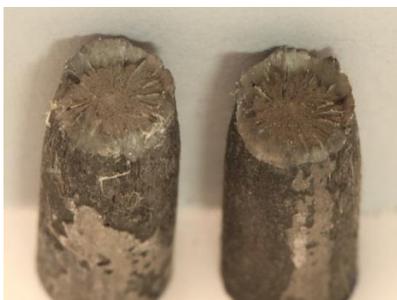
(a) M-G-H-II-N-2
Fracture of near cup-cone type

Figure 6.50 SEM images for galvanised tendon (M-G-H-II-N-2), 80% UTS

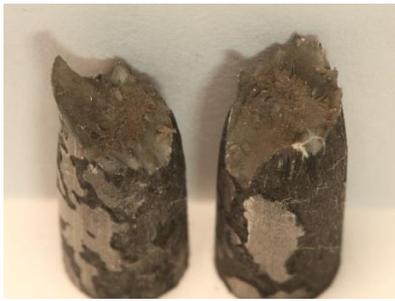
(a) M-G-H-III-N-3
Shear type fracture

In the light of the above, there is no damage to the steel due to the application of ICCP-N. This can be seen from the type of fracture modes. The only severe damage has been observed in specimen M-G-H-III-N-3 (Figure 6.51), but this damage is more likely caused by corrosion as shown in Figure 6.48, where the roughness (Ra) is $6.17 \mu\text{m}$ (Table 5.7) and mass loss is 4.1% (Table 5.11). Therefore, ICCP-N has had little or no effect on the pre-stresses tendons. Comparison is made between ICCP-N and ICCP-O in Chapter 7.

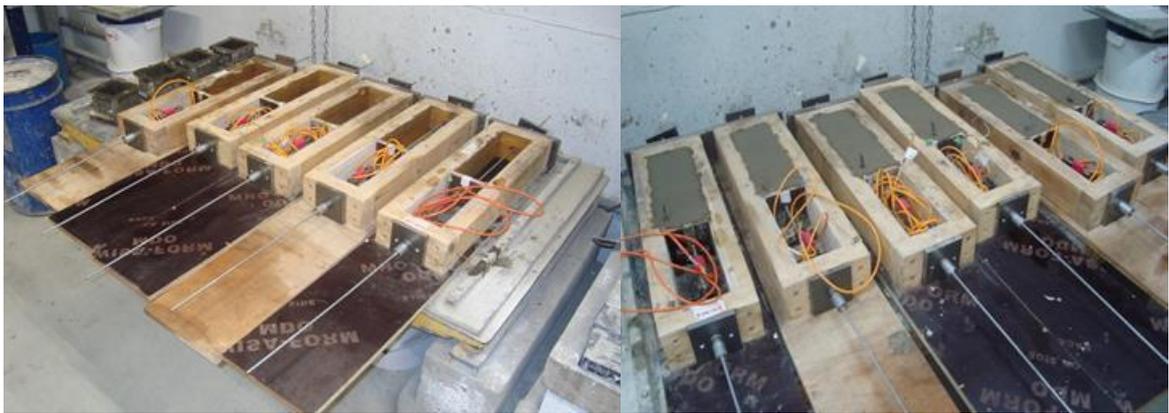
(a) Specimens pre-stressed & ready for casting

(b) Specimens cast

ICCP-O was applied to the pre-corroded specimens as stipulated in Table 7.2. The specimen's dimensions and mortar mix are described in Section 5.4.3. The compressive strength of the mortar for each batch is also presented in Table 5.2 in Section 5.4.3.1. The pre-tensioning procedures and different levels of applied service stress are described in Section 5.4.4. The corrosion process has been described in Section 5.5, where mixed metal oxide (MMO) titanium mesh ribbon was connected to the negative terminal of a D.C power supply, working as the cathode while the tendons were connected to the positive terminal of a D.C power supply. Corrosion took place in both a saline solution containing 3.5% NaCl and mortar without adding sodium chloride. The samples were kept moist by spraying water on a daily basis. The current and potential were monitored and recorded on a daily basis.

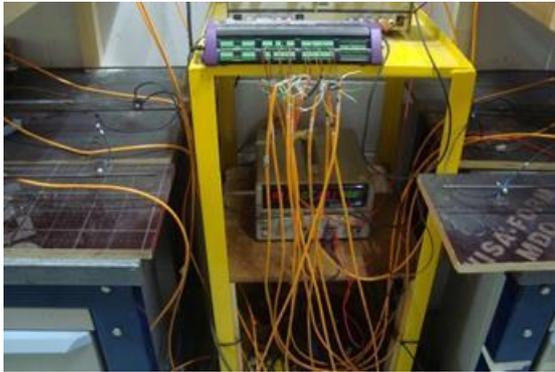
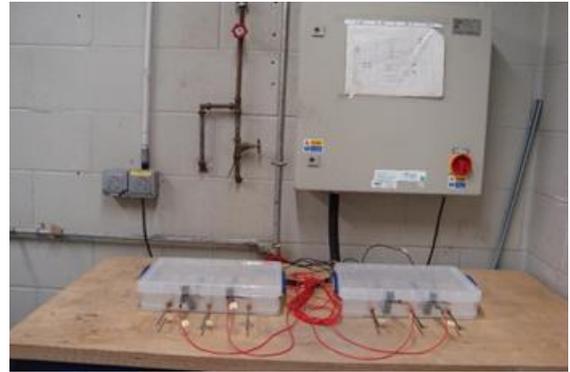
(a) DC power supply

(b) CPI manual power system

Figure 7.2 Power supplies to generate the target potential

The application of ICCP has been previously described in Chapter 6, Section 6.4.2. A DC power supply with high DC Voltage (60V) was used to provide a high potential. Due to the requirements of the laboratory in terms of safety, the connections of the wires were protected by a plastic tube (Figure 7.3). Two types of DC power supply were provided to generate the necessary voltage for the target potential. One type was used for the pre-stressed tendons (Figure 7.2 (a)) and the other one was a CPI manual power

system, supplied by Cathodic Protection International Aps., for the non stressed tendons within the saline solution (Figure 7.2 (b)). The method used for applying ICCP-O is the same method used in applying ICCP-N, where the current is allowed to float until the target potential is obtained and then maintained at a constant value.
