Cathodic Protection of Corroded Pre-stressed Tendons

A thesis submitted in partial fulfilment of the requirements of
Sheffield Hallam University
for the degree of Doctor of Philosophy

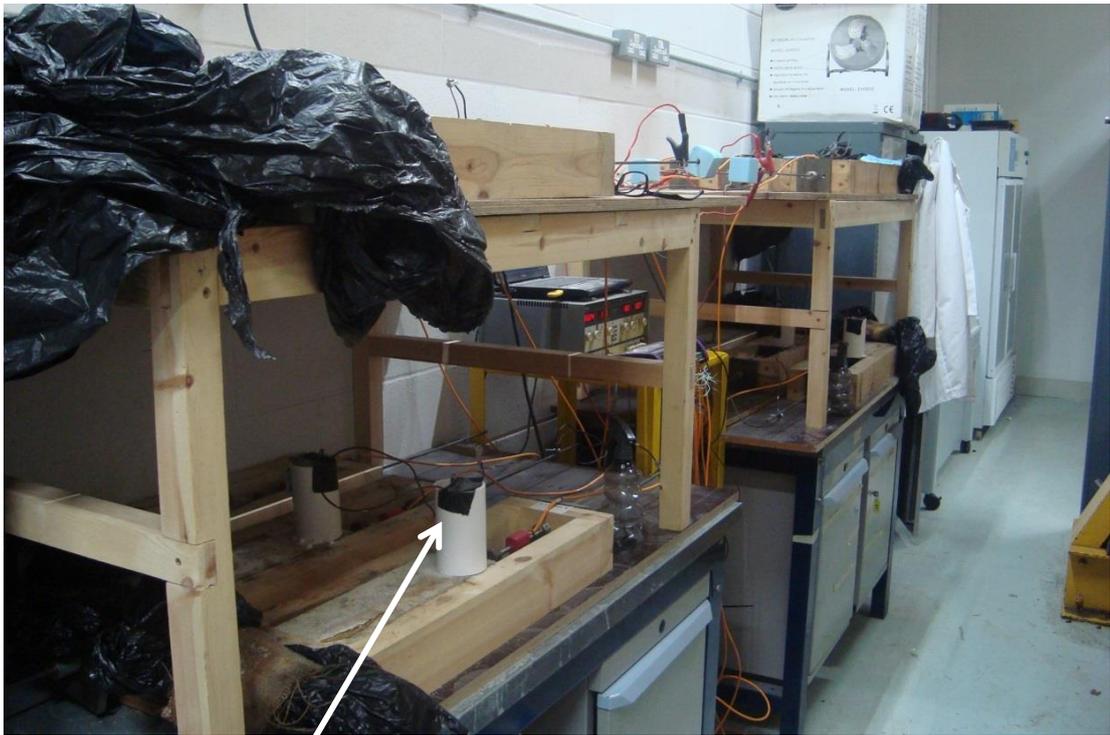
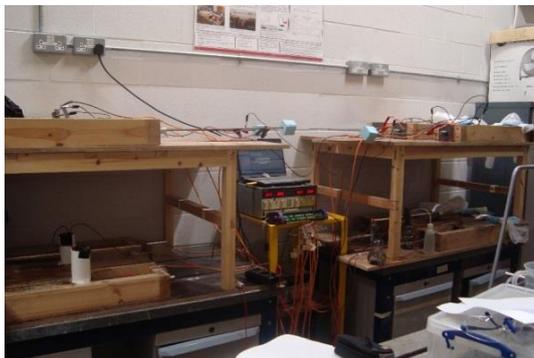
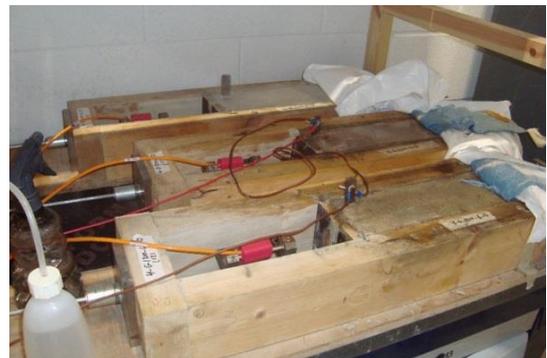
(a) Test set-up

(d) Test set-up

(e) Galvanised tendons with High Level of pre-stress under ICCP-O

Figure 7.3 Set-up of specimens under the application of ICCP overprotection

Figure 7.3 (a, b ,c, d and e) shows the test set-up for the pre-stressed and pre-corroded ungalvanised and galvanised specimens, while Figure 7.4 (a, b, and c) shows the test set-up for unstressed ungalvanised and galvanised specimens.

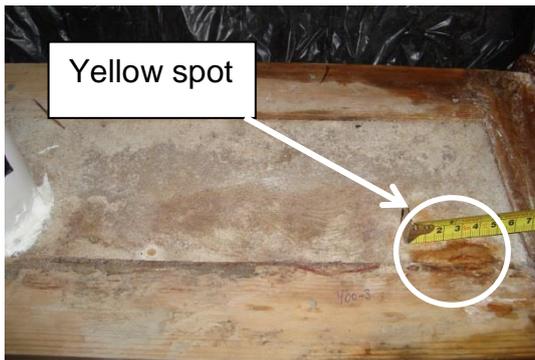
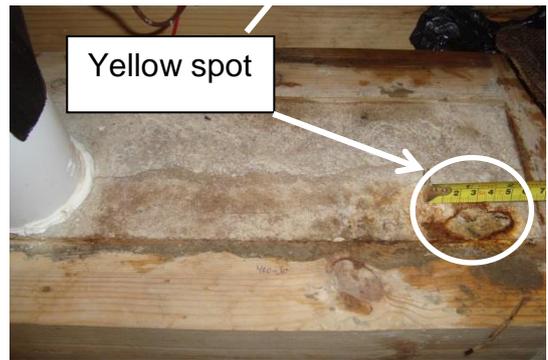
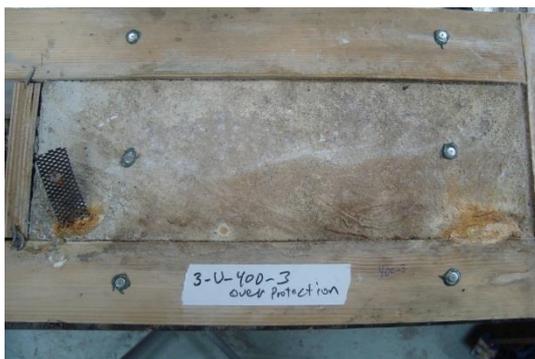
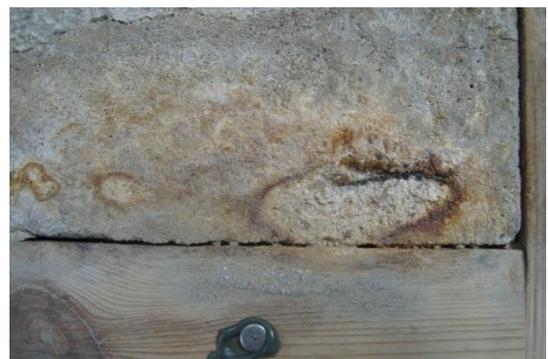
(b) ICCP-O after 176 days, Stage II Corr.

(c) ICCP-O after 176 days, Stage III Corr.

(d) ICCP-O after 245 days, Stage II Corr.

(e) ICCP-O after 245 days, Stage III Corr.

Figure 7.5 Yellow spots on the mortar surface for ungalvanised tendons with Low Level of pre-stress

Daily observation and data (Volts, Amps, Potential and Instant-Off steel potential) were recorded during the overall period of applying ICCP-O. For ungalvanised tendons (Batch 3) for Low Level of pre-stress with Stage II and Stage III corrosion, yellow spots appeared on the surface of the mortar on the opposite side to the connection, above the anode location. The spot size is about 5 cm long and 1.5 cm wide as shown in Figure 7.5 (a-c) The spot area remained as described until the end of the test.

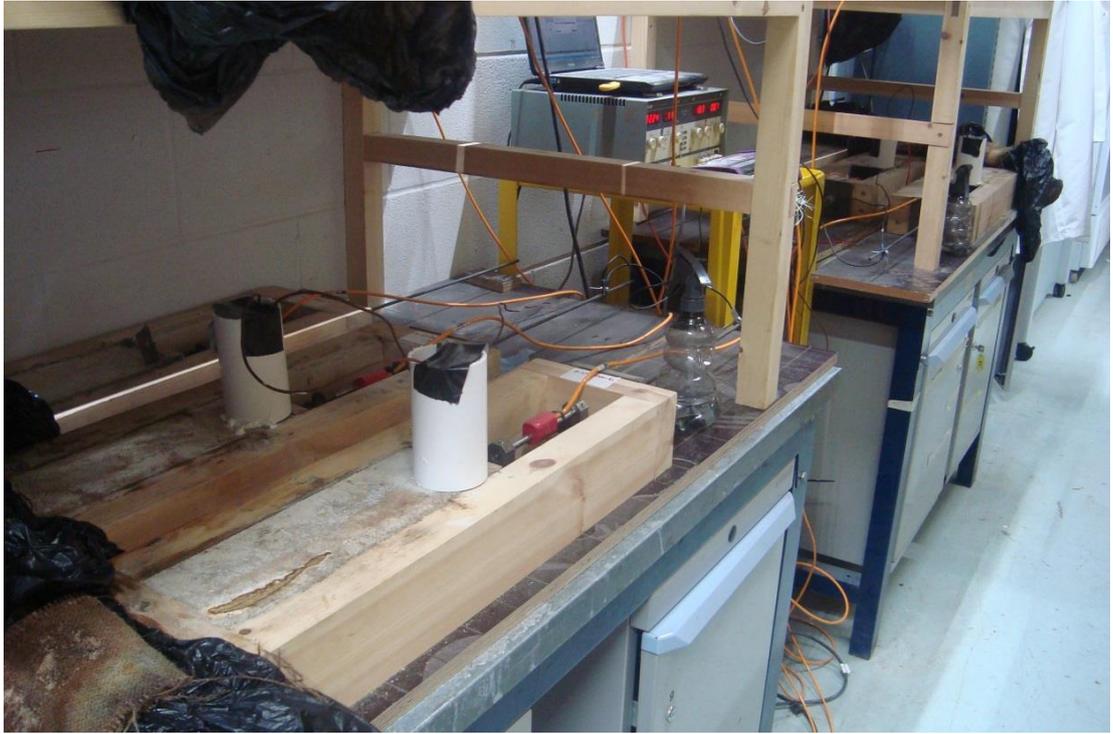
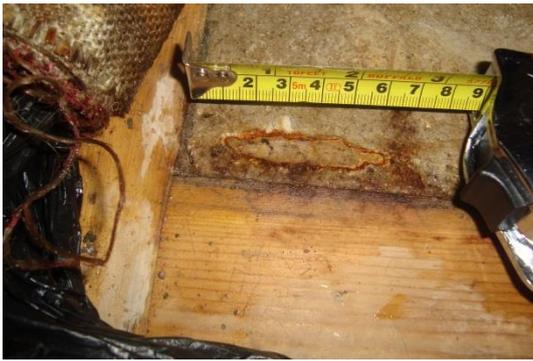
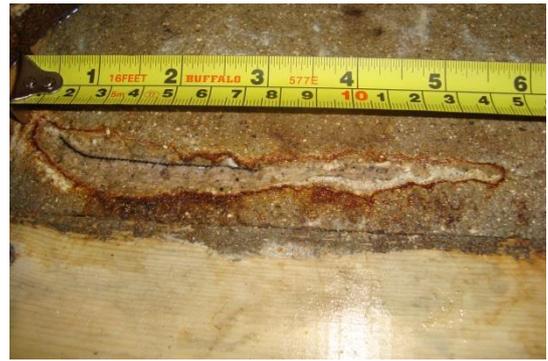
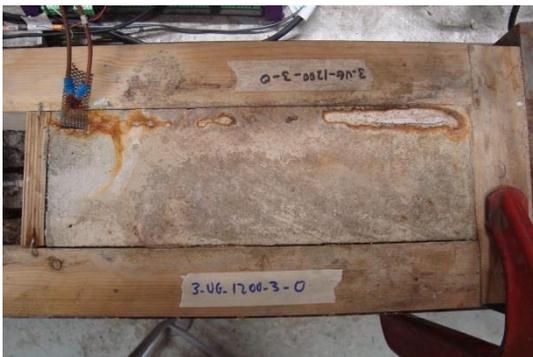
(a) Test Set-up

(b) ICCP-O after 165 days, Stage II Corr.

(c) CCP-O after 165 days, Stage III Corr.

(d) ICCP-O after 411 days, Stage II Corr.

Figure 7.6 Yellow spots on the mortar surface for ungalvanised tendons with High Level of pre-stress

For ungalvanised tendons (Batch 3) for High Level of pre-stress with Stage II corrosion, yellow spots appeared on the surface of the mortar along the anodic zone about 5 cm long and 1 cm wide, this spot increased in size, the length reached 10 cm long and 1.5 cm wide after 411 days of applying ICCP-O as shown in Figure 7.6 (b-e). For the tendon with Stage III corrosion, it was noticed that the spot increased in length to about 14 cm long and 1.5 cm wide after 165 days of applying ICCP-O. This spot further increased along the whole length of the anode after 411 days of applying ICCP-O. In general, the size of the yellow spot in the tendons with High Level of pre-stress is greater than in the tendons with Low Level of pre-stress. These yellow spots appear to have occurred due to acid generation from the lack of mortar cover for the experimental tests. In practice, the tendon is embedded within the concrete with sufficient cover to provide protection to the anode material.

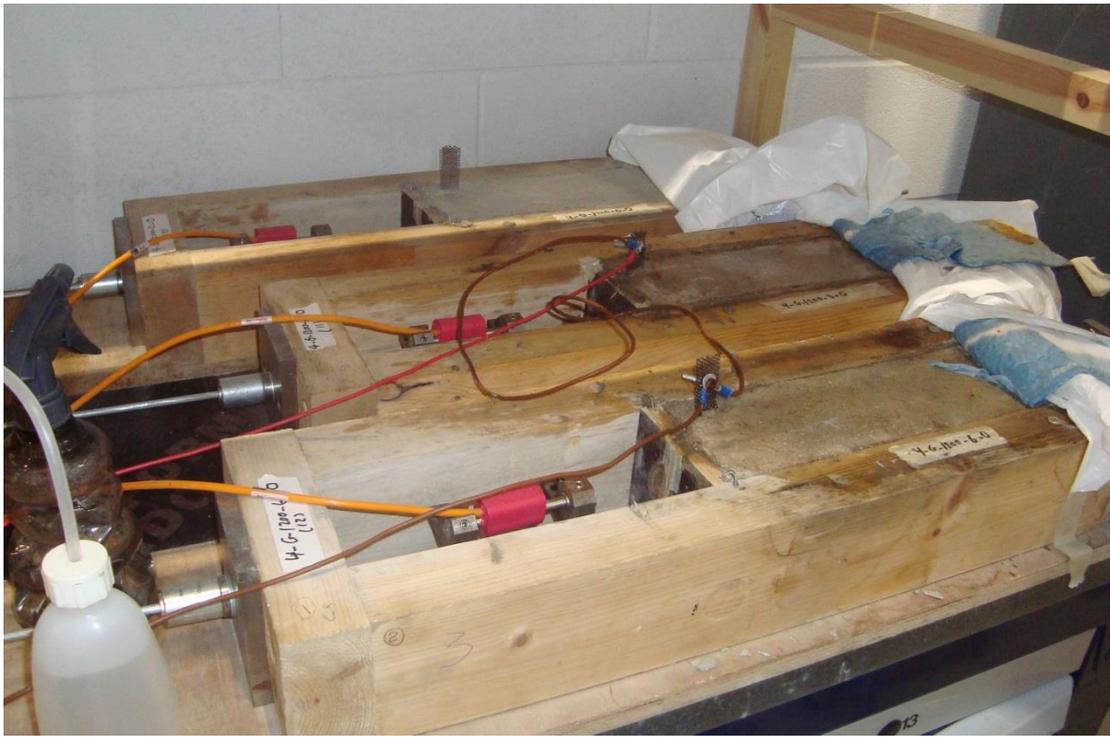
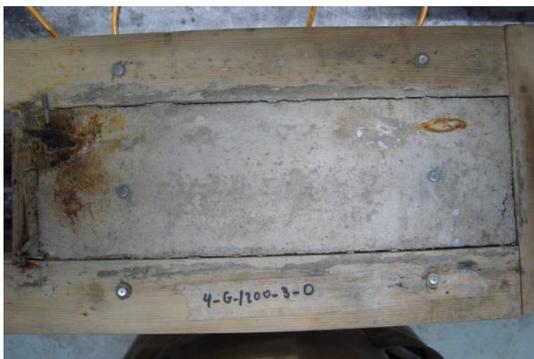
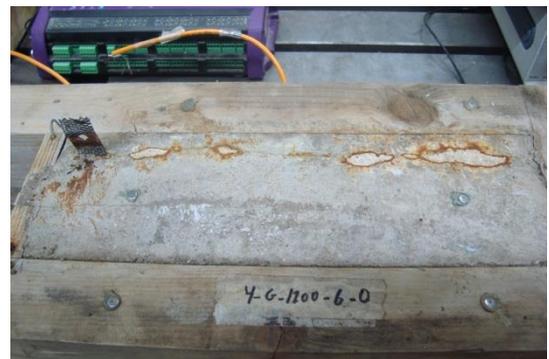
(a) Test Set-up

(d) ICCP-O after 154 days, Stage II Corr.

(e) ICCP-O after 154 days, Stage III Corr.

Figure 7.7 Yellow spots on the mortar surface for galvanised tendons with High Level of pre-stress

Figure 7.7 (b-e) shows the yellow spots for the galvanised tendons (Batch 4). Overall, the size and shape of the yellow spot remained the same for both degrees of corrosion at Stage II and Stage III. For the tendon with Stage II corrosion, the spot was 3 cm long and 1 cm wide and for the tendon with Stage III corrosion, the spot was distributed along the anode in different sizes, (Figure 7.7 (b, e)). The area for both remained approximately the same until the end of the test.

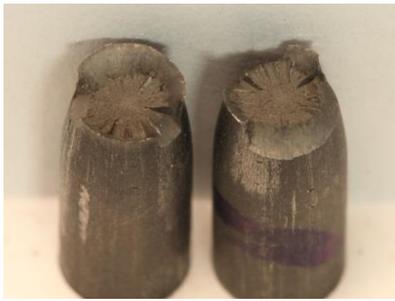
(a) M-U-L-I-O-1
Fracture

Figure 7.40 SEM images for ungalvanised tendon (M-U-L-I-O-1), 30% UTS

For Batch 3 ungalvanised with the Low Level of pre-stress as shown in Figure 7.40 to Figure 7.42, all test specimens at different corrosion stages had cup-cone characteristics and necking that were largely indistinguishable. For specimen M-U-L-I-O-1 (Figure 7.40 (b, c)), there are small dimples and a shear area presented in the whole fracture, indicating that the fracture is more ductile. The shear area can be seen more clearly in sample M-U-L-II-O-2 (Figure 7.41 (b)), although there are small dimples but also a brittle mechanism (identified by red dashed square), the fracture is less ductile or mix fracture mode. For specimen M-U-L-III-O-3 (Figure 7.42 (a-c)), the radial cracks appeared with the shear area and small dimples, demonstrating the fracture mechanism is a mixed fracture mode.

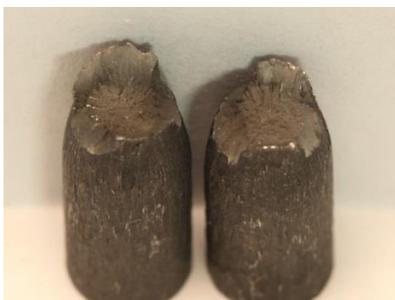
(a) M-U-L-II-O-2
Fracture

Figure 7.41 SEM images for ungalvanised tendon (M-U-L-II-O-2), 30% UTS

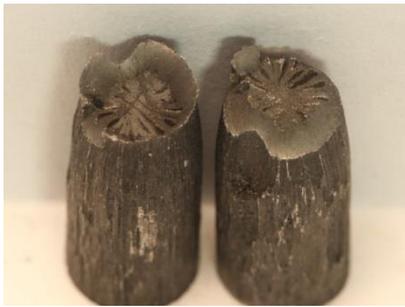
(a) M-U-L-III-O-3
Fracture

Figure 7.42 SEM images for ungalvanised tendon (M-U-L-III-O-3), 30% UTS Batch 3 ungalvanised with high level of pre-stress as shown in Figure 7.43 (a-c) to Figure 7.45 (a-c), all teste samples at different corrosion stages showed characteristic cup-cone failure and necking. The shear area and radial fractures were evident in the whole fractures, while dimples were not presented in the microstructures. This indicates the mechanism of the fracture is less ductile and more brittle.

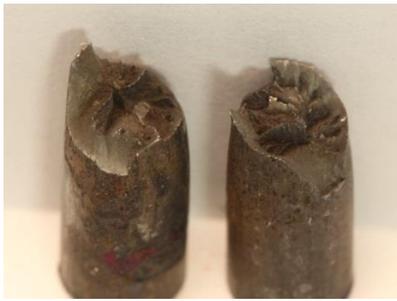
(a) M-U-H-I-O-1
Fracture

Figure 7.43 SEM images for ungalvanised tendon (M-U-H-I-O-1), 80% UTS

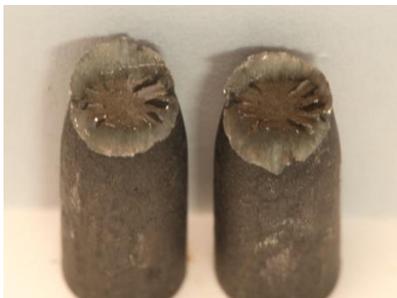
(a) M-U-H-II-O-2
Fracture

Figure 7.44 SEM images for ungalvanised tendon (M-U-H-II-O-2), 80% UTS

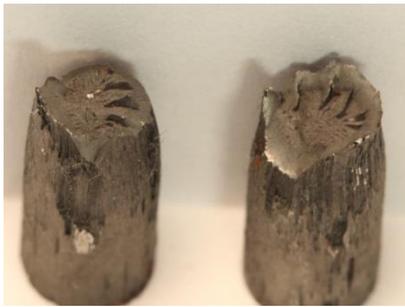
(a) M-U-H-III-O-3
Fracture

Figure 7.45 SEM images for ungalvanised tendon (M-U-H-III-O-3), 80% UTS

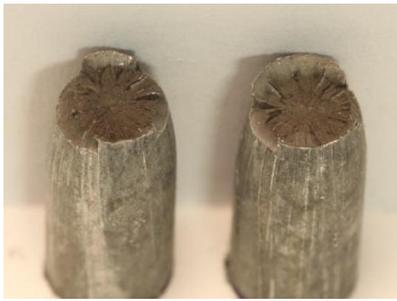
(a) M-G-H-I-O-1
Fracture

Figure 7.46 SEM images for galvanised tendon (M-G-H-I-O-1), 80% UTS

For Batch 4 galvanised with High Level of pre-stress as shown in Figure 7.46 to Figure 7.48, all test samples at different corrosion stages showed cup-cone characteristics and necking. For specimen M-G-H-I-O-1 (Figure 6.46 (b, c)), there is a small shear area in the whole fracture surface and there are very small dimples evident in the microstructure, indicating a mix of ductile (identified by yellow circle) and brittle (identified by red box) mode structure. The shear area can be seen more clearly in sample M-G-H-II-O-2 (Figure 7.47 (c, c)), although there are small dimples, but also brittle mechanism is evident (identified by red dashed square), and the fracture is less ductile or mixed fracture mode. For specimen M-U-L-III-O-3 (Figure 7.48 (b, c)), no dimples are present and the fracture mechanism is brittle fracture mode.

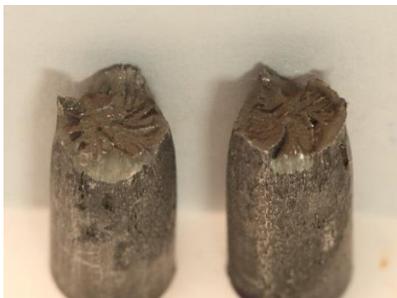
(a) M-G-H-II-O-2
Fracture

Figure 7.47 SEM images for galvanised tendon (M-G-H-II-O-2), 80% UTS

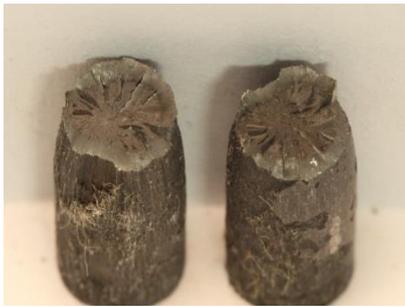
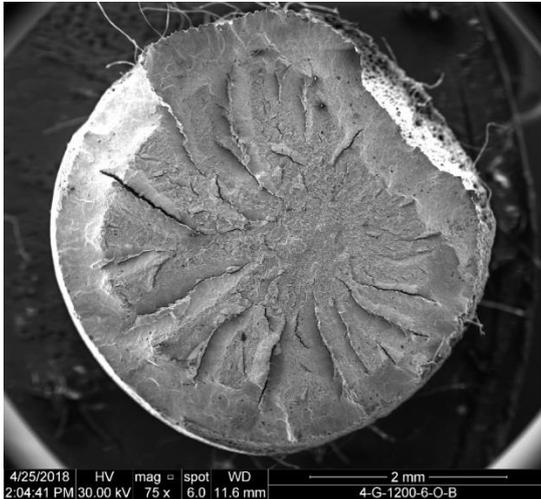
(a) M-G-H-III-O-3
Fracture

(b) The whole fracture surface

Figure 7.48 SEM images for galvanised tendon (M-G-H-III-O-3), 80% UTS

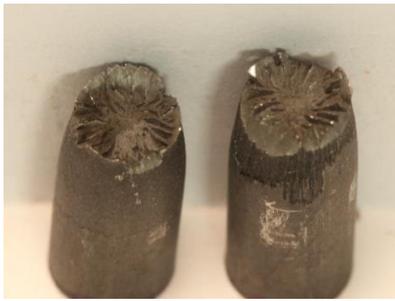
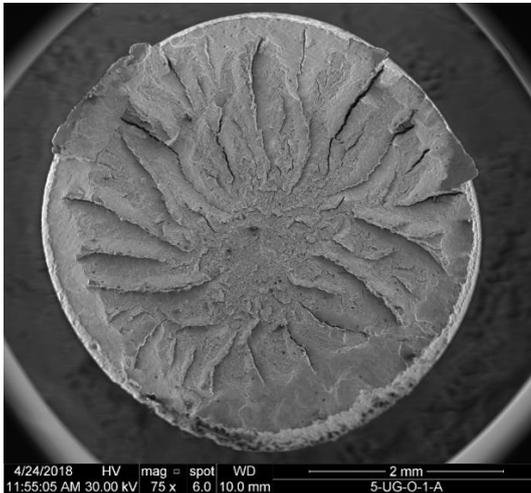
(a) 5-U-O-1
Fracture

(b) The whole fracture surface

Figure 7.49 SEM images for ungalvanised tendon (5-U-O-1), Batch 5

For Batch 5 ungalvanised with no corrosion and unstressed, as shown in Figure 7.49 to Figure 7.51, all test samples showed evidence of cup-cone characteristics and necking. Under powerful magnification the dimples, as presented in the microstructure images, indicate that the fracture surface was ductile.

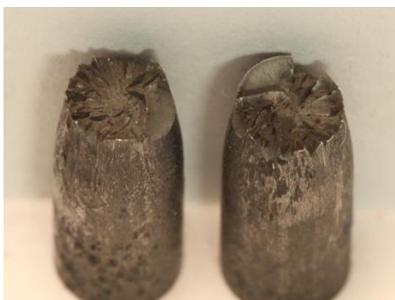
(a) 5-U-O-2
Fracture

Figure 7.50 SEM images for ungalvanised tendon (5-U-O-2), Batch 5

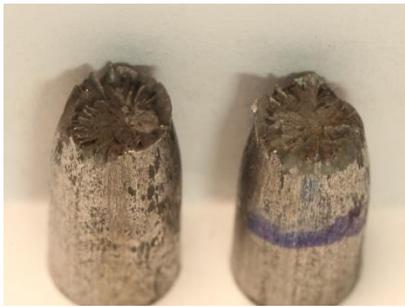
(a) 5-U-O-3
Fracture

Figure 7.51 SEM images for ungalvanised tendon (5-U-O-3), Batch 5

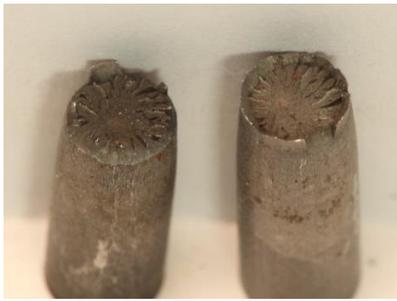
(a) 5-G-O-1
Fracture

Figure 7.52 SEM images for galvanised tendon (5-G-O-1), Batch 5

For Batch 5 galvanised with no corrosion and unstressed as shown in Figure 7.52 to Figure 7.54, although specimen 5-G-O-3 (Figure 7.54 (b, c)) has a shear area, cup-cone character and necking were still distinguishable. Under powerful magnification the dimples, as presented in the microstructure images, indicate that the fracture surfaces were ductile.

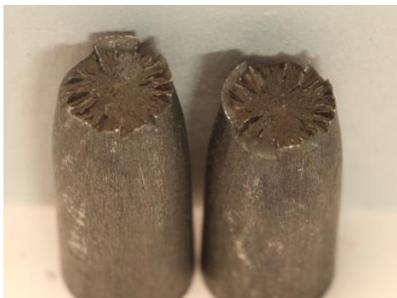
(a) 5-G-O-2
Fracture

Figure 7.53 SEM images for galvanised tendon (5-G-O-2), Batch 5

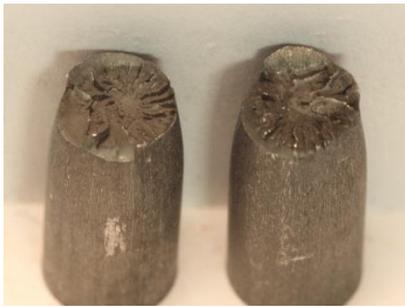
(a) 5-G-O-3
Combined fracture mode

Figure 7.54 SEM images for galvanised tendon (5-G-O-3), Batch 5

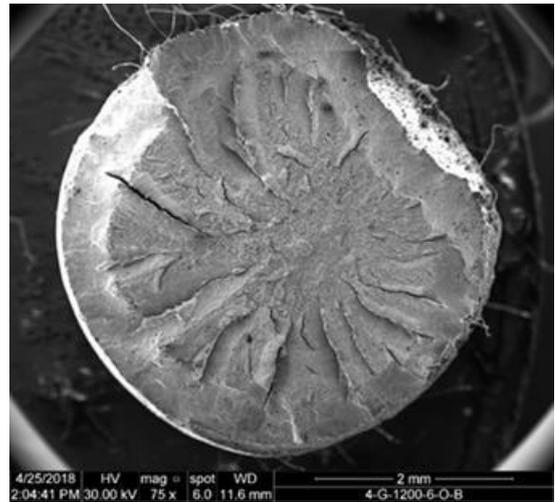
M-G-H-III-O-3

Figure 7.71 (cont.) Comparison of fracture mode for galvanised tendons

For galvanised tendons, both ICCP-N and ICCP-O have influenced the fracture more than the ungalvanised tendons in Stage II and Stage III corrosion. However, the damage is more in ICCP-O than ICCP-N and the degree of corrosion also has to be considered as a factor that has influence on the damage of the tendons (Figure 7.71).
