Sustainable building assessment of colonial shophouses after adaptive reuse in Kuala Lumpur

Sustainable Building Assessment of Colonial Shophouses after Adaptive Reuse in Kuala Lumpur

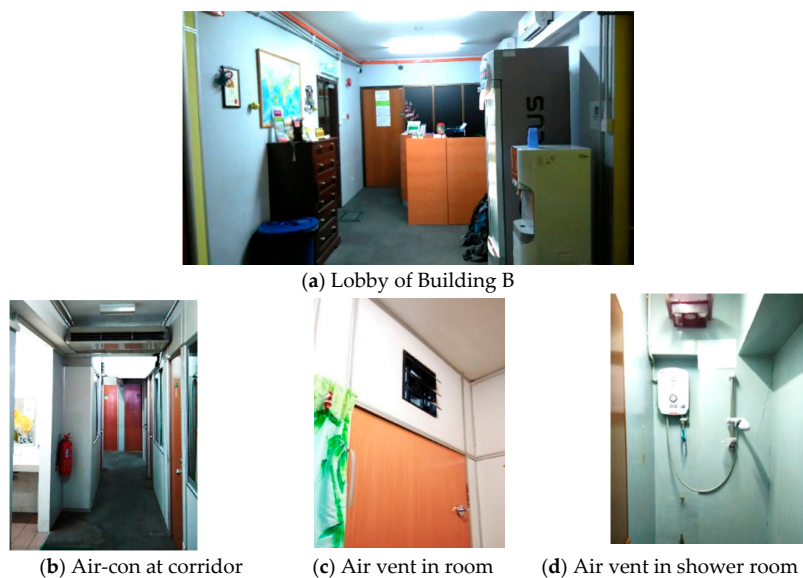
Figure 7. Building condition in Building B.

On the contrary, all spaces in Building B are entirely air-conditioned as shown in Figure 7. This building only has openings on the front and back facades. Side openings are not provided on the wall of the additional floors. During the adaptive reuse renovation, the courtyard area which was originally situated in the middle of the building was fully covered with new suspended floors. It was also found that Building B now consumes more electricity, as previously recorded by the building owner. All air-conditioning systems are positioned in the corridor while wall-mounted mechanical air vents are provided to distribute cold air into each hotel room. More air vents are provided at the toilets and shower rooms. For both case studies, neither obvious dampness on the indoor surfaces nor moisture was visually spotted in the interior spaces.

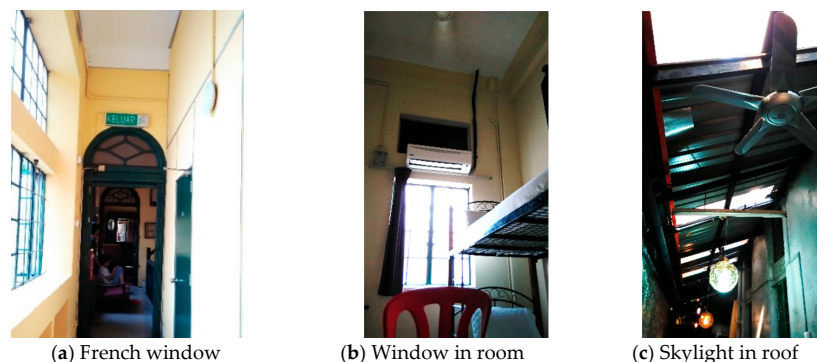
Figure 8. Architectural features in Building A.

For Lighting, Visual and Acoustic section in the indoor environmental assessment, there are eight main requirements that were assessed. Building A shows more functional openings which were maintained, and provides sufficient level of daylight for the occupants as compared to Building B (Figure 8). Inadequate amount of openings at Building B, as mentioned earlier, plus the deep building plan causes the interior of this building to have a low level of natural light. It was also found that not all windows provided in each room are functional; they only act for decorative purposes. Both case studies provided flexible lighting control and blinds to prevent glare which meet the second and fourth requirements. In addition, energy saving lighting, such as LED lighting, was found in Building A, however, they were not functional, while Building B gained a zero rating for this assessment. In addition, both shophouses do not provide any motion sensors to further reduce the electricity usage.

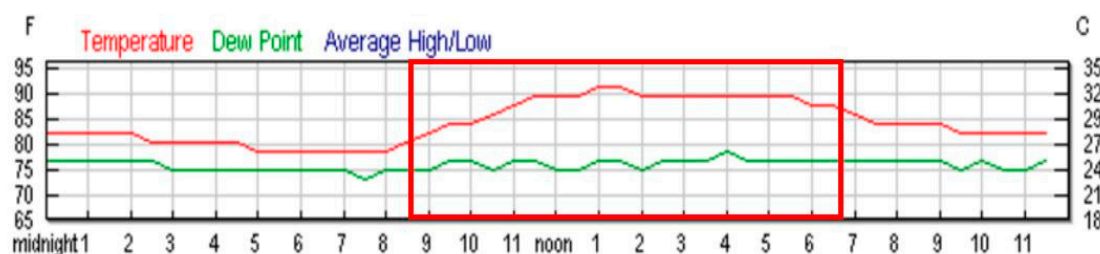
Figure 10. Air temperature in Kuala Lumpur on 18 March 2016.

This section presents one day of data which represents a typical clear and sunny day in Kuala Lumpur. Figure 10 shows the air temperature of Kuala Lumpur on 18 March 2016 which was recorded and collected from a nearby weather station. The records showed that the air temperature ranged between 28 °C and 34 °C in the 24 h cycle and the average air temperature was approximately 30 °C. Besides this, the average air humidity for the same day as recorded by the same weather station was approximately 76% while the maximum was 89% and minimum 39%.
