# The Palace of Westminster Courtyards Project: Sourcing Stone for Repair and Conservation

**Abstract.** *The Palace of Westminster, commonly known as the Houses of Parliament, serves as the meeting place of the House of Commons and the House of Lords and is situated on the north bank of the River Thames in London, England. The site is part of the UNESCO Westminster World Heritage Site. The building was constructed of magnesian limestone, selected following a nationwide survey of building stones carried out by a Government Select Committee. However, some of this stone began to decay soon after construction in the mid 1800s. As the majority of the stonework has survived very well the aim of the work was to source a demonstrably durable material with characteristics which align with the majority of the existing stonework. Samples were taken from the building for petrographic analysis in order to identify compatible material in quarries, either working or which could be re-opened. Durability of the magnesian limestone was assessed using both accepted tests and novel methodology. Large scale walls were constructed in the laboratory and exposed to accelerated frost weathering with real

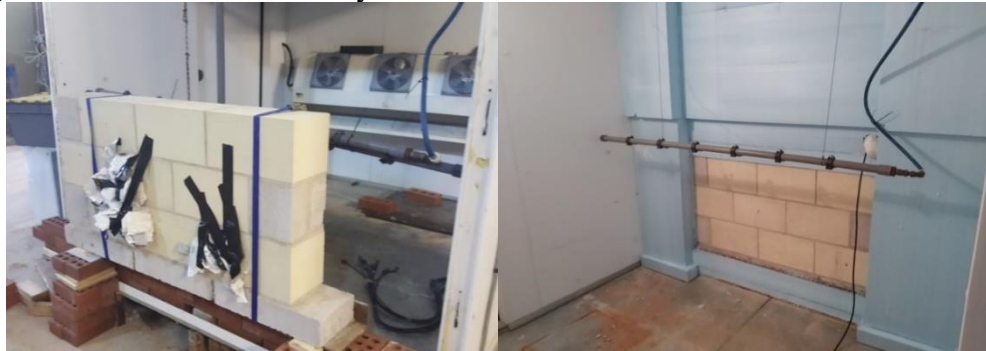
**Figure 1.** Test wall installed into climate chamber for frost testing.  
1a. Exterior, prior to installation. 1b. Interior, after sealing.

surrounding chamber using polystyrene sheeting and were sealed to prevent water ingress from above or around the sides of the panels (Figure 1). Chamber conditions were verified by test run with the wall in situ to confirm thermal performance. Testing commenced as soon as chamber conditions were confirmed. A study of data from the Meteorological Office suggested that a moderate frost cycle should be utilised. Chamber temperatures were initially set at -4 but the frost front did not penetrate deeply enough into the stone to initiate damage (Laycock, 1997). It was therefore incrementally lowered when the panel was in situ in order to ensure that the frost front passed through the block to a depth of 30mm and released during the thaw cycle. This regime was found in previous work on the Magnesian Limestone to cause damage. This resulted in a final cycle between +8 to -10°C, cooling and warming at 0.45°C/min, 2 minutes of simulated rain and 10 cycles per day. The chamber was maintained at -10°C for 14 minutes. A total of 300 freeze/thaw cycles were carried out. Phase 2 repeated this regime with 9 blocks of Cadeby stone cut to the same sizes as before.
