Mechanical Analysis of Explanted Telescopic Rods in the Management of Osteogenesis Imperfecta: A Multicenter Study

Mechanical Analysis of Explanted Telescopic Rods in the Management of Osteogenesis Imperfecta- A Multi-Centre Study

Abstract

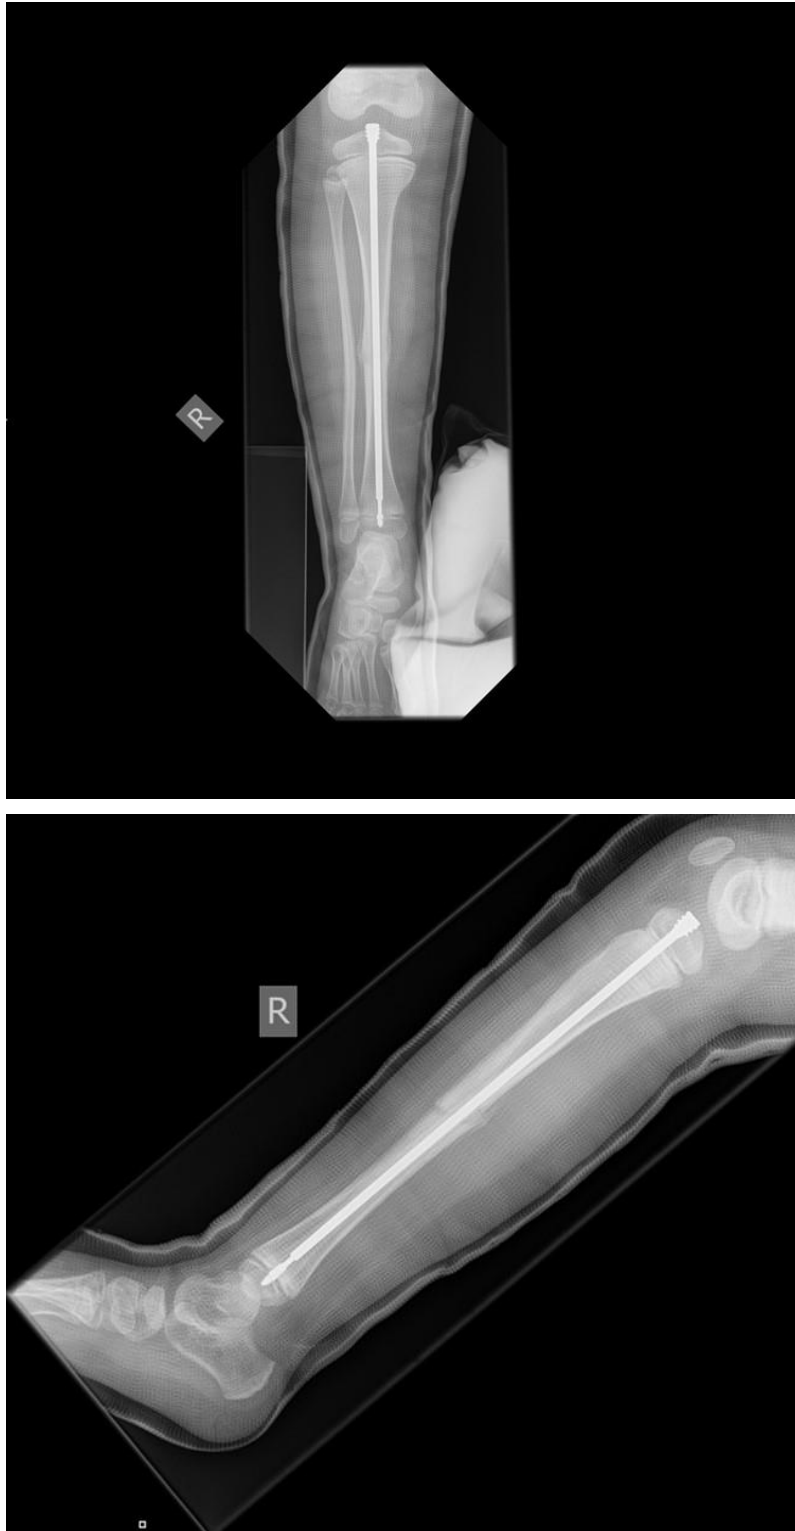
Figure 1a and b: Rod 17- AP and Lateral view. Type IV OI with previous multiple fractures managed with Fassier-Duval Rod for diaphyseal fracture of the right tibia. Described as technically adequate by all reviewing surgeons. Revised at 21 months for a mobile female component blocking knee extension.

We conducted investigations blinded to study centre and patient characteristics. In order to exclude whether failure of rod was due to an implant error, we asked 4 experienced surgeons to rate the quality of rod implantation. The first post-operative full length anteroposterior and lateral radiographs of the tibia or femur after insertion were collected into a slide presentation at high resolution in random. Each surgeon, excluding the Chief Investigator, commented on the radiographs by grading each as having no, minor (unlikely to affect the telescoping) or major (likely to affect telescoping) technical errors. Each was asked to exclude any case they recognised as their own despite blinding. An error was considered if 2 or more of the 4 surgeons concurred (figure 1a & b).

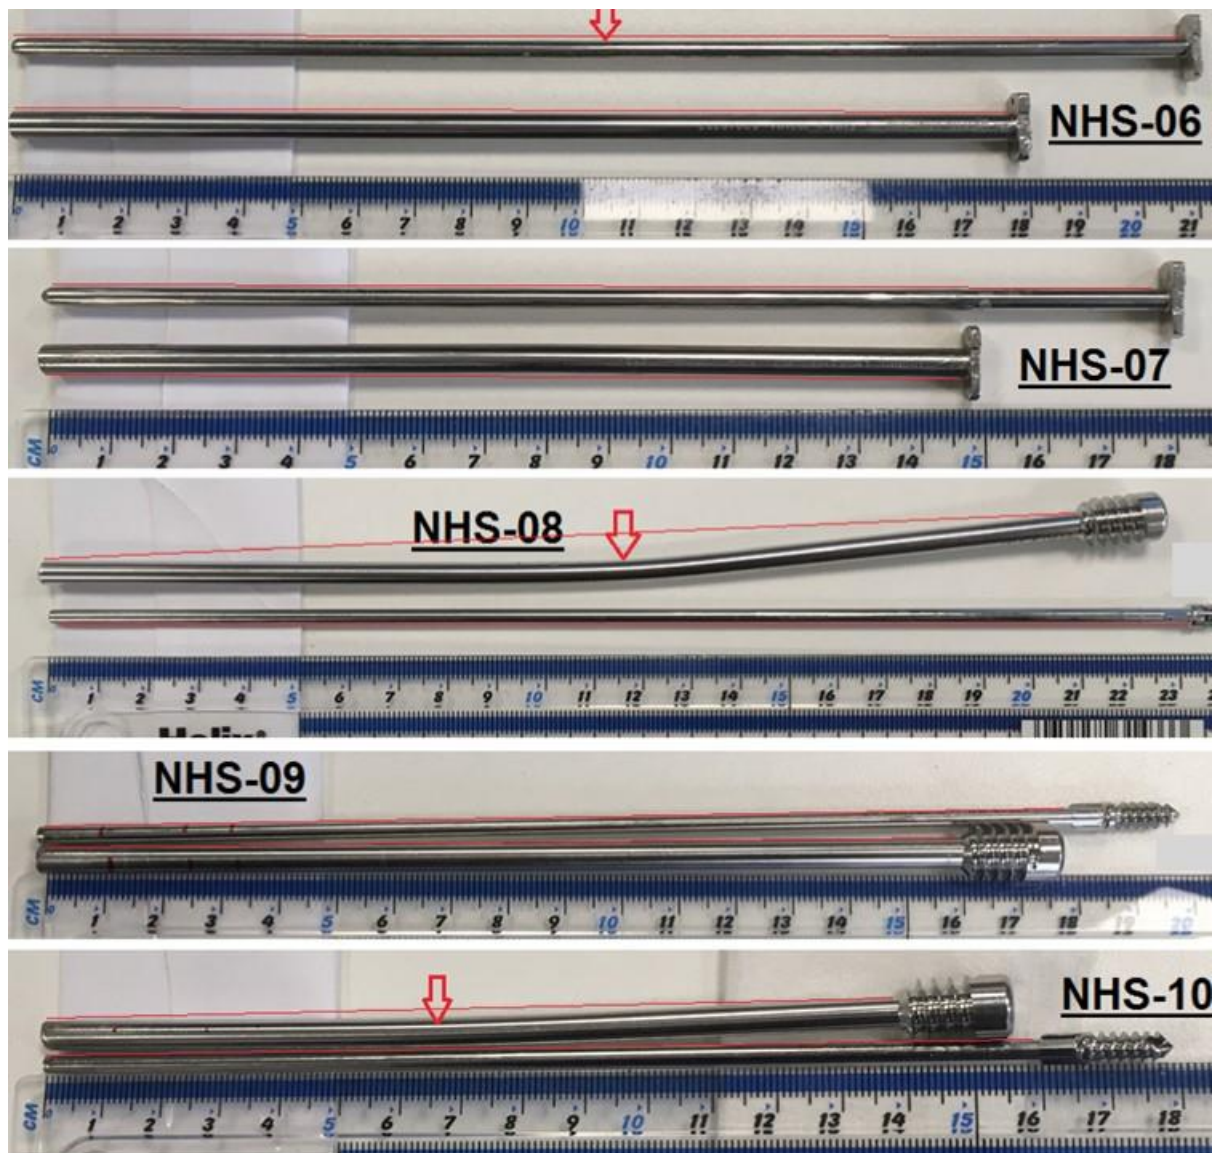
Figure 2: Photograph of rod samples 6 to 10. The red line is used to reference deviation from straight in the plane of maximal bow. Red arrows identify the apex of deformity.

Macroscopic analysis revealed 14 of 25 rods had some degree of bending of the male and/or female components that was not always visible on pre-revision radiographs (Figure 2). The distal end of some female and male rods had irregularities (Figure 3).
