The impact of an ambulance vehicle preparation service on the presence of bacteria: a service evaluation

Yorkshire Ambulance Service NHS Trust

British Paramedic Journal

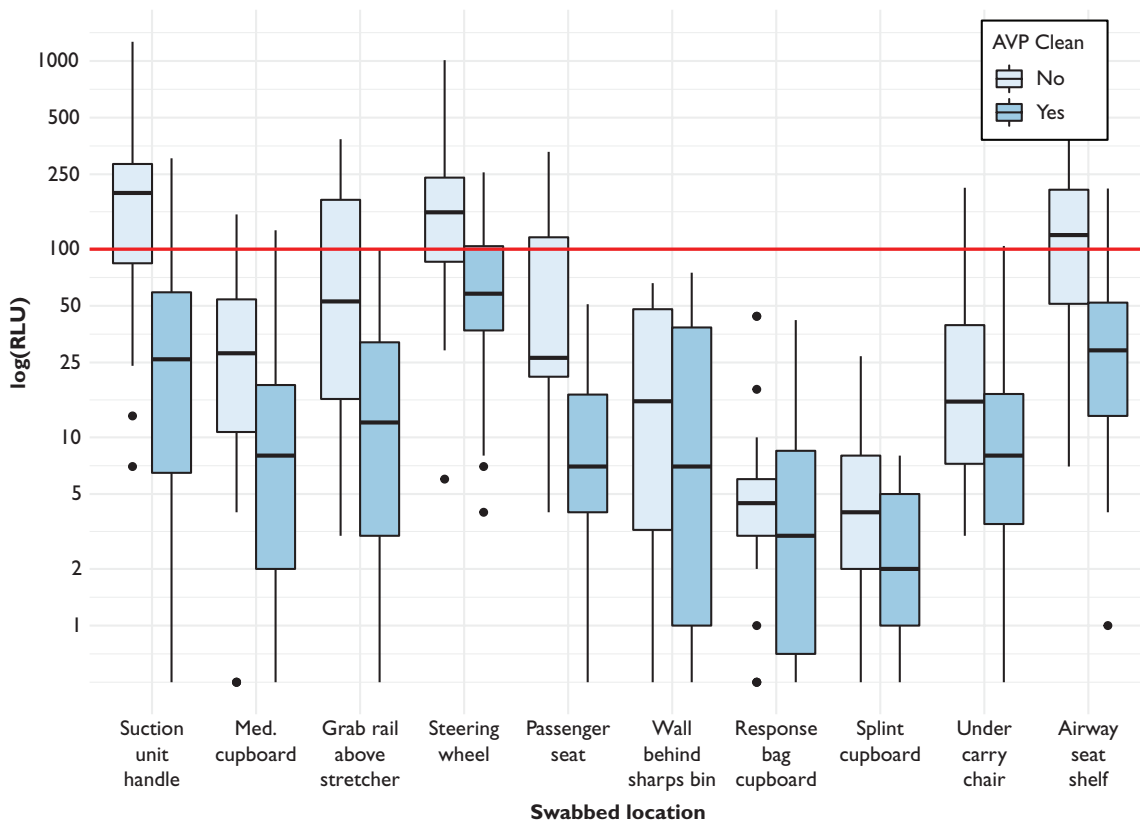
However, when stratified by swabbing area, some areas for concern became apparent (Table 2 and Figure 1). Three areas had a median RLU of > 100 in the BAU group: suction unit handle, steering wheel and airway seat shelf. In addition, the upper quartile RLU values for the grab rail above the stretcher and the passenger seat in the BAU group were also > 100. No swab areas had a median RLU > 100 in the AVPS group, although the steering wheel had the highest median value (58), and had an upper quartile value of 104.

Figure 1. Boxplot of swab results, stratified by swab location and whether cleaning conducted by AVPS.

The results of this evaluation clearly show that the median RLU values in all areas were lower in the AVPS group compared to the BAU group. In addition, the interquartile ranges (IQR) for all swabbing sites (with the exception of the steering wheel) in the AVPS group were under the safe threshold of 100 RLUs. This contrasts with the BAU group, where the suction unit handle, steering wheel, passenger seat and airway seat shelf all recorded an IQR that exceeded the 100 RLU threshold. The BAU group also recorded the highest RLU values, with two sites (suction unit handle and steering wheel) recording a maximum RLU of over 1000.
