Testing the durability of limestone for Cathedral façade restoration

LAYCOCK, E. A., SPENCE, Kevin, JEFFERSON, D. P., HETHERINGTON, S., MARTIN, B. and WOOD, C. (2008). Testing the durability of limestone for Cathedral façade restoration. *Environmental Geology*, 56 (3-4), 521-528. [Article]

Testing the durability of limestone for cathedral façade restoration

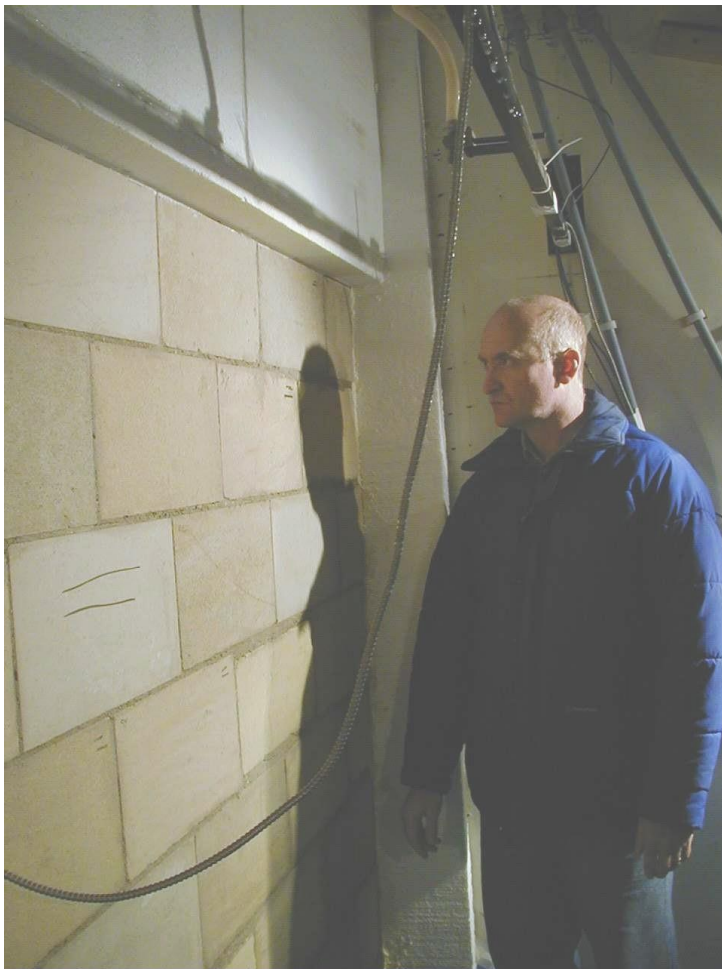
the literature (TAYLOR-FIRTH & LAYCOCK 1998, TAYLOR-FIRTH & LAYCOCK 1999 LAYCOCK 2002) and gives control over both interior and exterior conditions to more closely mimic likely weathering elements. The simulator itself is composed of two chambers each of dimensions 4m long, 3m wide and 2.6m in height. A wall was constructed which separated the two chamber halves and contained 8 samples of each of the stone types to be tested, a total of 64 blocks (Figure 4). The sample sizes were 350x200x200mm for full blocks and 170x200x200mm for half blocks and a mortar joint of 6mm was used. Typically the stone supplied from the North Porch of the Cathedral was of more irregular shape and variable in size, averaging approximately 350x190x150mm and thus required the use of a larger mortar joint to keep coursing level.

Figure 4. Inspection of test wall in Climatic Simulation test chamber
