Testing the durability of limestone for cathedral façade restoration

Abstract

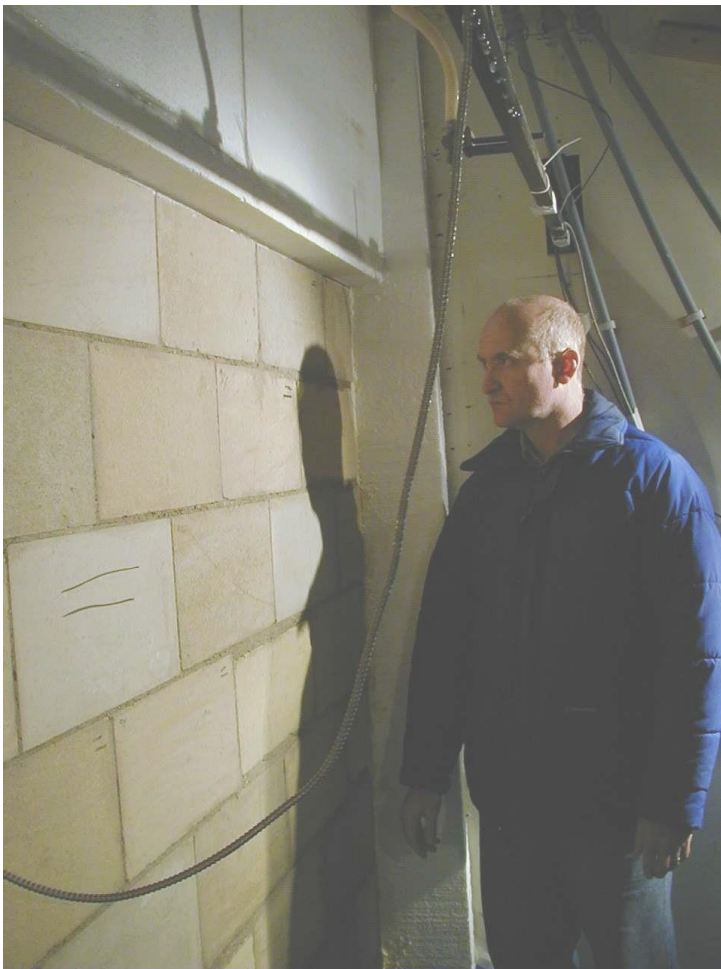
the literature (TAYLOR-FIRTH & LAYCOCK 1998, TAYLOR-FIRTH & LAYCOCK 1999 LAYCOCK 2002) and gives control over both interior and exterior conditions to more closely mimic likely weathering elements. The simulator itself is composed of two chambers each of dimensions 4m long, 3m wide and 2.6m in height. A wall was constructed which separated the two chamber halves and contained 8 samples of each of the stone types to be tested, a total of 64 blocks (Figure 4). The sample sizes were 350x200x200mm for full blocks and 170x200x200mm for half blocks and a mortar joint of 6mm was used. Typically the stone supplied from the North Porch of the Cathedral was of more irregular shape and variable in size, averaging approximately 350x190x150mm and thus required the use of a larger mortar joint to keep coursing level.

Figure 4. Inspection of test wall in Climatic Simulation test chamber

Figure 4. Inspection of test wall in Climatic Simulation test chamber
