## **Testing the durability of limestone for cathedral façade restoration**

LAYCOCK, Elizabeth A, SPENCE, Kevin, JEFFERSON, David P, HETHERINGTON, Stephen, MARTIN, Bill and WOODS, Christopher (2008). Testing the durability of limestone for cathedral façade restoration. *Environmental Geology*, 56 (3-4), 521-528.

# Testing the durability of limestone for cathedral façade restoration

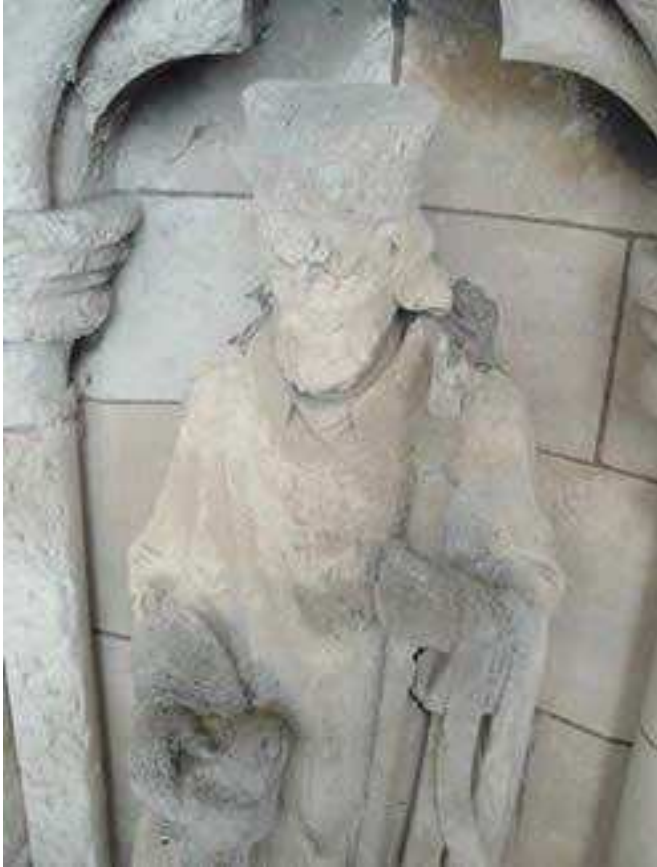
Figure 2. Weathered statue. (Truro Cathedral, 2005)

The Bath stone in this building are weathered variably. Some parts of the fabric appear to be in very good condition, whilst others have disintegrated completely (Figure 2). Investigation of the fabric by Jefferson Consulting for English Heritage concluded that there was no apparent correlation between the degree of exposure and decay levels and it was concluded that there was probably a wide variation in the durability of the stone itself. This latter hypothesis was further investigated through much more detailed examination of a selection of six stones in 1999. The stones conformed to the typical visual and petrographic description of Bath Stone although there were variations in the sizes and composition of the clastic and matrices of the stones. However an obvious reason for selective decay was not discerned (JEFFERSON 2001).

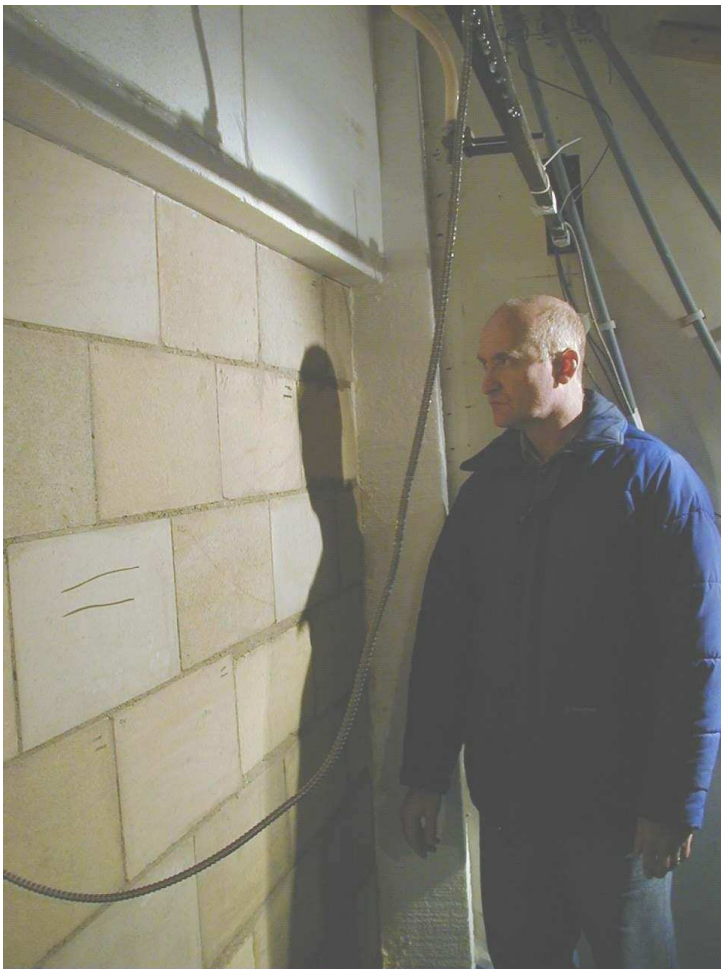
Figure 4. Inspection of test wall in Climatic Simulation test chamber

the literature (TAYLOR-FIRTH & LAYCOCK 1998, TAYLOR-FIRTH & LAYCOCK 1999 LAYCOCK 2002) and gives control over both interior and exterior conditions to more closely mimic likely weathering elements. The simulator itself is composed of two chambers each of dimensions 4m long, 3m wide and 2.6m in height. A wall was constructed which separated the two chamber halves and contained 8 samples of each of the stone types to be tested, a total of 64 blocks (Figure 4). The sample sizes were 350x200x200mm for full blocks and 170x200x200mm for half blocks and a mortar joint of 6mm was used. Typically the stone supplied from the North Porch of the Cathedral was of more irregular shape and variable in size, averaging approximately 350x190x150mm and thus required the use of a larger mortar joint to keep coursing level.

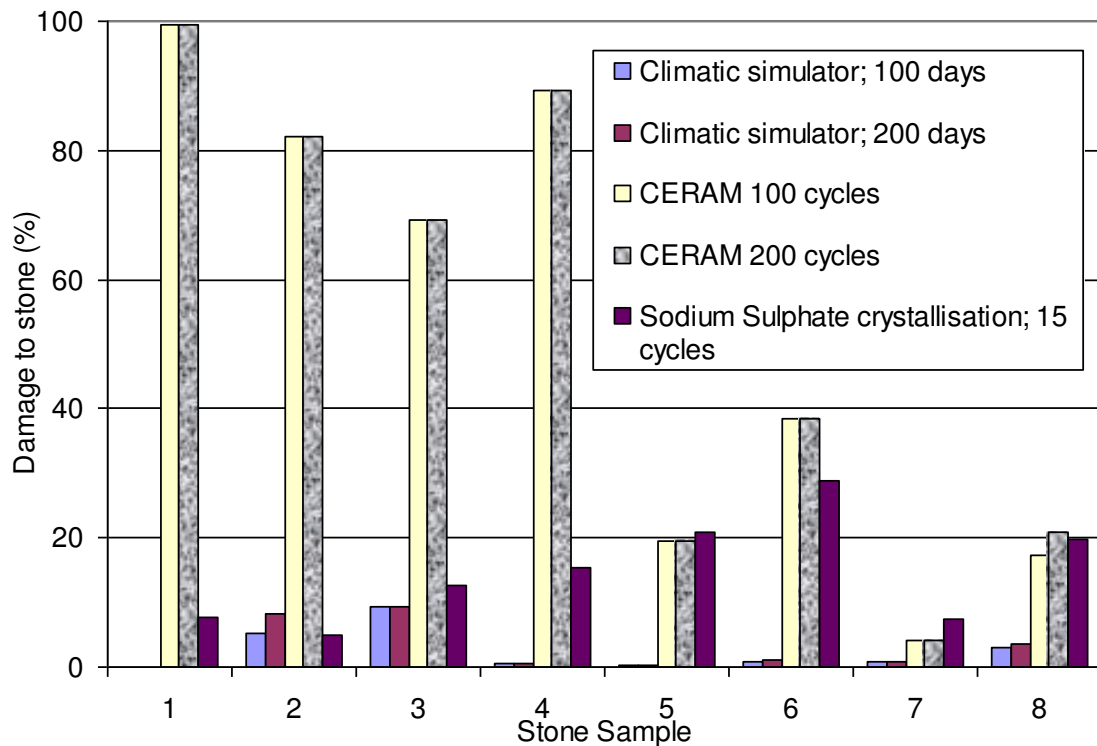
Figure 6 Mean damage to stone for different test apparatus

Figures 6 and 7 compare the overall block damage of the materials in both freeze thaw testing regimes to those of the salt crystallisation test. It can be seen that the CERAM chamber causes significantly more damage than the climatic simulation. Extending the test from 100 to 200 cycles in the CERAM test seems largely unnecessary as little change in both mean and standard deviation of damage occurred.

The CERAM test consistently causes the greatest amount of damage in the materials tested with about half the samples suffering significantly more damage than the salt crystallisation test. Where a high level of damage occurs in the salt crystallisation test, this correlates with similar levels of frost damage in the CERAM test although the standard deviation in the latter is much higher. A high standard deviation (Figure 7) indicates selective weathering and

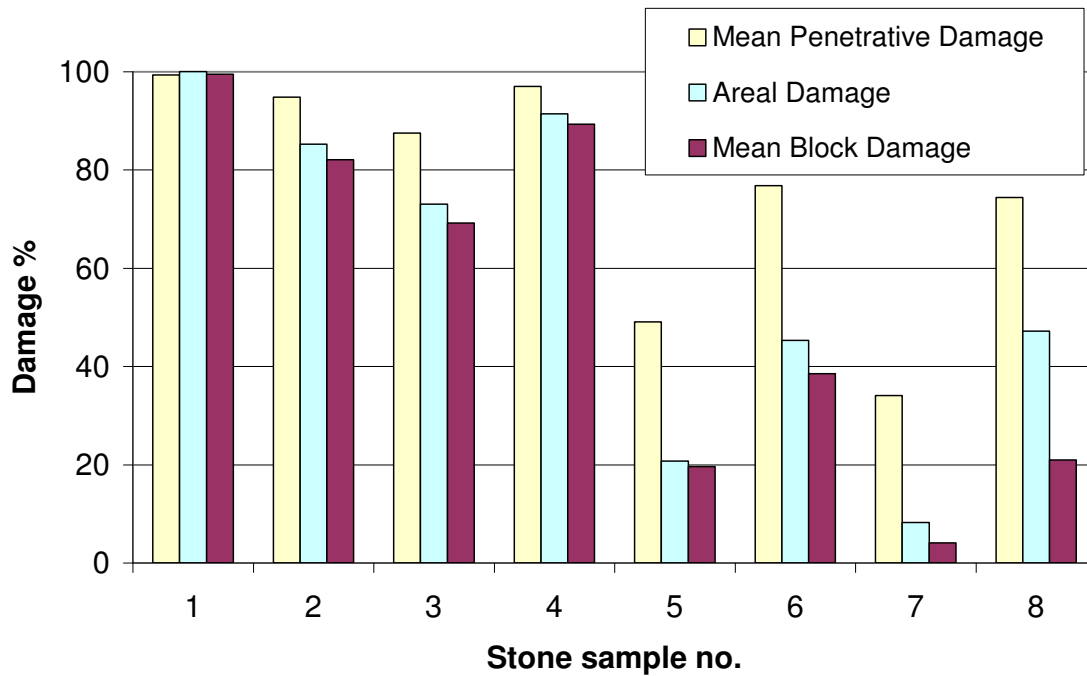
Figure 8 Summary of the lateral extent and penetrative nature of damage generated during testing in CERAM apparatus after 200 cycles

damaged areas. The CERAM test method causes damage which is both widespread and to considerable depth (Figure 8) notably for samples 1 to 4. In comparison, the climatic chamber (Figure 9) causes much less areal damage and generally lower penetrative decay.
