## **Testing the durability of limestone for cathedral façade restoration**

LAYCOCK, Elizabeth A, SPENCE, Kevin, JEFFERSON, David P, HETHERINGTON, Stephen, MARTIN, Bill and WOODS, Christopher (2008). Testing the durability of limestone for cathedral façade restoration. *Environmental Geology*, 56 (3-4), 521-528. [Article]

## **Abstract**

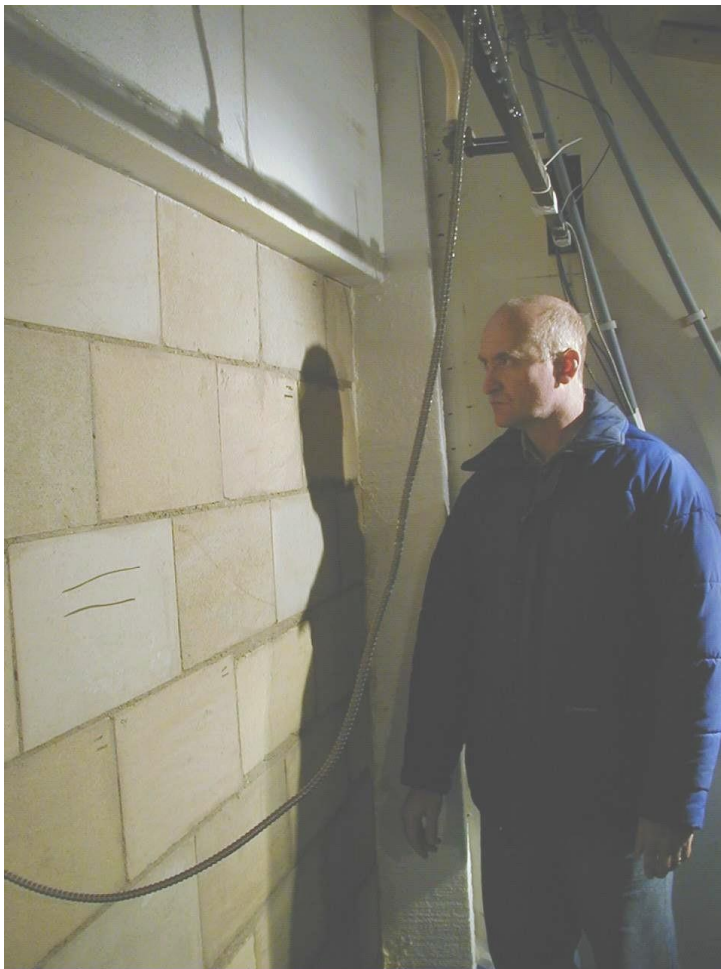
Figure 4. Inspection of test wall in Climatic Simulation test chamber

the literature (TAYLOR-FIRTH & LAYCOCK 1998, TAYLOR-FIRTH & LAYCOCK 1999 LAYCOCK 2002) and gives control over both interior and exterior conditions to more closely mimic likely weathering elements. The simulator itself is composed of two chambers each of dimensions 4m long, 3m wide and 2.6m in height. A wall was constructed which separated the two chamber halves and contained 8 samples of each of the stone types to be tested, a total of 64 blocks (Figure 4). The sample sizes were 350x200x200mm for full blocks and 170x200x200mm for half blocks and a mortar joint of 6mm was used. Typically the stone supplied from the North Porch of the Cathedral was of more irregular shape and variable in size, averaging approximately 350x190x150mm and thus required the use of a larger mortar joint to keep coursing level.
