Dual function carbon fibre fabric strengthening and impressed current cathodic protection (ICCP) anode for reinforced concrete structures

LAMBERT, Paul, VAN NGUYEN, Chinh, MANGAT, Pritpal S., O'FLAHERTY, Fin and JONES, Graeme (2015). Dual function carbon fibre fabric strengthening and impressed current cathodic protection (ICCP) anode for reinforced concrete structures. *Materials and structures*, 48 (7), 2157-2167.

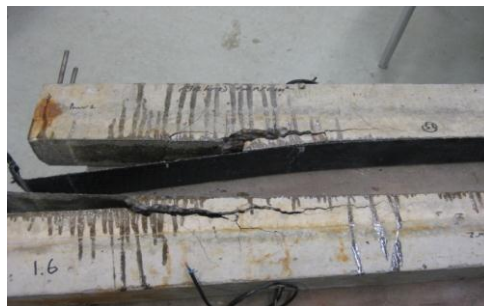
Fig. 10 Debonding of CFRP fabrics after load testing

Beams 1.5 and 1.6 used the dual function CFRP fabric for both strengthening and ICCP. The average ultimate strength of the dual function beams (1.5 & 1.6) increased by approximately 77% compared to the un-strengthened beam 1.2. Both beams 1.5 and 1.6 failed due to the de-bonding or peeling of CFRP fabric (Fig.10). The average ultimate deflection of specimens 1.5 and 1.6 was about 6 % less than the ultimate deflection of specimen 1.2.

Therefore, the mean ultimate strength of dual function CFRP fabric strengthened beams (1.5 and 1.6) is approximately 13.5 % smaller than the mean ultimate strength of CFRP fabric reinforced beams without CP (beams 1.3 and 1.4). This appears to be due to the ICCP affecting the bond at the CFRP fabric anode and concrete interface, and as a consequence beams 1.5 and 1.6 failed due to de-bonding of the CFRP fabric.

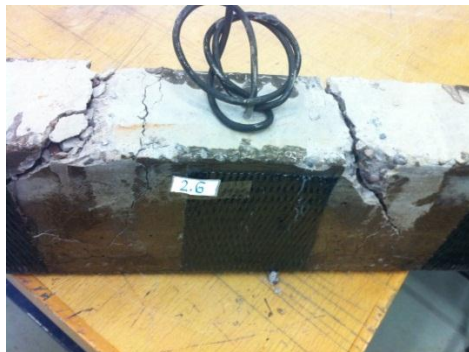
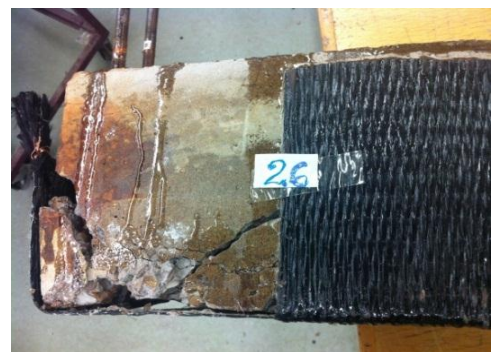
Fig. 12 Photographs of failed beams

All beams were tested to failure and the failure modes were monitored and recorded. Figs.12a to 12d show the failure modes of 4 CFRP strengthened beams. Although there were some shear cracks occurred for beams 2.4 and 2.6, the flexural failure happened before shear failure. Flexural failures of CFRP strengthened beam 2.3 included de-bonding of U-wrapping, following by steel yielding, delamination of cover concrete and CFRP fracture at the mid-span (Fig.12a). The failure mode of beam 2.4 included de-bonding of U-wrapping, delamination of cover concrete and de-bonding of a long section of CFRP at the end point (Fig. 12b). The failure mode of beam 2.5 is similar to that of beam 2.3, however, it has been noticed that the CFRP fabric was ruptured at the areas where yellow deposits appeared. It was noted that the deposit is directly above three large pieces of aggregate with little or no cement paste present (Fig.13). In a similar manner to beam 2.4, beam 2.6 failed in flexure due to end cover delamination, de-bonding of U-wrapping and longitudinal CFRP (Fig. 12d). The failure of the concrete layer between the CFRP and steel and peeling of CFRP from the concrete surface appears to be very brittle in nature. The prevention of brittle failure is an important criterion for safe and effective CFRP strengthening.

From Fig. 12, CFRP fabrics were used full strength as they failed by rupture (Figs.12a & 12c). The failure modes of these beams are analysed above. Most of these beams failed due to delamination of the cover concrete plus de-bonding at the CFRP fabric and concrete interface. However when using the U-shaped wrapping, this de-bonding was restricted and the strength of the strengthened beams increased (increase of 109.7% and 111.37% for U-wrapping in compared with 104% and 77 % without U-wrapping as described in group 1). This demonstrates that the use of U-wrapping for the dual function CFRPs is an effective solution for increasing the bonding at the CFRP fabric anode and concrete interface and significantly enhances the effectiveness of this technique.
