Dual function carbon fibre fabric strengthening and impressed current cathodic protection (ICCP) anode for reinforced concrete structures

LAMBERT, Paul, VAN NGUYEN, Chinh, MANGAT, Pritpal S., O'FLAHERTY, Fin and JONES, Graeme (2015). Dual function carbon fibre fabric strengthening and impressed current cathodic protection (ICCP) anode for reinforced concrete structures. *Materials and structures*, 48 (7), 2157-2167. [Article]

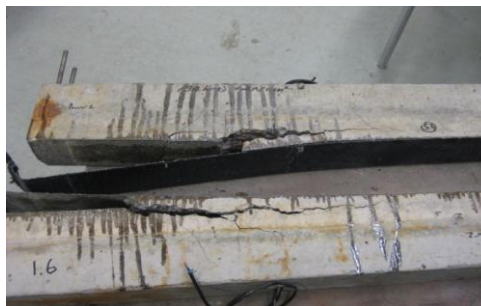
Fig. 10 Debonding of CFRP fabrics after load testing

Beams 1.5 and 1.6 used the dual function CFRP fabric for both strengthening and ICCP. The average ultimate strength of the dual function beams (1.5 & 1.6) increased by approximately 77% compared to the un-strengthened beam 1.2. Both beams 1.5 and 1.6 failed due to the de-bonding or peeling of CFRP fabric (Fig.10). The average ultimate deflection of specimens 1.5 and 1.6 was about 6 % less than the ultimate deflection of specimen 1.2.

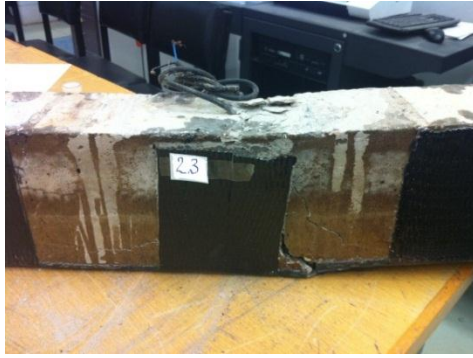
a: Beam 2.3

Fig. 12 Photographs of failed beams

All beams were tested to failure and the failure modes were monitored and recorded. Figs.12a to 12d show the failure modes of 4 CFRP strengthened beams. Although there were some shear cracks occurred for beams 2.4 and 2.6, the flexural failure happened before shear failure. Flexural failures of CFRP strengthened beam 2.3 included de-bonding of U-wrapping, following by steel yielding, delamination of cover concrete and CFRP fracture at the mid-span (Fig.12a). The failure mode of beam 2.4 included de-bonding of U-wrapping, delamination of cover concrete and de-bonding of a long section of CFRP at the end point (Fig. 12b). The failure mode of beam 2.5 is similar to that of beam 2.3, however, it has been noticed that the CFRP fabric was ruptured at the areas where yellow deposits appeared. It was noted that the deposit is directly above three large pieces of aggregate with little or no cement paste present (Fig.13). In a similar manner to beam 2.4, beam 2.6 failed in flexure due to end cover delamination, de-bonding of U-wrapping and longitudinal CFRP (Fig. 12d). The failure of the concrete layer between the CFRP and steel and peeling of CFRP from the concrete surface appears to be very brittle in nature. The prevention of brittle failure is an important criterion for safe and effective CFRP strengthening.

From Fig. 12, CFRP fabrics were used full strength as they failed by rupture (Figs.12a & 12c). The failure modes of these beams are analysed above. Most of these beams failed due to delamination of the cover concrete plus de-bonding at the CFRP fabric and concrete interface. However when using the U-shaped wrapping, this de-bonding was restricted and the strength of the strengthened beams increased (increase of 109.7% and 111.37% for U-wrapping in compared with 104% and 77 % without U-wrapping as described in group 1). This demonstrates that the use of U-wrapping for the dual function CFRPs is an effective solution for increasing the bonding at the CFRP fabric anode and concrete interface and significantly enhances the effectiveness of this technique.
