**Dual function carbon fibre fabric strengthening and impressed current cathodic protection (ICCP) anode for reinforced concrete structures**

LAMBERT, Paul, VAN NGUYEN, Chinh, MANGAT, Pritpal S., O'FLAHERTY, Fin and JONES, Graeme (2015). Dual function carbon fibre fabric strengthening and impressed current cathodic protection (ICCP) anode for reinforced concrete structures. *Materials and structures*, 48 (7), 2157-2167.

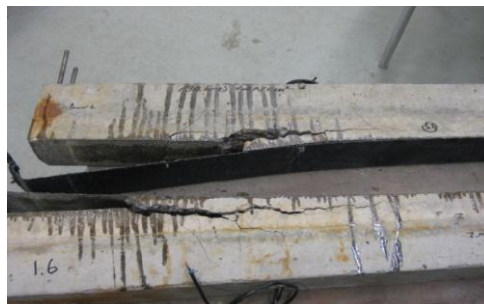
**Fig. 10** Debonding of CFRP fabrics after load testing

Beams 1.5 and 1.6 used the dual function CFRP fabric for both strengthening and ICCP. The average ultimate strength of the dual function beams (1.5 & 1.6) increased by approximately 77% compared to the un-strengthened beam 1.2. Both beams 1.5 and 1.6 failed due to the de-bonding or peeling of CFRP fabric (Fig.10). The average ultimate deflection of specimens 1.5 and 1.6 was about 6 % less than the ultimate deflection of specimen 1.2.

Therefore, the mean ultimate strength of dual function CFRP fabric strengthened beams (1.5 and 1.6) is approximately 13.5 % smaller than the mean ultimate strength of CFRP fabric reinforced beams without CP (beams 1.3 and 1.4). This appears to be due to the ICCP affecting the bond at the CFRP fabric anode and concrete interface, and as a consequence beams 1.5 and 1.6 failed due to de-bonding of the CFRP fabric.

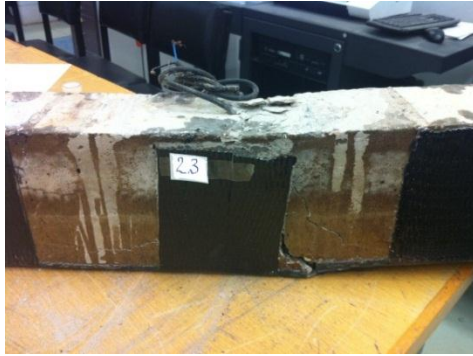
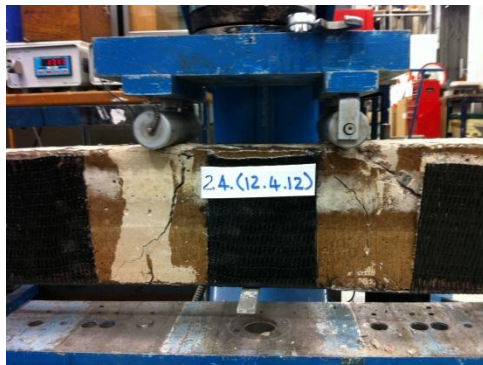
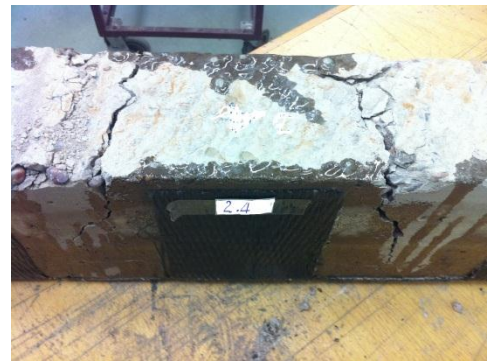
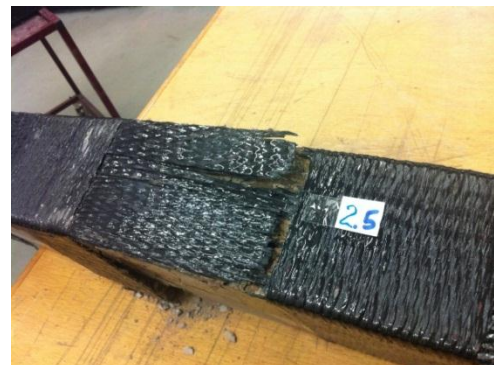
a: Beam 2.3

b: Beam 2.4

c: Beam 2.5

**Fig. 12** Photographs of failed beams

All beams were tested to failure and the failure modes were monitored and recorded. Figs.12a to 12d show the failure modes of 4 CFRP strengthened beams. Although there were some shear cracks occurred for beams 2.4 and 2.6, the flexural failure happened before shear failure. Flexural failures of CFRP strengthened beam 2.3 included de-bonding of U-wrapping, following by steel yielding, delamination of cover concrete and CFRP fracture at the mid-span (Fig.12a). The failure mode of beam 2.4 included de-bonding of U-wrapping, delamination of cover concrete and de-bonding of a long section of CFRP at the end point (Fig. 12b). The failure mode of beam 2.5 is similar to that of beam 2.3, however, it has been noticed that the CFRP fabric was ruptured at the areas where yellow deposits appeared. It was noted that the deposit is directly above three large pieces of aggregate with little or no cement paste present (Fig.13). In a similar manner to beam 2.4, beam 2.6 failed in flexure due to end cover delamination, de-bonding of U-wrapping and longitudinal CFRP (Fig. 12d). The failure of the concrete layer between the CFRP and steel and peeling of CFRP from the concrete surface appears to be very brittle in nature. The prevention of brittle failure is an important criterion for safe and effective CFRP strengthening.

From Fig. 12, CFRP fabrics were used full strength as they failed by rupture (Figs.12a & 12c). The failure modes of these beams are analysed above. Most of these beams failed due to delamination of the cover concrete plus de-bonding at the CFRP fabric and concrete interface. However when using the U-shaped wrapping, this de-bonding was restricted and the strength of the strengthened beams increased (increase of 109.7% and 111.37% for U-wrapping in compared with 104% and 77 % without U-wrapping as described in group 1). This demonstrates that the use of U-wrapping for the dual function CFRPs is an effective solution for increasing the bonding at the CFRP fabric anode and concrete interface and significantly enhances the effectiveness of this technique.

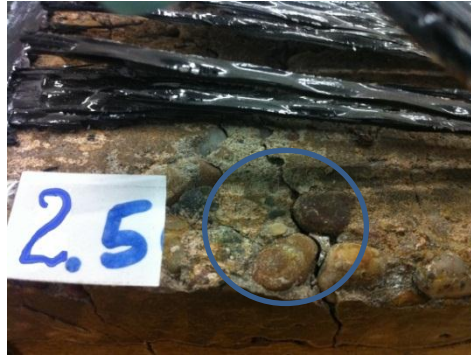
**Fig. 13** Area beneath yellow gaseous deposit (circled)

For group 1, after 984.25 hours of application of ICCP, a very small gaseous and yellow liquid deposit appeared on the surface of CFRP fabric anode. For group 2, the gaseous and yellow liquid deposit appeared earlier at 474 hours due to higher applied current density, compared with

group 1. This could, if more widespread, result in the de-bonding of the CFRP fabric anode from the concrete interface.
