Near-surface mounted carbon fibre rod used for combined strengthening and cathodic protection for reinforced concrete structures

NGUYEN, Chinh, LAMBERT, Paul, MANGAT, Pal, O'FLAHERTY, Fin and JONES, Graeme (2015). Near-surface mounted carbon fibre rod used for combined strengthening and cathodic protection for reinforced concrete structures. *Structure and Infrastructure Engineering*, 12 (3), 356-365. [Article]

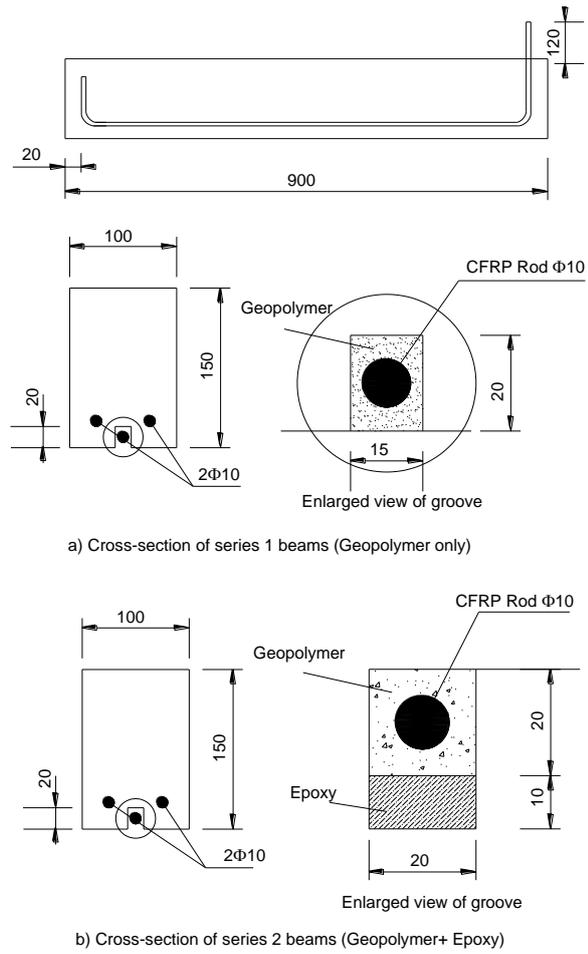
Figure 1. Detailed dimensions of beam specimens

plain steel bars of 10 mm diameter. There was no shear reinforcement (Figure 1). This was aimed to avoid any effects of shear steel bars in accelerating corrosion of longitudinal reinforcement. All beams were designed for flexural failures; therefore, premature shear failure was prevented through the use of external steel collars during flexural testing. Each steel collar included 2 mild steel plates each dimensions of 210 x 200x 10 (mm) and 2 mild steel plates each dimensions of 270x 150x 10 (mm). Details of the steel collars are shown in Figure 2. The dimensions of the groove in Figure 1 were selected in accordance with ACI 440.2R-08 (2008) "Guide for the design and construction of externally bonded FRP systems for strengthening concrete structures" (American Concrete Institute, 2008).

The first group using CFRP rod utilised a pre-formed groove on the tension soffit of the concrete beams using geopolymer only (Figure 1a). The groove was half filled with the geopolymer, the CFRP rod was placed inside the groove and further geopolymer was added to completely fill the groove (see Figure 4).

For the second group, the CFRP rod was bonded to the pre-cut groove by two layers of repair material. A schematic of repair is shown in Figure 1b. Firstly, the CFRP rods were bonded into the grooves by geopolymer (Figure 5a). The geopolymer repair was cured in the ambient laboratory conditions for 7 days at which time epoxy was overlaid as the second repair material (Figure 5b). The purpose of the epoxy layer was to improve the bond between the CFRP rod anode and repair material. This is the difference between Groups 1 and 2 and should have some influence on the improvement in strength capacity due to the greater elasticity of the epoxy compared to the brittle nature of the geopolymer at the zone of greatest tensile stress. These samples were cured in the laboratory environment for a further 21 days prior to ICCP application.

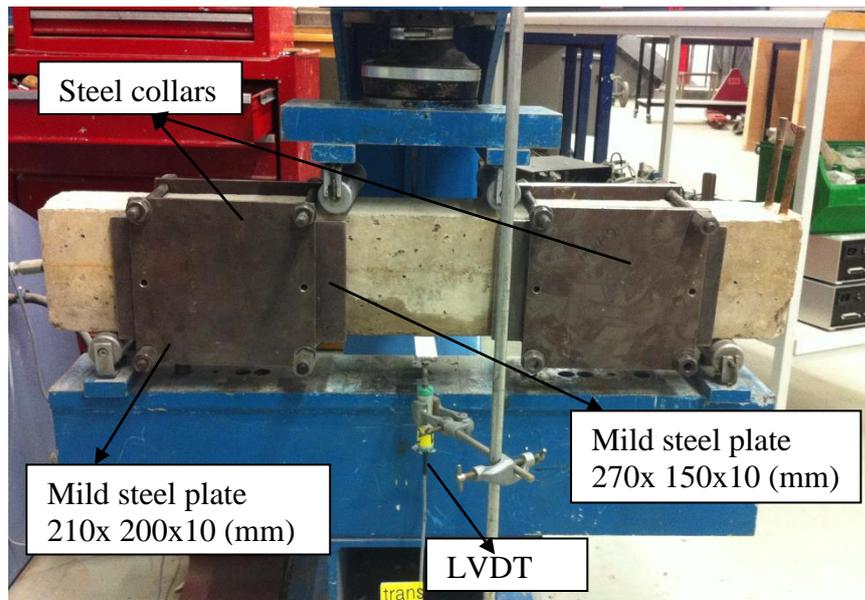
Figure 2. Four point bending test of beams and detailed steel collars

All beams were tested under four point bending (see Figure 2). Load measurements were taken by means of a 3000kN load cell connected to a signal amplifier with low pass filter which in turn was connected to a load cell power supply and digital balancing and monitoring unit. The amplifier was calibrated to ensure a direct reading of the applied load on the digital monitoring unit, with an accuracy of 0.1kN. The loading rate was 5KN/min.

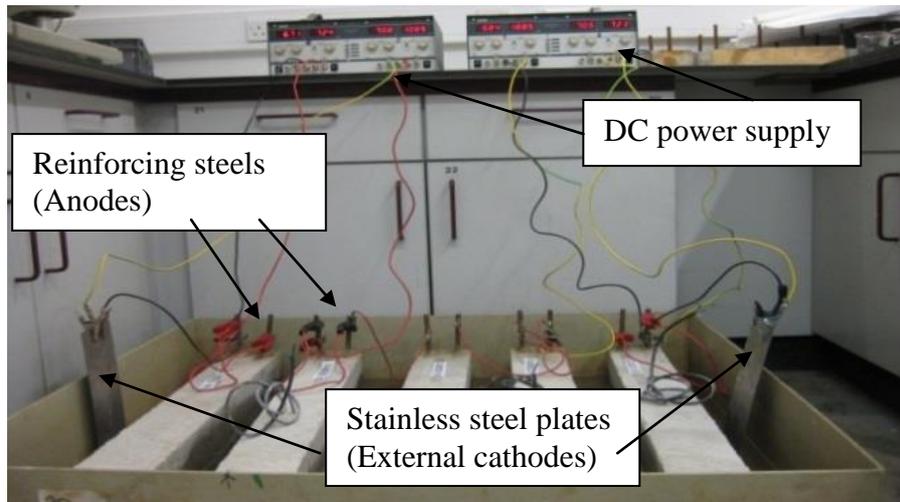
Figure 3. Accelerated corrosion of reinforcing steel by means of an anodic impressive current technique

At 21 days after casting, 5 beams from each group were subjected to accelerated corrosion of the reinforcing steel using an anodic impressed current method. A current density of $1\text{mA}/\text{cm}^2$ was applied to simulate general corrosion of reinforcing steel. This current density was previously adopted in earlier experiments (O'Flaherty, Mangat, Lambert & Browne, 2008), and was found to provide an appropriate level of corrosion, similar in nature and composition to the naturally occurring process but within a reasonable timescale. The period of current application was 94 hours to achieve nominal degree of corrosion of 2.5% of diameter loss. The layout of the corrosion set up is shown in Figure 3. The current was provided by a DC power supply. The polarity of the current was such that the steel reinforcement served as the anode and a stainless steel plate worked as the cathode. The corrosion process took place in a polymer tank where 3.5% NaCl solution was used as the electrolyte. The solution level in the tank was adjusted to ensure adequate submersion of the steel bars, while ensuring sufficient oxygen for the corrosion process to proceed.

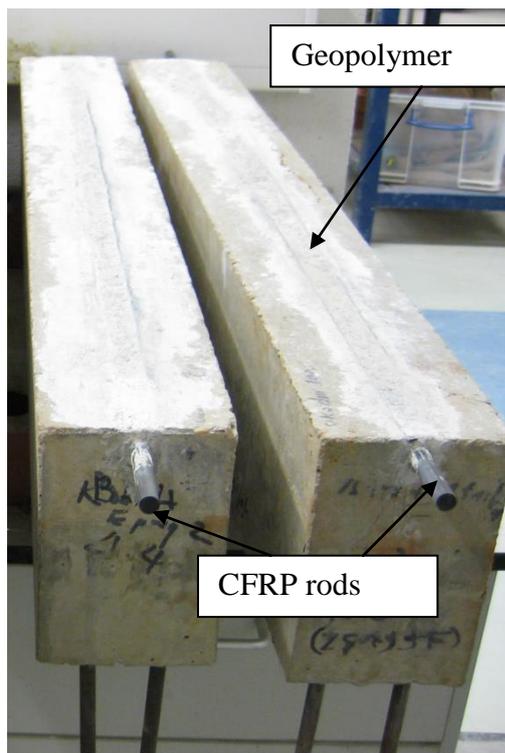
Figure 4. Bonding CFRP rods to grooved beams by geopolymer- Group1

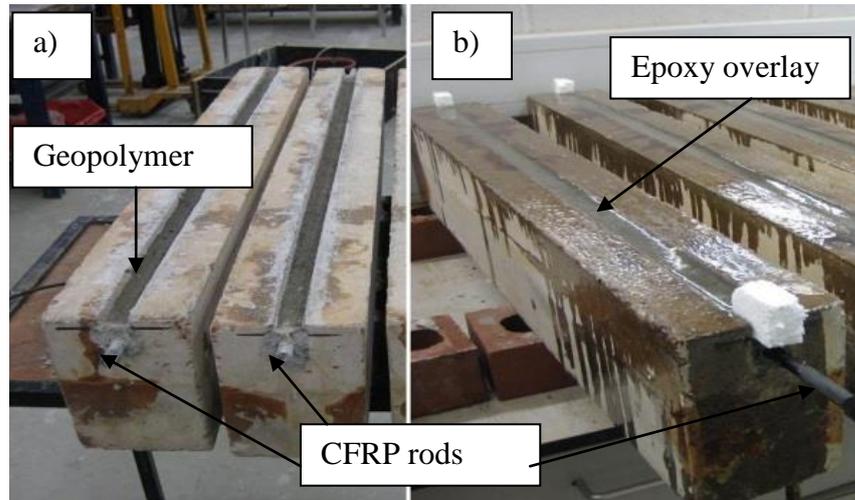
Figure 5. (a). Bonding CFRP rods to pre-grooved beams by geopolymer (first layer of repair material) (b). Overlay of epoxy as the second layer of repair

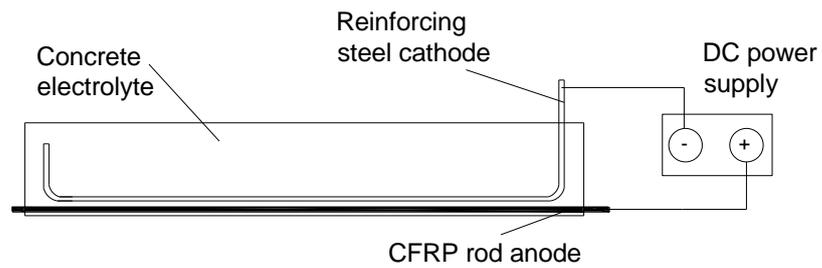
Figure 6. Schematic ICCP application to corroded reinforced concrete beams

terminal of a multi-channel power supply. The schematic of ICCP application is shown in Figure 6. The system was cathodically protected at room temperature (nominally 20°C) and 60% relative humidity (plus or minus 5%). These conditions ensured the resistivity of the concrete remained high, representing a dry site environment. The applied current densities were 64.2mA/m² of steel surface area for Beams 1.5 and 1.6 (Group 1-Table 1) and were varied between 125mA/m² and 310mA/m² of steel surface area for Beams 2.5 and 2.6 (Group 2-Table 1). The current was checked and the on and instant -off potentials of the embedded steel were recorded daily.

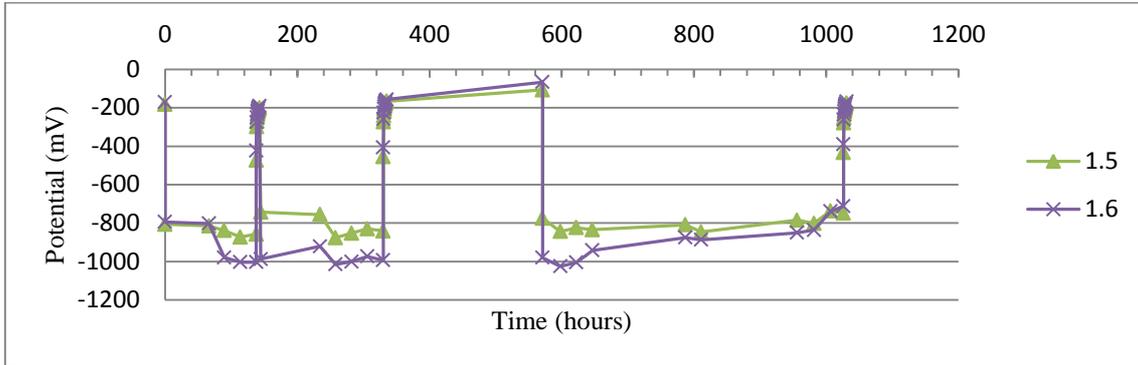
Figure 7. Potential (vs Ag/AgCl/0.5M KCl) of steels during operation of ICCP - Beams 1.5 and 1.6 (constant current density of 64.2mA/m^2 of steel area)

During the 1026 hours (corresponding to approximately 43 days) of operation of ICCP (Figure 7), the on- potential and potential decays of steel bars were recorded using embedded Ag/AgCl/0.5M KCl reference electrodes and a high impedance digital voltmeter (DVM). The ICCP was interrupted three times at 138 hours, 330 hours and 1026 hours, respectively. Although ICCP was achieved at each interruption (138 and 330 hours) the ICCP was re-run again to investigate the long term performance of dual function CFRP rod. At 330 hours, the ICCP was interrupted for 241 hours before it was restarted at 571 hours and continued to 1026 hours. The potential decays at these three occasions were monitored and are shown in Table 2.

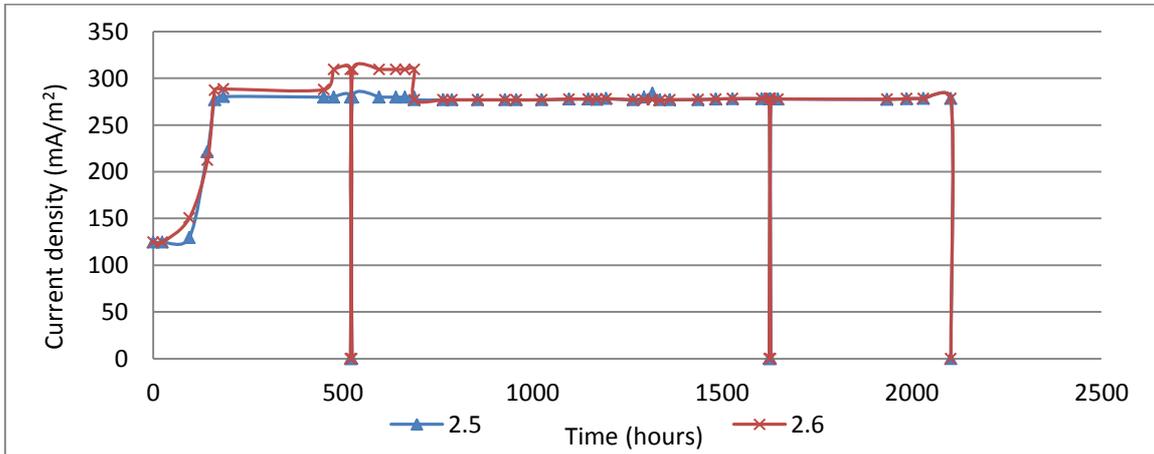
Figure 8. ICCP applied current densities (mA/m^2 of steel surface area)- Beams 2.5 and 2.6

The applied currents to Beams 2.5 and 2.6 were recorded and plotted in Figure 8. The applied current densities for both beams were around 125mA/m² for

approximately 100 hours before this was increased to around 280mA/m^2 to ensure adequate polarisation of the steel. The potential drop defined as difference between instant- off potential and rest potential should be greater than 150mV (The Concrete Society 2012). However, there was a small increase in current density applied to Beam 2.6 for a period of about 200 hours. The current density applied to Beam 2.6 was increased to around 310mA/m^2 at approximately 470 hours and reduced again to 280mA/m^2 at 688 hours. These adjustments of current densities were based on the polarisation of the steel. It also aimed to reduce the risk of any possible negative effect of too high a current on the bond at the CFRP rod/geopolymer interface.

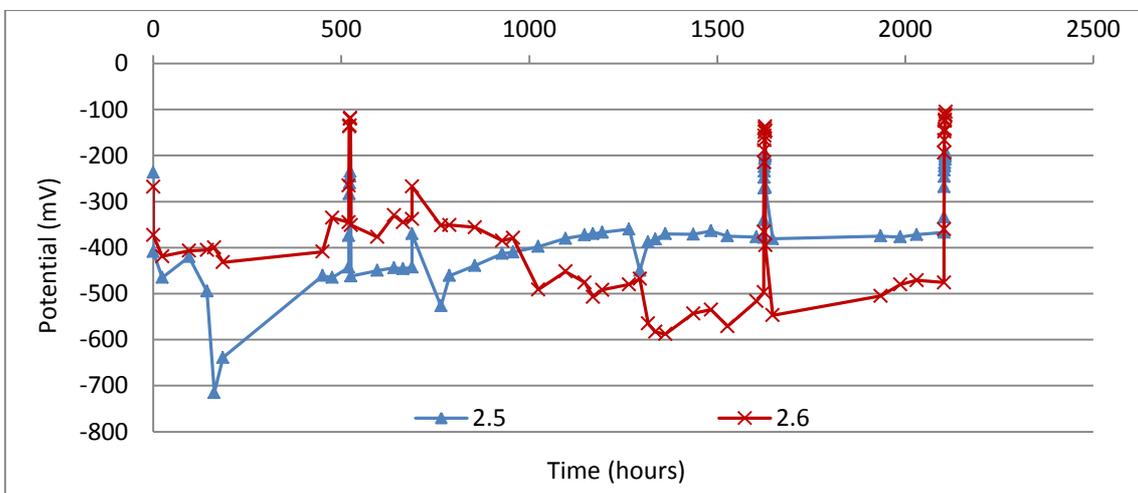
Figure 9. Potential (vs Ag/AgCl/0.5M KCl) of steel bars during ICCP application- Beams 2.5 and 2.6

During the total 2,103 hours of operation of ICCP, the on-potential and potential decays of the steel bars in Beams 2.5 and 2.6 were monitored and recorded. The total period is plotted in Figure 9. The ICCP was interrupted three times at 520, 1,624 and 2,103 hours and the potential decays are shown in Table 2. Figures 7 and 8 show that the potential of the steel bars in Beam 2.5 shifted quickly when the applied current density increased from about 138mA/m^2 to approximately 277mA/m^2 while the potential of the steels in Beams 2.6 shifted more slowly. During the period of ICCP application, the potential of the steel bars in Beam 2.5 is notably different from that of Beam 2.6. The difference of moisture contents of two specimens is suggested as the reason as Beam 2.6 was sprayed with water at the start of ICCP operation in order to help polarise the steel bars. Figure 9 shows that the potential of the steel bars shifted to values less negative than the initial rest potential, specifically from -237mV to -193mV for Beam 2.5 and from -268mV to -105mV for Beam 2.6 after 2013 hours of ICCP application.

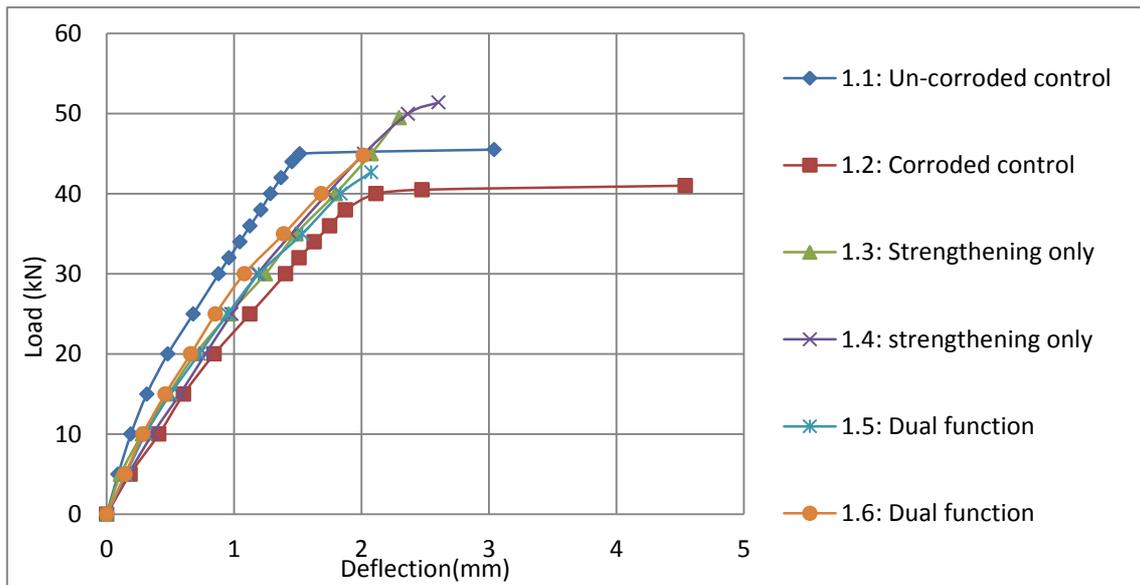
Figure 10. Load deflection curves of Group 1 beams- geopolymer only

The load- deflection relationships of Group 1 beams are shown in Figure 10. While the ultimate strength of corroded control Beam 1.2 (41.0kN) reduced compared to the un-corroded control Beam 1.1 (45.5kN), the deflection at failure of Beam 1.2 (4.54mm) increased compared to Beam 1.1 (3.04mm). This was due to the influence of steel reinforcement corrosion on the stiffness of beam. Previous research (O'Flaherty, et al 2010) shows that reinforced concrete beams show a loss in stiffness with increasing corrosion of the main steel reinforcement and as the result the stiffness of corroded Beam 1.2 reduced.

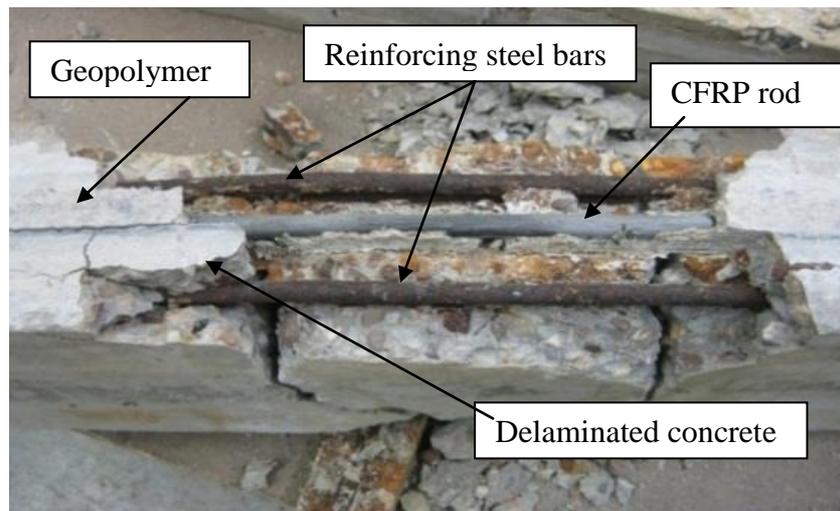
Figure 11. Debonding of CFRP rod after load testing- Group1

Beam 1.2 (Table 3). Beams 1.3 and 1.4 both failed due to the debonding of the CFRP rod (Figure 11). The average ultimate deflection of Beams 1.3 and 1.4 (2.45mm) was reduced by 46% compared with the ultimate deflection of Beam 1.2 (4.54mm) (Table 3). This was attributed to the CFRP rod application to Beams 1.3 and 1.4 leading to an increase in their stiffness compared to Beam 1.2.

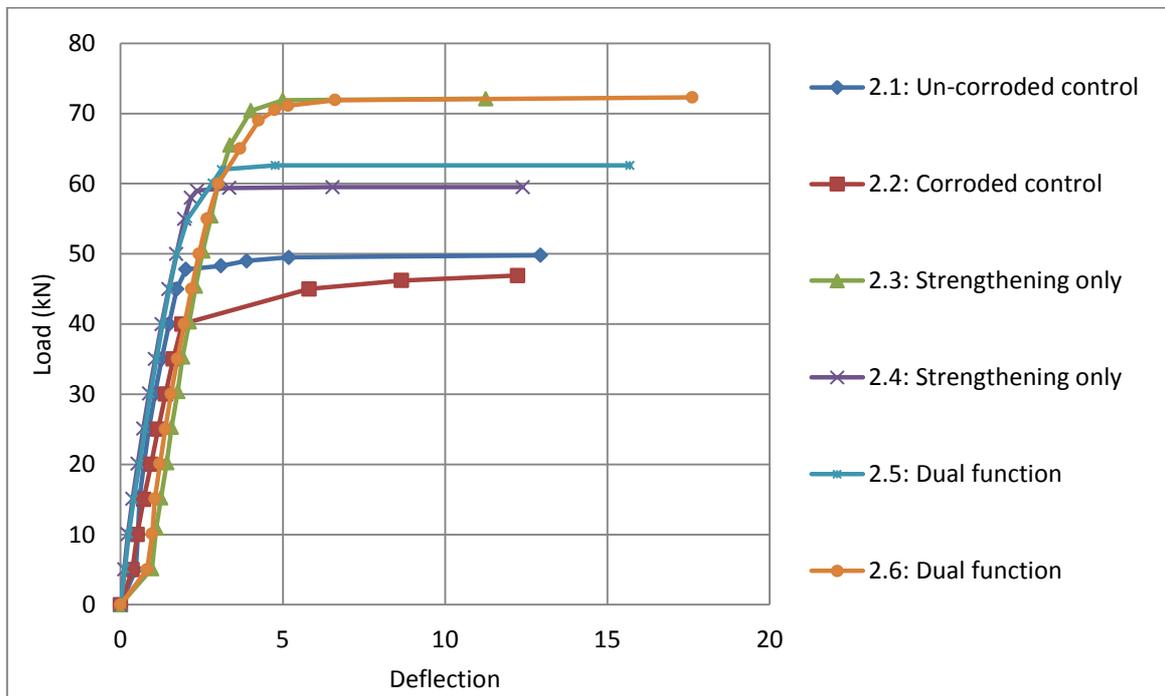
Figure 12. Load-deflection curves of Group 2 beams- combination of geopolymer and epoxy

The load-deflection relationships of Group 2 are plotted in Figure 12. While the ultimate strength of corroded control Beam 2.2 (46.9kN) reduced

compared to the un-corroded control Beam 1.1 (49.8kN), the deflection at failure of Beam 2.2 (8.68mm) increased compared to Beam 1.1 (5.18mm). Similar to Group 1, this was due to the influence of steel reinforcement corrosion on the stiffness of beam as stated previously.

The mean ultimate strength of the CFRP rod strengthened beams without CP (2.3 and 2.4) is 40.3% higher than the equivalent value for the un-strengthened Beam 2.2. The mean ultimate strength of the dual function beams (CFRP rod strengthening and CP) (Beams 2.5 and 2.6) is 43.81% higher than Beam 2.2 (see Table 3). The ultimate strength of the dual function beams is marginally higher than that of beams with strengthening only. In Group 2 beams, the effect of the ICCP current on the bond strength at the CFRP rod and repair material interface is very small when utilising the combination of geopolymer and epoxy.

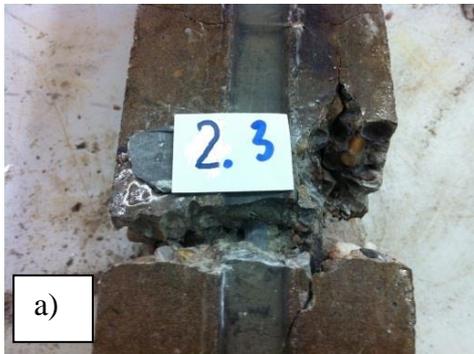
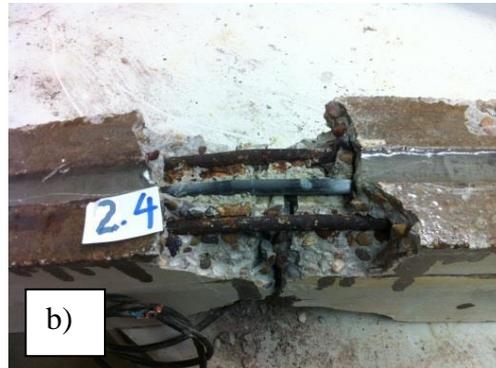
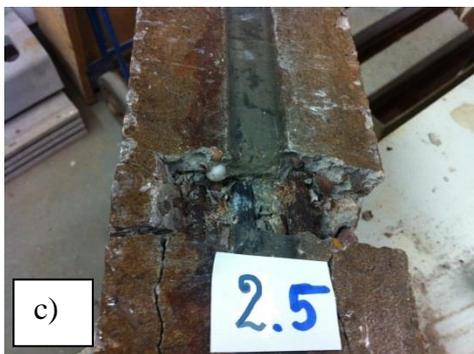
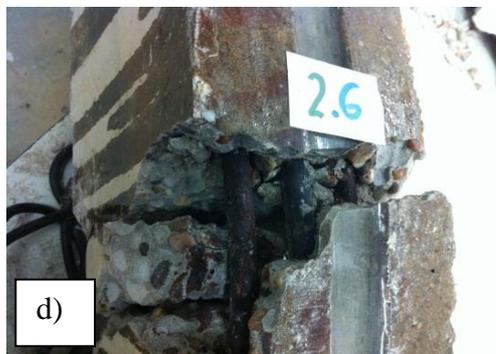
Figure 13. Failed beams

- a) Failure of strengthening only beam 2.3
- b) Failure of strengthening only beam 2.4
- c) Failure of dual function beam 2.5
- d) Failure of dual function beam 2.6

The failure modes of four strengthened beams were recorded and shown in Figures 13a to 13d. Flexural failure of Beam 2.3 (Figure 13a) started by the yielding of steel reinforcement followed by the rupture of second layer repair material (epoxy) and debonding at the CFRP rod/geopolymer interface. Post-bending investigation was conducted at the flexural failure section. There was no debonding at the geopolymer/concrete interface or geopolymer/epoxy interface. The failure mode of Beam 2.4 (Figure 13b) was similar to Beam 2.3; however, it was observed that the CFRP rod had a crack across the cross-section. The flexural failure of Beam 2.5 (Figure 13c) started by the yielding of the reinforcing steel, followed by the rupture of the epoxy layer. There was debonding at the CFRP rod/geopolymer interface, however, there was no debonding at the geopolymer/epoxy interface. Further examination revealed that there was minor debonding at the geopolymer/concrete substrate interface, due to inadequate cover to the CFRP rod provided by the geopolymer layer.

The failure mode of Beam 2.6 (Figure 13d) was more complicated. After yielding of the steel bars, the epoxy layer was ruptured following the formation of longitudinal cracks in the CFRP rod. Post-bending test investigation revealed that there was no debonding at the geopolymer/concrete or geopolymer/epoxy interfaces, however there was debonding at the CFRP rod/geopolymer interface. The CFRP rod had slipped, which is attributed to a loss of bond at the CFRP rod/geopolymer interface.

From the detailed examination of the four CFRP rod strengthened beams, debonding was only observed at the CFRP rod/geopolymer interface. In comparison with the NSM technique using geopolymer only as the repair material in Group 1, there is an improvement in the bonding between the CFRP rod and repair materials, and therefore the capacity of strengthening is increased significantly.
