Fatigue crack initiation and propagation in plain carbon-manganese steels.

FOX, Peter.

A Sheffield Hallam University thesis

FATIGUE CRACK INITIATION AND PROPAGATION
IN PLAIN CARBON-MANGANESE STEELS

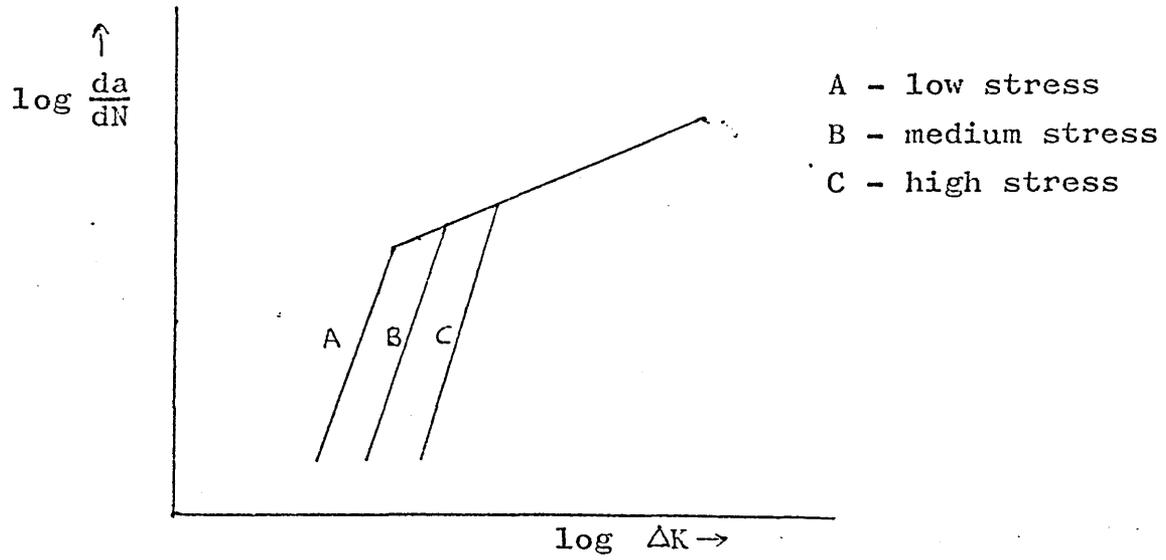
Fig. 3. Diagrammatic Representation of Results of Crack Propagation Measurements on Carbon-Manganese Steels (after Gurney (78)).

The lower branch of the $\log \frac{da}{dN}$ v. $\log \Delta K$ plot had a steeper gradient, and the position of the change in slope was stress dependant. No change in mechanism was noted at this position.

Broek⁽⁷⁹⁾ working on aluminium-zinc and aluminium-copper alloys showed a departure from linearity of the $\log da/dN$ v. $\log \Delta K$ curve at both low and high stress intensities, giving an S-shaped curve. He considered that at high stress intensities static tearing was taking place, and at low stress intensities the crack was "still in the initiation stage".

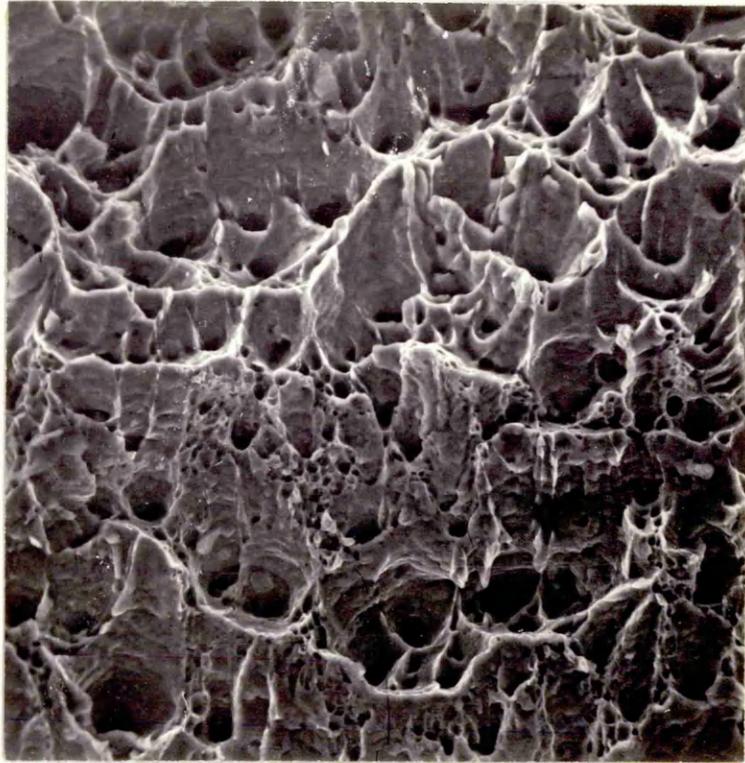
Fig. 5. Scanning Electron Micrograph of Fracture Surface of Tensile Specimen 0.01% Carbon Steel.

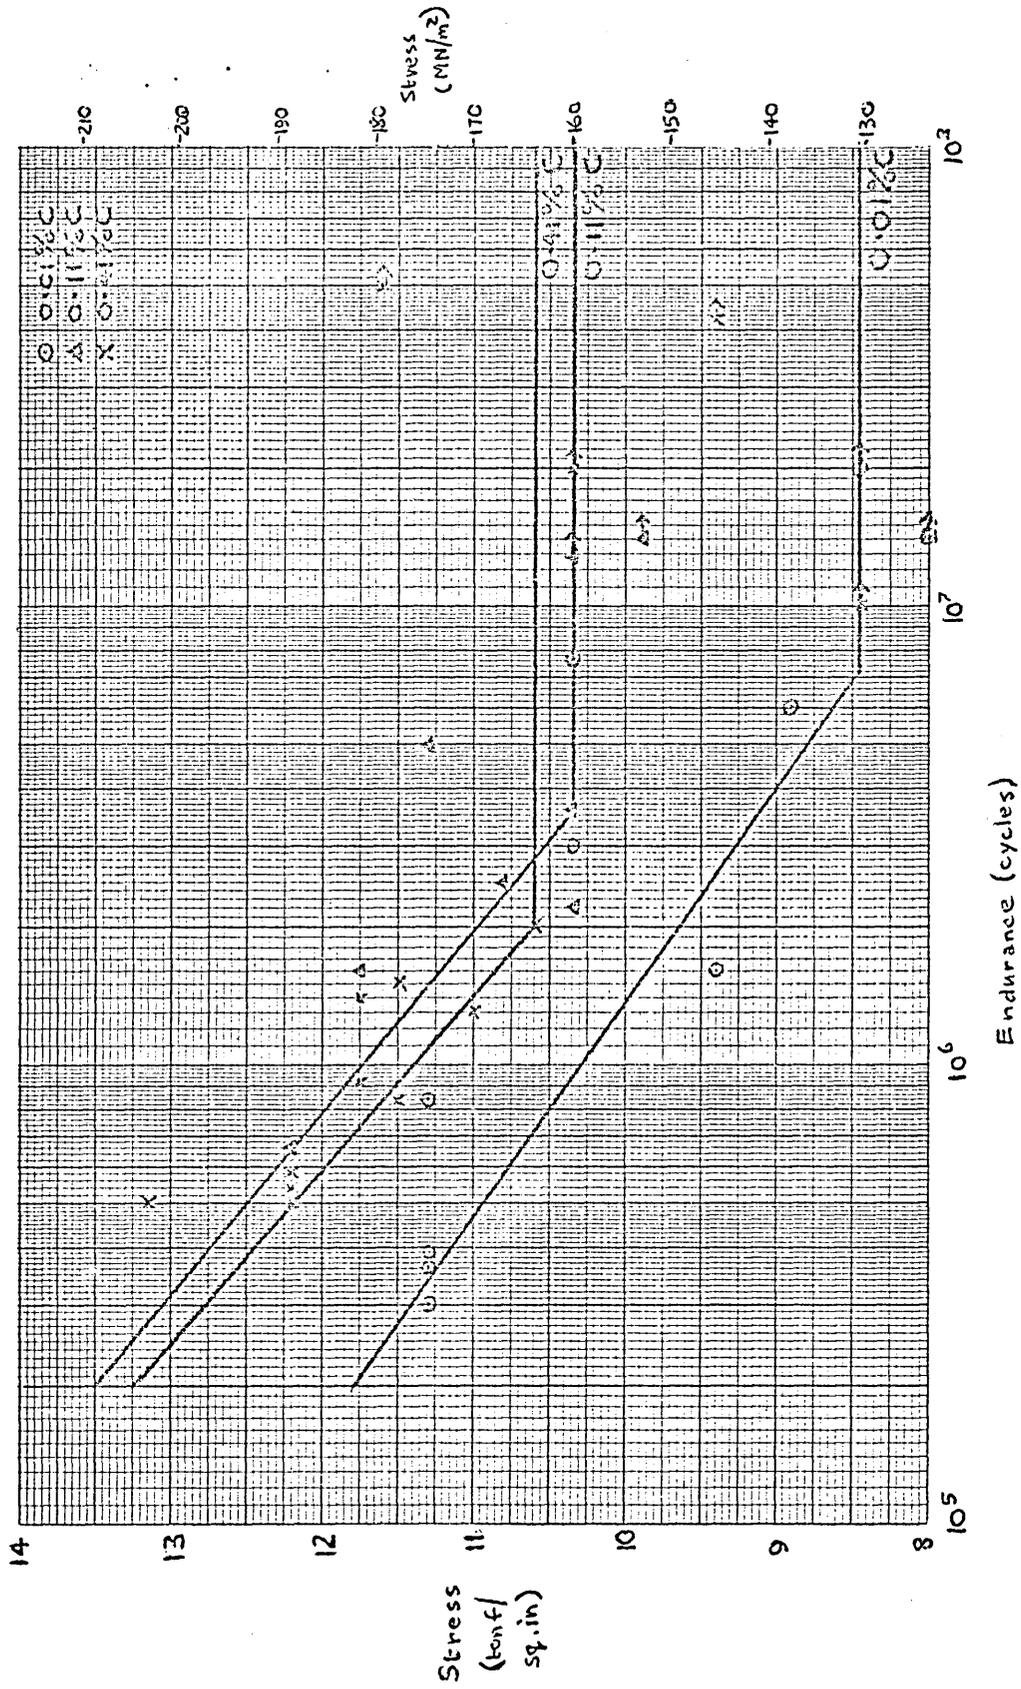
Fig. 11. S-N Curves for Plain specimens of 0.01, 0.11 & 0.41% Carbon Steels

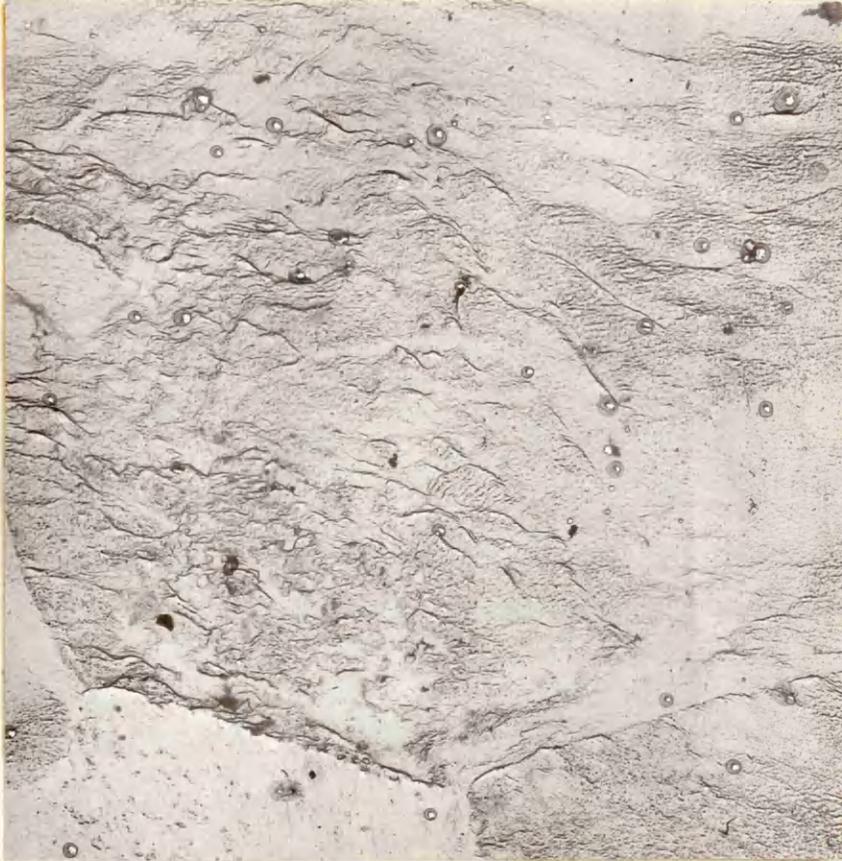
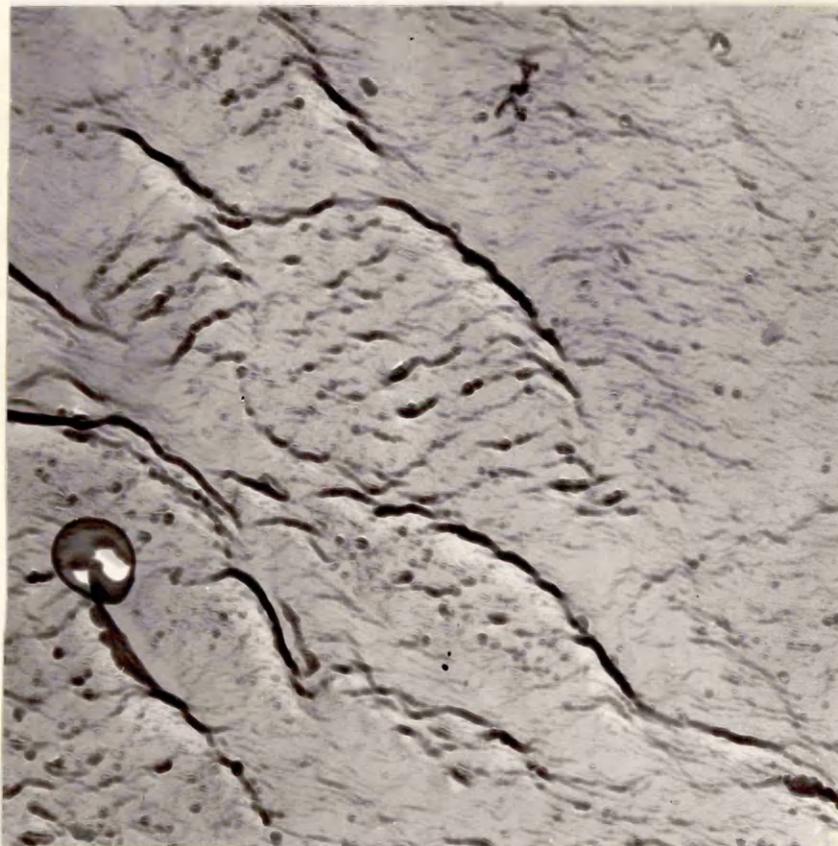
Fig. 14. Surface damage in a 0.41% Carbon Steel Specimen. Stress 12.2 tons/sq.in (188 MN/m^2) Endurance 5×10^5 cycles (Electron Micrographs of two stage platinum - carbon shadowed carbon replica).

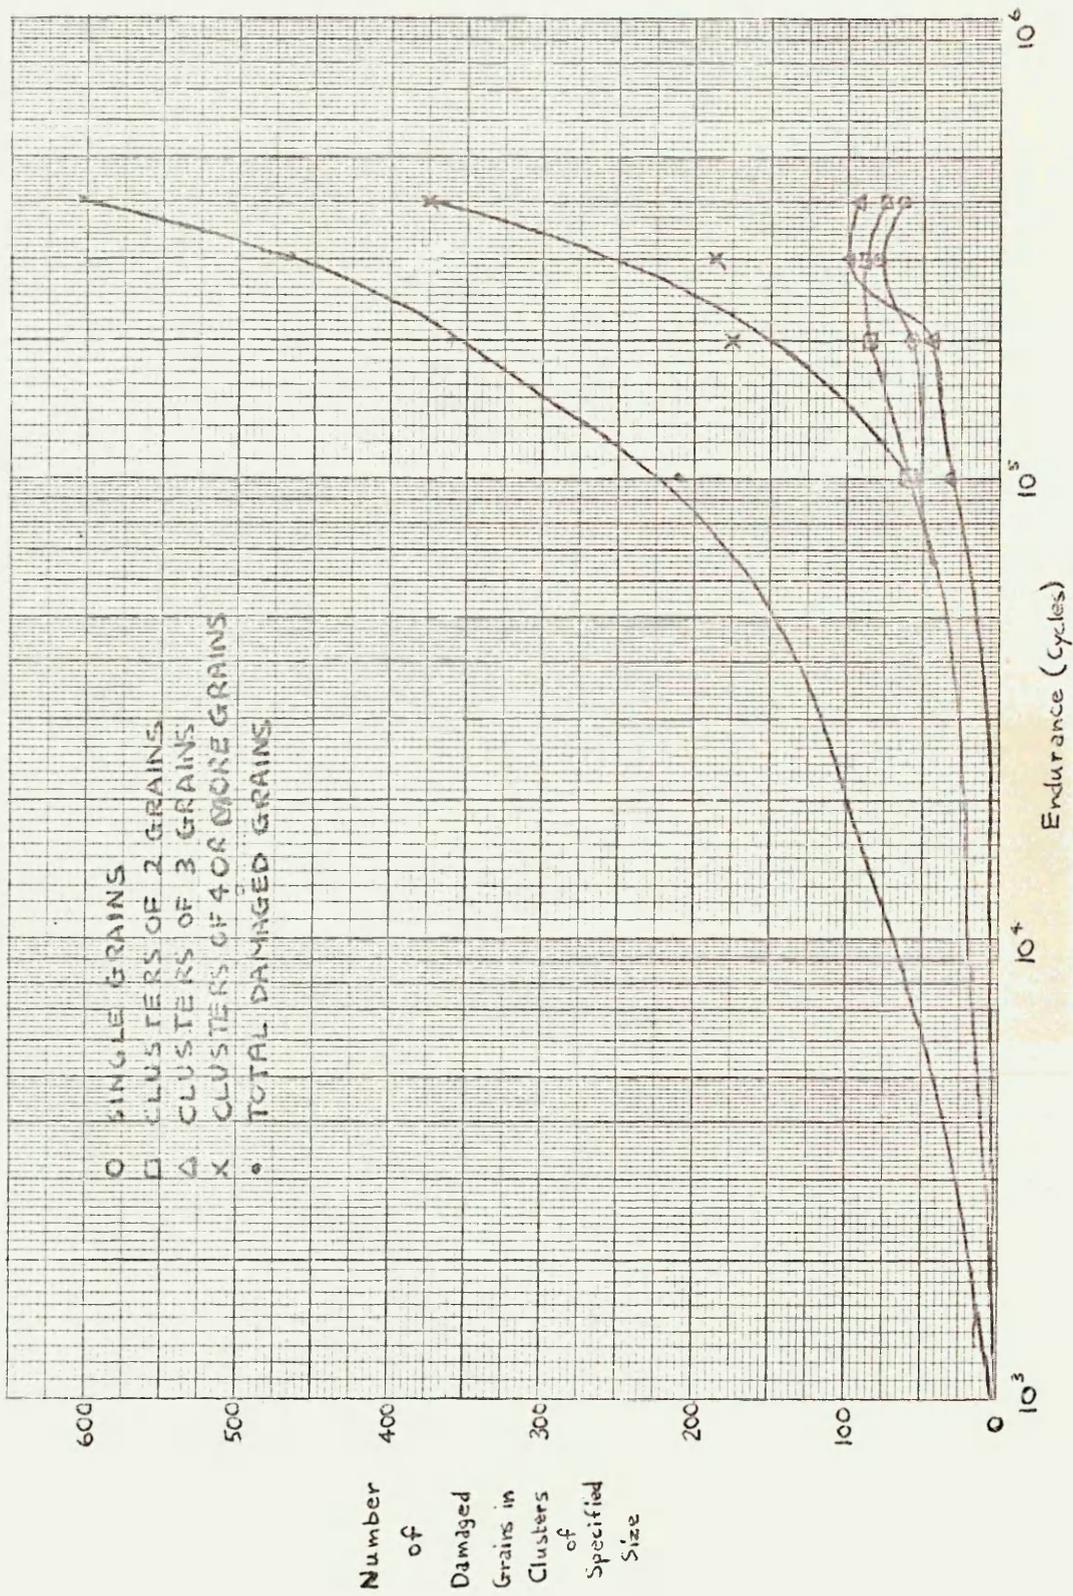
Fig. 19. Variation in number of Grains containing fatigue damage with endurance. Specimen F12. Stress 12 tons/sq.in. (185 MN/m²) Endurance 9 x 10⁵ cycles.

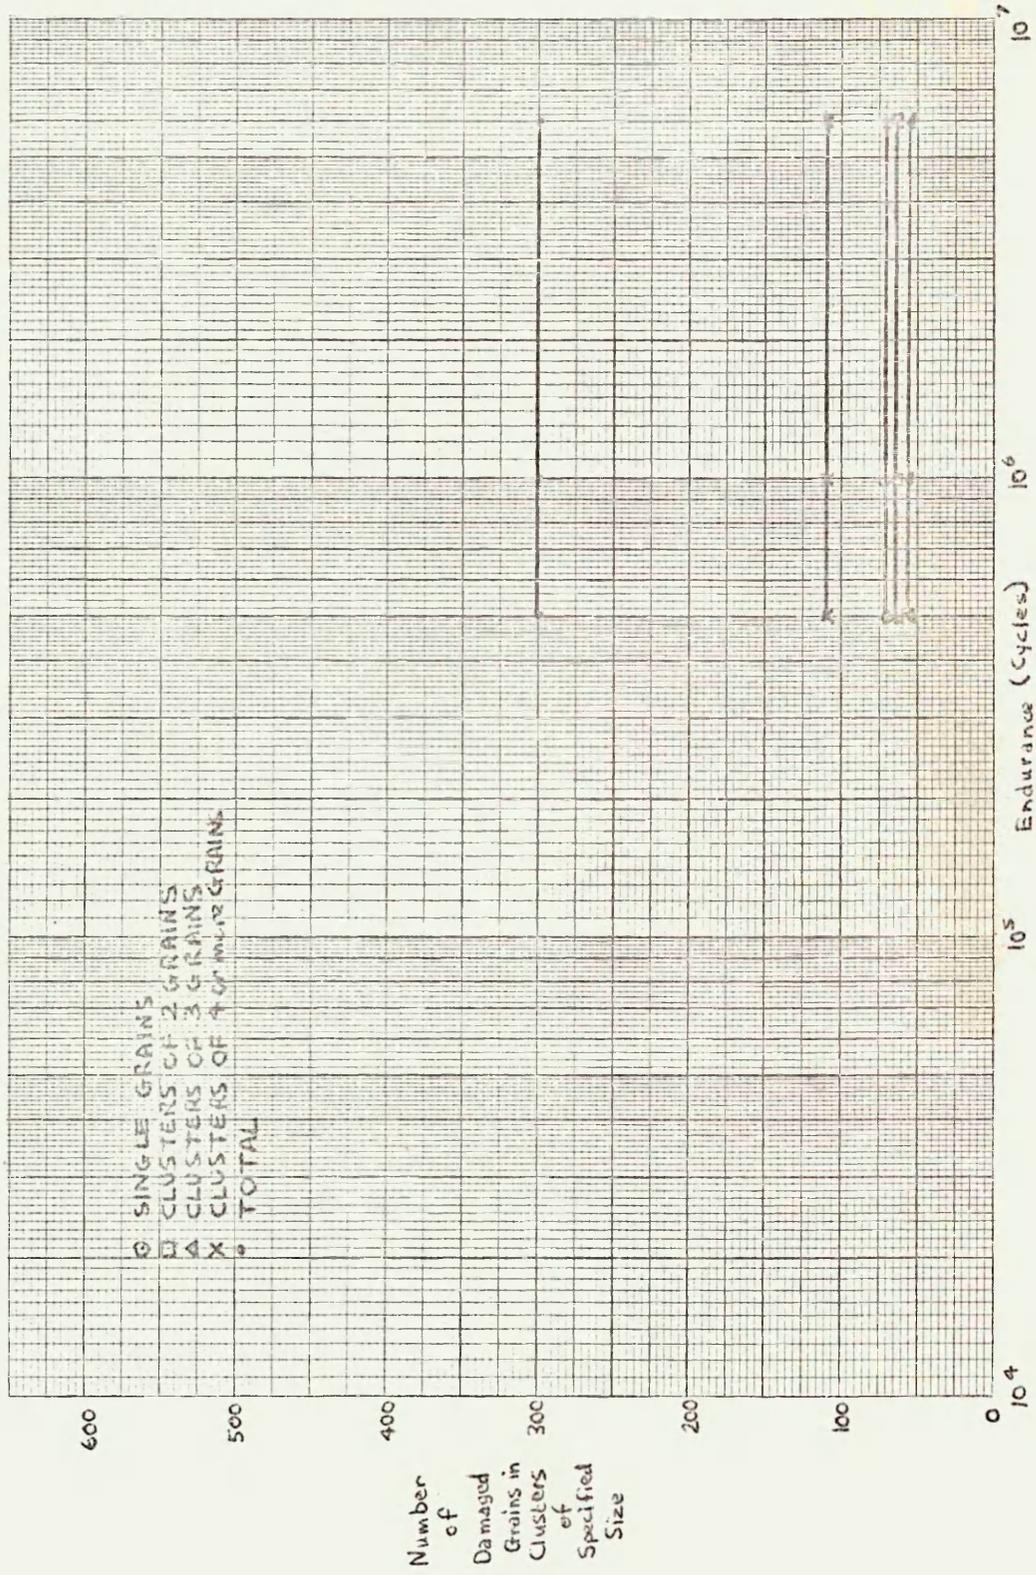
Fig. 20. Variation in Number of Grains Containing fatigue damage with endurance. Specimen F16. Stress 10.5 tons/sq.in. (162 MN/m²) Endurance 7 x 10⁶ cycles.

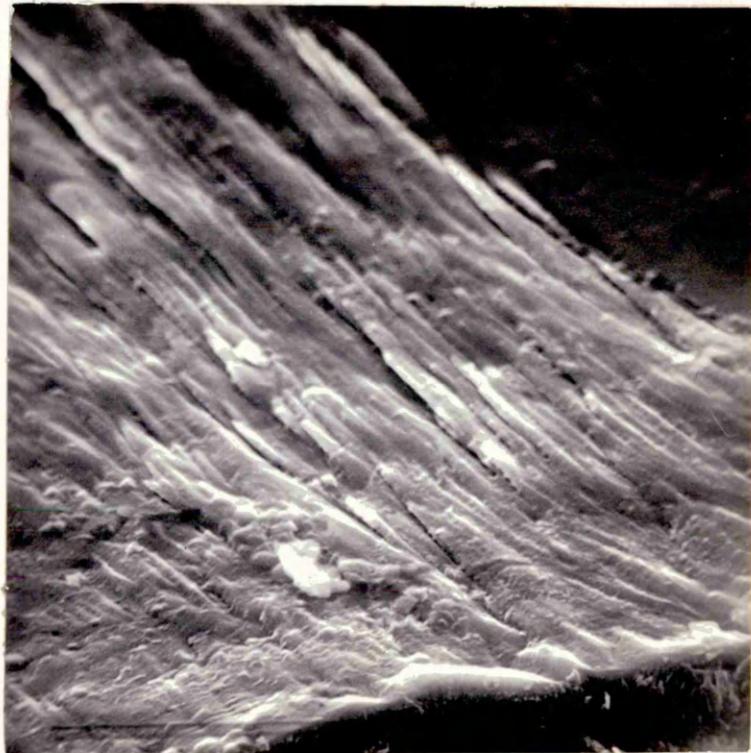
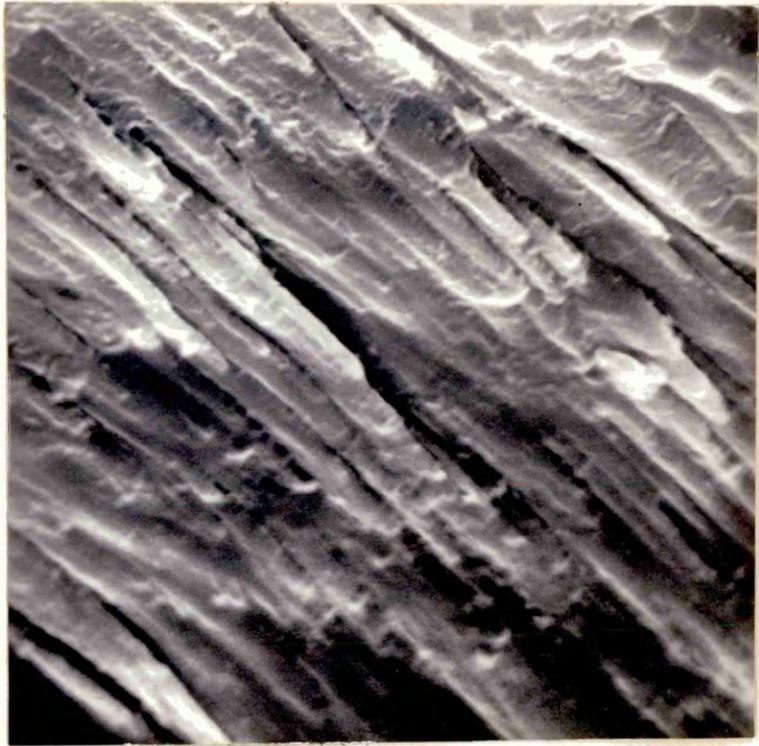
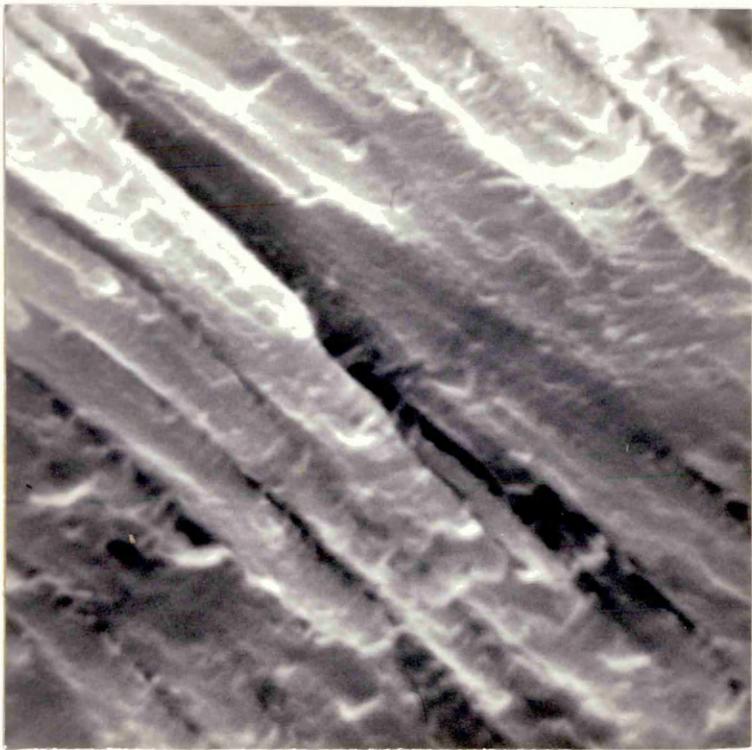
Fig. 25

Scanning Electron Micrographs of an 0.01% Carbon Steel Specimen Surface showing Slip Band Cracking. Fig. 25A also shows a ridge at the grain boundary separating a grain in which much slip has occurred from one in which little slip has occurred. Stress 11.3 tons/sq. in. (175 MN/m^2). Endurance 3×10^5 cycles.

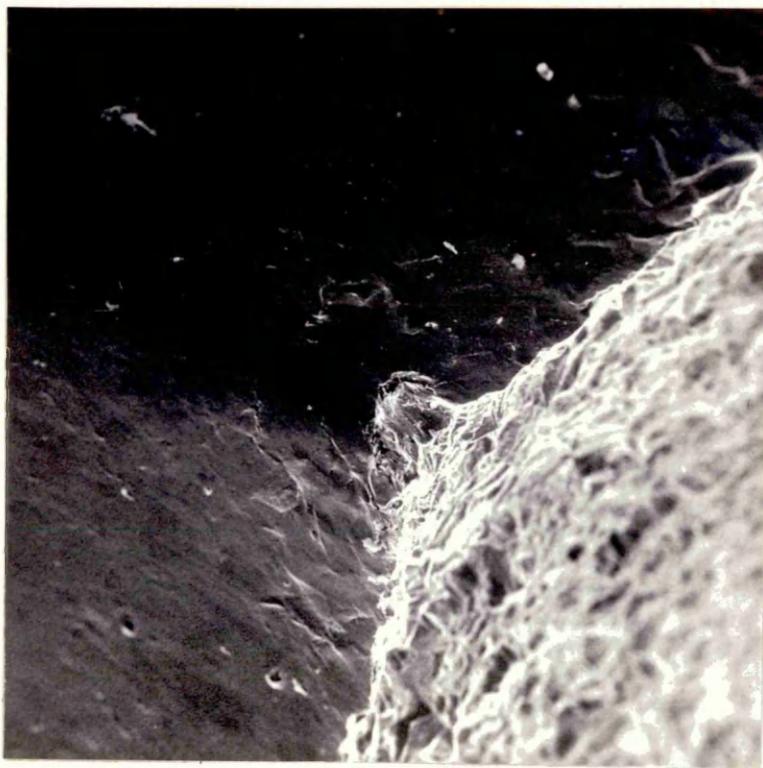
Secondary Crack in a 0.01% Carbon Steel Specimen. Stress: 10.35 tons/sq.in (160 MN/m^2). Endurance: 3×10^6 cycles.

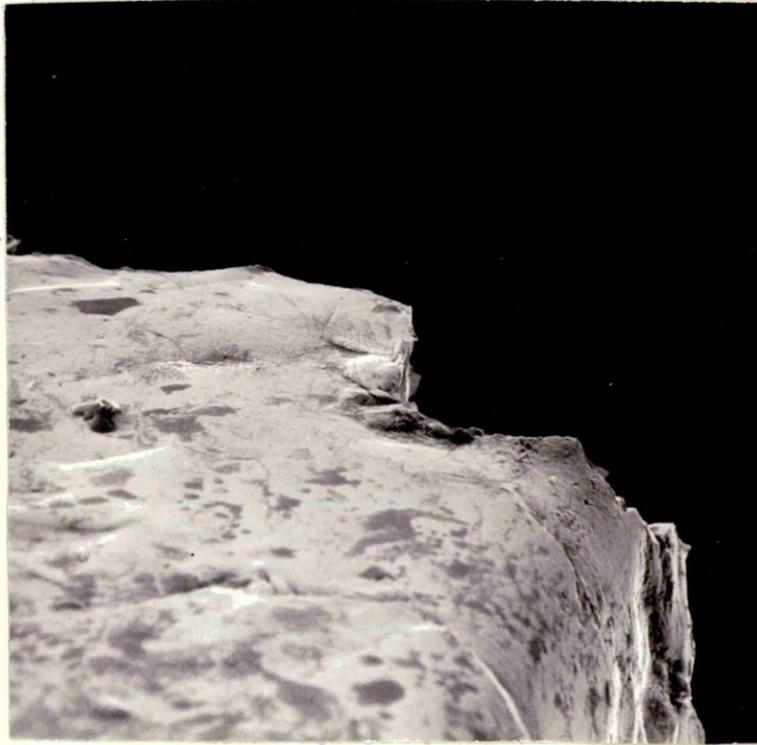
Fig. 33. Scanning Electron Micrograph of 0.01% Carbon Steel Specimen, showing Area of Stage II Crack Propagation. Stress: 11.3 tons/sq.in (175 MN/m²). Endurance: 3×10^5 cycles

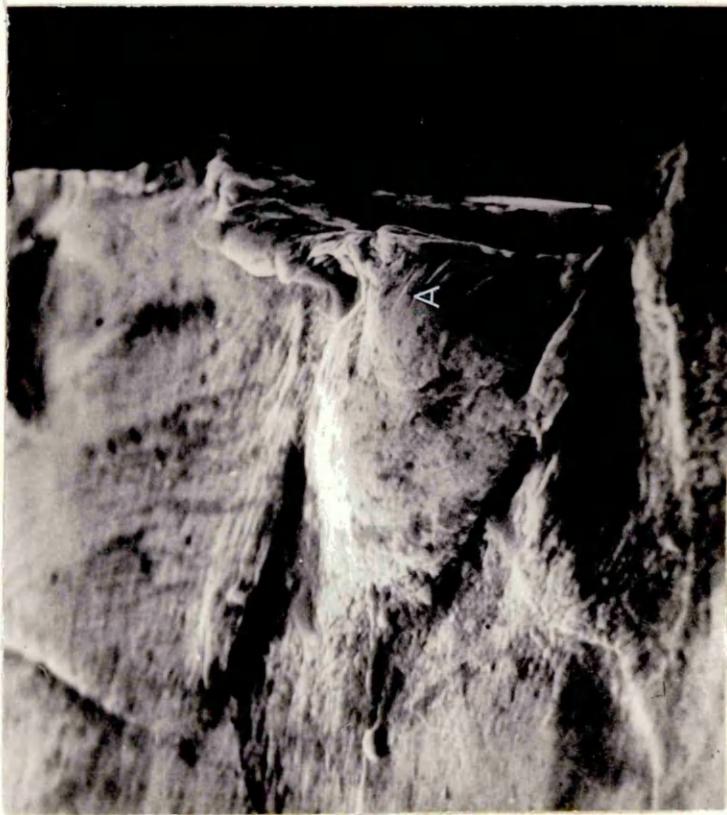
Fig. 34

View of surface of specimen shown in Fig. 32 from an angle of 30° to the specimen surface showing the edge of the Stage I fracture.

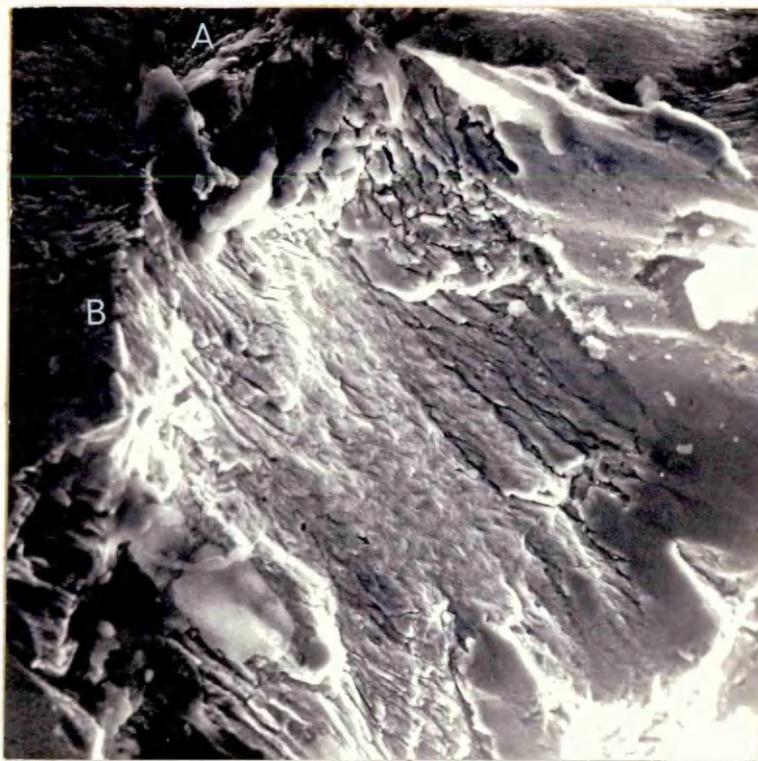
Fig. 35 High Magnification view of the edge of the Stage I fracture taken from the same angle as Fig. 34

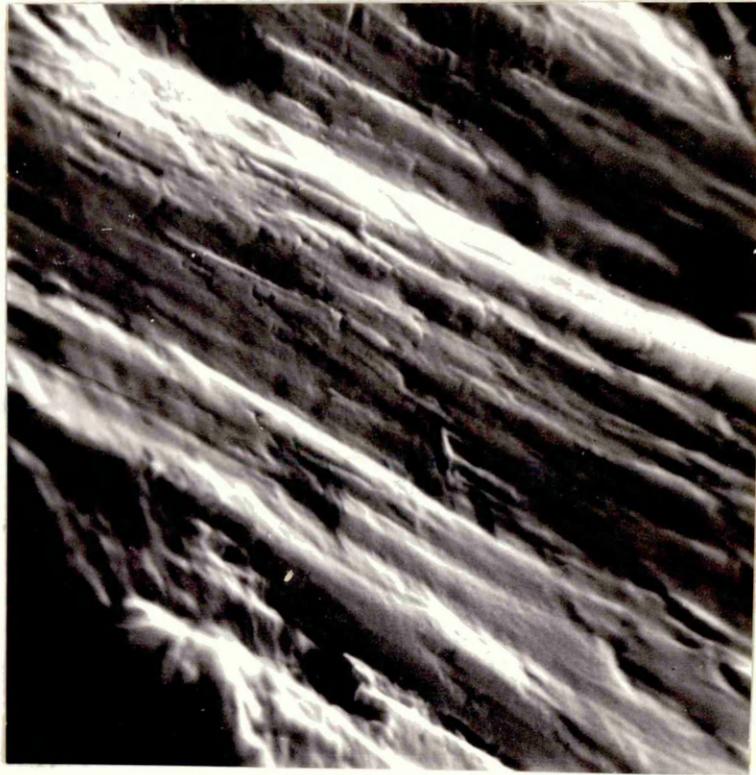
Fig. 37

Stage I Crack Propagation in 0.41% Carbon Steel. Scanning Electron Micrographs. Stress: 9.85 tons/sq. in. (152 MN/m^2)
Endurance : 4.7×10^6 cycles.

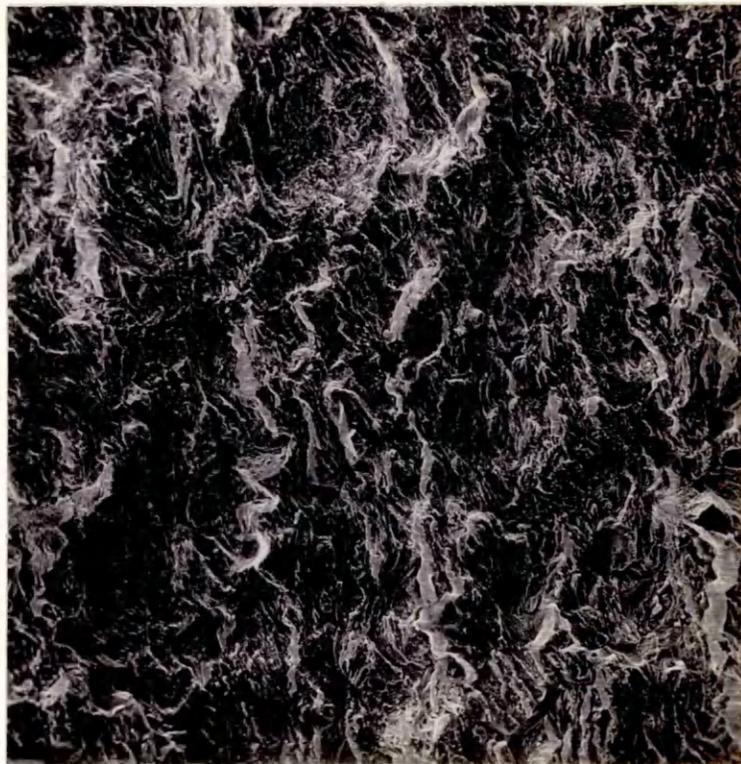
Fig. 38
Early form of Stage II fracture in 0.01% Carbon Steel showing mixed transgranular and intergranular propagation 1 mm from root of notch. Scanning electron micrograph.

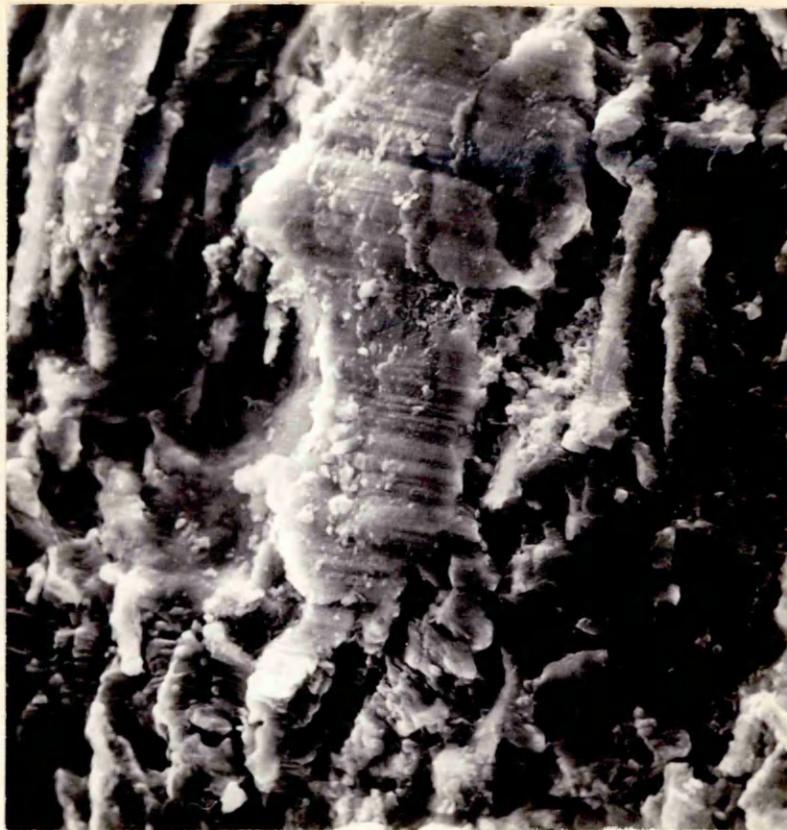
Diagrammatic Representation of Fatigue Striations on Hills and Valleys on a Stage II Fatigue Fracture Surface.

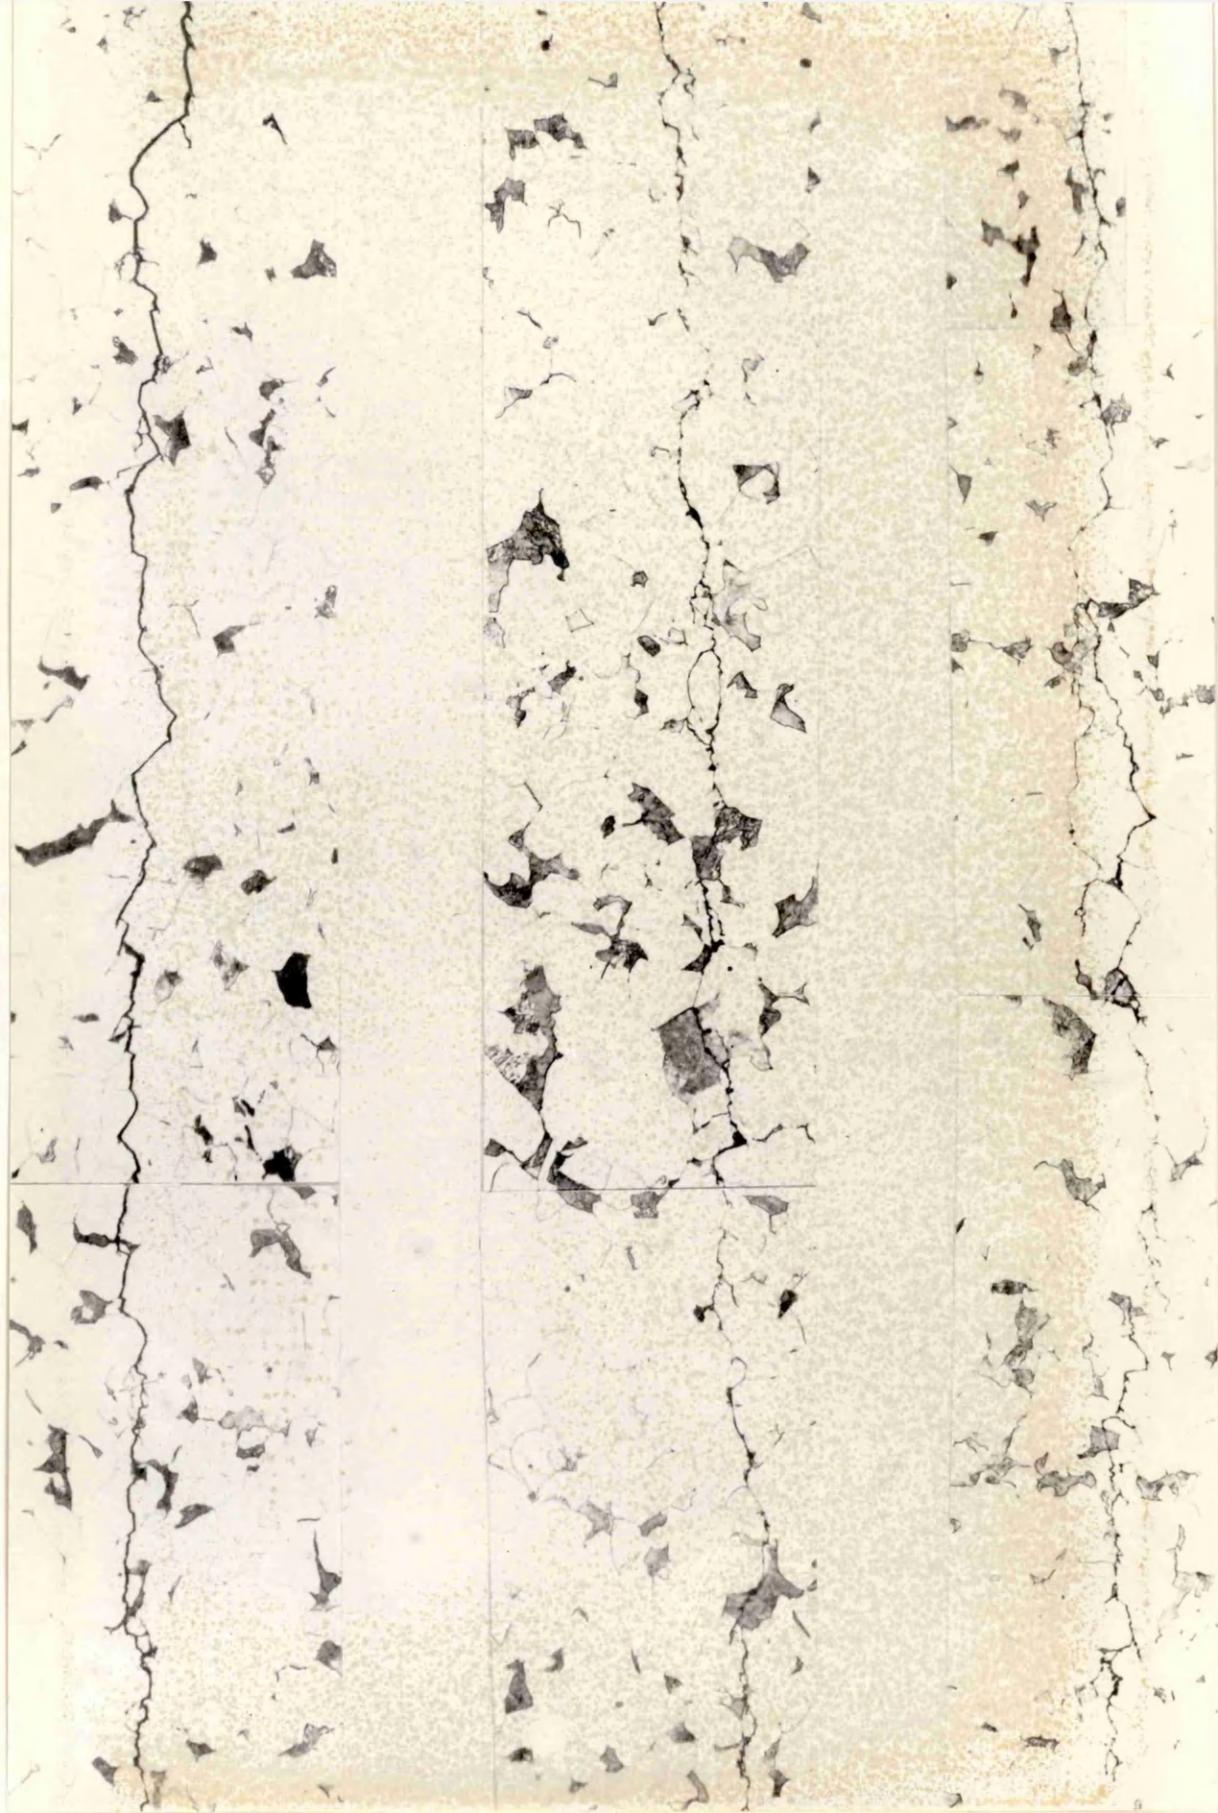
Fig. 44 Crack Propagation in 0.11% Carbon Steel. X 200

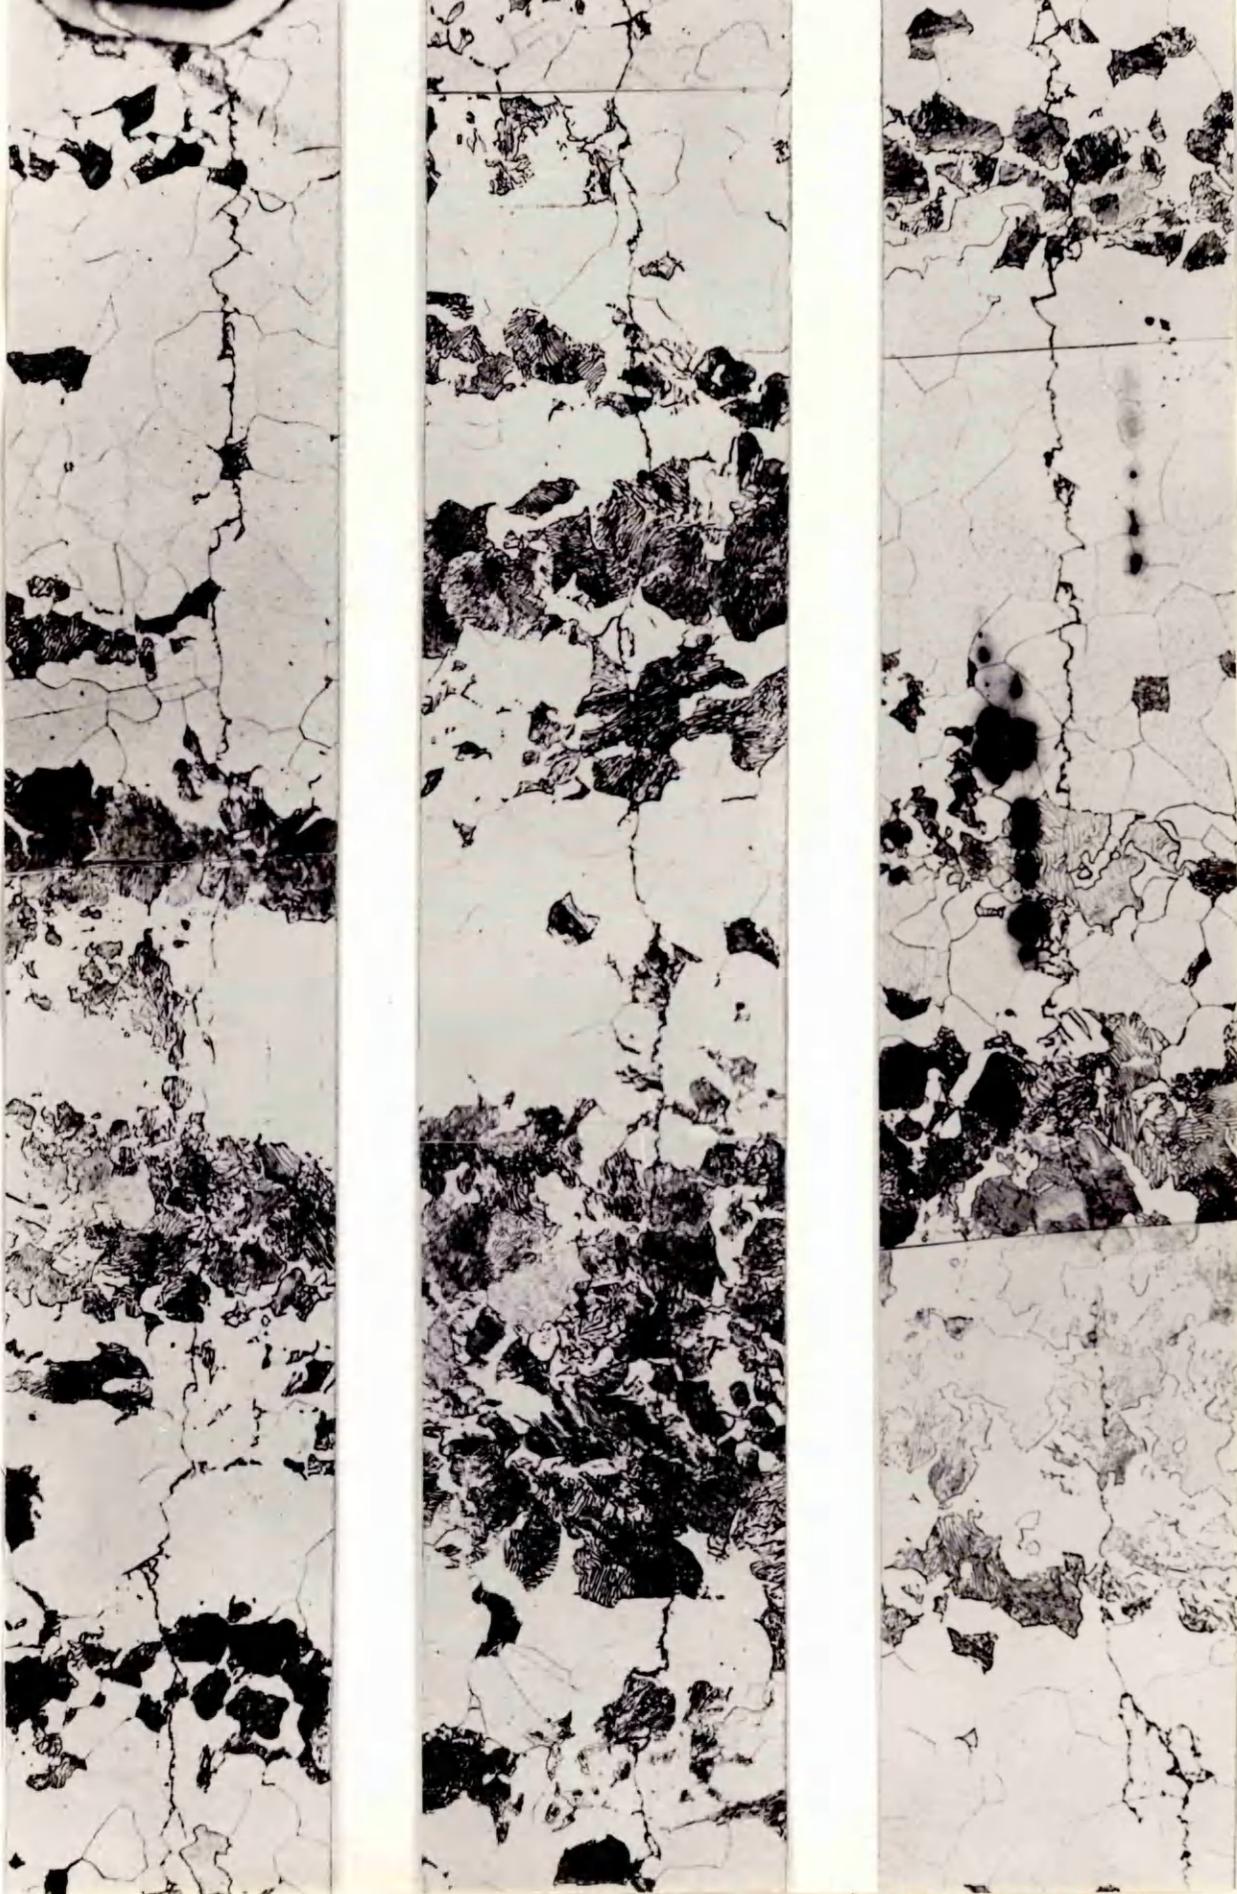
Fig. 45. Crack Propagation in 0.41% Carbon Steel X200

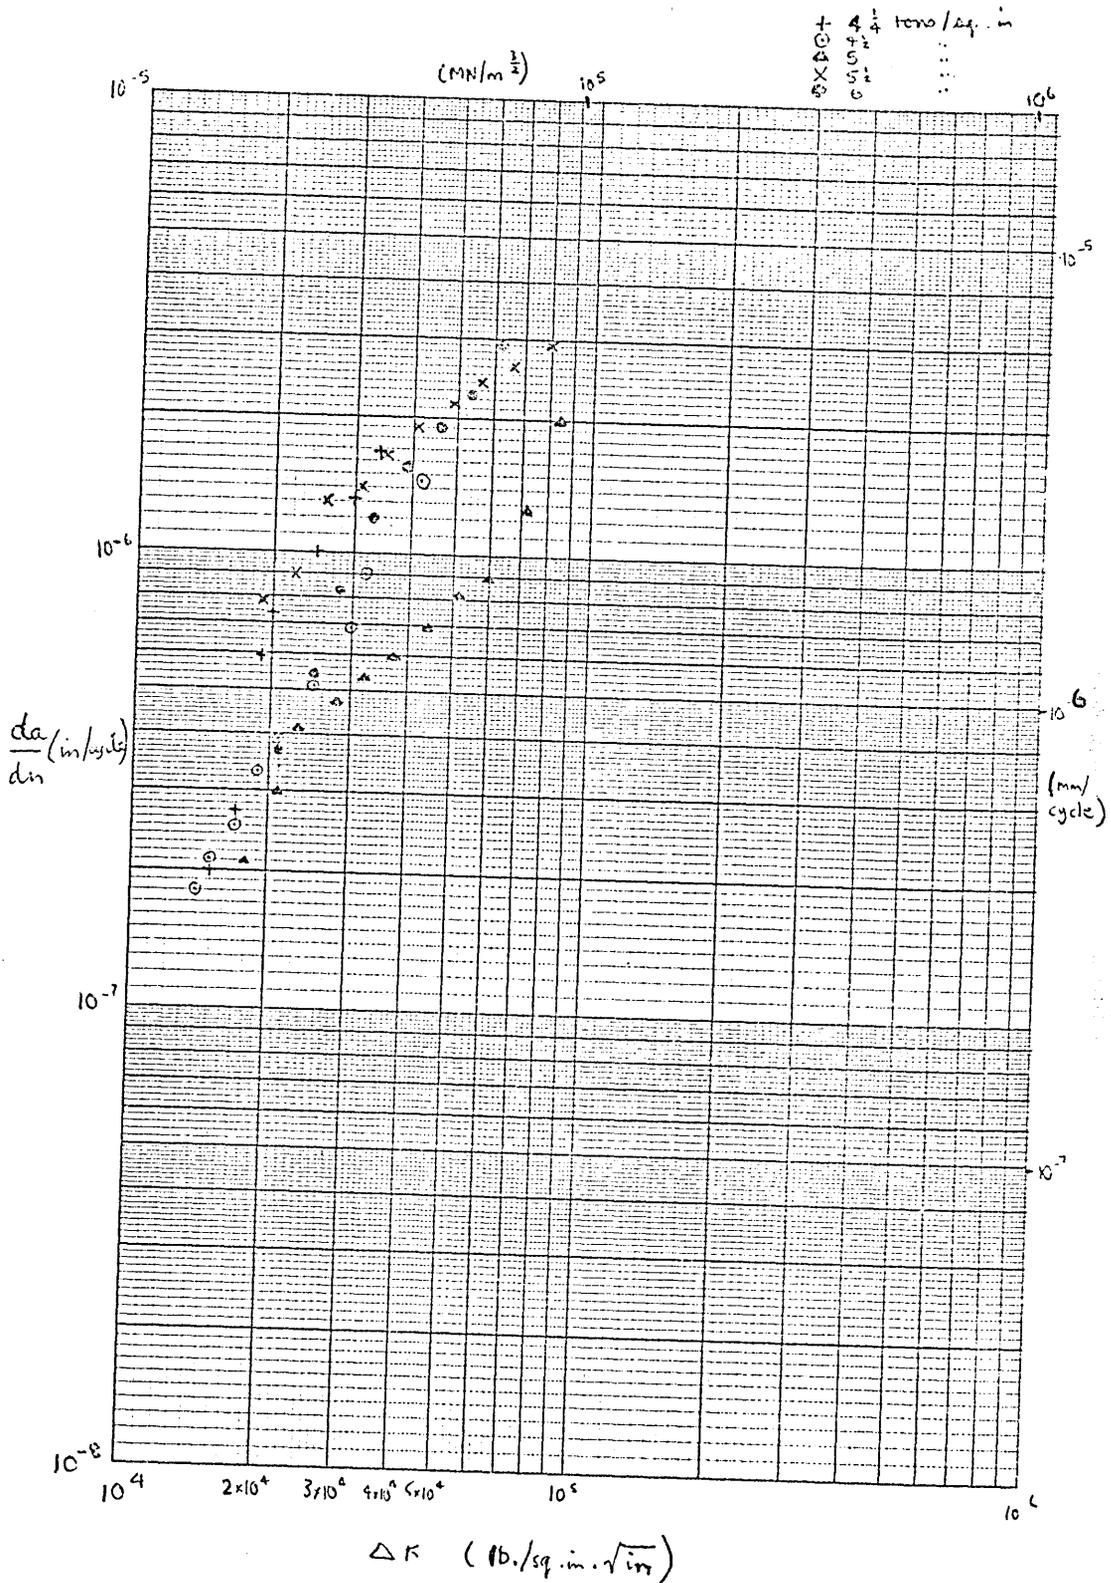
Fig. A2 RELATIONSHIP BETWEEN CRACK GROWTH RATE & STRESS INTENSITY
 RANGE FOR 0.01% CARBON STEEL,

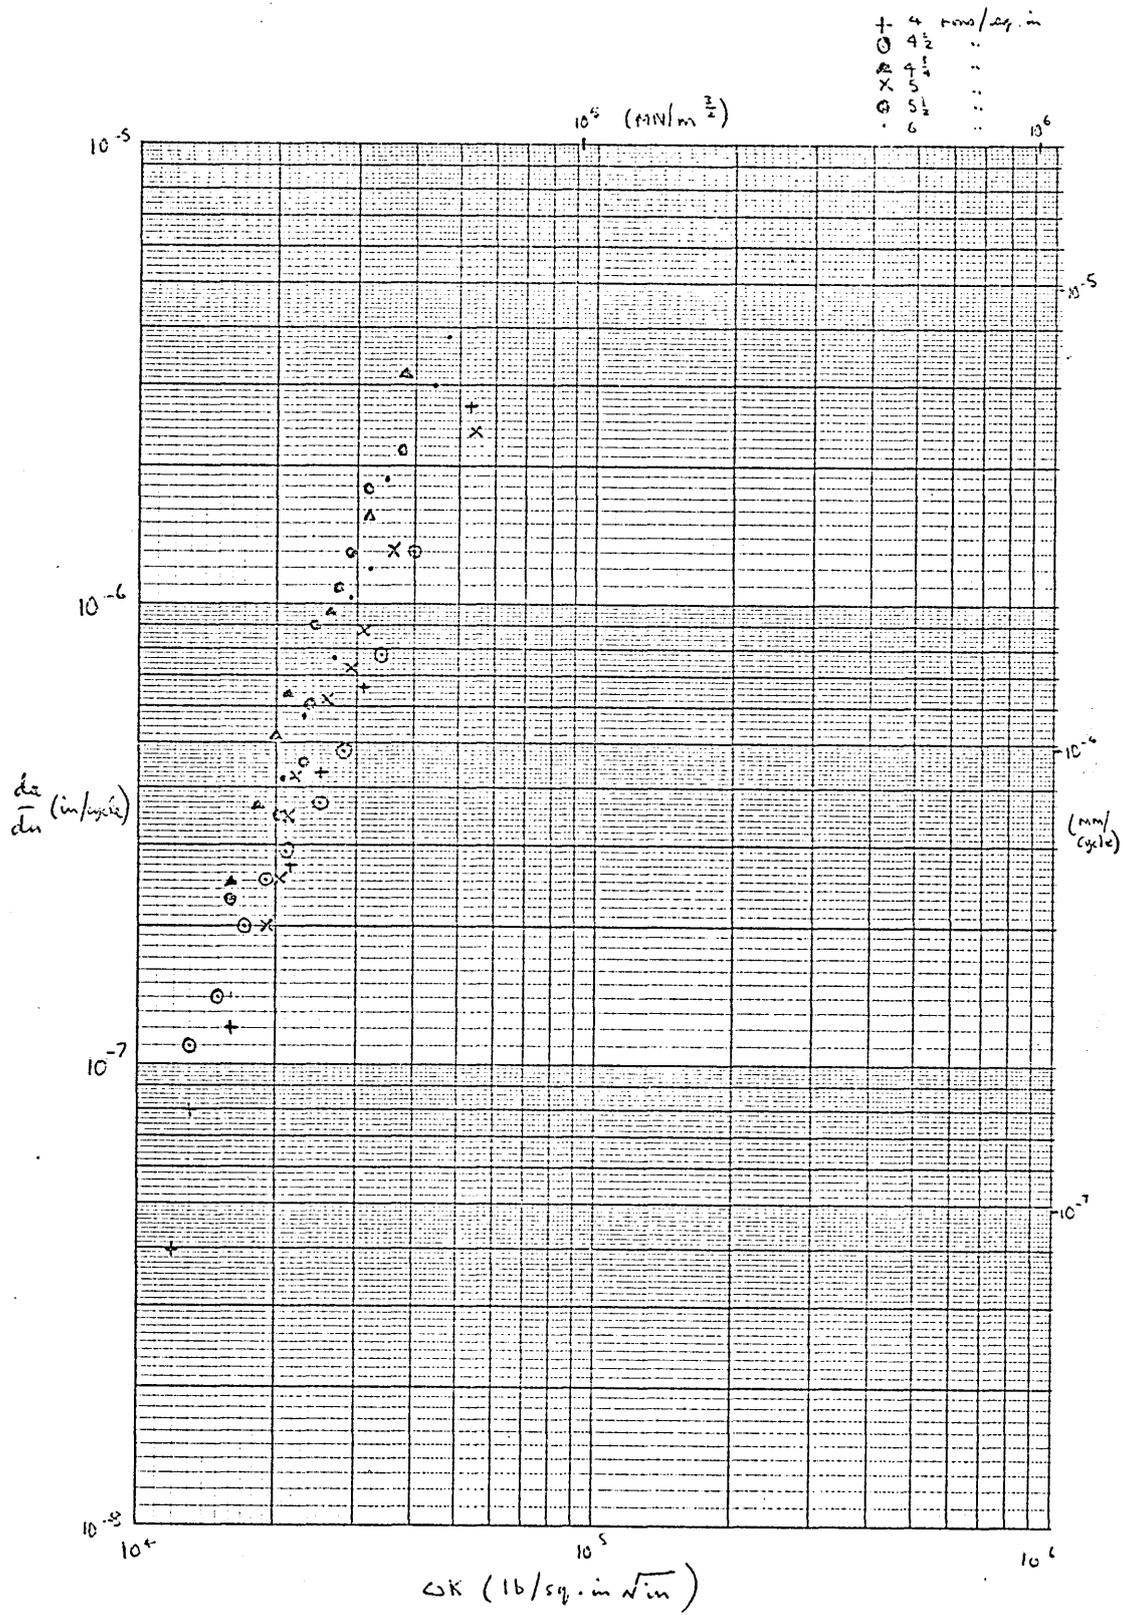
Fig. AB. RELATIONSHIP BETWEEN CRACK GROWTH RATE & STRESS INTENSITY RANGE FOR 0.11% CARBON STEEL.
