Fatigue crack initiation and propagation in plain carbon-manganese steels.

FOX, Peter.

A Sheffield Hallam University thesis

FATIGUE CRACK INITIATION AND PROPAGATION
IN PLAIN CARBON-MANGANESE STEELS

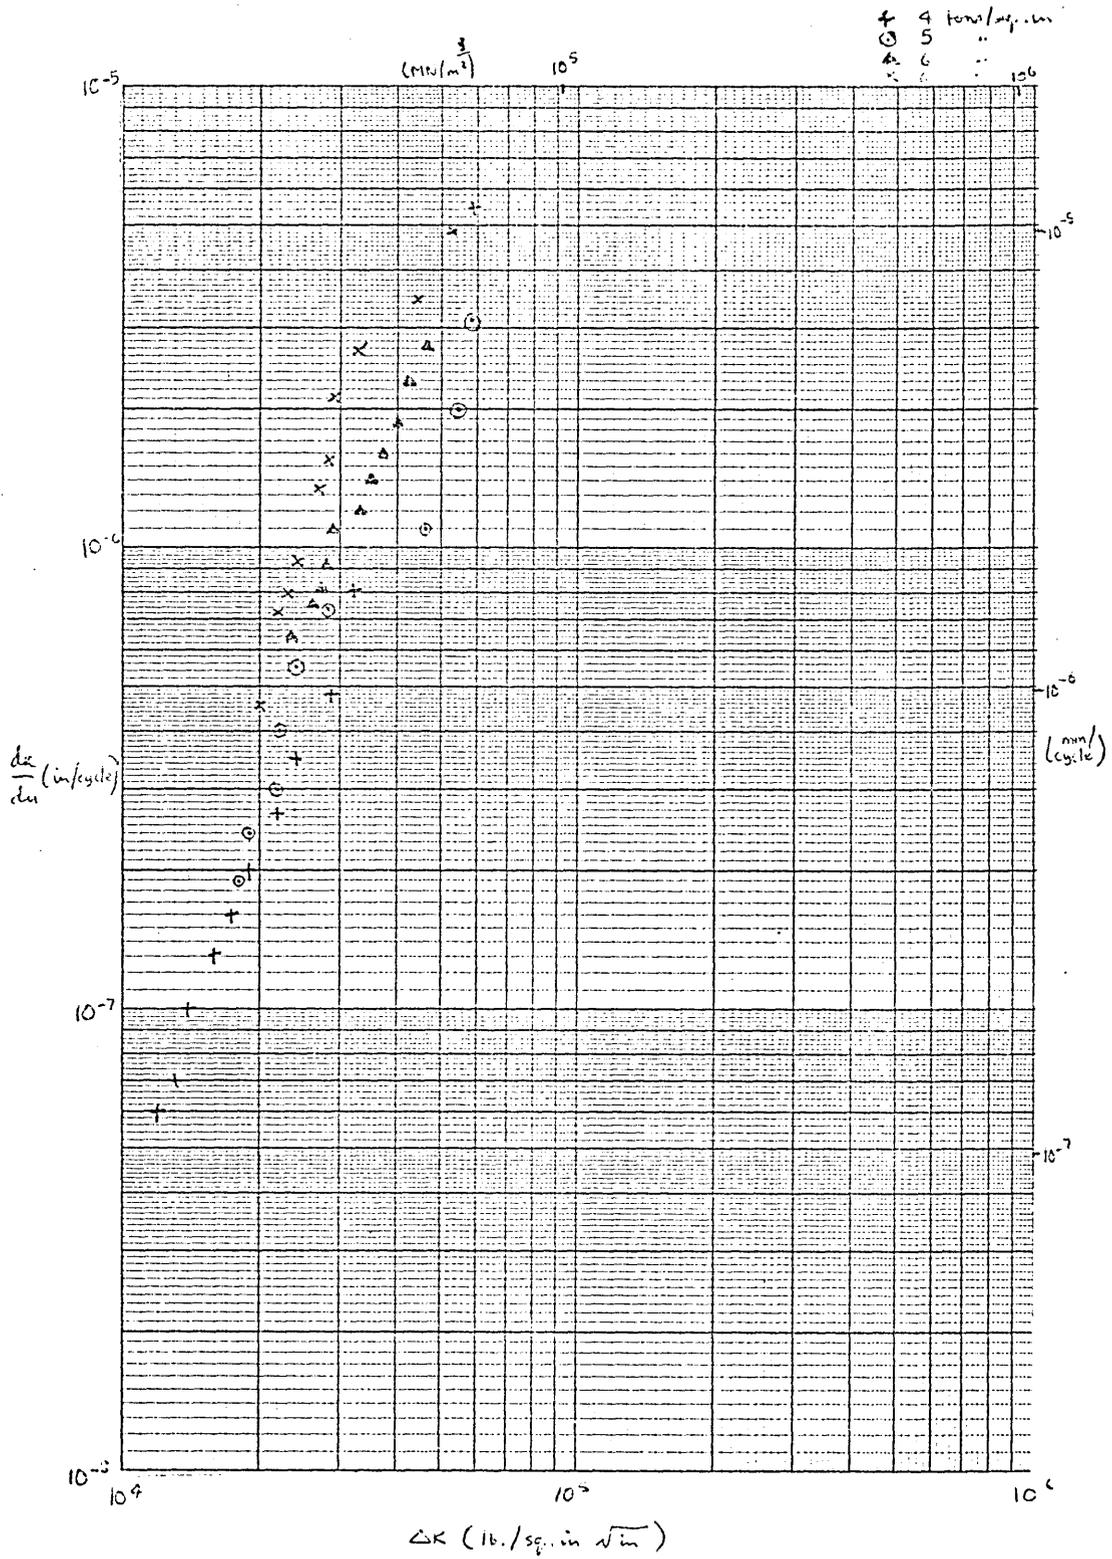
Fig. A4 RELATIONSHIP BETWEEN CRACK GROWTH RATE & STRESS INTENSITY
RANGE FOR 0.41% CARBON STEEL

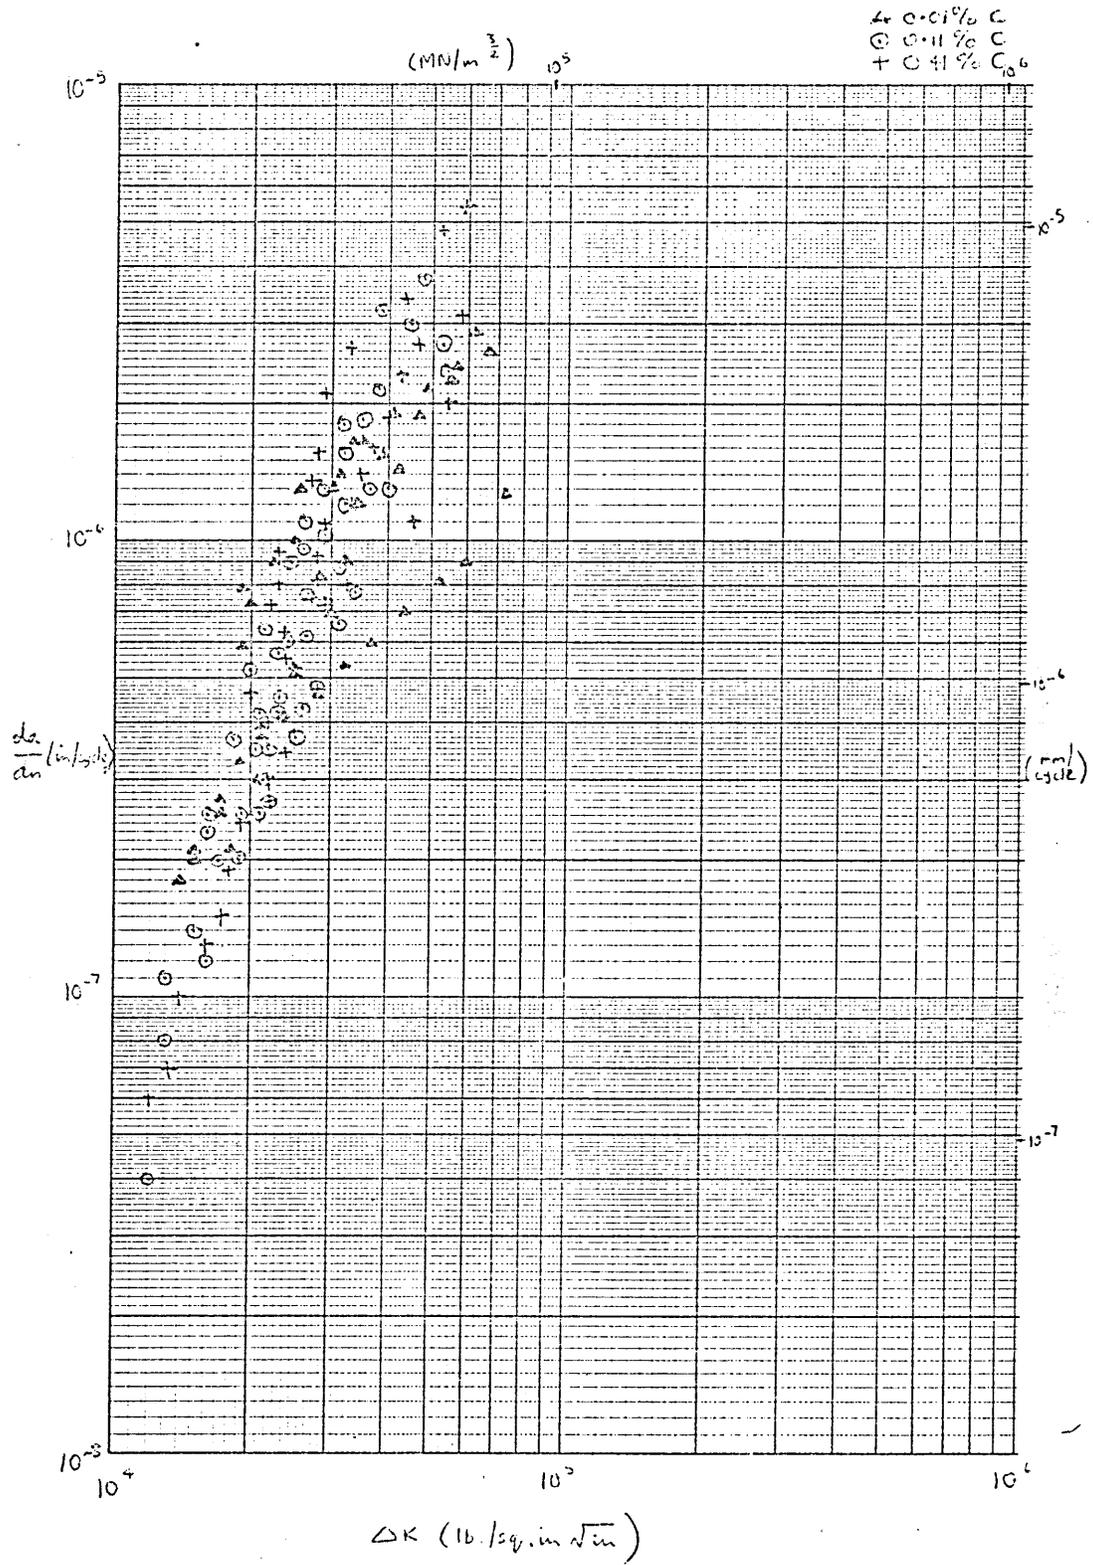
FIG. A5 RELATIONSHIP BETWEEN CRACK GROWTH RATE & STRESS INTENSITY RANGE FOR ALL THREE STEELS.
