Testing the durability of limestone for Cathedral façade restoration

LAYCOCK, E. A., SPENCE, Kevin, JEFFERSON, D. P., HETHERINGTON, S., MARTIN, B. and WOOD, C. (2008). Testing the durability of limestone for Cathedral façade restoration. *Environmental Geology*, 56 (3-4), 521-528.

Testing the durability of limestone for cathedral façade restoration

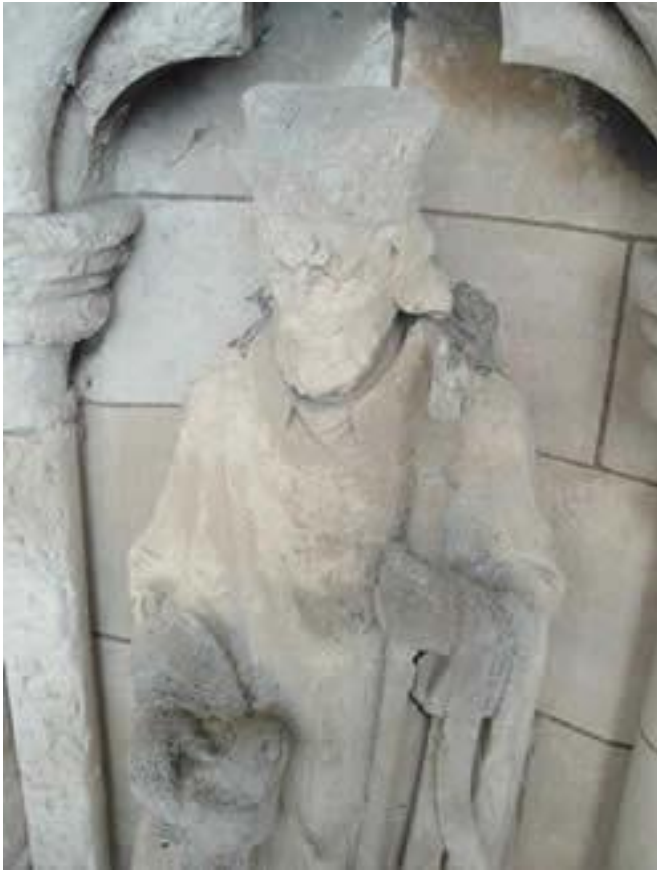
The Bath stone in this building are weathered variably. Some parts of the fabric appear to be in very good condition, whilst others have disintegrated completely (Figure 2). Investigation of the fabric by Jefferson Consulting for English Heritage concluded that there was no apparent correlation between the degree of exposure and decay levels and it was concluded that there was probably a wide variation in the durability of the stone itself. This latter hypothesis was further investigated through much more detailed examination of a selection of six stones in 1999. The stones conformed to the typical visual and petrographic description of Bath Stone although there were variations in the sizes and composition of the clastic and matrices of the stones. However an obvious reason for selective decay was not discerned (JEFFERSON 2001).

Figure 2. Weathered statue. (Truro Cathedral, 2005)

Figure 2. Weathered statue. (Truro Cathedral 2005)

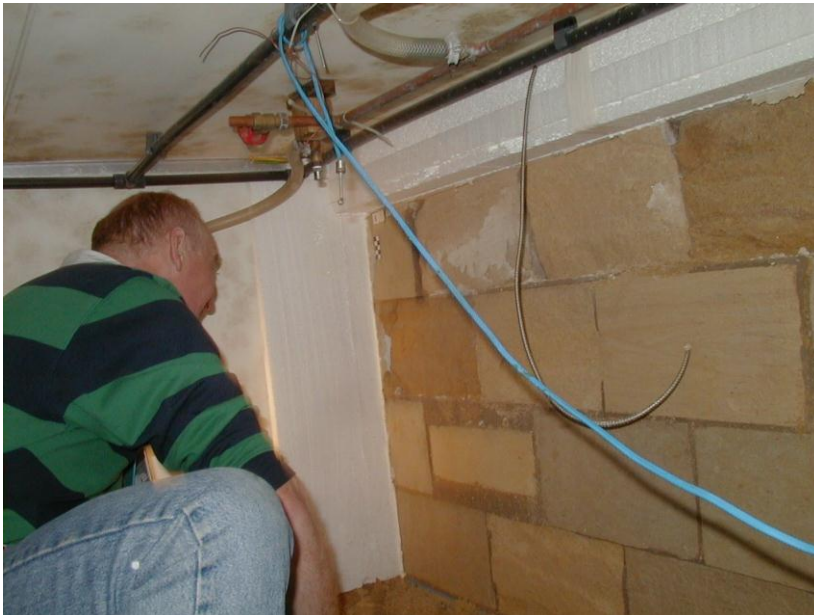
The freeze-thaw test to BS EN 772-22 (BSI 1999) utilises the CERAM (the trading name of British Ceramic Research Ltd) research chamber, which is 1.9m by 2.0m on plan and 1.2m high (external dimensions) with the outer skin having 80mm of insulation between external (ambient) and internal conditions. Two sets of two stone panels, where each panel had a length of 560mm and a height of 740mm, were constructed at one end of the chamber (Figure 3). The panels were isolated thermally from the laboratory. The standard test, first described by Peake & Ford (1984), lasts for 100 cycles (10 days). The elements of each cycle are given in Table 3. In general, a durable brick (e.g. an

Figure 3. Inspection of test wall in CERAM test chamber

Figure 3. Inspection of test wall in CERAM test chamber

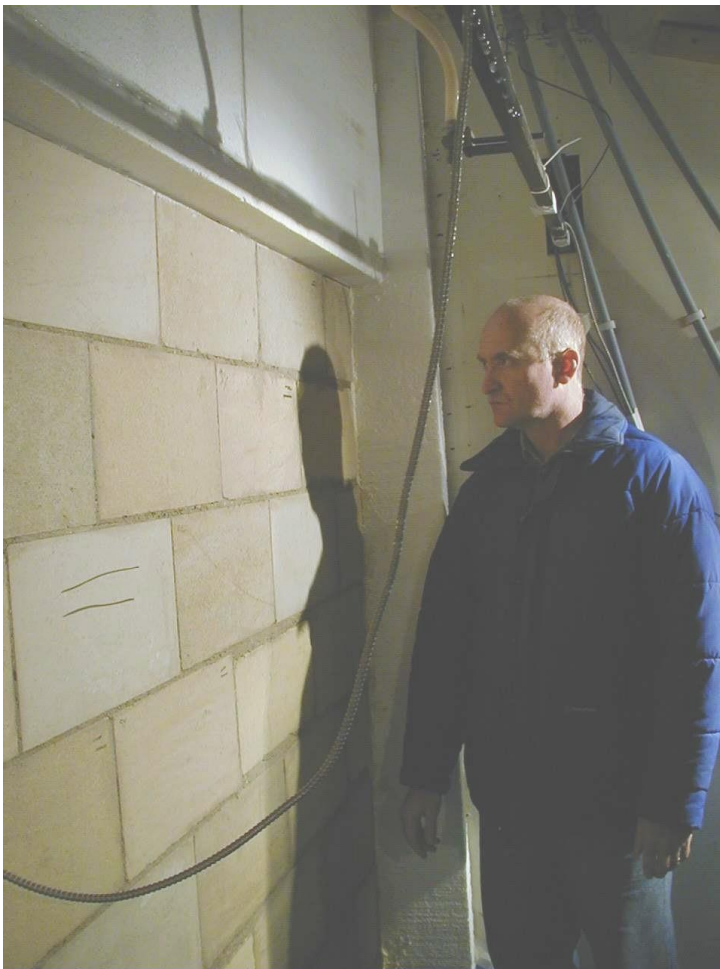
the literature (TAYLOR-FIRTH & LAYCOCK 1998, TAYLOR-FIRTH & LAYCOCK 1999 LAYCOCK 2002) and gives control over both interior and exterior conditions to more closely mimic likely weathering elements. The simulator itself is composed of two chambers each of dimensions 4m long, 3m wide and 2.6m in height. A wall was constructed which separated the two chamber halves and contained 8 samples of each of the stone types to be tested, a total of 64 blocks (Figure 4). The sample sizes were 350x200x200mm for full blocks and 170x200x200mm for half blocks and a mortar joint of 6mm was used. Typically the stone supplied from the North Porch of the Cathedral was of more irregular shape and variable in size, averaging approximately 350x190x150mm and thus required the use of a larger mortar joint to keep coursing level.

Figure 4. Inspection of test wall in Climatic Simulation test chamber

Figure 4. Inspection of test wall in Climatic Simulation test chamber
