## **Testing the durability of limestone for cathedral façade restoration**

LAYCOCK, Elizabeth A, SPENCE, Kevin, JEFFERSON, David P, HETHERINGTON, Stephen, MARTIN, Bill and WOODS, Christopher (2008). Testing the durability of limestone for cathedral façade restoration. *Environmental Geology*, 56 (3-4), 521-528.

# Testing the durability of limestone for cathedral façade restoration

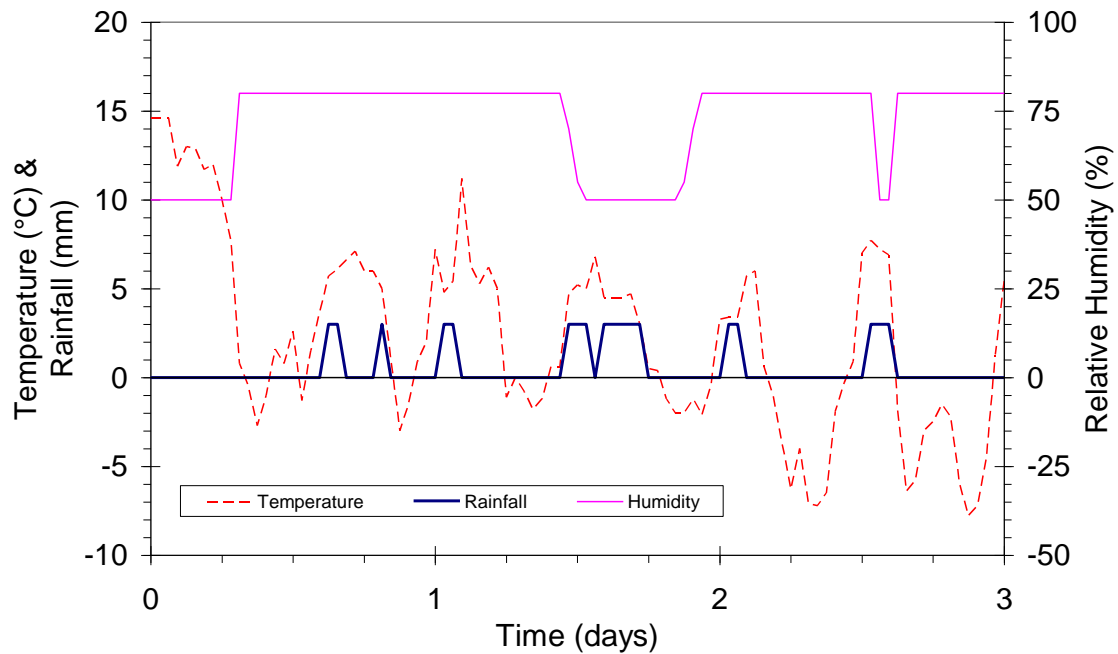
The weathering conditions on one side, denoted as the external face, are shown in Figure 5, whilst the other internal face was maintained at 5°C. Driving rain is created by surface wetting and pressurisation as used in BS 4315-2 (BSI 1970), with the constant air pressure difference of 250N/m<sup>2</sup> (25mm H<sub>2</sub>O) being equivalent to the dynamic pressure head of a 20m/sec wind speed. The constructed wall was allowed to cure at ambient temperature for 28 days, then exposed to 28 days of 'autumnal' conditions, which preceded the realistic freeze-thaw cycling. This was

Winter simulation involved a cycle of weather Figure 5, based on 30 years of weather data from the Meteorological Office St. Mawgan site approximately 25 km to the NNE of Truro. Conditions were generated for a 3 day cycle repeated initially for 100 days, and then, as little degradation had occurred, for a further 100 days, giving a total of 800 events below freezing. At intervals the climatic simulator wall was subjected to driving rain conditions as described previously.

Figure 5. Applied 3 day weather cycle; Climatic simulation chamber

Figure 5. Applied 3 day weather cycle; Climatic simulation chamber

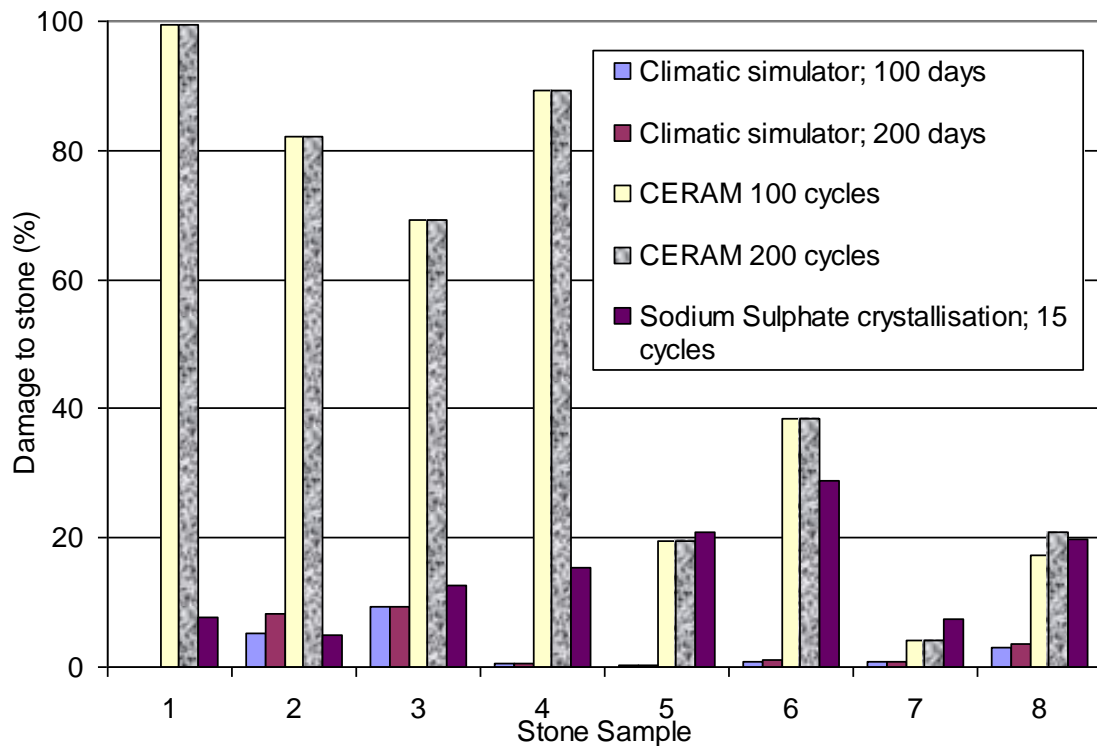
Figure 6 Mean damage to stone for different test apparatus

Figures 6 and 7 compare the overall block damage of the materials in both freeze thaw testing regimes to those of the salt crystallisation test. It can be seen that the CERAM chamber causes significantly more damage than the climatic simulation. Extending the test from 100 to 200 cycles in the CERAM test seems largely unnecessary as little change in both mean and standard deviation of damage occurred.

The CERAM test consistently causes the greatest amount of damage in the materials tested with about half the samples suffering significantly more damage than the salt crystallisation test. Where a high level of damage occurs in the salt crystallisation test, this correlates with similar levels of frost damage in the CERAM test although the standard deviation in the latter is much higher. A high standard deviation (Figure 7) indicates selective weathering and

The original Bath Stone from the Cathedral performed extremely well in the CERAM test, being the second most durable after sample number 7. However, its performance in the other two tests was below average. The stones' performance in the frost tests indicated that the juxtaposition of the Cathedral stones with other potential replacements in this case did not cause noticeably enhanced degradation.

Figure 6 Mean damage to stone for different test apparatus

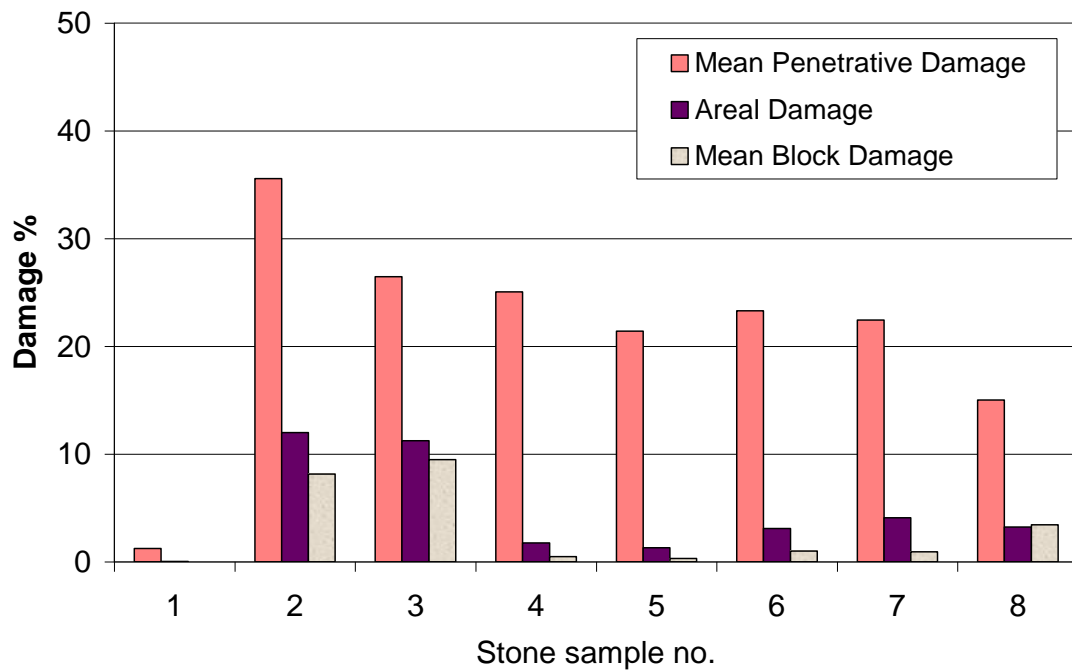
Figure 9. Summary of the lateral extent and penetrative nature of damage generated during testing in Climatic Simulation Chamber after 200 days

damaged areas. The CERAM test method causes damage which is both widespread and to considerable depth (Figure 8) notably for samples 1 to 4. In comparison, the climatic chamber (Figure 9) causes much less areal damage and generally lower penetrative decay.

Figure 9. Summary of the lateral extent and penetrative nature of damage generated during testing in Climatic Simulation Chamber after 200 days
