Near-surface mounted carbon fibre rod used for combined strengthening and cathodic protection for reinforced concrete structures

NGUYEN, Chinh, LAMBERT, Paul, MANGAT, Pal, O'FLAHERTY, Fin and JONES, Graeme (2015). Near-surface mounted carbon fibre rod used for combined strengthening and cathodic protection for reinforced concrete structures. *Structure and Infrastructure Engineering*, 12 (3), 356-365.

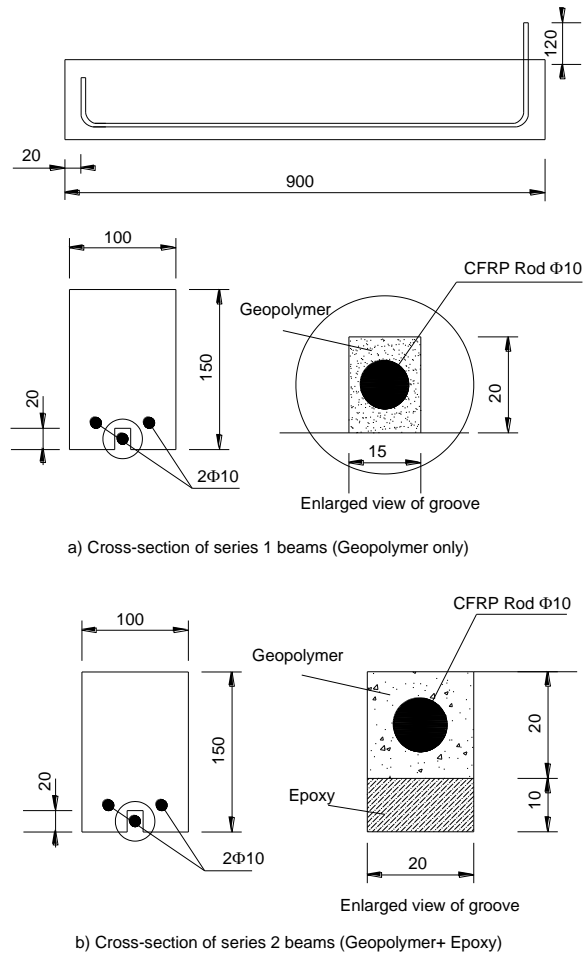
Figure 1. Detailed dimensions of beam specimens

The specimens were designed as under-reinforced concrete beams, each 900mm long with a rectangular cross-section 150 mm depth and 100mm width. Failures of under reinforced beams are ductile and require large deformations that can serve as a warning. Longitudinal steel bars were provided to resist the tensile forces in the bottom of the beam due to bending in accordance with BS EN 1992-1-1:2004 (British Standard Institute, 2004). Each beam was reinforced by two

plain steel bars of 10 mm diameter. There was no shear reinforcement (Figure 1). This was aimed to avoid any effects of shear steel bars in accelerating corrosion of longitudinal reinforcement. All beams were designed for flexural failures; therefore, premature shear failure was prevented through the use of external steel collars during flexural testing. Each steel collar included 2 mild steel plates each dimensions of 210 x 200x 10 (mm) and 2 mild steel plates each dimensions of 270x 150x 10 (mm). Details of the steel collars are shown in Figure 2. The dimensions of the groove in Figure 1 were selected in accordance with ACI 440.2R-08 (2008) “Guide for the design and construction of externally bonded FRP systems for strengthening concrete structures” (American Concrete Institute, 2008).

The first group using CFRP rod utilised a pre-formed groove on the tension soffit of the concrete beams using geopolymer only (Figure 1a). The groove was half filled with the geopolymer, the CFRP rod was placed inside the groove and further geopolymer was added to completely fill the groove (see Figure 4).

For the second group, the CFRP rod was bonded to the pre-cut groove by two layers of repair material. A schematic of repair is shown in Figure 1b. Firstly, the CFRP rods were bonded into the grooves by geopolymer (Figure 5a). The geopolymer repair was cured in the ambient laboratory conditions for 7 days at which time epoxy was overlaid as the second repair material (Figure 5b). The purpose of the epoxy layer was to improve the bond between the CFRP rod anode and repair material. This is the difference between Groups 1 and 2 and should have some influence on the improvement in strength capacity due to the greater elasticity of the epoxy compared to the brittle nature of the geopolymer at the zone of greatest tensile stress. These samples were cured in the laboratory environment for a further 21 days prior to ICCP application.

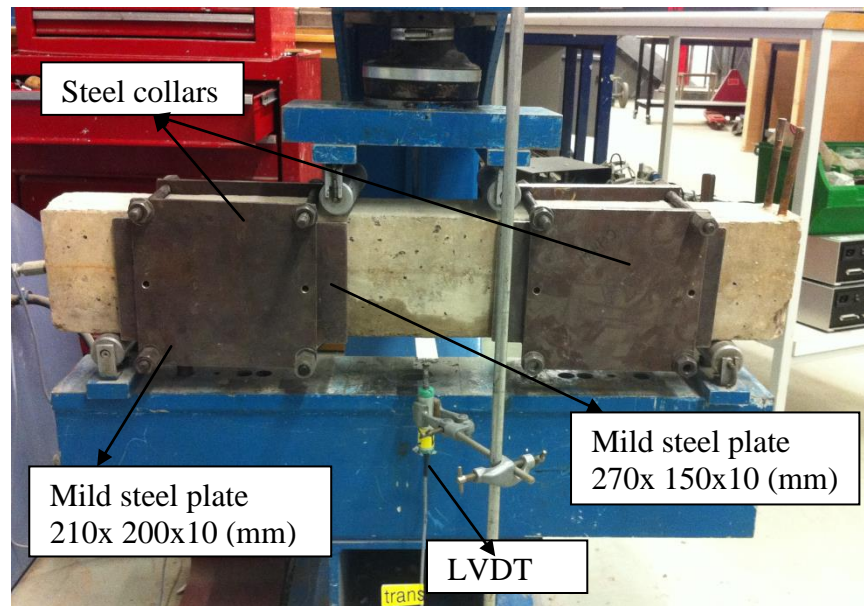
Figure 2. Four point bending test of beams and detailed steel collars

All beams were tested under four point bending (see Figure 2). Load measurements were taken by means of a 3000kN load cell connected to a signal amplifier with low pass filter which in turn was connected to a load cell power supply and digital balancing and monitoring unit. The amplifier was calibrated to ensure a direct reading of the applied load on the digital monitoring unit, with an accuracy of 0.1kN. The loading rate was 5KN/min.

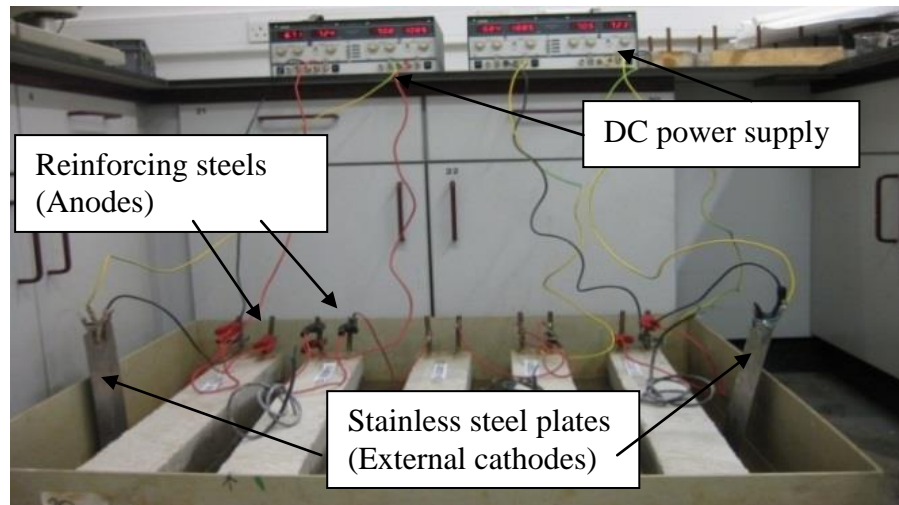
Figure 3. Accelerated corrosion of reinforcing steel by means of an anodic impressive current technique

At 21 days after casting, 5 beams from each group were subjected to accelerated corrosion of the reinforcing steel using an anodic impressed current method. A current density of $1\text{mA}/\text{cm}^2$ was applied to simulate general corrosion of reinforcing steel. This current density was previously adopted in earlier experiments (O'Flaherty, Mangat, Lambert & Browne, 2008), and was found to provide an appropriate level of corrosion, similar in nature and composition to the naturally occurring process but within a reasonable timescale. The period of current application was 94 hours to achieve nominal degree of corrosion of 2.5% of diameter loss. The layout of the corrosion set up is shown in Figure 3. The current was provided by a DC power supply. The polarity of the current was such that the steel reinforcement served as the anode and a stainless steel plate worked as the cathode. The corrosion process took place in a polymer tank where 3.5% NaCl solution was used as the electrolyte. The solution level in the tank was adjusted to ensure adequate submersion of the steel bars, while ensuring sufficient oxygen for the corrosion process to proceed.

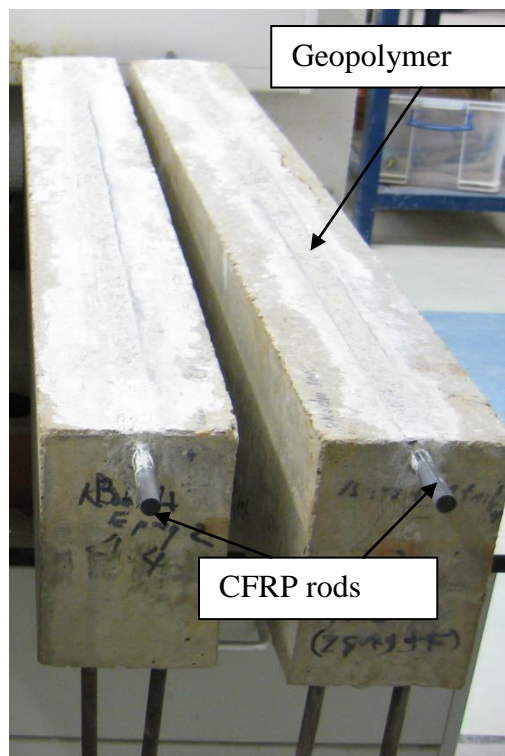
Figure 4. Bonding CFRP rods to grooved beams by geopolymer- Group1

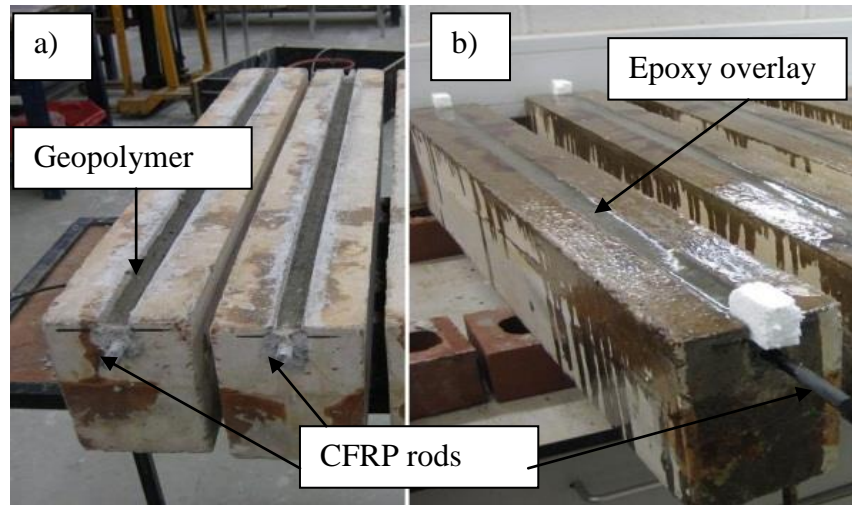
Figure 5. (a). Bonding CFRP rods to pre-grooved beams by geopolymer (first layer of repair material) (b). Overlay of epoxy as the second layer of repair

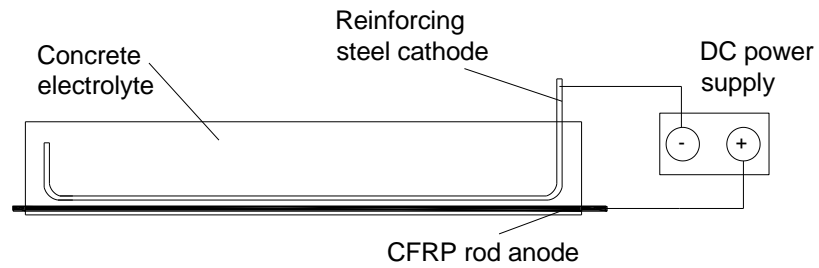
Figure 6. Schematic ICCP application to corroded reinforced concrete beams

ICCP was applied to the corroded reinforced concrete beams by connecting the reinforcing steel to the negative terminal and the CFRPs anode to the positive

terminal of a multi-channel power supply. The schematic of ICCP application is shown in Figure 6. The system was cathodically protected at room temperature (nominally 20°C) and 60% relative humidity (plus or minus 5%). These conditions ensured the resistivity of the concrete remained high, representing a dry site environment. The applied current densities were 64.2mA/m² of steel surface area for Beams 1.5 and 1.6 (Group 1-Table 1) and were varied between 125mA/m² and 310mA/m² of steel surface area for Beams 2.5 and 2.6 (Group 2-Table 1). The current was checked and the on and instant -off potentials of the embedded steel were recorded daily.

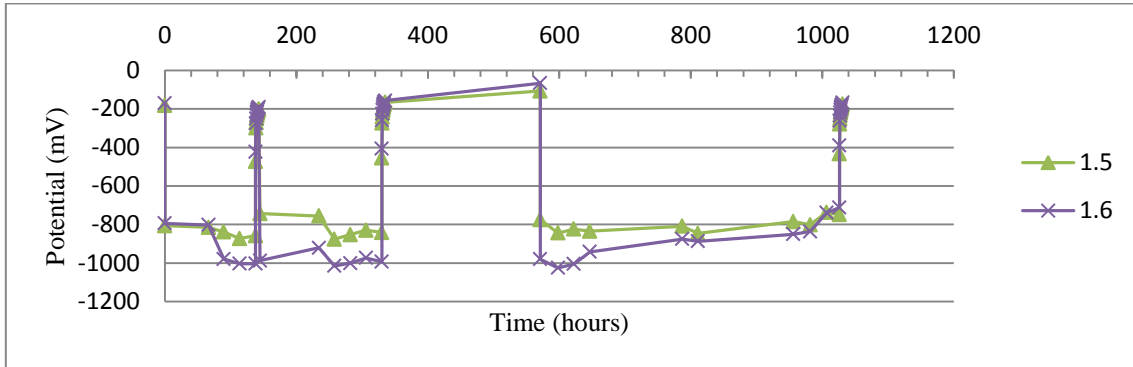
Figure 7. Potential (vs Ag/AgCl/0.5M KCl) of steels during operation of ICCP - Beams 1.5 and 1.6 (constant current density of 64.2mA/m^2 of steel area)

During the 1026 hours (corresponding to approximately 43 days) of operation of ICCP (Figure 7), the on- potential and potential decays of steel bars were recorded using embedded Ag/AgCl/0.5M KCl reference electrodes and a high impedance digital voltmeter (DVM). The ICCP was interrupted three times at 138 hours, 330 hours and 1026 hours, respectively. Although ICCP was achieved at each interruption (138 and 330 hours) the ICCP was re-run again to investigate the long term performance of dual function CFRP rod. At 330 hours, the ICCP was interrupted for 241 hours before it was restarted at 571 hours and continued to 1026 hours. The potential decays at these three occasions were monitored and are shown in Table 2.

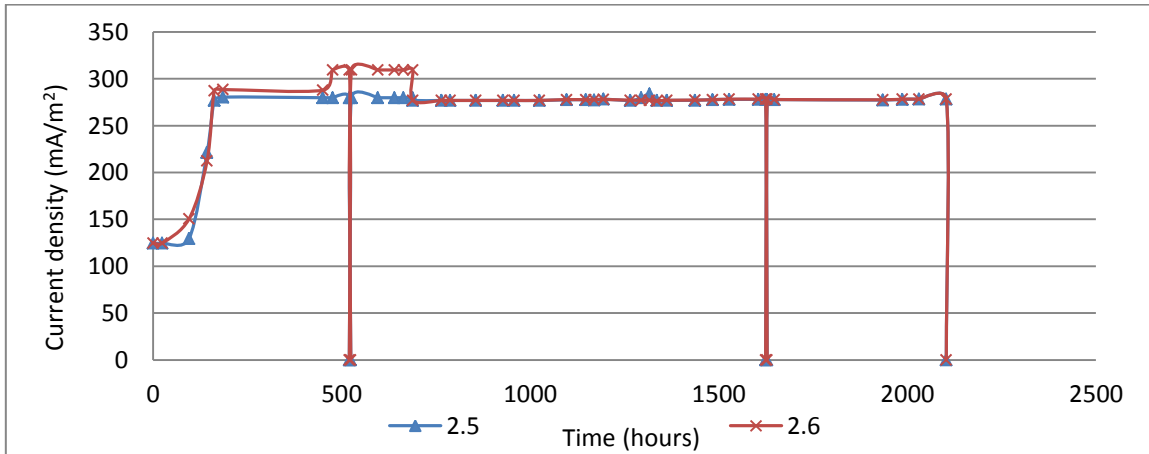
Figure 8. ICCP applied current densities (mA/m^2 of steel surface area)- Beams 2.5 and 2.6

The applied currents to Beams 2.5 and 2.6 were recorded and plotted in Figure 8. The applied current densities for both beams were around 125mA/m² for

approximately 100 hours before this was increased to around 280mA/m^2 to ensure adequate polarisation of the steel. The potential drop defined as difference between instant- off potential and rest potential should be greater than 150mV (The Concrete Society 2012). However, there was a small increase in current density applied to Beam 2.6 for a period of about 200 hours. The current density applied to Beam 2.6 was increased to around 310mA/m^2 at approximately 470 hours and reduced again to 280mA/m^2 at 688 hours. These adjustments of current densities were based on the polarisation of the steel. It also aimed to reduce the risk of any possible negative effect of too high a current on the bond at the CFRP rod/geopolymer interface.

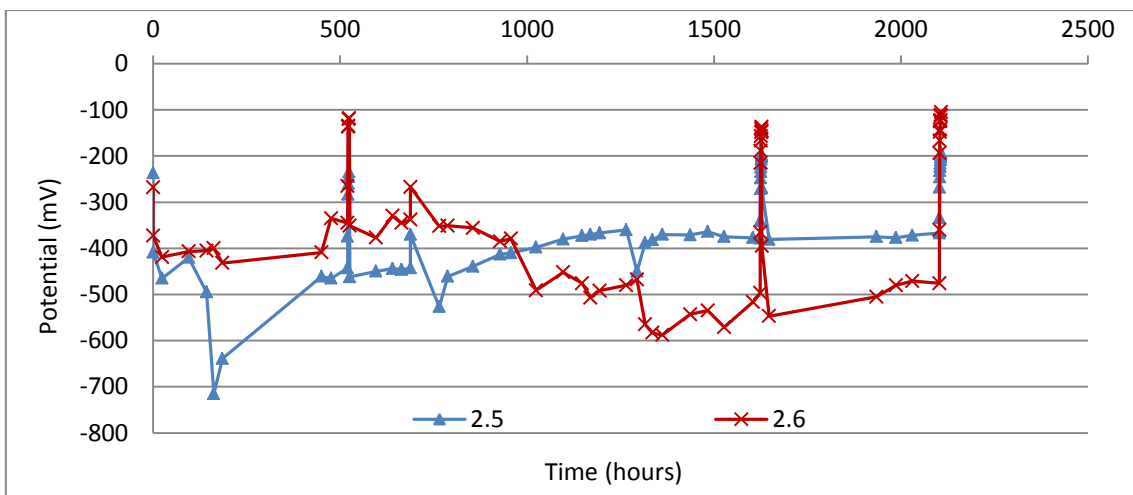
Figure 9. Potential (vs Ag/AgCl/0.5M KCl) of steel bars during ICCP application- Beams 2.5 and 2.6

During the total 2,103 hours of operation of ICCP, the on-potential and potential decays of the steel bars in Beams 2.5 and 2.6 were monitored and recorded. The total period is plotted in Figure 9. The ICCP was interrupted three times at 520, 1,624 and 2,103 hours and the potential decays are shown in Table 2. Figures 7 and 8 show that the potential of the steel bars in Beam 2.5 shifted quickly when the applied current density increased from about 138mA/m^2 to approximately 277mA/m^2 while the potential of the steels in Beams 2.6 shifted more slowly. During the period of ICCP application, the potential of the steel bars in Beam 2.5 is notably different from that of Beam 2.6. The difference of moisture contents of two specimens is suggested as the reason as Beam 2.6 was sprayed with water at the start of ICCP operation in order to help polarise the steel bars. Figure 9 shows that the potential of the steel bars shifted to values less negative than the initial rest potential, specifically from -237mV to -193mV for Beam 2.5 and from -268 mV to -105mV for Beam 2.6 after 2013 hours of ICCP application.

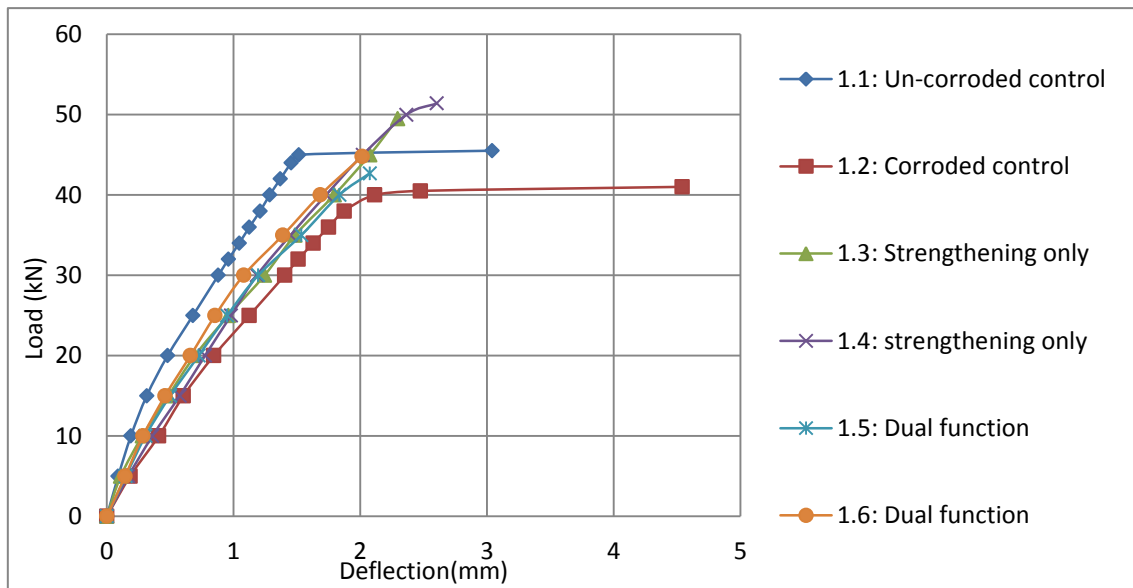
Figure 10. Load deflection curves of Group 1 beams- geopolymer only

The load- deflection relationships of Group 1 beams are shown in Figure 10. While the ultimate strength of corroded control Beam 1.2 (41.0kN) reduced compared to the un-corroded control Beam 1.1 (45.5kN), the deflection at failure of Beam 1.2 (4.54mm) increased compared to Beam 1.1 (3.04mm). This was due to the influence of steel reinforcement corrosion on the stiffness of beam. Previous research (O'Flaherty, et al 2010) shows that reinforced concrete beams show a loss in stiffness with increasing corrosion of the main steel reinforcement and as the result the stiffness of corroded Beam 1.2 reduced.

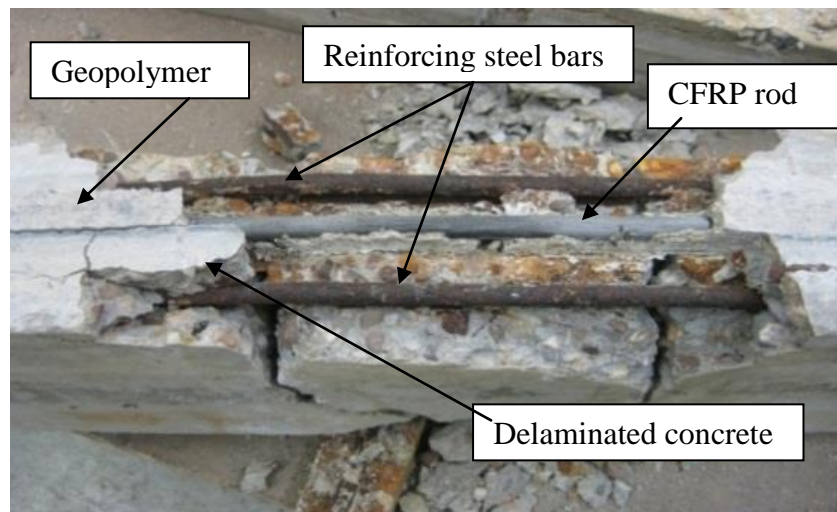
Figure 11. Debonding of CFRP rod after load testing- Group1

Beam 1.2 (Table 3). Beams 1.3 and 1.4 both failed due to the debonding of the CFRP rod (Figure 11). The average ultimate deflection of Beams 1.3 and 1.4 (2.45mm) was reduced by 46% compared with the ultimate deflection of Beam 1.2 (4.54mm) (Table 3). This was attributed to the CFRP rod application to Beams 1.3 and 1.4 leading to an increase in their stiffness compared to Beam 1.2.

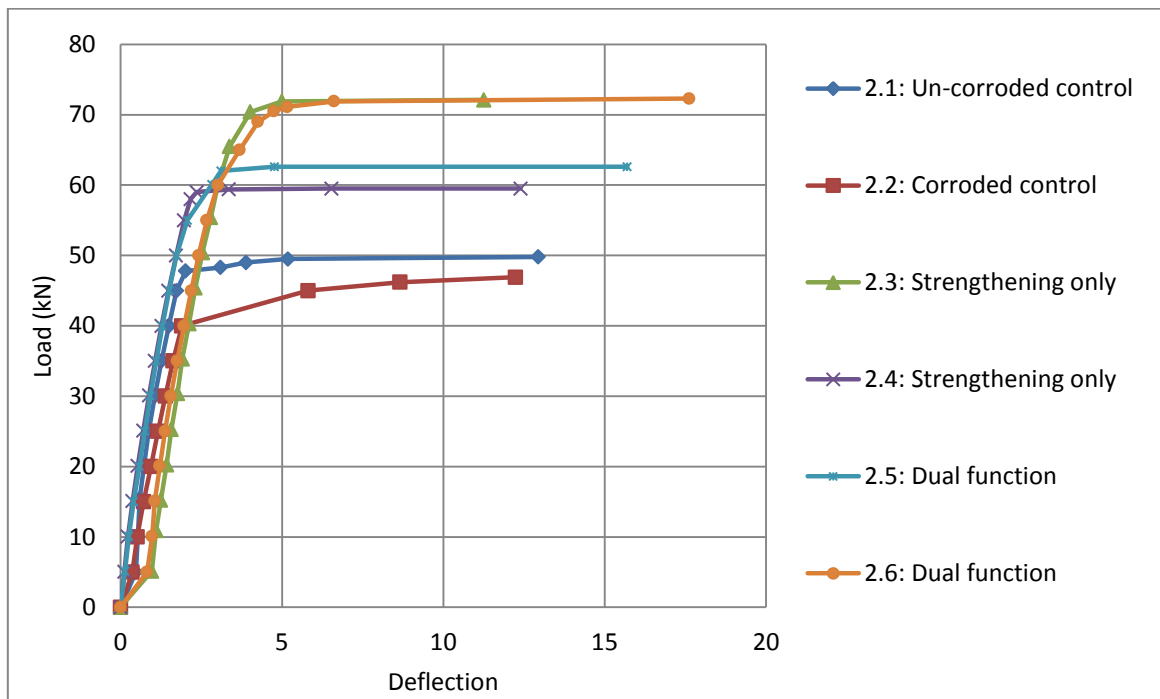
Figure 12. Load-deflection curves of Group 2 beams- combination of geopolymer and epoxy

The load-deflection relationships of Group 2 are plotted in Figure 12. While the ultimate strength of corroded control Beam 2.2 (46.9kN) reduced

compared to the un-corroded control Beam 1.1 (49.8kN), the deflection at failure of Beam 2.2 (8.68mm) increased compared to Beam 1.1 (5.18mm). Similar to Group 1, this was due to the influence of steel reinforcement corrosion on the stiffness of beam as stated previously.

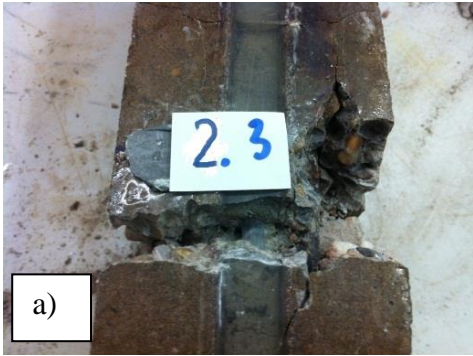
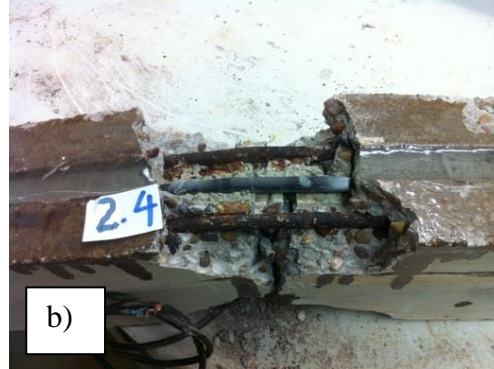
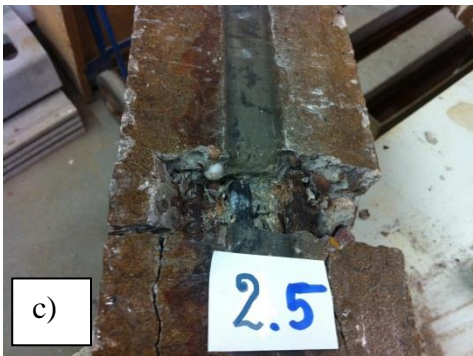
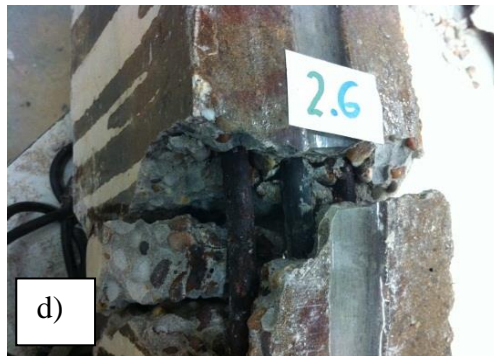
Figure 13. Failed beams

- a) Failure of strengthening only beam 2.3
- b) Failure of strengthening only beam 2.4
- c) Failure of dual function beam 2.5
- d) Failure of dual function beam 2.6

The failure modes of four strengthened beams were recorded and shown in Figures 13a to 13d. Flexural failure of Beam 2.3 (Figure 13a) started by the yielding of steel reinforcement followed by the rupture of second layer repair material (epoxy) and debonding at the CFRP rod/geopolymer interface. Post-bending investigation was conducted at the flexural failure section. There was no debonding at the geopolymer/concrete interface or geopolymer/epoxy interface. The failure mode of Beam 2.4 (Figure 13b) was similar to Beam 2.3; however, it was observed that the CFRP rod had a crack across the cross-section. The flexural failure of Beam 2.5 (Figure 13c) started by the yielding of the reinforcing steel, followed by the rupture of the epoxy layer. There was debonding at the CFRP rod/geopolymer interface, however, there was no debonding at the geopolymer/epoxy interface. Further examination revealed that there was minor debonding at the geopolymer/concrete substrate interface, due to inadequate cover to the CFRP rod provided by the geopolymer layer.

The failure mode of Beam 2.6 (Figure 13d) was more complicated. After yielding of the steel bars, the epoxy layer was ruptured following the formation of longitudinal cracks in the CFRP rod. Post-bending test investigation revealed that there was no debonding at the geopolymer/concrete or geopolymer/epoxy interfaces, however there was debonding at the CFRP rod/geopolymer interface. The CFRP rod had slipped, which is attributed to a loss of bond at the CFRP rod/geopolymer interface.

From the detailed examination of the four CFRP rod strengthened beams, debonding was only observed at the CFRP rod/geopolymer interface. In comparison with the NSM technique using geopolymer only as the repair material in Group 1, there is an improvement in the bonding between the CFRP rod and repair materials, and therefore the capacity of strengthening is increased significantly.
