On the fatigue response of a bonded repaired aerospace composite using thermography

Sotirios A. Grammatikos[a], Evangelos Z. Kordatos[b], Theodore E. Matikas[c], Alkiviadis S. Paipetis[c],[*]

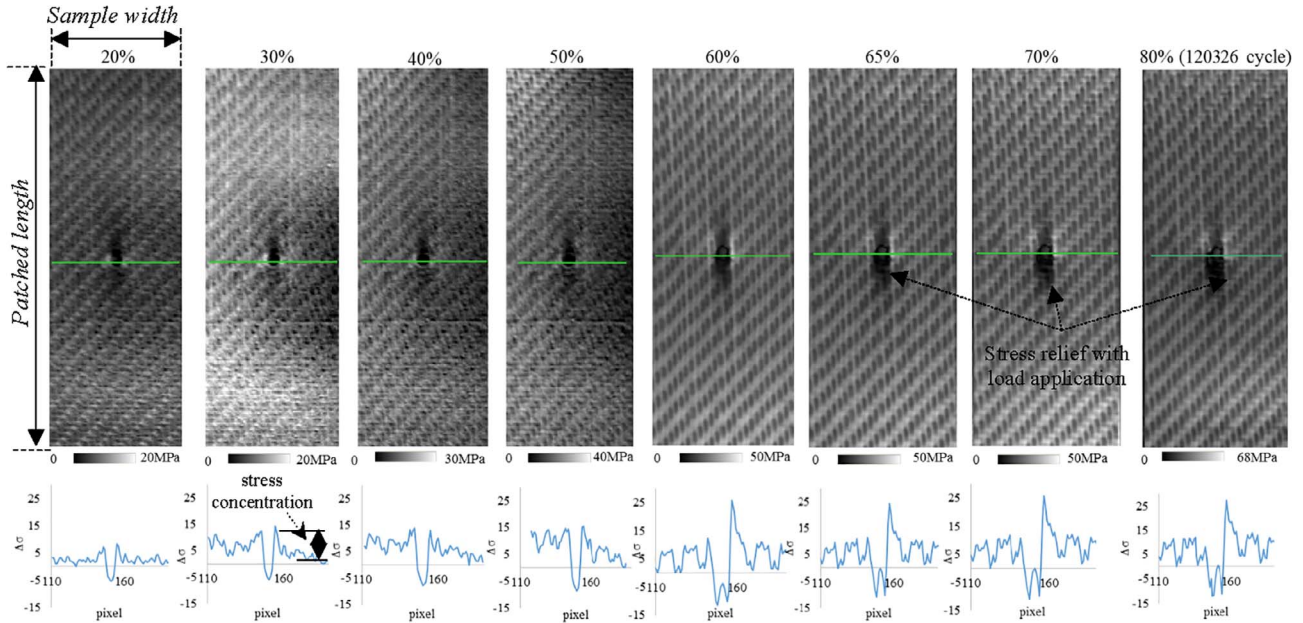
Fig. 7. Progress of delamination/separation/detachment of patch from the substrate during fatigue loading from 20 to 80% of σ_{uts}; respective normalised amplitude versus distance (pixels) graphs.

Fig. 7 represents amplitude snapshots at 20%, 30%, 40%, 50%, 60%, 65%, 70% and (early) 80% load levels, as recorded by the thermal camera. For 20%, 30%, 40%, 50%, 60%, 65% and 70% load levels, images were extracted towards the end of each test level i.e. at the steady state. With respect to 80% load level, images were more frequently extracted in order to showcase the more significant (visible) transition phases taking place (Fig. 8). Up until the early (120,326 cycle) fatigue cycles at 80%, the amplitude images did not change for all three tested coupons. On the contrary, in the case of 80% load level (Fig. 8), the amplitude image started changing characteristically during the fatigue loading until coupon failure. The deterioration trace of the patch/substrate interface (Fig. 8) is highlighted by arrows on some of the images. In all stress levels, stress concentration areas are depicted as bright spots in the corresponding snapshots around the circular notch or as bright areas at the edges of the patch, particularly at the loading (bottom) side of the test frame.

More specifically, the 1st thermal image in Fig. 7 is typical of the stress state at 20%, as no notable changes were recorded throughout the loading process. Stress concentrations can clearly be seen as bright spots on either side of the notch, where stresses are expected to be maximum. The application of higher stress levels did not alter the stress distribution on the sample surface which also remained stable for approximately 20 k cycles throughout the loading process until 60% σ$_{uts}$. A slight increase in stresses was then recorded which altered the thermographic images in the critical area around the notch which remained practically constant for another 40 k loading cycles. In the case of 80% load level (Fig. 8), the amplitude images did not alter for approximately more 20 k cycles. As can be seen, the amplitude disturbance at the vicinity of the notch clearly covered more extended area, with less prominent bright spots and characteristic dark areas which corresponded to unloaded (or less loaded) areas of the coupon. The examination of these thermographs led to the conclusion that stress concentrations caused initiation and propagation of stress-relief damage mechanisms, characteristic of the damage tolerant behaviour of the composite laminates: longitudinal splitting could be clearly seen on either side of the notch. This splitting occurred on the side of the specimen where the test frame applies the loading (bottom area in the thermograph). The same trend was observed in the thermal image cycle 120,326 of 80% loading (Fig. 7), where bright areas are less prominent at the edges of the notch and the damage manifested by the dark areas is slightly increased. Amplitude changes became more visible after approximately 140 k cycles. Stress concentrated areas mostly from the bottom part for the notch (loading side), started pronouncedly approaching the notch reflecting the gradual detachment of the patch from the substrate. Complete detachment of the patch (critical damage) occurred at approximately 160 k loading cycles which exposed the circular notch and led to the immediate failure of the component due to subcritical damage.

to early 80% which leads to the increase of cumulative stresses on the right side of the notch seen as bright spot. It is interesting to note that the stress concentration pattern in Fig. 7, remains almost stable until the 60% σ$_{uts}$, a fact that strongly indicates that the recorded stress variation is real and cumulative due to the notch and the weaving pattern. After that, Δσ exhibits a slight increase which oscillates around a constant value for 40 k cycles more (100–140 k cycles). In Fig. 8 the propagation of critical damage is manifested in the thermal images as areas of stress relief on the surface of the repaired composite coupon, or bright areas that propagate towards the centre of the coupon with further cyclic loading. The critical debonding process was also monitored in a previous work for unnotched patched aluminium coupons [14]. The non-monotonic behaviour of the amplitude peaks (stress concentration) can be explained by two competing mechanisms: (i) the gradual loss of lateral support due to the critical debonding results to the increase in the Δσ which reaches a mean value of ~25, while at this stage (ii) extensive longitudinal splitting (manifested as dark ribbons underneath the notch area) leads to the relief of the stress concentration. At the same time, the propagating critical failure gradually reaches the notch area (Fig. 8, cycle 148,257) which results in the catastrophic transverse failure of the coupon after a total of approximately 160 k cycles.

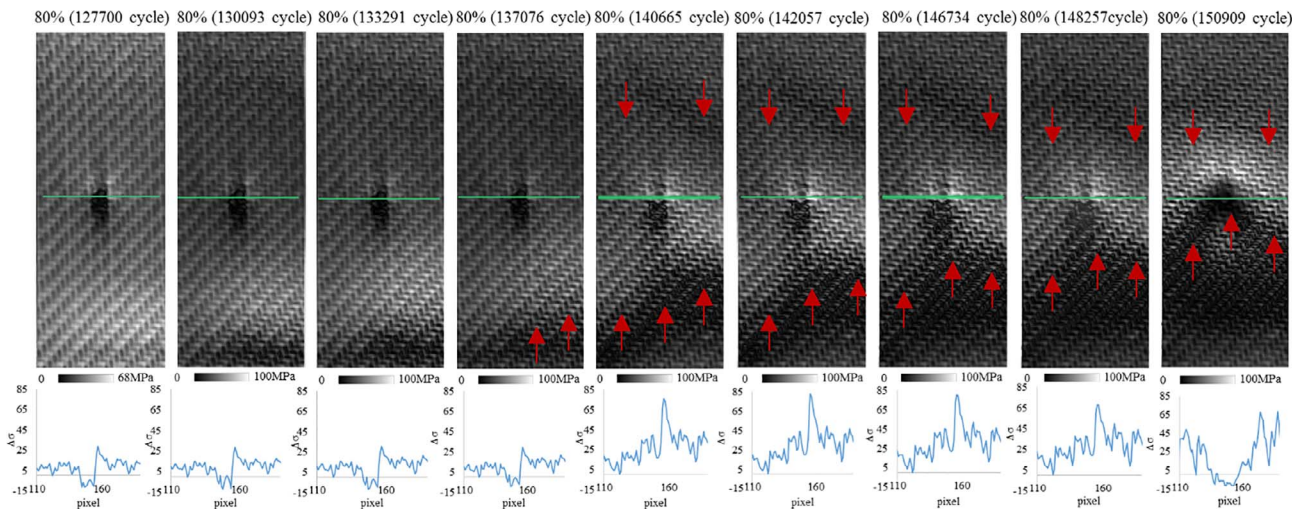
Fig. 8. Progress of delamination/separation/detachment of patch from the substrate during fatigue loading at 80% of σ_{uts} from cycle 127,700 cycle until rupture; respective normalised amplitude versus distance (pixels) graphs.

In Fig. 8, the bright areas on the top and bottom (mostly) of the image (patch edges) were clearly confined towards the middle of the specimen, denoting the onset and propagation of debonding. At the same time, the bright areas around the circular notch became more pronounced, as the localized stresses became gradually less inhibited by the failing patch. Further cyclic loading induced asymmetric debonding of the patch which significantly altered the stress distribution on the surface. Catastrophic failure took place at 150,909 cycles when the debonding front merged with the notch-induced stress concentration.

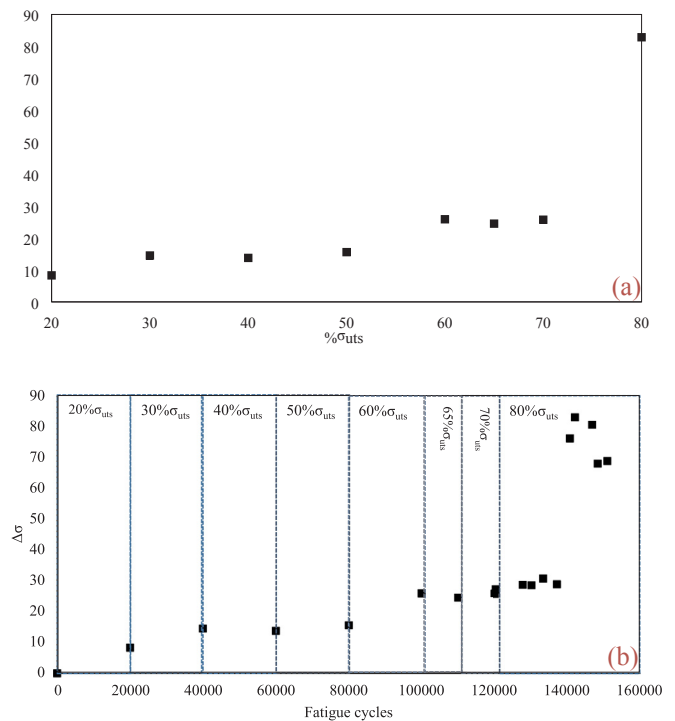
Fig. 9. Stress concentration vs. fatigue cycles from 20% to 80% of the σ$_{uts}$ and until rupture.

Fig. 9 shows the maximum Δσ (peak values of Δσ vs. distance plots from Figs. 7 to 8) as a function of the stress level and the total loading

cycles (number of cycles since the onset of the step-wise cyclic loading) until final failure at approximately total ~160 k cycles. In the specific geometry, the resolution of the amplitude picture was 0.65 mm/pixel. In Fig. 9, the plotted curve corresponds to the binning of two pixel values (Fig. 6a) at the centre of the notch, i.e. a resolution of 1.3 mm for a 5 mm notch. This was performed so that the centre of the notch was always included in the measurements. Binning decreases the uncertainty in the amplitude measurements due to the inherent resolution limitations, but it may provide a slight underestimation of the measured amplitude/stress concentration values. However, this limitation does not affect the observations regarding the evolution of the stress concentration values. There is an expected gradual increase in $\Delta\sigma$ with stress levels which is due to the increase in applied stress. This stress concentration increase also observed as bright spots at the two sides of the notch, led to longitudinal splitting shown as dark areas in the amplitude images (Fig. 7), which is obviously a local relief of the stress concentrations. Changes in $\Delta\sigma$ are within the recorded variation in the system up until 60% of σ_{uts}. In this respect, the $\Delta\sigma$ remains relatively constant at an approximate value of 15 ($\Delta\sigma$). In addition, the thermographs remained relatively unaltered during the fatigue loading suggesting that the damage induced heat is not significant compared to the thermoelastically induced temperature variations, i.e. if hysteretic phenomena were dominant, the local temperature increase would mask the increase in the stress concentration.

As observed for all tested coupons, the patch gradually debonded and the specimen failed catastrophically by a transverse crack at the vicinity of the notch. It is interesting to note that for approximately 80 k cycles there is little or no change in the $\Delta\sigma$ which oscillates around a value of 15 (stage I fatigue – Fig. 2). Thereafter, there is a slight increase to a value of 25. Interestingly enough, $\Delta\sigma$ remains stable again around a value of 25–30 (stage II fatigue – Fig. 2). The constant loading frame follows a substantial increase that reaches a maximum of approximately 80 (stage III fatigue – Fig. 2) which falls back to ~67 at the time of the failure of the coupon at approximately 160 k cycles. A closer examination of the amplitude images may justify the non-monotonic behaviour of the $\Delta\sigma$ and the subsequent damage profile with cyclic loading which follows a characteristic fatigue degradation trend (Fig. 2). As was initially postulated, thermoelastic phenomena do not affect the mean temperature or the relative amplitude values of the system which correspond directly to stress concentration. However, every recorded increase in amplitude values, which here is argued as stress concentration, corresponds to damage incidents. More specifically, at approximately 146,000 loading cycles (Fig. 9), a significant crack incident led to abrupt elevation of the stress amplitude values and the subsequent modification of the thermoelastic behaviour. This is a characteristic hysteretic phenomenon which surpasses the elastic at that point and prevails until the final fracture of the component. Stress concentration values decay when internal stresses reach a maximum ($\Delta\sigma = 80$ – Fig. 9) for the given material. As a result, stresses are

relieved together with the rupture of the coupon. Similar observation presented in Fig. 9 was reported by R. Steinberger et al. [53]. This is characteristic of a hysteretic energy dissipation effect due to intrinsic damage phenomena. Beyond the fatigue limit internal damage leads to significant temperature increase and subsequent heat dissipation which can be detected by the thermal camera [41]. It could be assumed that the 80% σ_{uts} corresponds to the fatigue limit of the studied repaired component.

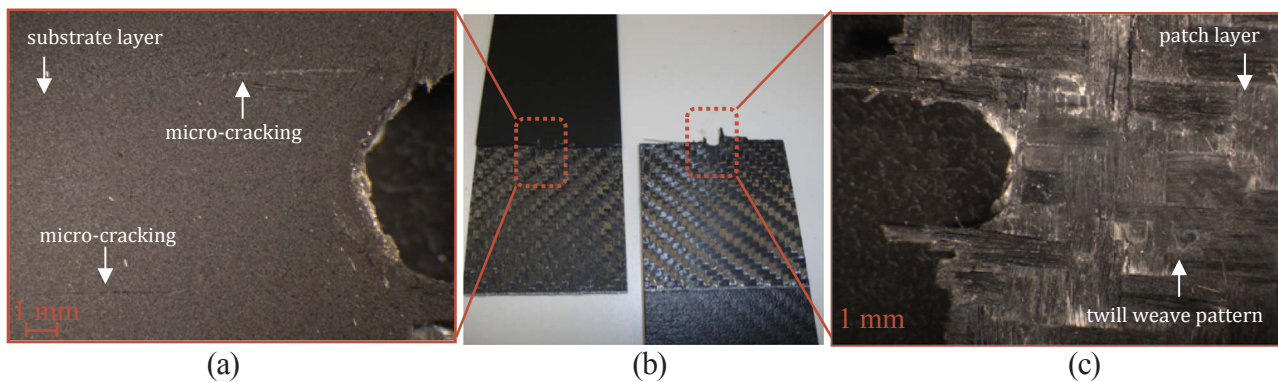
Fig. 10. (a, c) Post failure stereoscopic images of the patched specimen, (b) post failure image.

End of testing was followed by coupon separation in two parts. Both parts were examined using an optical microscope. Post failure pictures of the coupon exhibiting the brittle failure exactly at its centre are shown in Fig. 10. The magnification of the area of the notch (substrate part) (Fig. 10b), revealed the existence of cracks parallel to the loading axis which decreased the stress concentration with the incremental increase of the load level (Fig. 10a). The optical examination of the failed coupon also revealed the longitudinal cracks (Fig. 10a) which led to the relief in the stress concentration captured in Fig. 7. Fig. 10c is a magnification of the detached part which reveals the twill weave pattern of the employed pre-preg carbon fabric.
