An investigation into the non-uniform decay of Hardwick Stone

AN INVESTIGATION INTO THE NON-UNIFORM DECAY OF HARDWICK STONE

Robert Brough⁴ & Elizabeth Laycock

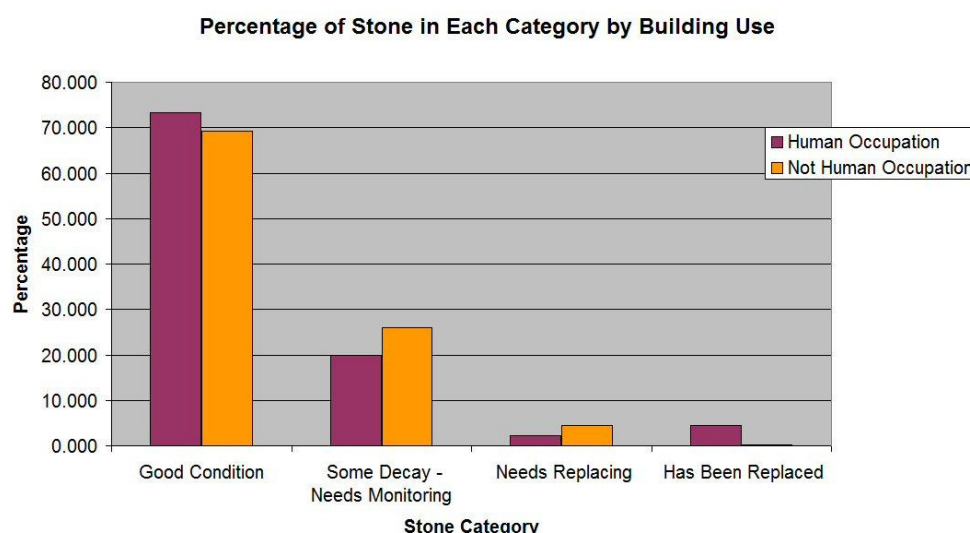
Figure 124: Graph of stone condition by building use

As can be seen from Figure 124 those buildings designed for human occupation have a slightly higher proportion of stone in good condition than those designed for other uses 73%

There are various reasons as to why stone might fare better on buildings designed for human occupation. They are generally built using better materials, techniques, designs and craftsmanship in the first place. For example a number of buildings designed for human occupation have overhanging roofs which provide protection to the walls. They have more efficient mechanisms for carrying rainwater off the roof and away from the building i.e. functioning gutters and downpipes. In addition there is more likelihood of earlier and effective care and maintenance, for example a building that is occupied by humans is less likely to be damp as the occupiers are likely to take steps to rectify any dampness and the internal space will be heated. Buildings not designed for human occupation probably suffer more abuse over their lifetimes. For example: buildings that have been used as animal shelters often have contaminated masonry due to contact with animal waste which occurs over a period of many years. Water is a major agent of decay since water can transport salts into the pore spaces of stones, either from the ground or other sources; cause decay due to the freeze-thaw process and can also cause decay due to its acidity. The text above sets out a number of reasons why buildings designed for human occupation may suffer less from water penetration and therefore from salt crystallisation, freeze-thaw and acid attack. However the Chi-square test has been carried out on the data for the relative proportions of stone in good condition for human and not-human occupation. The results of the test show there is no significant difference between the two sets of data and thus the hypothesised better quality of stone in human habitations cannot be proved by the observations made.

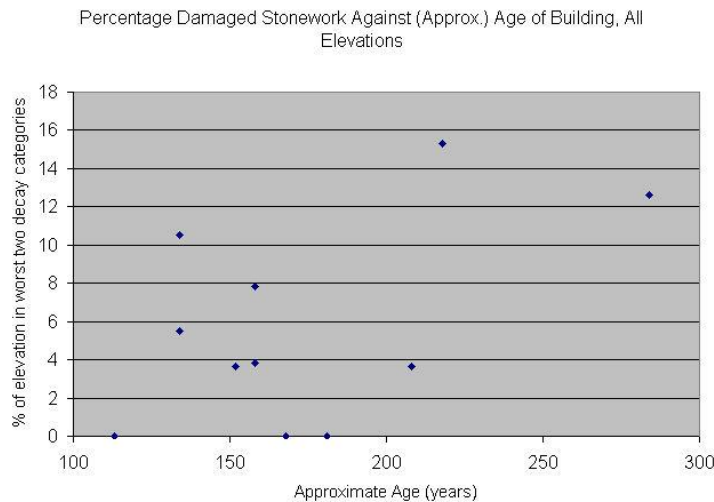
Figure 14: Graph of stonework damage against building age - all elevations

There appears to be a general correlation between building age and the percentage of stonework in the worst two damage categories, the older a building is, the higher the proportion of damaged stone, indicating that decay continues throughout the life of the building in a progressive, although not necessarily linear, manner. Factors such as the quality of the stone used, the local topography, the building's design, the maintenance regime will also affect the rate of decay.
