# **Efficacy of Different Materials and Methods of Repair in Highway Bridges**

**P S Mangat, F J O'Flaherty**

School of Construction, Sheffield Hallam University

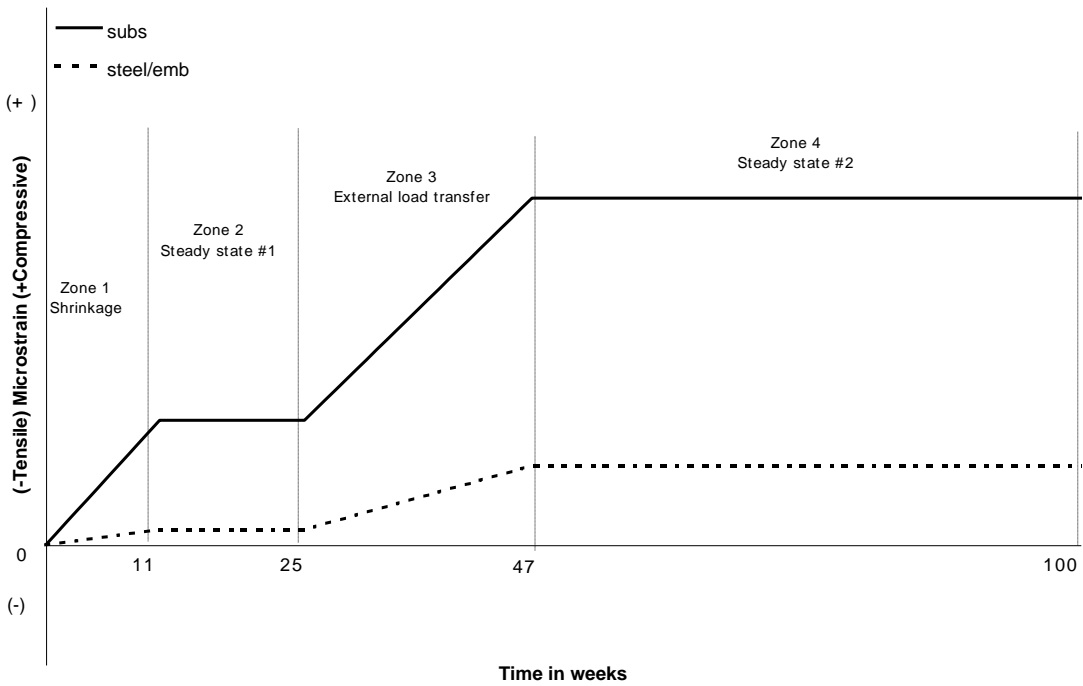
The typical long-term strains monitored in the repair patches on the abutments at Lawns Lane and Gunthorpe bridges are plotted in Figure 7. Repairs were applied to unpropped members. Repair materials of elastic modulus,  $E_{rm}$ , greater than that of the substrate,  $E_{sub}$ , are considered. Strains in the substrate at the repair interface, in the steel reinforcement and in the repair material (in the plane of the longitudinal reinforcement) are plotted. A simplified schematic representation of the strain-time relationship is made in Figure 8 in which the strains monitored by the reinforcement gauge and the embedment gauge in the plane of the reinforcement are averaged. Figure 8 clearly identifies four stages (zones) of strain (and, therefore, stress) transfer. Stage 1 represents the shrinkage strain transfer from the stiffer repair material ( $E_{rm} > E_{sub}$ ) into the substrate concrete at the interface and into the steel reinforcement. The degree of shrinkage transfer is a function of  $E_{rm}/E_{sub}$  and the free shrinkage characteristics of the repair material<sup>(5)</sup>. Zone 2 is a steady state condition of strain (and, therefore, stress) transfer which occurs after the repair material shrinkage stabilises. Zone 3, from week 25 to 47, represents the long-term effects of load redistribution from the substrate structure into the repair patch<sup>(5)</sup>. The long-term load distribution from the substrate is effective in neutralising the tension in the repair material caused by restrained shrinkage.

**Figure 7:** Long-term strain distribution in repair patch.  $E_{rm} > E_{sub}$ . Lawns Lane Bridge abutment. Sprayed repairs
