Efficacy of Different Materials and Methods of Repair in Highway Bridges

P S Mangat, F J O'Flaherty

School of Construction, Sheffield Hallam University

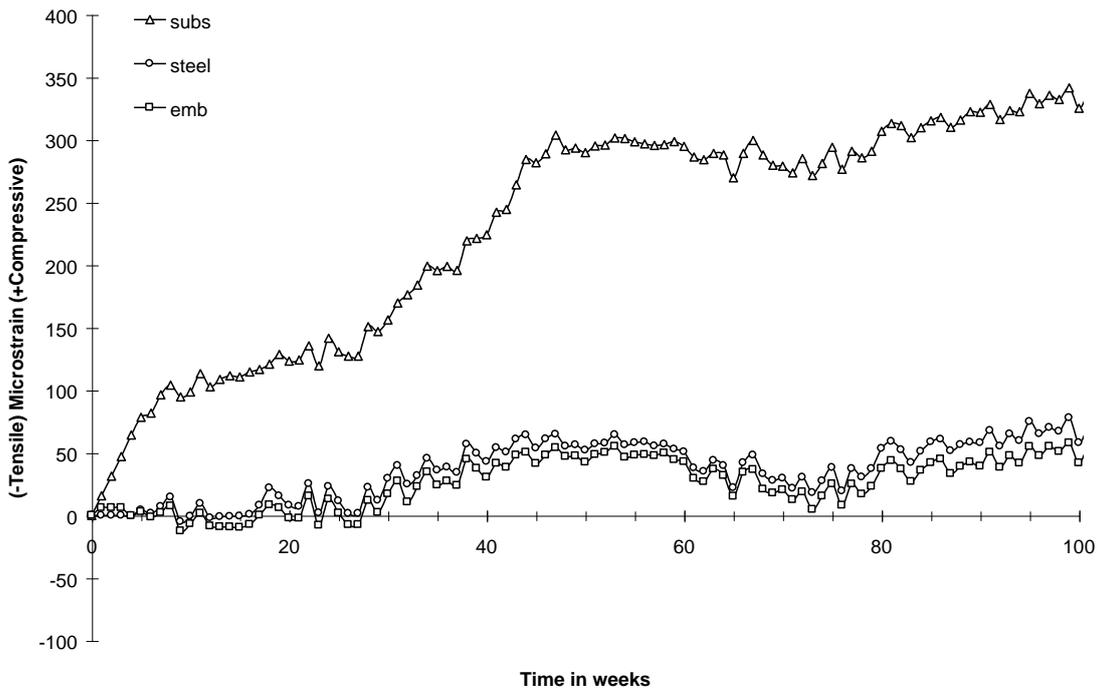
The typical long-term strains monitored in the repair patches on the abutments at Lawns Lane and Gunthorpe bridges are plotted in Figure 7. Repairs were applied to unpropped members. Repair materials of elastic modulus, E_{rm} , greater than that of the substrate, E_{sub} , are considered. Strains in the substrate at the repair interface, in the steel reinforcement and in the repair material (in the plane of the longitudinal reinforcement) are plotted. A simplified schematic representation of the strain-time relationship is made in Figure 8 in which the strains monitored by the reinforcement gauge and the embedment gauge in the plane of the reinforcement are averaged. Figure 8 clearly identifies four stages (zones) of strain (and, therefore, stress) transfer. Stage 1 represents the shrinkage strain transfer from the stiffer repair material ($E_{rm} > E_{sub}$) into the substrate concrete at the interface and into the steel reinforcement. The degree of shrinkage transfer is a function of E_{rm}/E_{sub} and the free shrinkage characteristics of the repair material⁽⁵⁾. Zone 2 is a steady state condition of strain (and, therefore, stress) transfer which occurs after the repair material shrinkage stabilises. Zone 3, from week 25 to 47, represents the long-term effects of load redistribution from the substrate structure into the repair patch⁽⁵⁾. The long-term load distribution from the substrate is effective in neutralising the tension in the repair material caused by restrained shrinkage.

Figure 7: Long-term strain distribution in repair patch. $E_{rm} > E_{sub}$. Lawns Lane Bridge abutment. Sprayed repairs

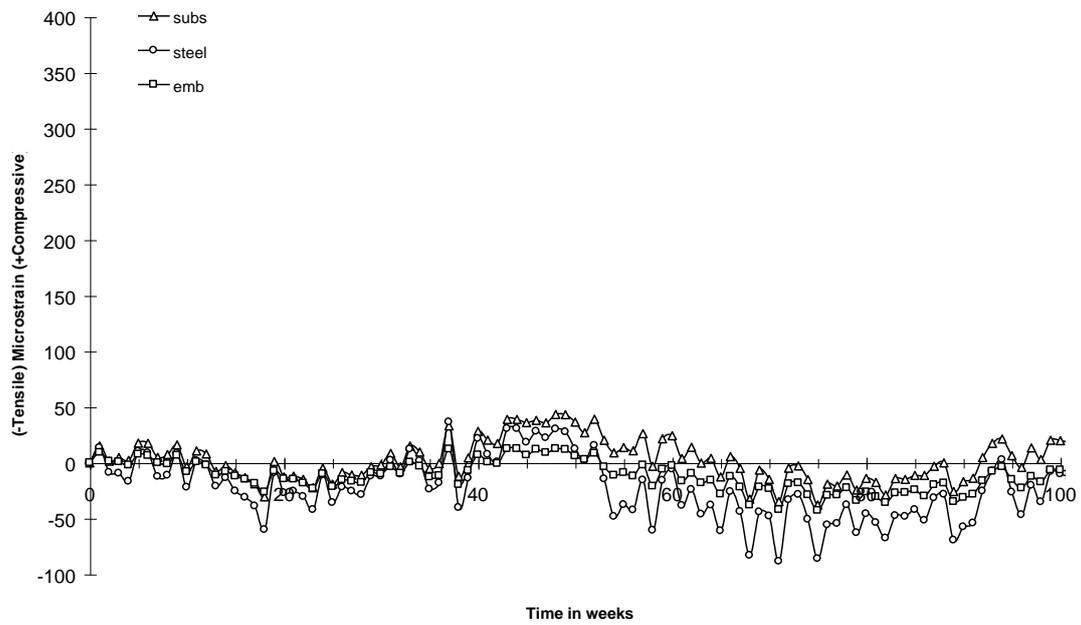
A representative example of long-term strain distribution in repairs with low stiffness materials ($E_{rm} < E_{sub}$) is presented in Figure 9. Spray applied repairs to unpropped bridge abutments are considered. Figure 9 does not identify any of the zones of strain transfer which are evident for high stiffness repair materials ($E_{rm} > E_{sub}$) in Figures 7 and 8. Low stiffness repair materials ($E_{rm} < E_{sub}$) are ineffective in transferring shrinkage strain to the substrate and, therefore, sustain higher degrees of restrained shrinkage tension. Consequently, low stiffness repairs are prone to cracking as evident in Figure 10.

Figure 9: Long-term strain distribution in repair patch. $E_{rm} < E_{sub}$. Gunthorpe Bridge abutment. Sprayed repair

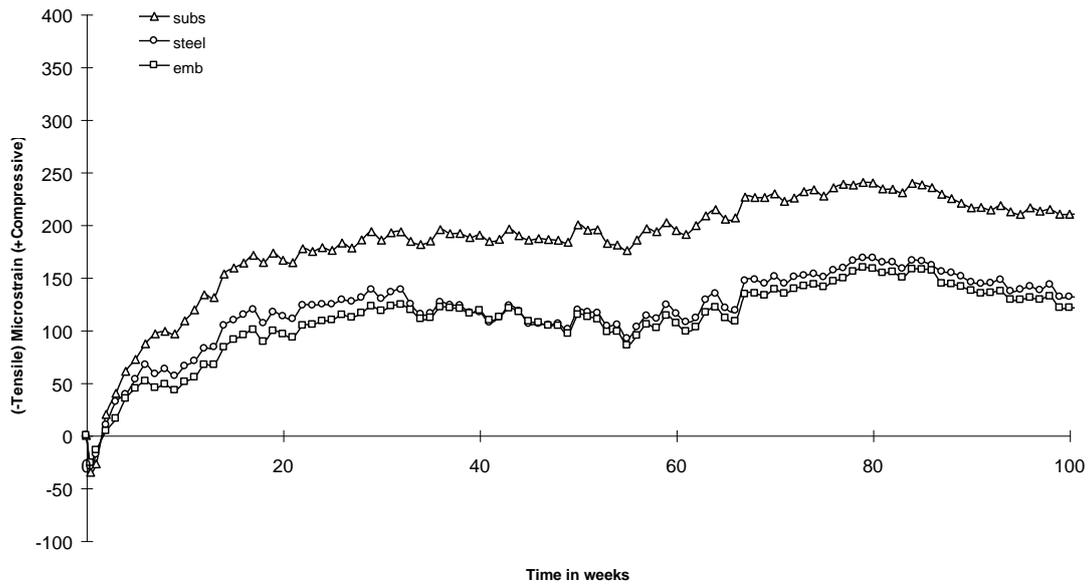
Figure 11 shows the long-term strain distribution in the repair patch of a flowing material applied to an unpropped compression member. The figure shows a well defined shrinkage transfer stage followed by a steady state. A long-term external load redistribution stage is not identified (Zone 3) as in the case of spray applied repairs to unpropped members.

Figure 11: Long term strain distribution in repair patch. $E_{rm} > E_{sub}$. Sutherland Street Bridge column. Flowing repair.

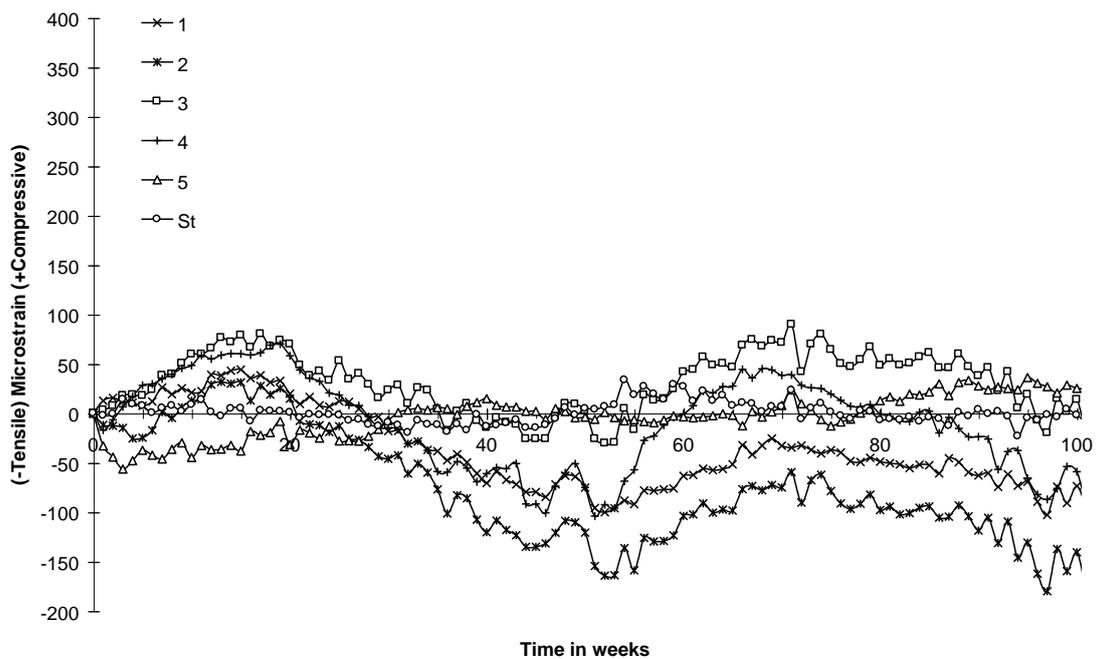
Hand applied repairs to the very heavily reinforced lateral deck beams at Gunthorpe bridge (Figure 1), using repair materials of $E_{rm} < E_{sub}$ (Table 1), resulted in cosmetic repairs. A strain-time plot of the strain gauges attached at different locations of a beam (Figure 2) is shown in Figure 12. The strain-time plots of different beams showed no clear and consistent pattern of strain distribution in the different phases of the repair patch. There was little interaction between the substrate beam and the repair patch; no significant load transfer from the substrate to the repair was evident in the long term.

Figure 12: Long term strain distribution in the repairs to bridge beams at Gunthorpe Bridge. $E_{rm} < E_{sub}$.
