## **Continuous debonding monitoring of a patch repaired helicopter stabilizer: damage assessment and analysis**

# Continuous debonding monitoring of a patch repaired helicopter stabilizer: Damage assessment and analysis

The present work focuses on the structural health monitoring of an aluminium vertical helicopter stabiliser with a pre-introduced crack which was repaired with an adhesively bonded composite patch. The structure was monitored under bending fatigue and its performance was evaluated with Lamb waves, lock-in thermography and ultrasonic testing. Outlier analysis of Lamb waves captured the onset and progress of the damage in the form of patch debonding, enabling the identification of five damage-severity regions. Principal component analysis showed distinctive clusters that corresponded to different damage levels while the application of principal curves on the selected features proved to be an additional damage detection index. Amplitude and phase lock-in images accurately captured the onset and evolution of the damage in the form of patch debonding and honeycomb/skin debonding in agreement with the damage indices obtained from Lamb waves. C-scan further validated th

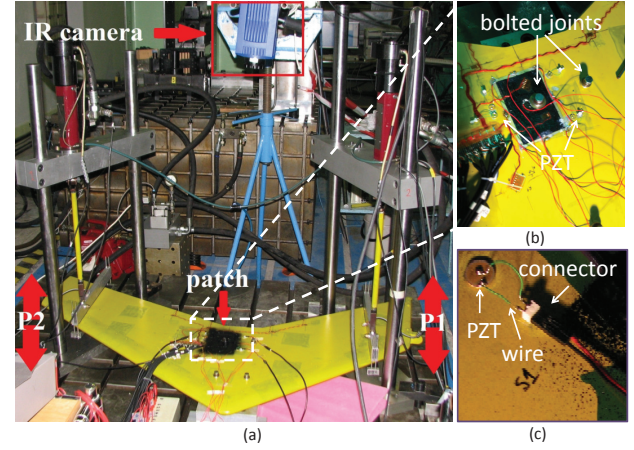
Figure 3: (a) Schematic illustration of the repaired stabilizer (a) test set up for bending fatigue of the repaired stabilizer at two loading points P1 and P2 with the IR camera positioned on top of the repaired region (b) repair patch sprayed with a black paint for thermography inspection; one repaired and one non repaired bolted joint and (c) PZT transducer for Lamb wave monitoring.<sup>1</sup>

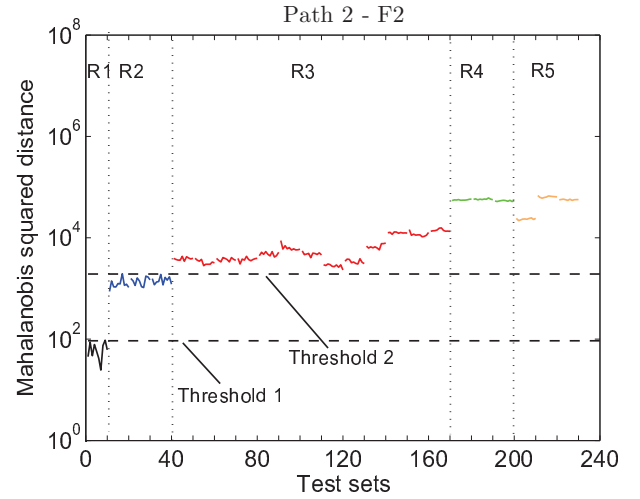
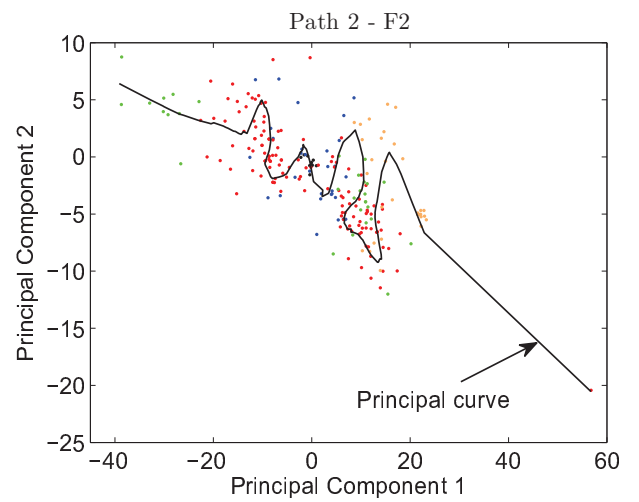
Figure 12: (a) Outlier analysis and (b) principal component analysis for path 2 - feature 2 (F2). Regions R1-R5 are clear in OA results and while PCA clusters can not be attributed to certain region.

haviour is in general similar. Region R3 is the one which mostly draws the attention, since it is the one which shows a certain deviation from the normal condition. The key requirement here is the identification of the damage sensitivity of each path with respect to an early stage damage onset detection, namely area R3. The OA for path 1 and path 2 exhibits similar results except for the second feature (F2), which shows significantly higher levels of deviation for path 1. In addition, PCA shows a more distinctive separation between the resulting clusters for the first feature (F1) of path 1 compared to the same feature for path 2. Even though this is not very clear at this stage, one could in general conclude that path 1 exhibits a relatively higher damage sensitivity, especially at the area where the first notable damage seems to develop, in region R3. This was later verified from the lock-in images which showed that the first noticeable type of damage was in the form of patch debonding which initiated at the repaired bolted joint. This would significantly affect path 1

more than path 2 (Figure 5), hence justifying the higher damage sensitivity as observed from OA and PCA results.

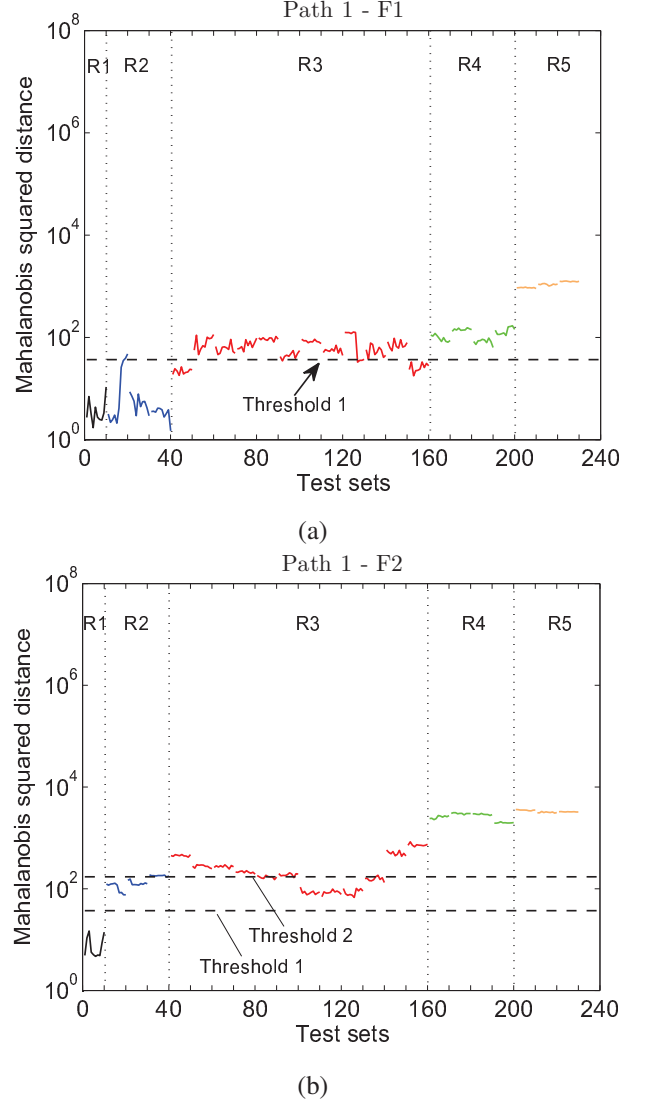
Figure 14: (a) Outlier analysis at the first 10 principal components for path 1, corresponding to feature 1 (F1) and (b) feature 2 (F2).

Feature 1 (F1) in Figure 14(a) shows that the results are more representative of the assumption made for the OA on the original time signals in section 4.1; it verifies that region R2 is not indicative of damage. This means that regions R1 and R2 are indeed labelled as inliers (below the threshold 1) while region R3 is very close to the threshold only slightly flagged above it without any considerable variation. In this case there was no need to assign threshold 2. It is only after 480,000 cycles that OA gives clear outliers (regions R4 and R5). On the other hand, feature 2 (F2) shown in Figure 14(b) illustrates a slightly different be-

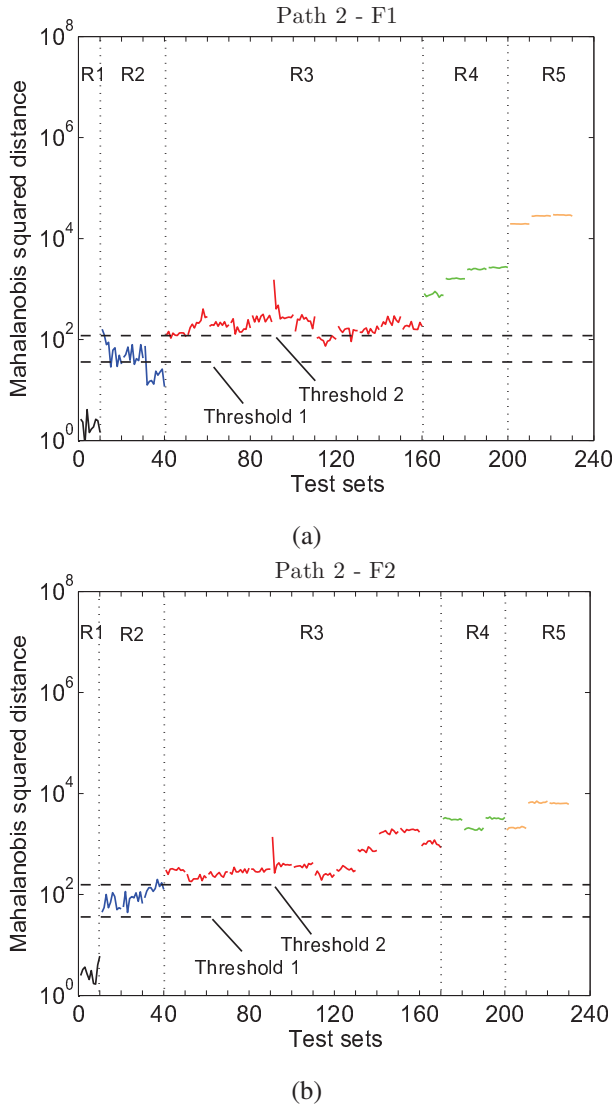
Figure 15: (a) Outlier analysis at the first 10 principal components for path 2, corresponding to feature 1 (F1) and (b) feature 2 (F2).

haviour, almost similar to the OA of the respective path/feature for the original time signals although the values of the deviation are smaller due to the change in the number of the dimensions of the feature (10-dimensional instead of 50-dimensional).
