Continuous debonding monitoring of a patch repaired helicopter stabilizer: damage assessment and analysis

PAVLOPOULOU, S., GRAMMATIKOS, S.A., KORDATOS, E. Z., WORDEN, K.,
PAIPETIS, A.S., MATIKAS, T.E. and SOUTIS, C. (2015). Continuous debonding
monitoring of a patch repaired helicopter stabilizer: damage assessment and
analysis. *Composite Structures*, 127, 231-244. [Article]

S. Pavlopoulou^{a,*}, S. Grammatikos^b, E. Z. Kordatos^c, K. Worden^d, A. Paipetis^e, T. Matikas^e, C. Soutis^a

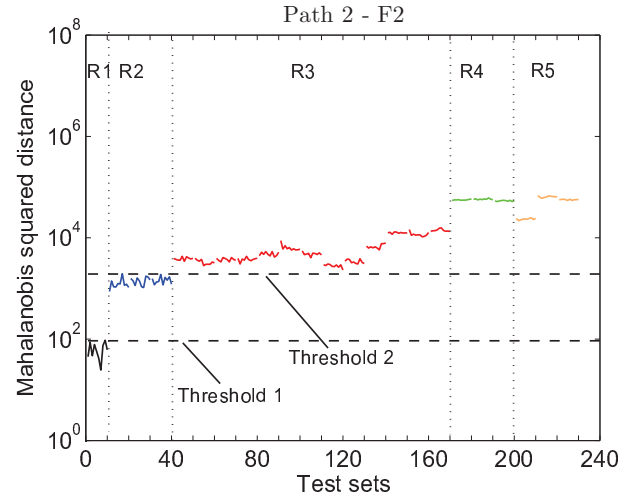
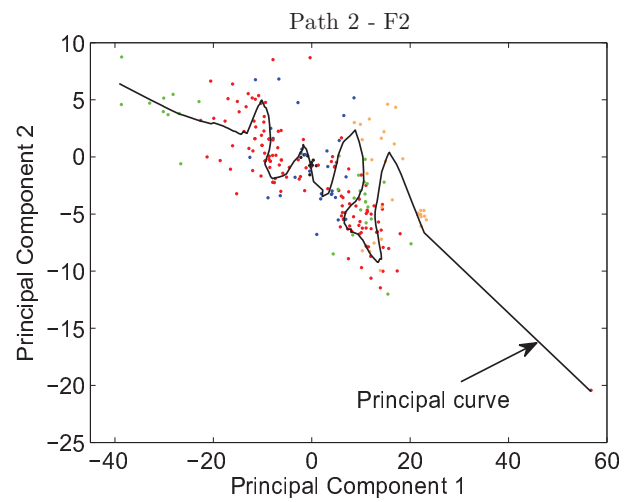
Figures 11 and 12 illustrate the same results but for path 2. The y-axis is scaled in the same way as for path 1 for comparison purposes. The first observation is that the same regions (R1-R5) can be assigned in the OA figures, which indicate the level of deviation from the baseline reference (pristine condition) and from the assigned thresholds as shown in Figures 11(a) and 12(a). One difference is that region R4 starts one set of data later (e.g. 170 test sets) for the second feature (F2) compared to F1 for the same path and also compared to both features F1 and F2 for path 1. Furthermore, PCA exhibits quite mixed clusters, from which only the region R5 can be separated for the F1, as shown in Figures 11(b) and 12(b).

Figure 12: (a) Outlier analysis and (b) principal component analysis for path 2 - feature 2 (F2). Regions R1-R5 are clear in OA results and while PCA clusters can not be attributed to certain region.

haviour is in general similar. Region R3 is the one which mostly draws the attention, since it is the one which shows a certain deviation from the normal condition. The key requirement here is the identification of the damage sensitivity of each path with respect to an early stage damage onset detection, namely area R3. The OA for path 1 and path 2 exhibits similar results except for the second feature (F2), which shows significantly higher levels of deviation for path 1. In addition, PCA shows a more distinctive separation between the resulting clusters for the first feature (F1) of path 1 compared to the same feature for path 2. Even though this is not very clear at this stage, one could in general conclude that path 1 exhibits a relatively higher damage sensitivity, especially at the area where the first notable damage seems to develop, in region R3. This was later verified from the lock-in images which showed that the first noticeable type of damage was in the form of patch debonding which initiated at the repaired bolted joint. This would significantly affect path 1
