Case Study: Wear Mechanisms of NiCrVMo-steel
and CrB-steel Scrap Shear Blades

Case Study: Wear Mechanisms of NiCrVMo-steel and CrB-steel Scrap Shear Blades

Abstract

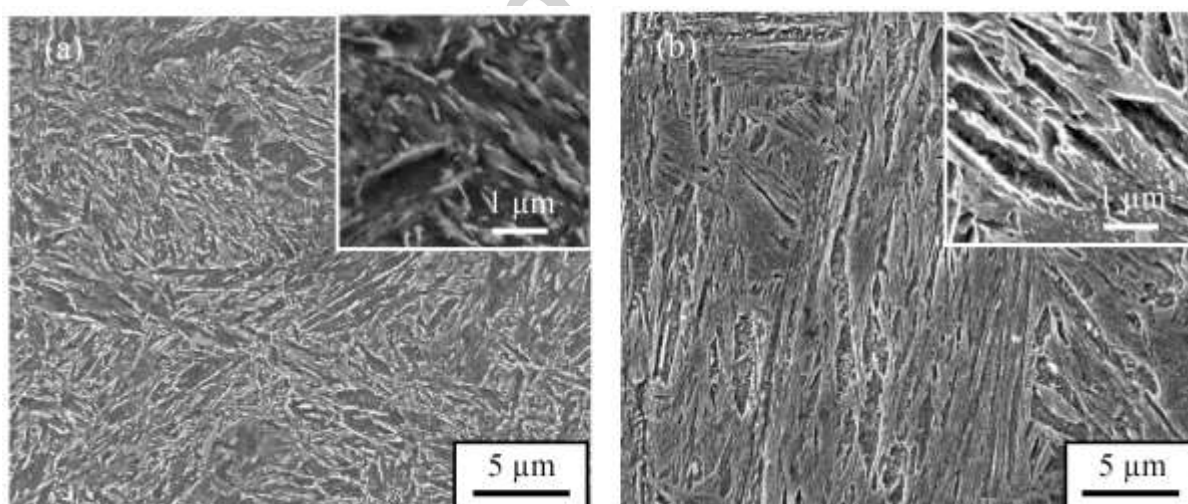
Fig. 2 shows SEM micrographs corresponding to the microstructure of matrix of studied blades. The microstructure of NiCrVMo blades mainly consisted of a tempered martensitic structure, while CrB blades were comprised of martensite. A comparison between SEM results (e.g. Fig. 2) demonstrated that the lath shaped tempered-martensitic structure in NiCrVMo steel was rather finer than martensitic structure in CrB steel (e.g. Fig. 2). Moreover, microscopy observations along rolling and transverse directions indicated no significant difference in the microstructure of both blades. From FEG-SEM observations at higher magnification (e.g. $\geq 40000\times$), it was also found that the microstructure of both blades comprised nano-scale Fe/alloy precipitates (Fig. 2). The results indicated that the density of observed carbides was qualitatively and considerably higher in the NiCrVMo steel. SEM-EDS results also revealed micro-scale non-metallic inclusions with different chemical compositions, sizes and morphologies that were distributed non-uniformly through the microstructure in both steels. In NiCrVMo blades, inclusions have an equi-axed morphology along both rolling and transverse directions. However, inclusions showed an equi-axed shaped morphology in the transverse direction and an elongated morphology along the rolling direction of CrB blades.

Further microstructural characterisations by XRD demonstrated the presence of martensite and retained austenite in the matrix of both blades. However, the amount of retained austenite was slightly lower in CrB steel compared to NiCrVMo steel (i.e. 1.1 vs. 2.7 wt%, respectively).

Fig. 2, SEM micrographs corresponding to the microstructure of matrix in studied blades, (a) NiCrVMo steel, (b) CrB steel.

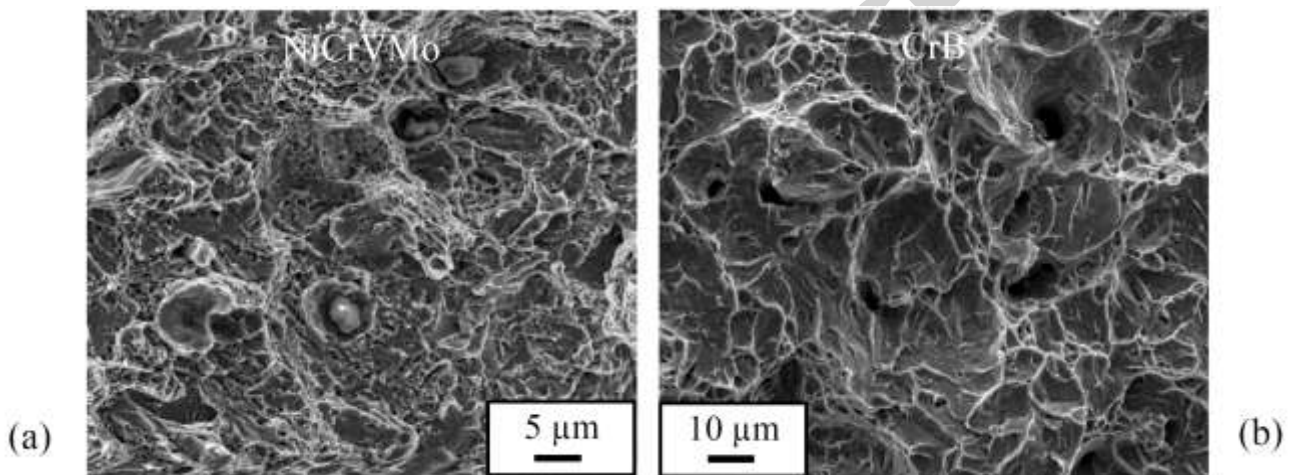
HRC. Furthermore, the results showed a higher toughness in CrB steel compared to NiCrVMo steel which can be mainly attributed to the effect of microstructure and chemical composition, especially the level of carbon content, i.e. 0.3 vs. 0.5 (wt%) [16]. SEM observations of Charpy specimens also indicated quasi-cleavage features in NiCrVMo steel (Fig. 3). However, the fracture surface of CrB steel showed a more ductile mode in both shear and cleavage areas, including relatively deeper/larger dimples compared to NiCrVMo steel. These results are consistent with toughness energy in all samples, confirming a rather low toughness of NiCrVMo steel compared to CrB steel.

Fig. 3, (a) and (b) SEM micrographs corresponding to the cleavage area of fracture surface of Charpy specimens.

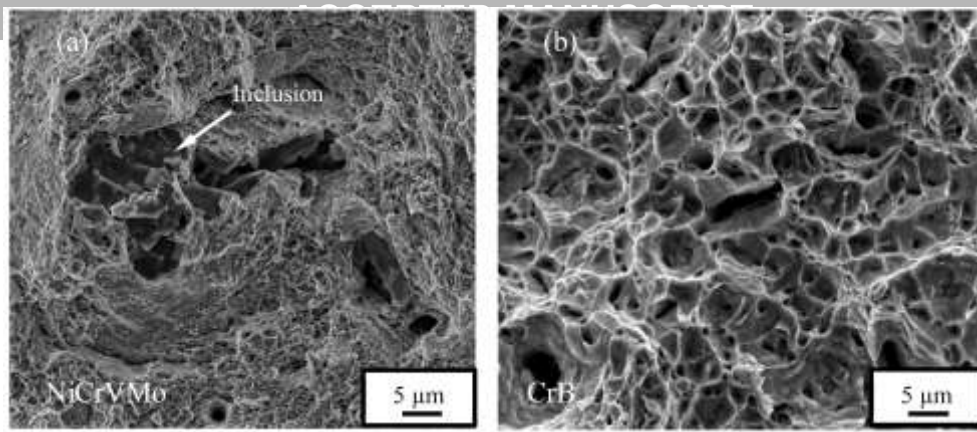
The tensile testing results showed similar yield and ultimate-tensile strengths for both steels, where the non-uniform elongation of NiCrVMo steels was significantly lower than CrB steel (Table 2). Moreover, tensile testing results indicated a ductile fracture in both steels, i.e. cup-and-cone. As with the fracture surface of Charpy specimens (e.g. Fig. 3), dimples were deeper/larger in CrB steel compared to NiCrVMo steel (Fig. 4).

Fig. 4, SEM micrographs corresponding to the fracture surface of tensile specimens, showing a dominant ductile mode fracture in all samples, (a) NiCrVMo blade, (b) CrB blade.

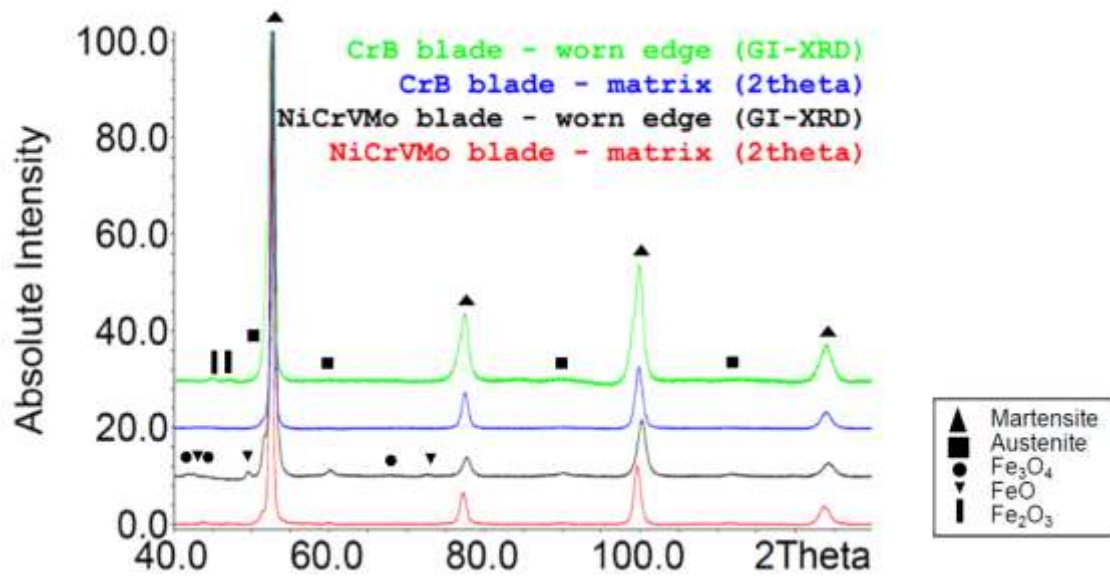
From the XRD spectra of both blades, two main phases were identified in worn areas which are martensite (with a BCC crystal structure [17]) and retained austenite (with a FCC crystal structure), e.g. Fig. 7. It should be noted that the peak shifting in the obtained spectra from the topmost surface was primarily attributed to residual stresses in worn surfaces. In fact, surface deformations due to wear resulted in residual stresses, though this was not studied as it was out of the scope of this research.

GI-XRD analysis successfully indicated the presence of retained austenite at worn surfaces of only NiCrVMo blades (Fig. 7). A comparison between the GI-XRD analysis of worn cutting edges with a dent shaped and round shaped regions showed a higher amount of retained austenite in the former regions (Table 3). These results indicated a wear induced phase transformation which could subsequently increase the retained austenite on the surface of worn edges in NiCrVMo blades. From the GI-XRD analysis of both blades, it was also found that Fe-oxides (i.e. FeO, Fe₂O₃ and Fe₃O₄) were formed during wear, though the type of oxides was different in two studied blades (Fig. 7).

Fig. 7, XRD spectra (2theta and grazing incidence methods), showing peaks corresponding to ferrite and retained austenite in the matrix and worn cutting edges of NiCrVMo and CrB blades.

detected on the worn edge of CrB blade (Fig. 7). It is thought that the oxide was mainly formed due to mutual interaction between blade surface and scraps. In fact, interfacial temperature rises due to frictional heat increased the temperature over the flash temperature, especially in asperity contacts [25,26,27,28]. A high temperature in addition to ambient humidity could enhance the oxide formation on the surface. The asperities were smeared and debris was formed during initial stage of impact/sliding wear by abrasion or adhesive spalling of mating surface asperities [29,30]. However, an abrasion due to sliding or rubbing the trapped debris or detached wear particles (e.g. hard oxides) between contact surfaces scratched and ploughed grooves on the worn surfaces (Fig. 5) [27,31].
