AN INVESTIGATION INTO THE NON-UNIFORM DECAY OF HARDWICK STONE

Robert Brough⁴ & Elizabeth Laycock

Hardwick stone as used on the vernacular Hardwick Estate buildings decays in a non-uniform way. Typically stones at Hardwick decay cavernously leaving the mortar matrix behind. Levels of decay can vary dramatically from stone to stone with one stone showing advanced decay whilst adjoining stones are relatively intact. Ten sample buildings giving a total of 1587m² of elevations and with a good geographical spread across the estate were surveyed. Ratings were assigned according to condition. It was shown with 95% confidence that the weathering on the western elevations is significantly worse than that seen on the eastern elevations of the sample buildings. Northern elevations had high levels of stonework in good condition, while western elevations had the lowest. The prevailing wind direction on the Estate is west to north-west. The difference in levels of decay below 1 metre and above 1 metre has been shown to be significant at the 95% confidence level with a slight correlation between levels of stone decay and building height (above sea level). The survey also highlighted stone decay

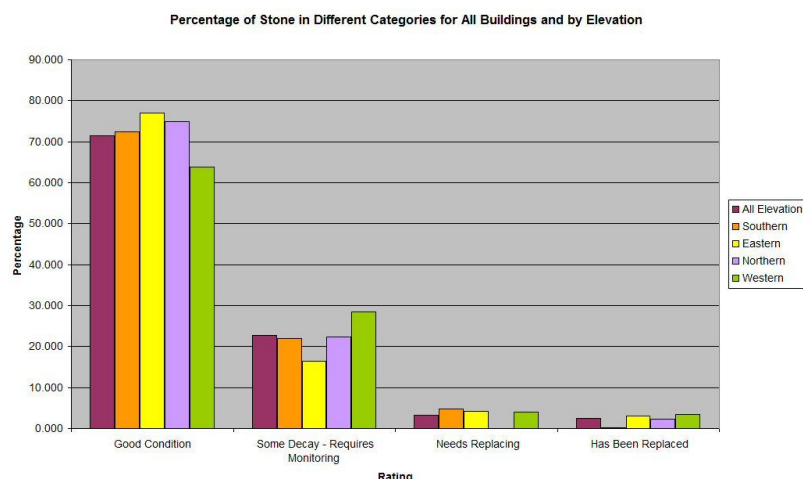
Figure 3: Graph of stone condition for all buildings

As can be seen from above the eastern elevations of the buildings surveyed have the highest proportion of stone in good condition (77%). The western elevations have the lowest proportion of stone in good condition (64%). The average for all elevations is 71%. The western elevations also have the highest proportion of stone that is showing some signs of decay (28%), the eastern elevations have the lowest (17%). The southern and northern elevations are close to the average figure for all elevations in this category both at 22%. The average is 23%. The northern elevations have no stone that requires replacement although 2% of northern elevations have already had stone replacement. The average for all elevations in

Given the difference between the proportion of western elevations that have stone in good condition and the proportion of eastern elevations that have stone in good condition the Chi-square test has been applied to the data to assess whether this apparent difference is statistically significant or not. The Chi-square test was used and it can be said with 95% confidence that the two sets of results are significantly different between the amount of weathering occurring on the western elevations of the sample buildings and the amount of weathering occurring on the eastern elevations. Ted Edwards, Head Warden Hardwick Hall Estate, (pers. comm. March 2008) states that the prevailing wind direction at Hardwick is west to north-west. This could help to explain the difference in weathering observed between the western and eastern elevations, however it would not necessarily explain the lower weathering seen on the northern elevations, as Figure 11 shows, the northern elevation has the second highest proportion of stone in good condition at 75%. This is an interesting finding as it may be expected that the northern elevation would receive high levels of wind and rain and low levels of insolation. Robinson and Williams (1999, p.11) investigating the weathering of Hastings Beds sandstone gravestones suggested that the more severe weathering of gravestones on their western sides could be attributed to their facing the prevailing wind, and thus being more frequently rain-soaked as well as them being sun-lit in the later parts of the day when air temperatures are highest, which may cause them to become drier than the eastern sides. This might indicate that decay is by cyclic wetting and drying rather than frost or chemical degradation.

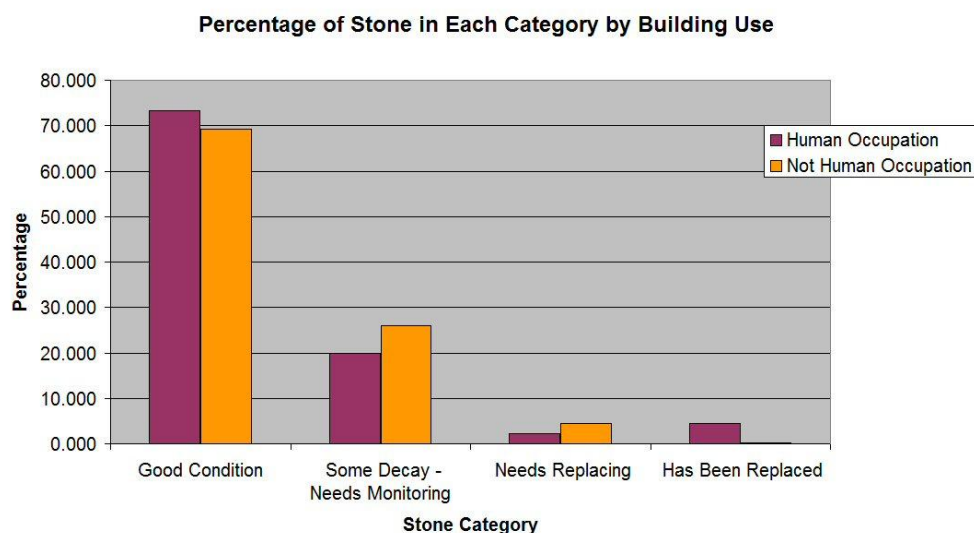
Figure 124: Graph of stone condition by building use

As can be seen from Figure 124 those buildings designed for human occupation have a slightly higher proportion of stone in good condition than those designed for other uses 73%

There are various reasons as to why stone might fare better on buildings designed for human occupation. They are generally built using better materials, techniques, designs and craftsmanship in the first place. For example a number of buildings designed for human occupation have overhanging roofs which provide protection to the walls. They have more efficient mechanisms for carrying rainwater off the roof and away from the building i.e. functioning gutters and downpipes. In addition there is more likelihood of earlier and effective care and maintenance, for example a building that is occupied by humans is less likely to be damp as the occupiers are likely to take steps to rectify any dampness and the internal space will be heated. Buildings not designed for human occupation probably suffer more abuse over their lifetimes. For example: buildings that have been used as animal shelters often have contaminated masonry due to contact with animal waste which occurs over a period of many years. Water is a major agent of decay since water can transport salts into the pore spaces of stones, either from the ground or other sources; cause decay due to the freeze-thaw process and can also cause decay due to its acidity. The text above sets out a number of reasons why buildings designed for human occupation may suffer less from water penetration and therefore from salt crystallisation, freeze-thaw and acid attack. However the Chi-square test has been carried out on the data for the relative proportions of stone in good condition for human and not-human occupation. The results of the test show there is no significant difference between the two sets of data and thus the hypothesised better quality of stone in human habitations cannot be proved by the observations made.
