TEM observations of wear mechanisms of TiAlCrN and TiAlN/CrN coatings grown by combined steered-arc/unbalanced magnetron deposition

LUO, Quanshun <<http://orcid.org/0000-0003-4102-2129>>, RAINFORTH, W.M. and MÜNZ, W.D.

Abstract: The dry sliding wear of monolayer TiAlCrN and TiAlCrYN and multilayer TiAlN/CrN coatings has been investigated against a BM2 tool steel counterface using a ring on block configuration at 91 N, 0.42 m/s. The coatings were deposited on a BM2 tool steel substrate by combined steered-arc/unbalanced-magnetron deposition. The wear rate of the multilayer was superior to the monolayer, although both provide a substantial improvement compared with the wear behaviour of the base BM2 tool steel e.g., wear rate = 6.1×10^{-4} mm³/m for the BM2 tool steel; 3.98×10^{-5} mm³/m for the TiAlCrN monolayer and 2.58×10^{-5} mm³/m for the TiAlN_rCrN multilayer. Wear of the coatings occurred by several mechanisms, fine scale -200 nm. detachment in the early stages and micron scale detachment associated with cracking in the coating in the later stages. Detailed transmission electron microscopy of cross-sections of the worn surface indicated that two dominant types of cracking we

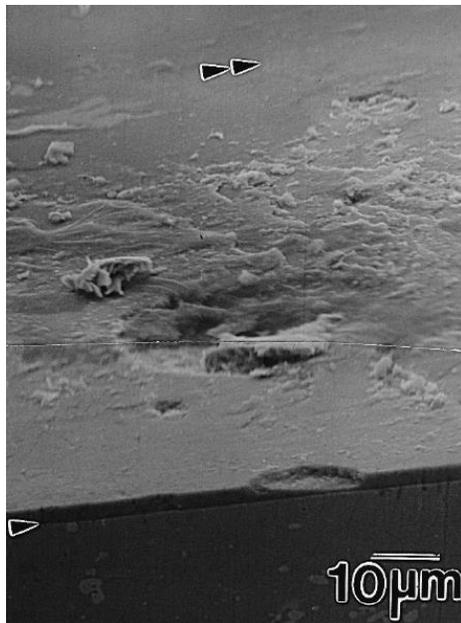
Fig. 1. Scanning electron micrograph of the worn multilayer TiAlN/CrN coating, taken after sectioning the worn surface the substrate/ coating interface is marked by a single arrow and the sliding direction by a double arrow. Note the spalling of the coating. The micrograph clearly demonstrates that the spalling is within the coating and not at the coating substrate interface.

Loss of the coating during the initial stages of wear was caused by spalling Fig. 1. Spalling was from within the coating at this stage, with no evidence of detachment at the coating-substrate interface. The base of the spall had an irregular morphology, but ran approximately parallel to the

coating surface. In contrast, the sides of the spall were generally smooth and perpendicular to the coating surface. In addition to the spalling, thin, irregular surface films were present Fig. 1. Despite the differences in wear rate between the coatings, no obvious differences in worn surface morphology could be detected in the SEM.

The spalling and delamination shown in Figs. 4 and 8 was on a scale that would not be detected in the SEM. Nevertheless, the SEM observations indicated that failure of the coating was preceded by a mm scale spalling within the coating e.g., Fig. 1., and that locally high concentrations of spalling was a mechanism by which the counterface penetrated the coating. Observations of spalling in 1st and 2nd generation coatings are common e.g., Refs.[11,39]. Regrettably, the TEM specimens taken from the early stages of wear prior to penetration. did not reveal macroscopic cracking. Nevertheless, the morphology of the spalling Fig. 1. correlated closely with the modes of cracking observed in Figs. 5 and 9. Two types of cracking appeared to be responsible for material loss. First, pre-existing cracks along columnar grain boundaries increased in number and length as a result of the wear process, shown schematically in Fig. 13. Additional cracking occurred within the columnar grains. However, since these cracks were perpendicular to the sliding direction, they do not, on their own, lead to material loss. Secondly, cracking was developed during the wear process with an orientation within approximately $\sim 20^\circ$

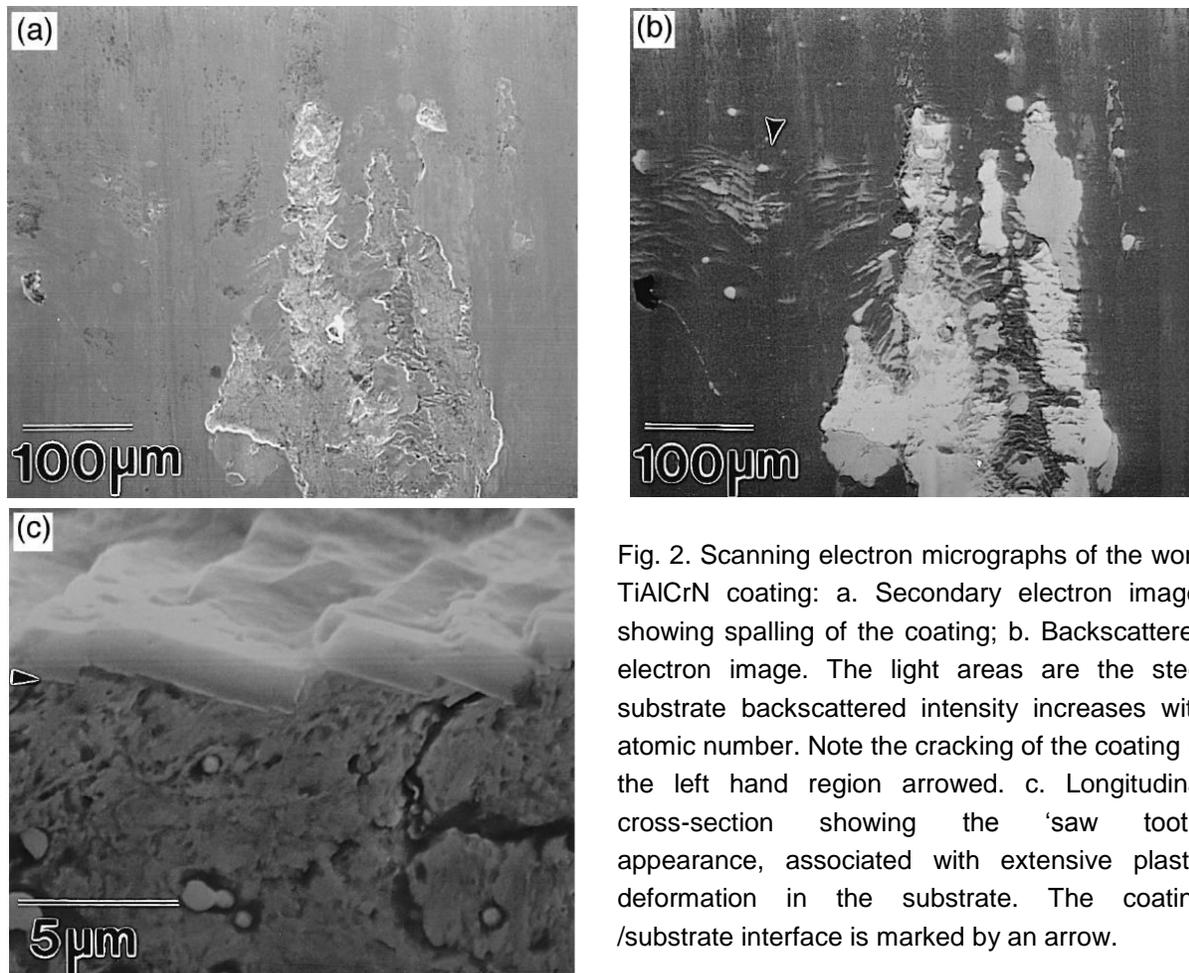
Fig. 2. Scanning electron micrographs of the worn TiAlCrN coating: a. Secondary electron image, showing spalling of the coating; b. Backscattered electron image. The light areas are the steel substrate backscattered intensity increases with atomic number. Note the cracking of the coating in the left hand region arrowed. c. Longitudinal cross-section showing the 'saw tooth' appearance, associated with extensive plastic deformation in the substrate. The coating /substrate interface is marked by an arrow.

Regions of locally dense spalling eventually led to complete loss of the coating and penetration of the counterface through to the BM2 substrate Fig. 2. At this point, wear of the coating at the edge of the wear scar was accelerated. This was associated with extensive cracking within the coating Fig. 2b. Similar gross cracking was observed in the coating just prior to exposure of the substrate and the presence of this cracking indicated the onset of coating failure Fig. 2c. Again, this type of wear mechanism was the same for all coatings tested. The full details of the SEM observations of the coating wear mechanisms as a function of sliding speed and load are given elsewhere [29].

Once the coating was lost in any place, or its thickness severely reduced by local spalling, contact with the substrate occurred i.e., penetration of the coating. At this point, the wear of the coating at the edge of the wear scar proceeded rapidly, as a result of severe cracking within the coating Fig. 2. Plastic deformation within the substrate resulted in a significant strain discontinuity between coating and substrate and therefore accelerated detachment rates, in a similar manner to that observed in Figs. 5 and 9. This is in contrast to the early stages of sliding where no deformation was found in the substrate material.

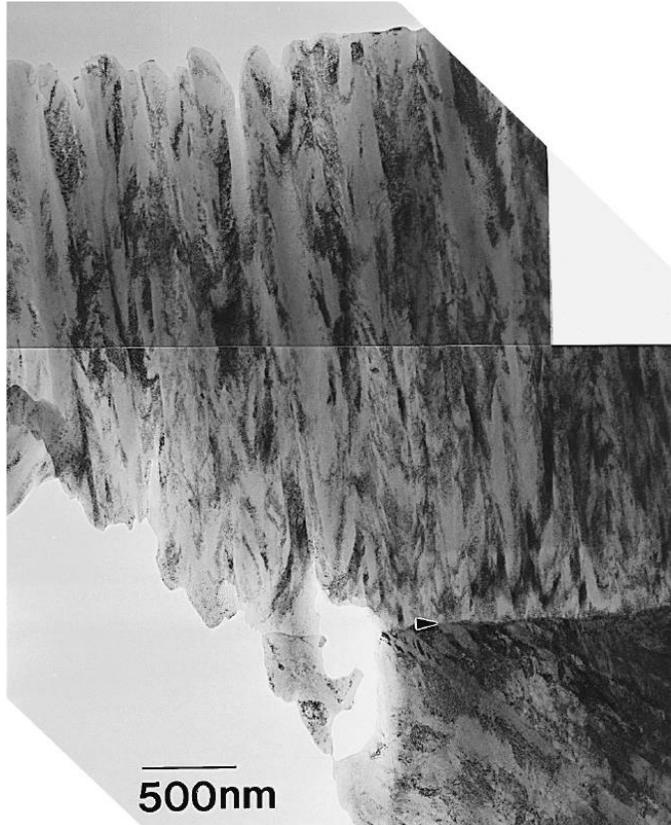
Fig. 3 Bright field TEM micro graph from a longitudinal cross-section sample of the worn TiAlN/CrN multilayer. The sample was taken during the initial stages of wear. The upper left surface has been eroded during ion thinning and is therefore not the original worn surface. Note the general absence of damage either by cracking or deformation. The arrow indicates the direction of sliding and the interface between coating and substrate.

For the TEM observations, samples were removed from the two distinct wear regimes where the wear scar was contained entirely within the coating: 1. the early stages of wear and 2. where gross cracking indicated the onset of coating failure. Fig. 3 gives a low magnification TEM micrograph taken from the TiAlN/CrN multilayer taken from regime 1. This shows no evidence of significant microstructural change either in the coating or substrate note also the

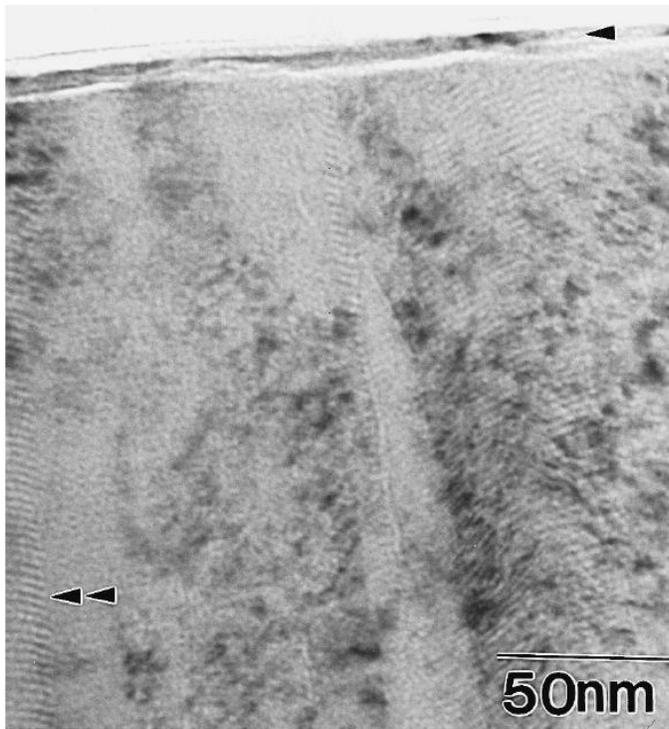
Fig. 4. Bright field TEM micrograph from a longitudinal cross-section sample of the worn TiAlN/CrN multilayer showing the extreme worn surface. A thin surface layer has become detached arrowed. However, detachment did not occur at a layer interface. This feature was not observed on either of the worn monolayer coatings. The multilayer structure can be seen from the Fresnel contrast e.g., at the double arrow. There is a columnar grain boundary running top to bottom at the mid position of the micrograph. The sliding direction is indicated by the direction of the arrows.

between coating and substrate and the columnar structure to the coating. Fig. 4 gives a higher magnification bright field micrograph of the extreme worn surface as labelled by the retention of the epoxy resin. A thin delaminated layer is present of thickness ~ 8 nm, which was observed at

several points on the surface. The multilayer structure is evident within this image the image is taken just out of focus to provide Fresnel fringe contrast of the multilayer structure. From which it can be seen that detachment of this layer did not occur along the TiAlN/CrN interface. Interestingly, the multilayer structure appears to be preserved up to the delaminated layer suggesting that frictional heating had not been sufficient to cause breakdown of the layered structure through diffusion.

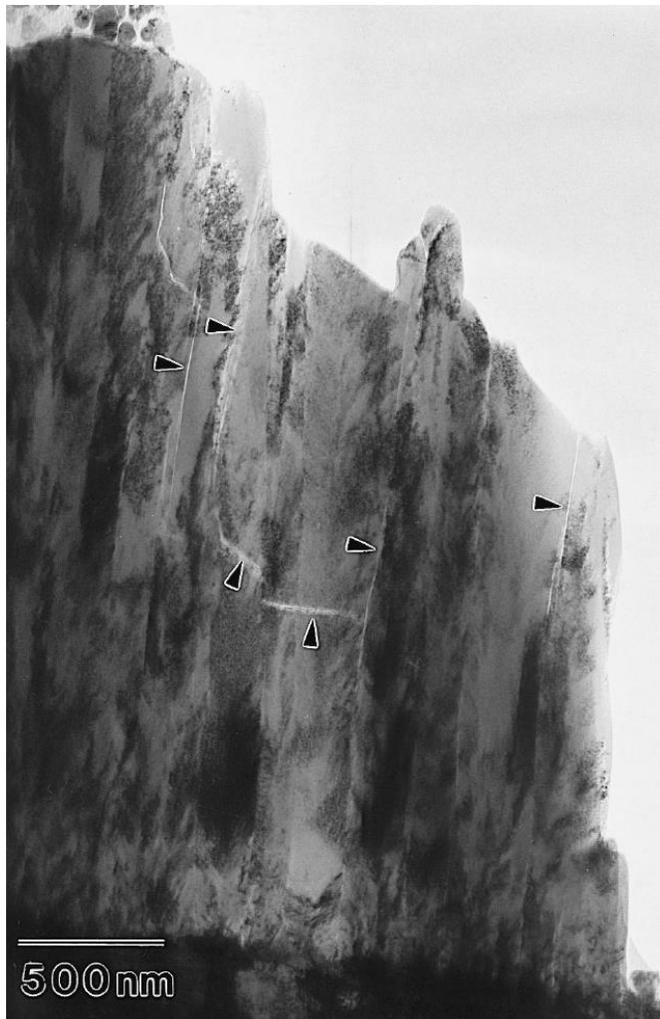
Fig. 5. Bright field TEM micrograph from a longitudinal cross-section sample of the worn TiAlN/CrN multilayer which exhibited damage in regime 2. The parallel cracks arrowed. did not run along the TiAlN/CrN interface, but those perpendicular to the worn surface were generally along columnar grain boundaries. The interface between substrate and coating corresponds to the position of the scale bar.

Fig. 5 gives a bright field TEM image from the edge of the TiAlN/CrN wear scar taken from regime 2., i.e., with the presence of macroscopic cracking which indicated the onset of coating failure. Extensive cracking is apparent within the coating. In this instance, cracking falls into two broad categories: 1. cracking perpendicular to the worn surface, frequently but not always, along the columnar grain boundaries; 2. cracking across the grain boundaries, often within $\pm 20^\circ$ to the coating surface. Some of the cracking along columnar grain boundaries was present in the as-deposited state, but its extent was substantially greater after wear testing. Fine wear debris from the TiAlN/CrN identified by selected area electron diffraction. was present at the worn surface Fig. 6.

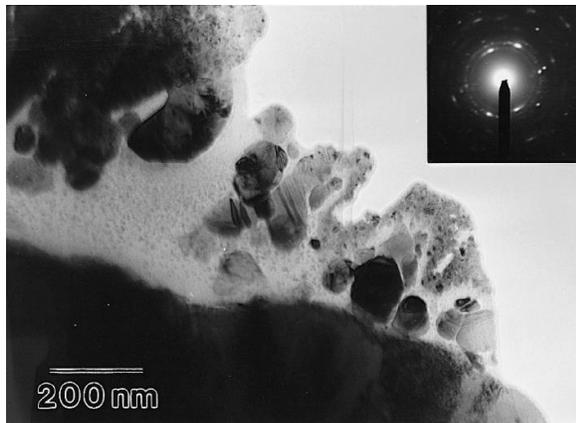
Fig. 6. Bright field TEM micrograph from a longitudinal cross-section sample of the worn TiAlN/CrN multilayer showing wear debris particles at the worn surface.

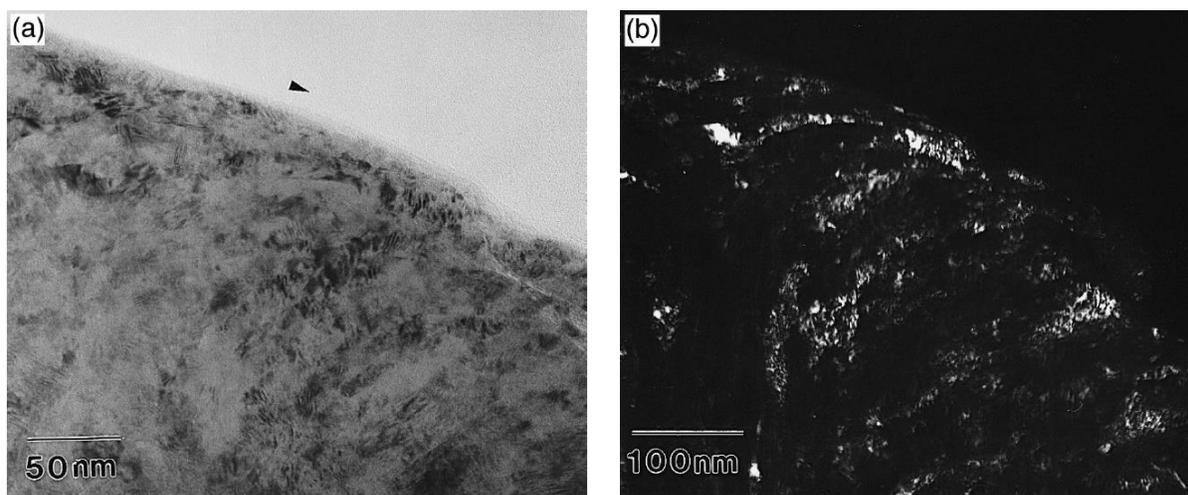
Fig. 7. TEM micrographs from a longitudinal cross-section sample of the worn TiAlCrYN monolayer showing the extreme worn surface. a. Bright field image; b. Dark field image. Note the bending of the structure in the direction of sliding arrowed, indicating surface deformation.

Fig. 7 gives a bright and dark field TEM images of the worn surface of the TiAlCrYN monolayer during the early stages of wear. The dark field image Fig. 7b. indicates a bending of the columnar grain structure in the direction of sliding, which is evidence of surface deformation. The depth of deformation as determined by the bending of the columnar structure. varied along the surface in the range ~50-200 nm. Similar deformation was observed for the TiAlCrN, but was never seen at the surface of the TiAlN/CrN multilayer.

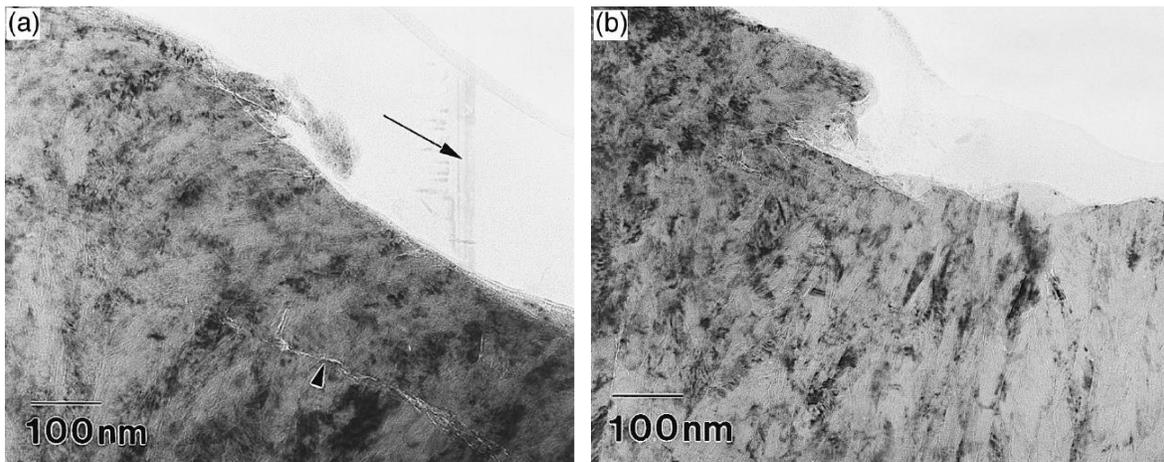
Fig. 8. Bright field TEM micrographs from a longitudinal cross-section sample of the worn TiAlCrYN monolayer showing the extreme worn surface. a. Cracking parallel to the worn surface arrowed. The cracking in this example, and several others, was at the interface between de formed and as-deposited material. b. Local detachment of a wear debris particle at a depth corresponding to the cracking in a. The sliding direction is shown by the large black arrow in each case.

Cracking parallel to the surface was observed in the TiAlCrYN sample in several places and was generally located at a depth where the deformation was just visible in the TEM, Fig. 8a. The cracking led to periodic spalling of the deformed layer Fig. 8b.

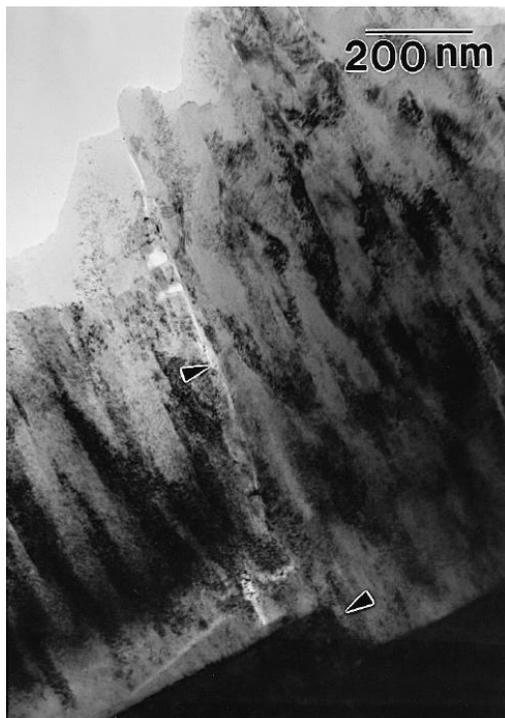
Fig. 9. Bright field TEM micrograph from a longitudinal cross-section sample of the worn TiAlCrN monolayer showing the displacement of the substrate arrowed. and the cracking in the coating arrowed., similar to that seen in the multilayer coating in Fig. 5.

Fig. 9 gives micrographs from the wear scar of the TiAlCrN in regime 2., i.e., where the coating contained macroscopic cracking. Extensive plastic deformation had occurred in the BM2 substrate. The coating had fractured extensively, with a regular displacement of both coating and substrate, giving a 'saw-tooth' type appearance, similar to that seen in Fig. 2c. Again,

fracture of the coating occurred predominantly in two orientations, along columnar grain boundaries and

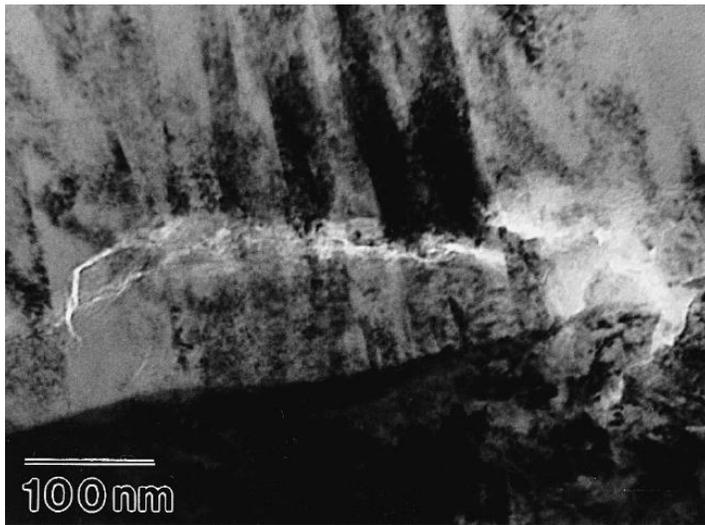
Fig. 10. Bright field TEM micrograph from a longitudinal cross-section sample of the worn TiAlCrN monolayer showing the cracking at the base of the coating.

within $\sim 20^\circ$ of parallel to the coating surface. Cracking was mainly contained within the coating, but occasionally propagated into the substrate Fig. 10. In contrast to the absence of plastic deformation in the multilayer coating and the limited plastic deformation in the TiAlCrYN and TiAlCrN coatings, extensive plastic deformation was found at the surface of the uncoated BM2

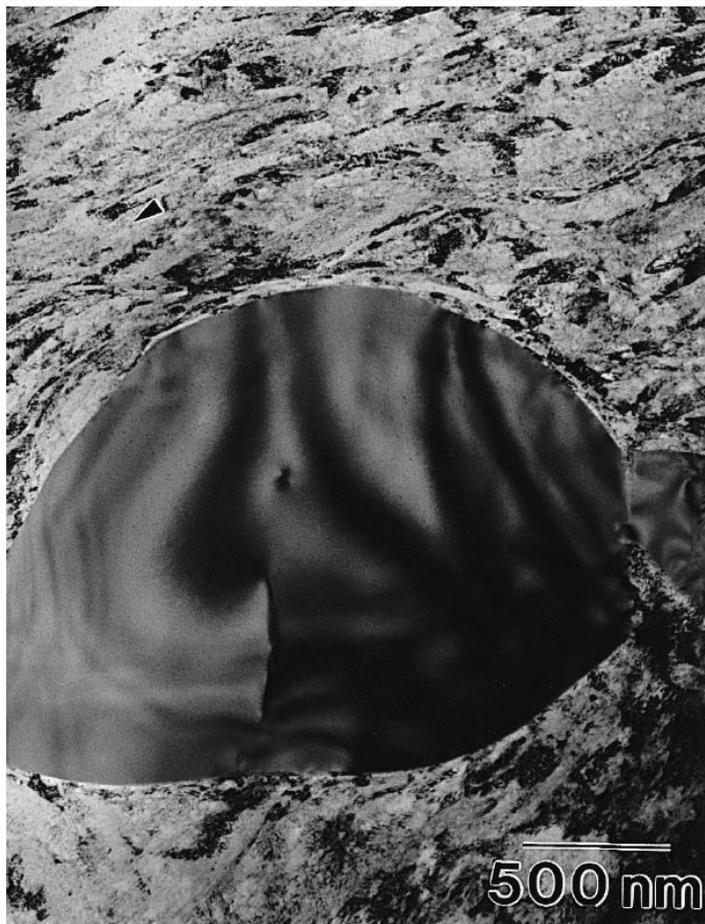
Fig. 11. Bright field TEM micrograph from a longitudinal cross-section of the worn surface of the uncoated BM2 steel. Extensive plastic deformation is present, which has flowed around an MC carbide worn surface at the upper end of the micrograph. The arrow indicates the direction of sliding.

steel Fig. 11. The martensitic structure present at the start of the test had been transformed into a predominantly α -Fe structure, with associated deformation texture a weak $\{100\}\langle 110 \rangle$ texture.

Subgrain size decreased as the worn surface was approached, with a minimum thickness of ~ 20 nm observed Fig. 12. Fig. 11 also shows the extensive plastic flow of the matrix around the

MC carbide where M denotes W, Mo, V, Cr. and the manner in which subgrain size reduces close to the MC/matrix interface.

the hard martensitic structure present before testing to a heavily deformed α -Fe structure. The same conditions induced minor deformation in the TiAlCrYN and TiAlCrN coatings and no deformation in the TiAlN/CrN multilayer. There has been considerable debate as to the origin of the very high hardness values of the 'superlattice' multilayer coatings [32–37]. While the precise origin is controversial many theories have been proposed, for example, elastic modulus effects [32], alternating stress fields [33], the difference in dislocation line energy between the layers [34–37] and coherency strains [37], Hall–Petch effect [38]., it is clear that dislocation flow is severely retarded by the multilayer structure compared with the monolithic counterparts. The current TEM observations are in accord with this view. The layer structure provides a useful microstructural marker that would allow the presence of plastic deformation at the surface to be readily detected. Even in the outer few nm, the superlattice structure was retained and showed no obvious distortion. It should be emphasized that dislocation flow in a hard tool steel such as the BM2 used here requires high contact stresses and the presence of such extensive plastic deformation Figs. 11 and 12. demonstrates the severity of the contact conditions.

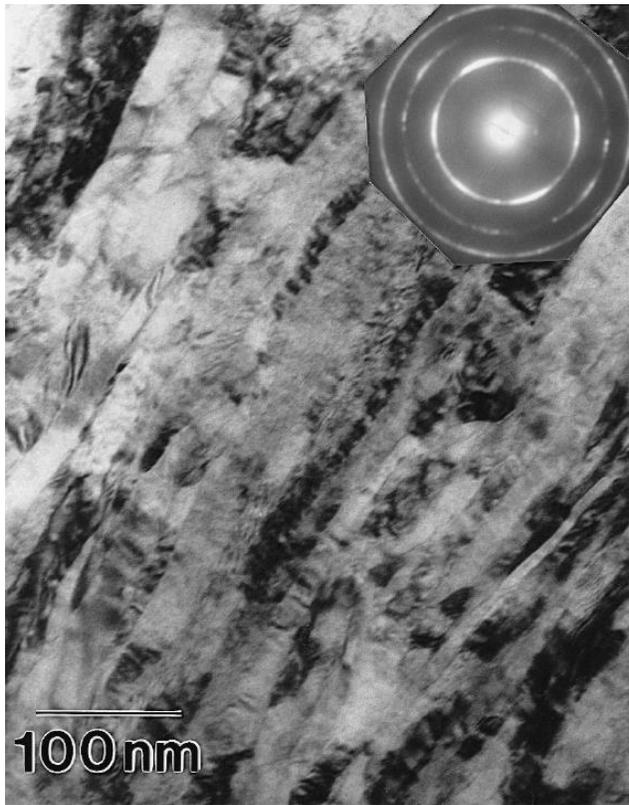
Fig. 12. Details from Fig. 11, showing a subgrain thickness of ~ 20 nm and the texture.

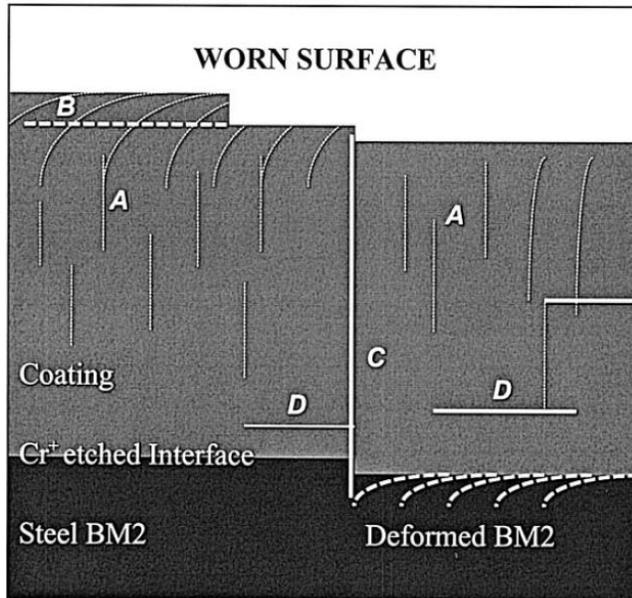
Fig. 13. Schematic of the cracking and deformation mechanisms in the coatings.

to the coating surface. These cracks tended to form initially within a single columnar grain, but propagation across columnar grains and intersection with the columnar boundary cracks provided a potent source of wear debris liberation Figs. 1 and 13. Interestingly, such cracking was constrained within the coating and did not occur at the coating-substrate interface. This
