## **Practical challenges in mitigating the aftermath of fire in historic buildings**

KINCAID, Simon (2020). Practical challenges in mitigating the aftermath of fire in historic buildings. *The Historic Environment: Policy & Practice*, 12 (1), 77-96. [Article]

## **Abstract**

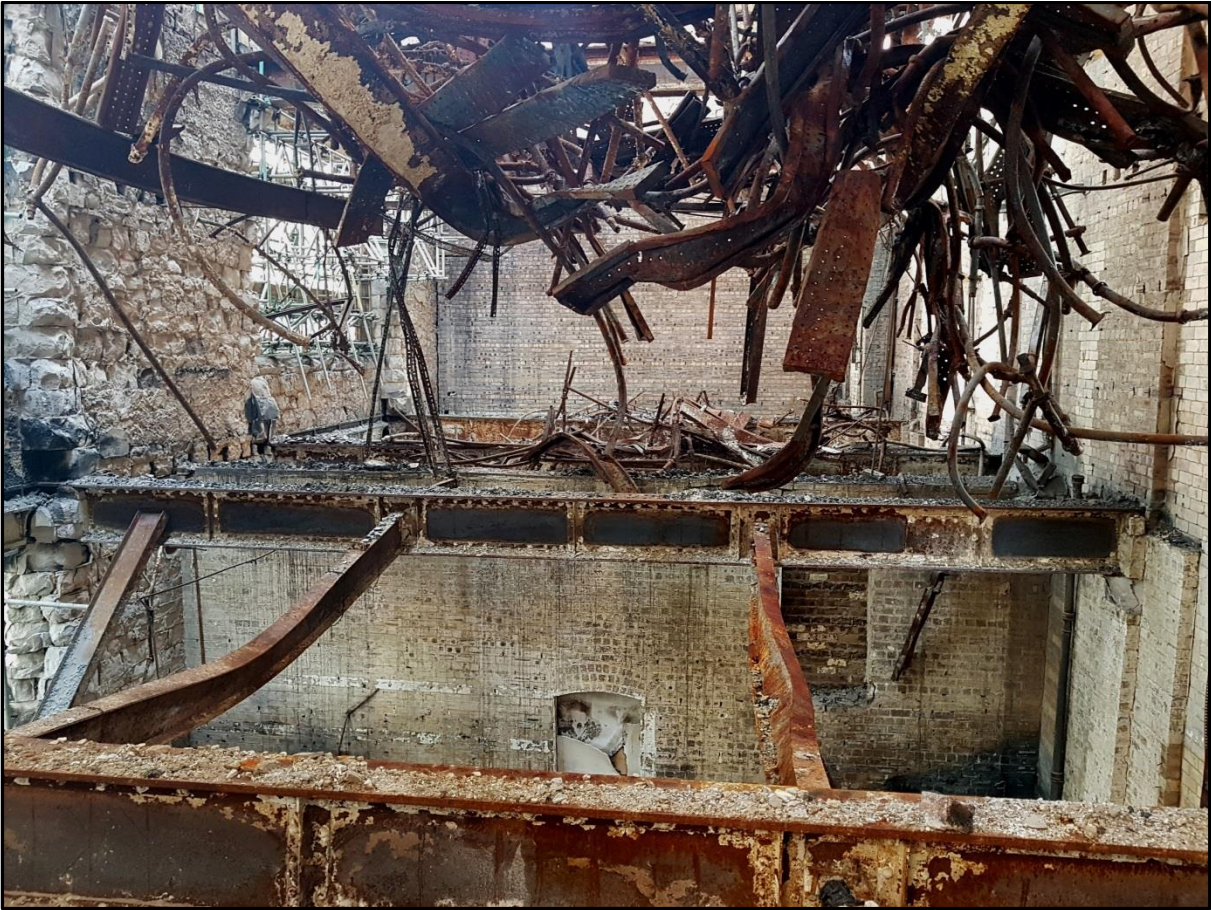
Figure 1. The interior of the Mackintosh Building at Glasgow School of Art following the 2018 fire. Note the distorted steel beams in the foreground; the hanging debris above and the badly damaged stonework on the left. The intense heat of the fire consumed the majority of interior fixings and finishes, leaving the brickwork exposed in most locations.

The potential scenario following a serious fire is a weakened structure, possibly with important structural elements missing or compromised. This is not limited to timber elements; high temperatures will often also cause distortions to steel elements and damage to masonry. In some circumstances there may be the danger of large-scale collapse and even if this is not the case sections of the building, particularly at high level, may pose a risk. The building may also be open to the sky, since it is common for roofs to be lost in fires. Internal floors may have been partially or totally lost and ground floor rooms may be full of substantial amounts of debris from above. Basements may be full of water from firefighting operations.
