Understanding and controlling the ingress of driven rain through exposed, solid wall masonry structures

Elizabeth A Laycock* (1) & Christopher Wood (2)

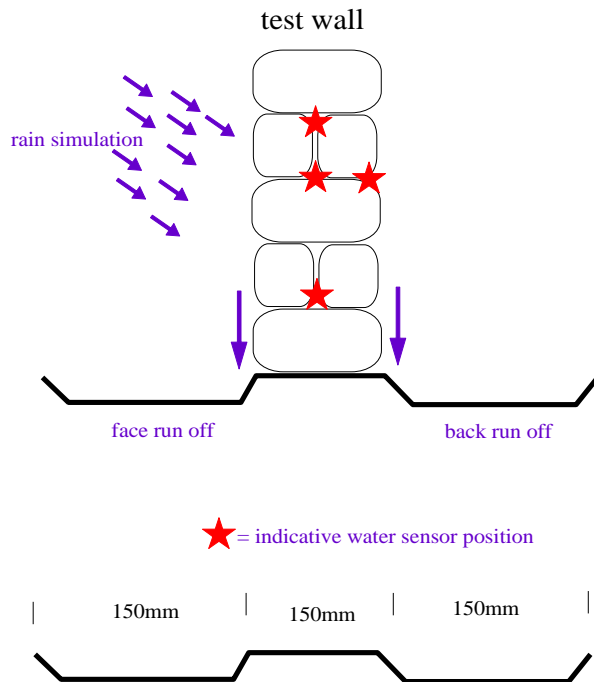
Figure 1 *Diagram of test wall and trough configuration for pilot work*

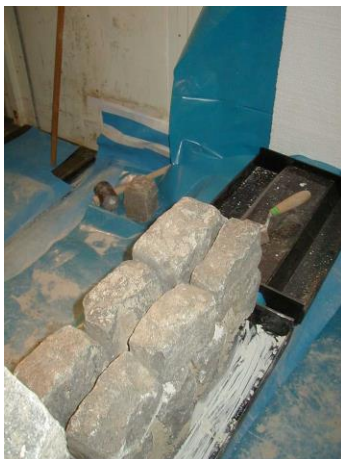
Figure 2 *Walls for pilot work under construction. Photograph from rear face*

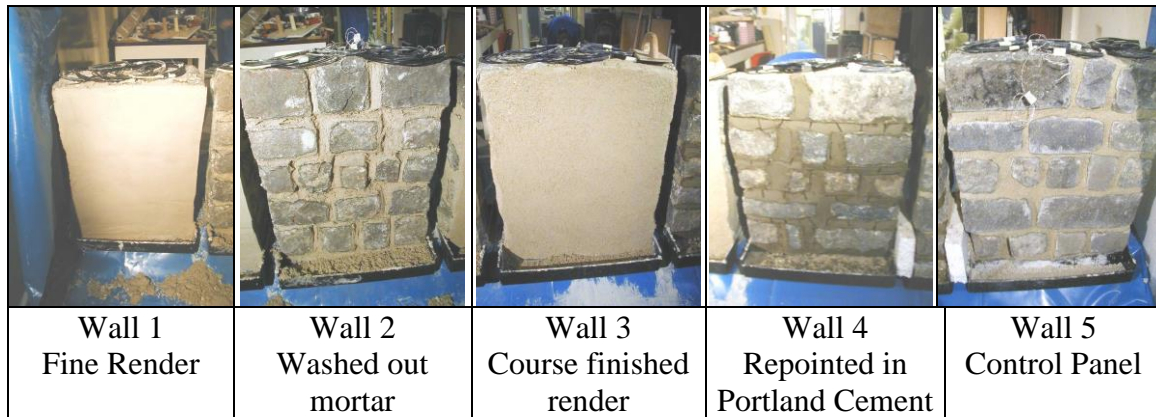
Figure 3 *Finished walls. View from Climate Side of Chamber*

Temperature sensors (copper constantan type-t thermocouples) proprietary humidity sensors and trial water sensors were implanted during the build, and the resulting wallettes were isolated from each other by polystyrene and silicone sealant. The test panels were also sealed to top of the chamber using a false wall to prevent water ingress from above. See Figure 3

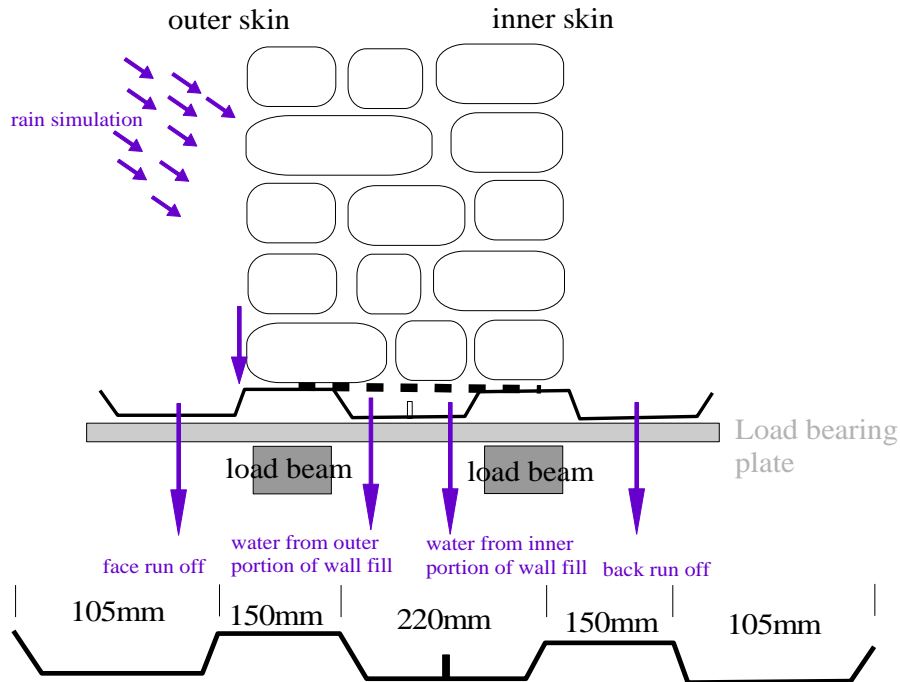
Figure 4 Diagram of test wall and trough set up for continuation work

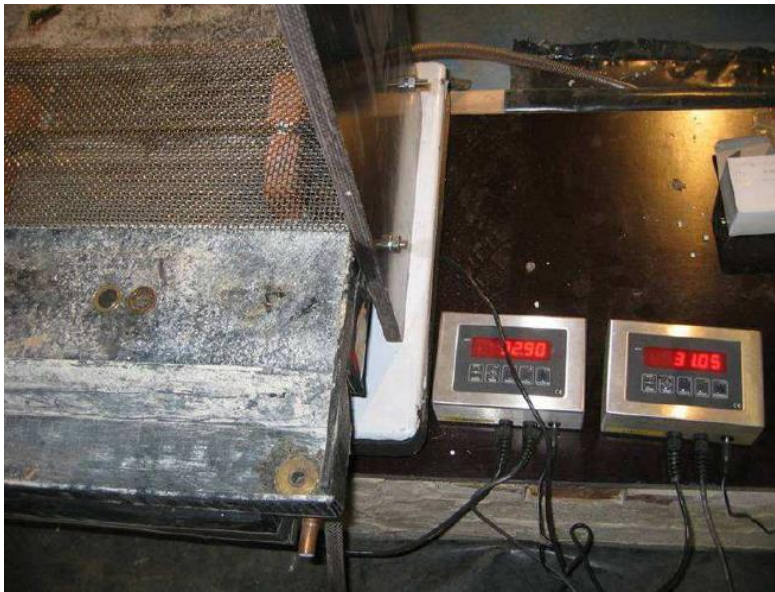
Figure 5 The weighing balance used in the continuation work showing the base with heavy duty gauze so that water discharging through the core can be collected in the trough. (Photograph from Wood, 2010)

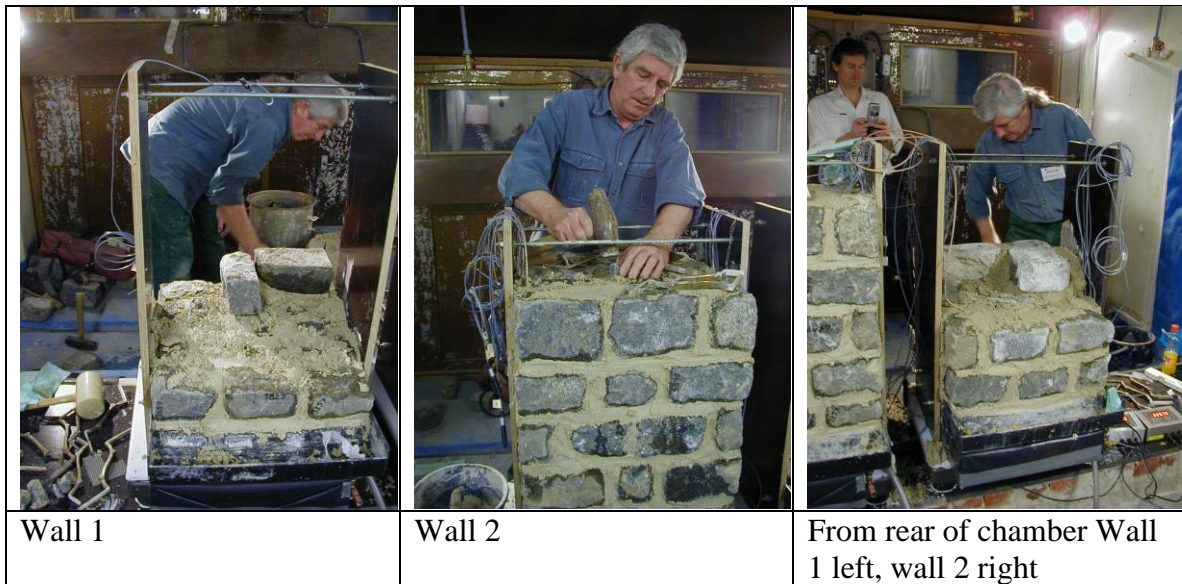
Figure 6 Continuation work walls 1 and 2 under construction

The initial work suggested a number of changes to be made for the full scale wall construction and testing in the continuation work. The chamber was split in order to accommodate the large wall sizes and a temporary solid wall 1160mm high x 540mm wide 4m long was built to be used as a base to support the four UWE 600 kg platform scales on which each wall was built. New bases were fabricated to allow a thickness of 420mm (Figure 4) with a configuration which would allow collection of water running off the front and back of the wall or running down through the central core area. Walls were built in two phases, with the first two constructed to best practice methods using the same diorite setts as the pilot work. Setts were numbered and weighed and thus an overview could be established of the components of the wall in terms of setts and mortar (Wood 2010). Embedded sensors for water, temperature and humidity were again used in addition to logging of mass changes registered on the platform scales. It was intended to allow curing of the walls to constant weight, but in practice this could not be achieved in an acceptable time frame and thus curing was for 109 days in total. Figure 6 shows the walls under construction.

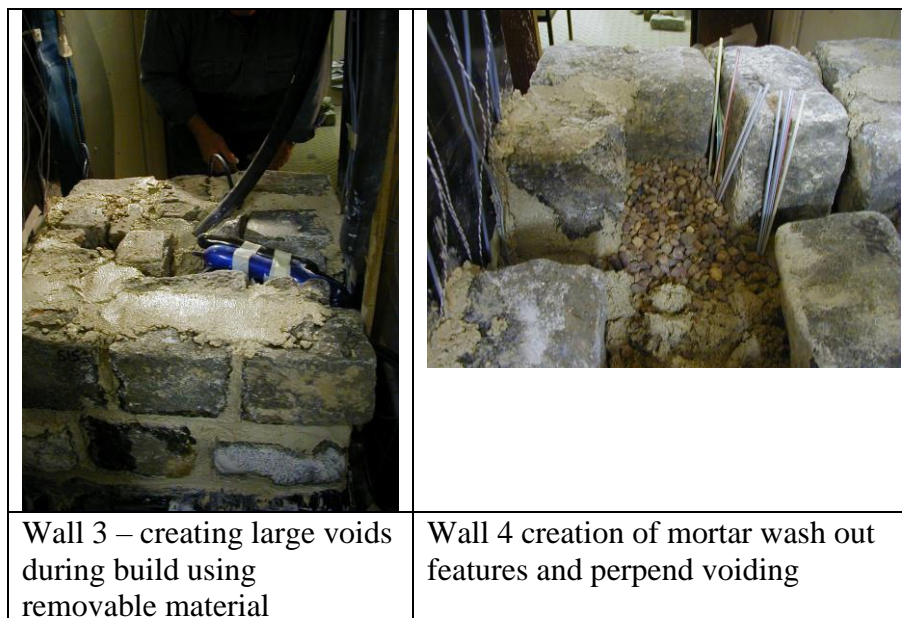
Figure 7 Building voided walls 3 and 4 for continuation work

The second phase of the continuation work would see construction of walls containing flaws usually seen in weathered walls and was overseen by Chris Wood. Walls 3 and 4 were built so as to incorporate voiding within the structure and two different methods were used. In wall 3 relatively large cavities were created by using temporary forms using an inner tube (to create a large continuous void, and modeling balloons to create discontinuous voids. The inner tube was withdrawn as building progressed and the deflated end of the balloon was left protruding from the back of the wall and was deflated and withdrawn after 48 hours. In wall 4 areas of gravel were used to mimic lime washout without significant cavity formation. In addition vertical pathways were created using straws which were withdrawn immediately prior to the construction of the subsequent course. Some perp-end joints were deliberately left dry or were damaged during building to encourage water flow (Figure 7). It was hoped that post testing work would be able to ascertain if these pathways were significant to water ingress and as such each course was photographed as it was constructed because this might help when the results were analysed.

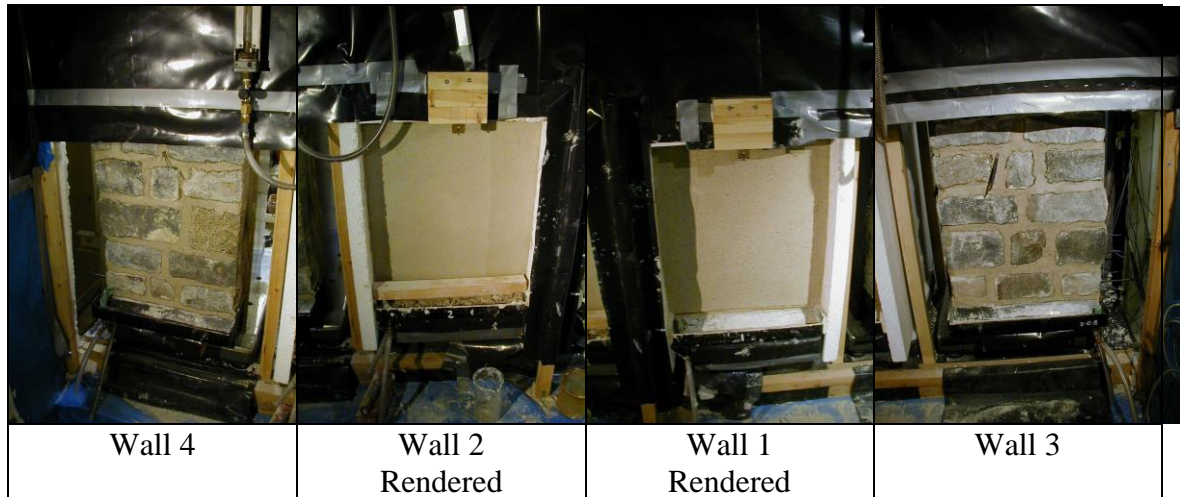
Figure 8 View of walls 1 to 4 of the continuation work as seen from climate side of chamber.

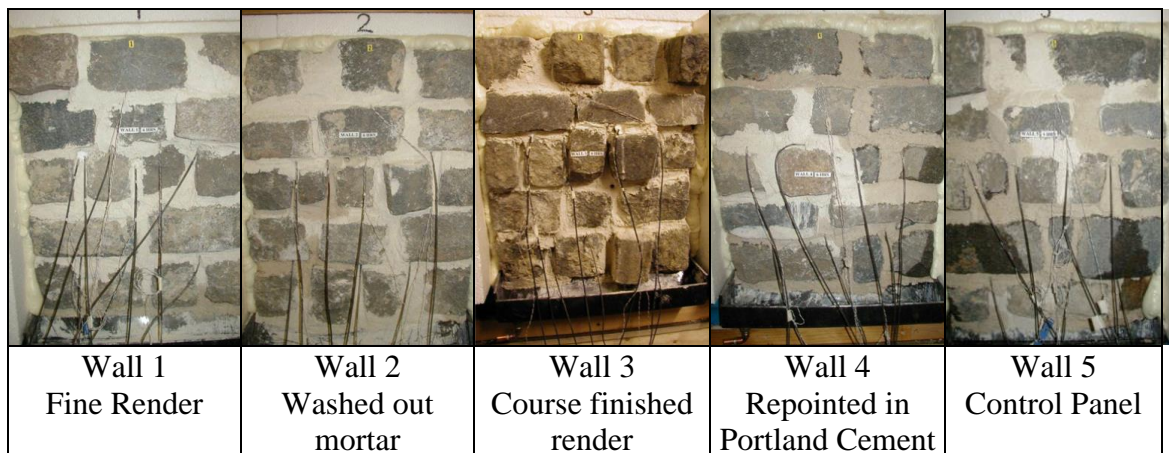
Figure 11 Photographic record of the pilot panels after 6 hours rain

Photographic evidence and notes based on observations were used to monitor water penetration (Figure 11) and moisture contents were monitored from drillings at the rear of the panel to assess ingress destructively by gravimetric means. Observations indicated that Walls 1 & 3 evidenced least water penetration, with small daily fluctuations. Once water had reached the rear of walls 4 and 5 the daily rates remained constant. Embedded water sensors and humidity sensors indicated advancements of the water fronts and humidity levels through the wall at times which conformed to the order at which damp was first observed at the rear of each of the wall. Performance of the embedded humidity sensors to detect water were disappointing providing an indication of wetting but not of subsequent drying and the wall 4 sensor failed during curing time. The initial work was assessed at the end of the run period. The control wall which had shown significant air leakage during initial pressure testing was subject to larger volumes of water, some

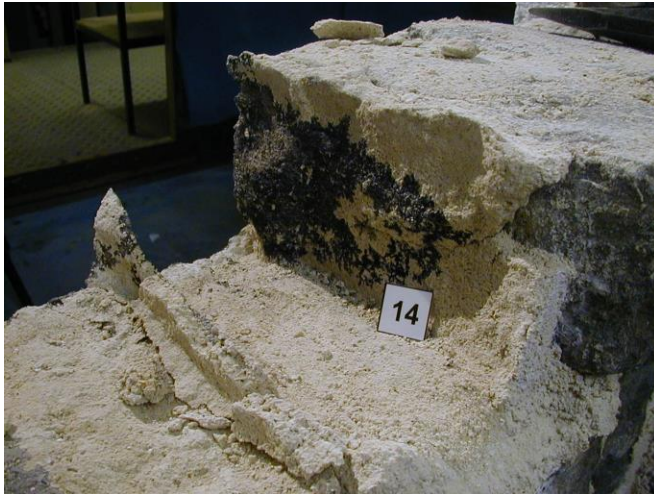
Figure 12 Dye penetration test on Wall 5 after first pilot work.

Before demolition wall 5 was exposed to water soluble paint with pressurised conditions to expose the routes taken by water flowing through the wall. Penetration was seen to be concentrated around the mortar at the front faces, as would be expected, and many of these failed to reach to any depth. There were a number of pathways along the perpendicular joints, a typical example is shown in Figure 12. Pathways were complex at the transition point between the front and rear skins of the wall, with water tracking behind the back of the blocks while the bed face beneath remained dry. In some cases this water managed to migrate on the same course to the rear of the wall, in others the water made no further lateral progress than to the central area of mortar but descended downwards through the wall core. Dye penetration through this wall could be visually seen as most commonly associated with blocks which ran from the front to the back of the wall which were also associated with the points of air leakage identified prior to testing. However water penetration was not consistently related to high air penetration although there were some areas where internal voids appeared to be allowing conduction of significant quantities of water.

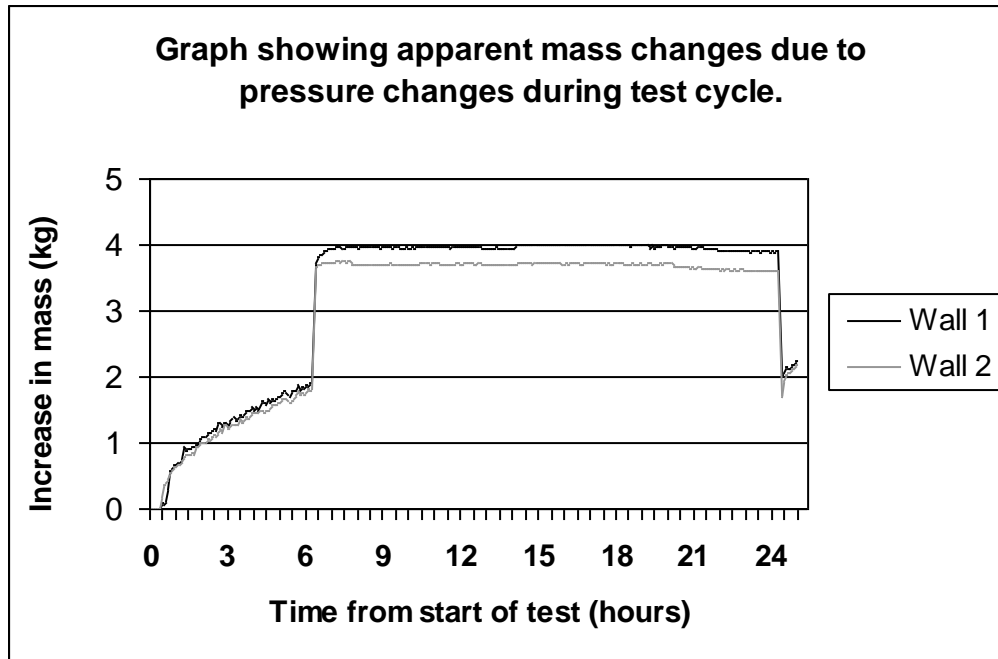
Figure 13 *Mass changes associated with pressurisation*

Following construction and curing as detailed, an initial calibration of the scales was carried out with a short rain run in which water delivered and collected was used to calculate water uptake which was then compared with change in scale reading. It was noted that pressurisation of the chamber caused the apparent mass of the panel to change abruptly, therefore the changes in mass during the pressured and unpressured phases were considered separately (Figure 13). Following the trial wetting, dry back weights of both panels were recorded. The rate at which both walls dried is similar, but even after 6 days the total mass of water absorbed during trial wetting had not been completely released. It can be inferred that approximately 40% of moisture is retained within the wall after this drying period (NB: the drying period had to be curtailed to enable work to progress with preparation of the chamber for the main tests). Interrogation of the original drying curves, presented here as logarithmic plots (Figure 14) indicates that about 40% of water would be lost after 100 hrs. This trial confirmed that the scales were in good working order and that they were recording the masses of water accurately. After calibration the initial phases of testing were carried out, following which the third and fourth walls were constructed, details of which follow.

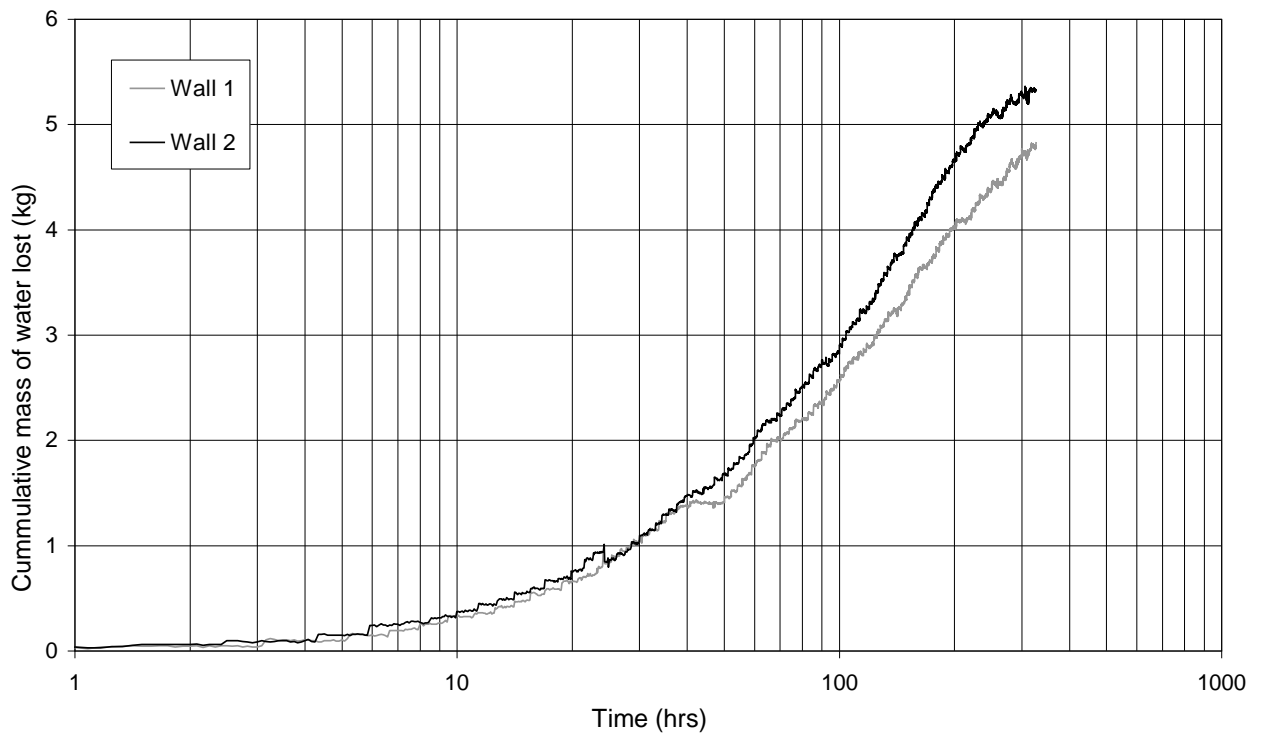
Figure 14 *Drying of test walls following calibration testing*

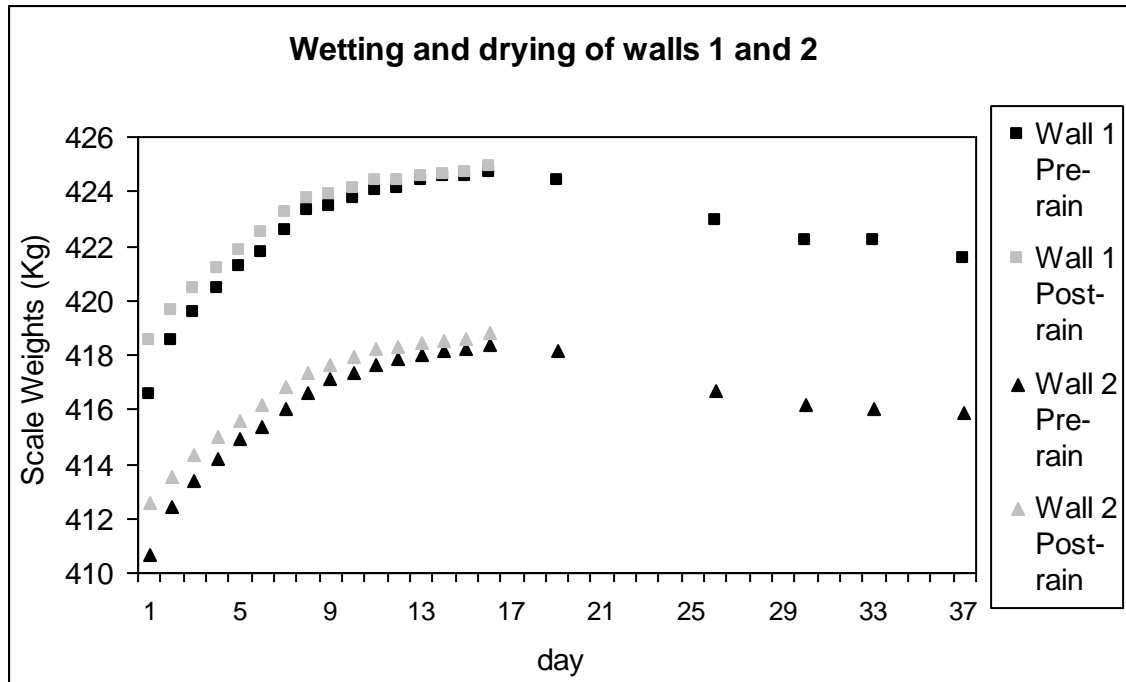
Figure 15 First wetting and drying run of walls 1 and 2

The results for all tests were analysed as each section of the work progressed and also after completion, to allow each treatment to be compared. While the overall performance in terms of mass water uptake and loss on drying is very similar for the two walls (Figure 15) the locations at which water penetrated were very different for the two walls. Wall 1 showed dampness initially towards the base of the panel, wall 2 toward the top of the wall. This underlines the complexity of water movements through complex wall types and the difficulty in producing models to predict behaviour of these systems at this stage. Water did not penetrate to the rear of the panel to the extent where free water was observed, which was the case very early on in the initial work. No water was collected in the internal trough which leads to the conclusion that the water is being held in the mortar. The slow drying rates lead to long term moisture build up within the structure. After drying back the second wetting run demonstrated repeatability of results. Changing the volume of rain water had no effect on increasing the weight gain.

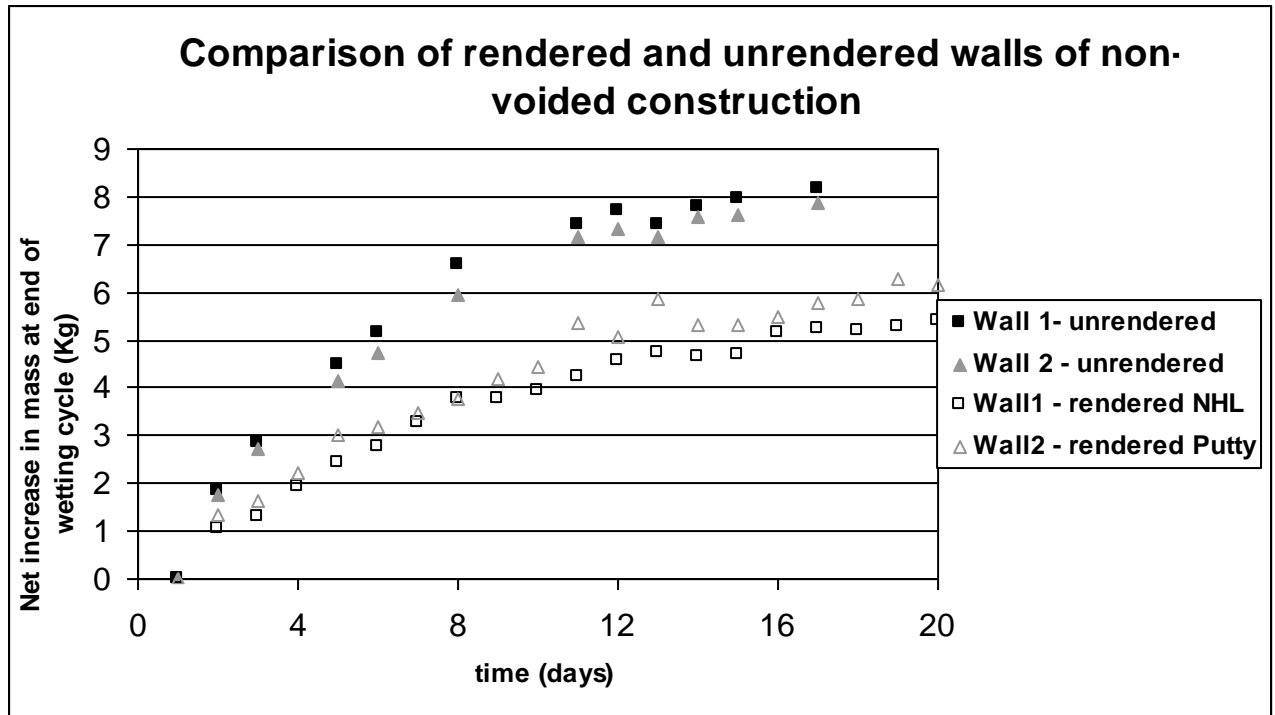
Figure 16 Graph to show performance of the same walls pre and post application of render

Figure 16 demonstrates that the slow moisture uptake seen on the walls can be further retarded by the application of render to the external face. The missing areas of data in the above graph are from power outages resulting from building work which corrupted the data on the loggers. Table 4 presents a summary of the findings of the work in a simplified form, based on the percentage reduction in water uptake. An unexpected finding was that the voided walls appear to take up less net water than the good quality walls. This may be due to breaking the pathways from front to back of the wall which prevents water from filling up the void spaces efficiently and rather that the voided walls tend to re-direct water away from the central part of the wall and cause drainage to the front of the wall. Alternatively the voids may equalize with the external pressure which may also act to prevent rain penetration in these test panels. It was therefore not possible to compare voided and unvoided walls with each other. Despite this the level of water uptake was reduced to a much greater extent when applying treatments to the voided rather than unvoided walls and it can be concluded that the application of render has a significant positive effect on reducing water intake by the voided walls, but does not entirely eliminate this.
