## **Factors affecting the efficiency of repair to propped and unpropped bridge beams**

MANGAT, P. S. and O'FLAHERTY, Fin (2000). Factors affecting the efficiency of repair to propped and unpropped bridge beams. Magazine of concrete research, 52 (4), 303-319. [Article]

# Factors affecting the efficiency of repair to propped and unpropped bridge beams

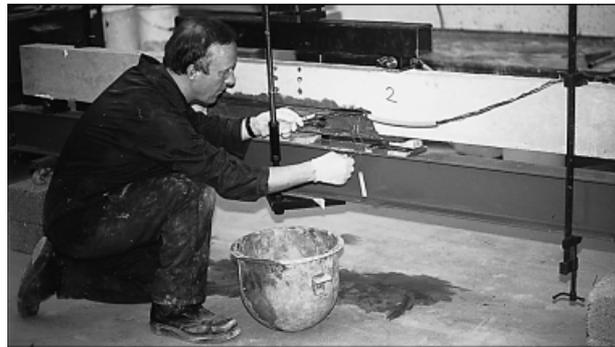
Fig. 2. Application of hand-applied repair, unpropped beam

unloaded (Table 1). Repairs to unpropped beams were applied by placing timber formwork on the soffit of the beam and supporting it with wedges built up from the top flange of the creep rig (see following subsection). This allowed the repair material to be inserted into the void from either side (vertical face) of the beam as shown in Fig. 2. Embedment gauges within the repair material were also inserted as the repair progressed (Fig. 2). Each repair material was mixed in accordance with the manufacturers' instructions. The material was hand-built to within 10 mm of the finished surface
