Determination of transfer stress from ruptured pre-load galvanised tendons in tanks and bund walls

Fin O'Flaherty · Paul Lambert · Pal Mangat · Vincenzo Starinieri

Abstract Circular concrete tanks and containment bunds constructed by the pre-load method involves pre-stressing the concrete by repeatedly wrapping layers of highly tensioned tendons. Each layer is covered with gunite. Corrosion may lead to rupture and an explosive type failure is avoided if the gunite is able to absorb the transfer stress. Zinc galvanizing is used to increase the tendons resistance to corrosion but its smoothness can influence bond characteristics, as can corrosion if extensive. This paper investigates the pre-stress transfer of ruptured pre-load tendons in gunite, both in the uncorroded and corroded state. Laboratory testing was conducted where tendons were pre-loaded in custom-built stressing moulds (to 1000 MPa) and simulated gunite applied. Different degrees of accelerated corrosion were applied to the tendons (0-10%). The bond stress at transfer was determined by measuring the contraction of the tendon during release of the pre-stress (replicating a broken tendon). The results show that a low bo

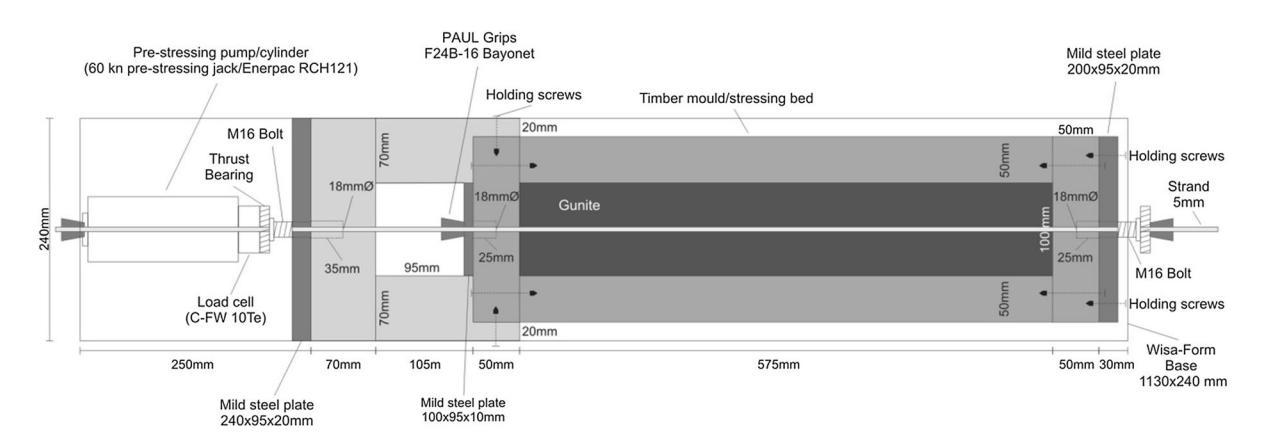
Fig. 1 Timber mould and stressing bed

A number of timber moulds/pre-stressing beds (Fig. 1) were designed and developed to (1) pre-load the tendon; (2) provide formwork for the 100 mm \times 100 mm mortar formulated to represent gunite in composition and strength (hereafter referred to as gunite) and (3) enable the magnitude of pre-stress transfer to the gunite to be determined at rupture. The

main components of the test system are given in Fig. 1.

The mould and stressing bed shown in Fig. 1 was used to determine the transfer of pre-stress to the gunite. The mould was securely fastened to the bed of a test frame and the pre-load was quickly released at one end by turning the mild steel bolt to relieve the stress in the tendon. The wedge was held with a vice-grip during stress release to prevent rotational bond failure of the tendon in the gunite. The contraction of the tendon was accurately measured via a linear variable displacement transducer (LVDT, accuracy calibrated using slip gauges) to give the 'shrink-length' upon release from which the transfer stress could be calculated.

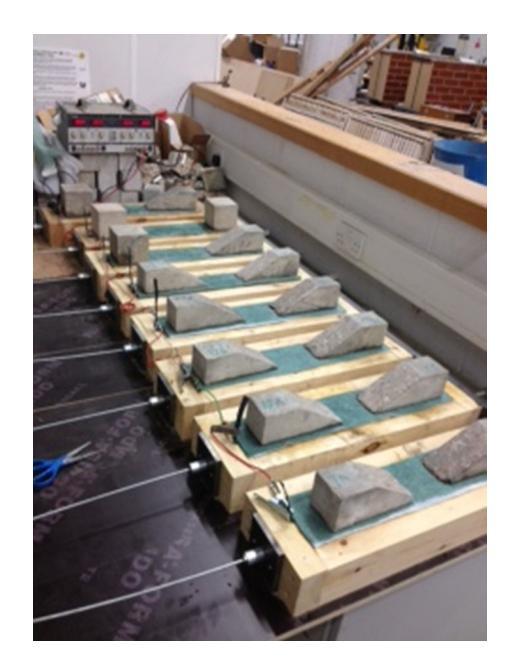
Fig. 2 Accelerated corrosion of tendons via power supply (top left)

Eight specimens were laid side-by-side in the laboratory for accelerated corrosion (Fig. 2) and current applied in parallel via a power supply. The polarity of the current was such that the tendon served as the anode and strips of mixed-metal oxide (titanium) placed on top of the specimens and weighed down to ensure full contact with the gunite

served as the cathode. The specimens were covered with a green landscaping fabric which was continuously moistened to maintain an electrolytic connection. For each batch of eight specimens, the applied current was fixed (48.8 mA \times 8, Eq. 4) and corrosion period was adjusted (Eq. 2) to give the required target degree of corrosion (e.g. 121.8 h for 3%, 243.6 h for 6%).

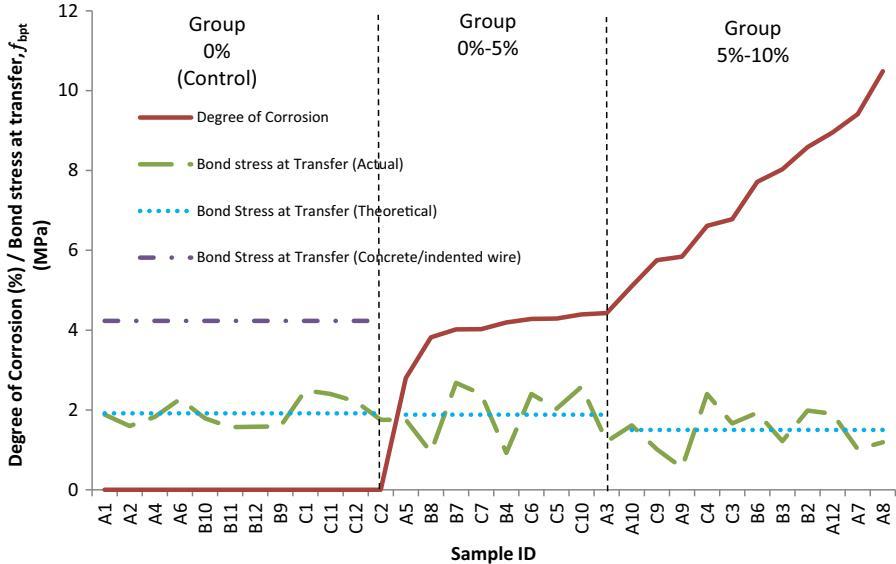
Fig. 4 Relationship between degree of corrosion and bond stress at transfer

The data presented in Cols. 2 and 6 in Table 1 is shown graphically in Fig. 4. The degree of corrosion is zero for the first twelve control samples but increases to a maximum of 10.49% for Sample A8. Referring to Table 1, the average bond stress at transfer for Groups 0 and 0–5% corrosion are quite similar, 1.91 and 1.88 N/mm² respectively, hence low levels of corrosion have not significantly influenced pre-stress transfer. However, this decreases to 1.50 N/mm² for corrosion Group 5–10% as the higher levels of corrosion has a greater influence on bond stress. For comparison, the design bond stress at transfer for a Grade 35 concrete and indented wire using the same parameters as used in the gunite example is also shown

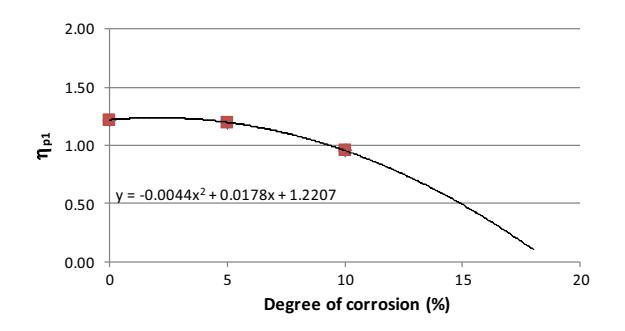
Fig. 5 Reduction in η_{p1} with increasing corrosion (unfactored)

Referring to Table 1, the average bond stress at prestress transfer, f_{bpt} (rupture of the tendons) is 1.91 N/ mm² at 0% corrosion, 1.88 N/mm² at 0–5% corrosion and 1.50 N/mm² at 5–10%. Subsituting these values for f_{bpt} into Eq. 8 gives empirical values for η_{p1} as shown graphically in Fig. 5. Referring to Fig. 5, once an estimate of the degree of corrosion is obtained from a field investigation, η_{p1} can be obtained from Fig. 5.

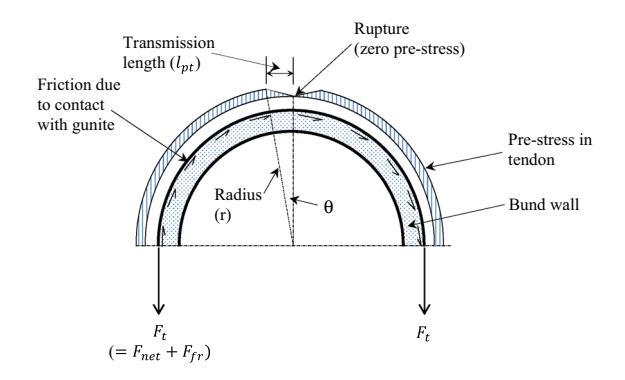
Fig. 7 Plan of half bund wall with pre-stressed single tendon

Referring to Fig. 7, it is assumed the tendon is wrapped in an anticlockwise direction. The frictional resistance encountered between the tendon and gunite in the transmission length can be analysed using the equation for post-tensioning loss due to curvature as follows [18]:

When the tendon ruptures, the pre-stress becomes zero at the point of failure but gradually increases along the transmission length (l_{pt} , Figs. 7, 8). The prestressing force (F_t) is fully mobilised beyond l_{pt} and transmitted to the gunite via bond. This is shown in Fig. 8 where a single tendon is isolated to clarify the transmission length, l_{pt} , and increasing stress from point of rupture (zero stress) to full pre-stress at a distance l_{pt} . From EC 2 [14], the transmission length, l_{pt} , is given by:

Referring to Figs. 7 and 8, the zero stress at point of rupture will increase gradually along the tendon until full pre-load is transferred to the gunite at the end of the transmission length (l_{pt}) . At this point, the force in the gunite (F_g) equals the force in the tendon (F_t) due to equilibrium and since force equals stress times area, it follows that:

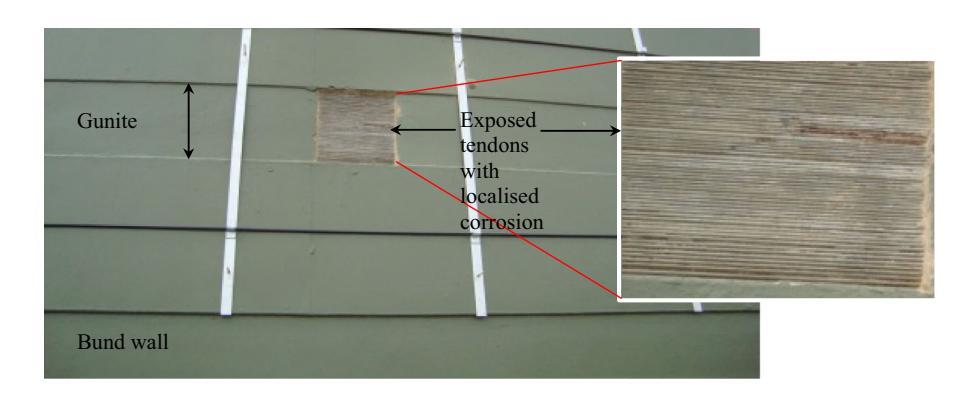
Fig. 6 Typical bund wall with exposed tendons

The tendon recess (Fig. 6) is shown idealised in Fig. 8 where a number of vertical layers of tendons with gunite cover between them is shown. The depth and length of the recess can vary from structure to structure, but in the bunds inspected by the authors', the number of tendons varied from about 240–370 for a depth of 80 mm and height around 500 mm (bund wall thickness was 500 mm). A tendon in the outermost layer is assumed to rupture as this will be a worst case scenario (an explosive failure is more likely at

Since corrosion can be very localised (see Fig. 6), it is possible for two or more adjacent tendons to suffer damage at a similar point along their circumference, hence there is a possibility of overstressing the gunite due to double (or more) pre-stress transfer. Referring to Fig. 12, the gunite area of influence overlaps for two adjacent tendons. It is assumed that both tendons do not rupture at exactly the same time, it is more likely that one will rupture first followed by the second sometime later, hence the concept of pre-stress transfer influencing a zone around the single tendon as analysed in Sect. 5.3 also applies here. Referring to Eq. 15, the area of gunite required for equilibrium for a single tendon rupture in this example is 935 mm^2 (A_{zone}) , hence this will be doubled to 1870 mm² at double tendon failure $(2A_{zone})$. However, the zone of influence from two ruptured adjacent tendons will overlap (Fig. 12) meaning the eclipsed area will be subjected to two pre-stress transfers and possible over stressing. Using $\emptyset_z = 17 \text{ mm}$ from Eq. 16 or 20, the eclipsed area ($A_{eclipse}$) is 143 mm² from [24]. However, this area will include tendons which will also help carry the pre-stress transfer and by inspection of Fig. 12, the adjacent zone of influence due to the second tendon rupture has moved downwards by one tendon diameter. It was established above (Eq. 24 or 29) that n equals 2.4 tendons in a single zone of influence, hence n in the eclipsed area will be one tendon diameter less or 1.4 (this includes the tendon which ruptured first as this will now support the prestress transfer to the gunite). Since the area of the eclipsed zone of influence ($A_{eclipse}$) equals 143 mm² from above, the net area of gunite in the eclipsed zone $(A_{g(eclipse)})$ will be $A_{eclipse}$ minus the area of the tendons within this zone i.e. nA_t or $1.4A_t$. As shown in Sect. 5.3, these tendons will contribute to carrying the pre-stress so an equivalent area of gunite $(A_{g(equiv)} = nmA_t)$ can be obtained to give:

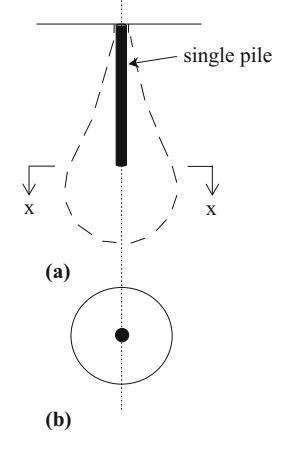
Fig. 9 a Vertical section through pile pressure bulb, **b** horizontal section xx through pile pressure bulb

In order to estimate the area of gunite in the idealised section that is influenced by the ruptured tendon, an analogy is made with the pressure exerted on adjacent soil through a loaded single pile. Referring to Fig. 9a, the adjacent soil is stressed in the shape of a bulb if a vertical section (y-y) is taken along its depth. However, if a horizontal section (x-x, Fig. 9b) is taken, the stress is distributed uniformly around the pile in a circular shape. Therefore, it will be assumed that when a tendon ruptures, the zone of the influenced gunite can also also be assumed as circular in the vertical plane commencing at a distance l_{pt} (Fig. 8).

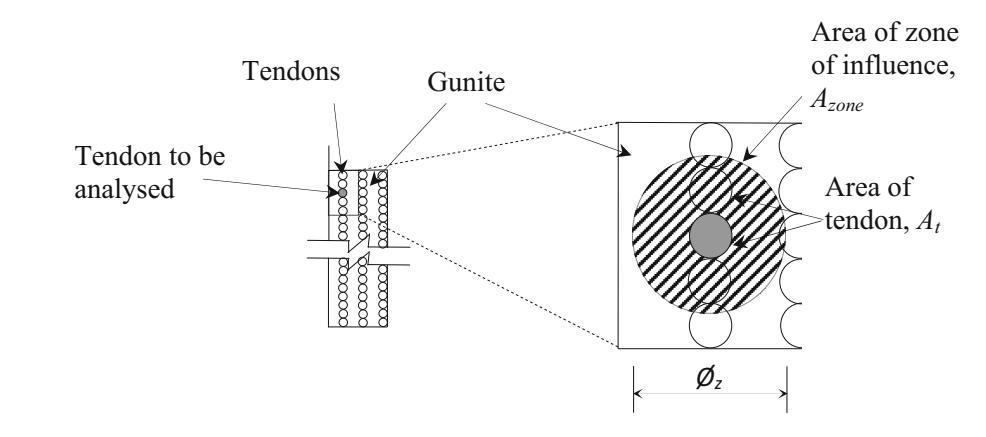
Fig. 10 Idealised area of zone of influence due to single tendon rupture

Referring to Fig. 10, a section through the recess is given which highlights the zone of influence, A_{zone} , as a result of the ruptured tendon. This circular area will overlap and/or intersect adjacent tendons above and below the ruptured tendon under consideration which will contribute to carrying the compressive force in the gunite. The area of the zone of influence, A_{zone} , is calculated from:

where A_{ring} is the area of a circular ring, inner diameter 5 mm (diameter of the ruptured tendon) and an outer diameter \emptyset_z but minus the area of the other unruptured tendons within it (i.e. nA_t). However, since these tendons will help absorb the pre-stress transfer, they can can be converted to an equivalent area of gunite, $A_{\text{g(equiv)}}$, using the modular ratio (*m*) between the tendon and gunite (E_t and E_g respectively), nmA_t .

and solving gives the positive root as 2.4, meaning the number of tendons in the zone of influence, *n*, is 2.4 (or 3.4 if the ruptured tendon is included). Inserting n = 2.4 back into Eq. 19 (or Eq. 20) gives $\emptyset_z = 17$ mm, the diameter of the zone of influence (Fig. 10). The cover, C_t , to the ruptured tendon can now be checked from:

In addition, rupture of tendons at other levels of prestress will also influence the diameter of the zone of influence, \emptyset_z , Fig. 10. This is also modelled in Fig. 11 where the number of tendons, *n* (secondary *y*-axis) contributing to absorbing the pre-stress transfer in the gunite can be determined from the pre-stress in the tendon. From the line of best fit, *n* can be determined from:

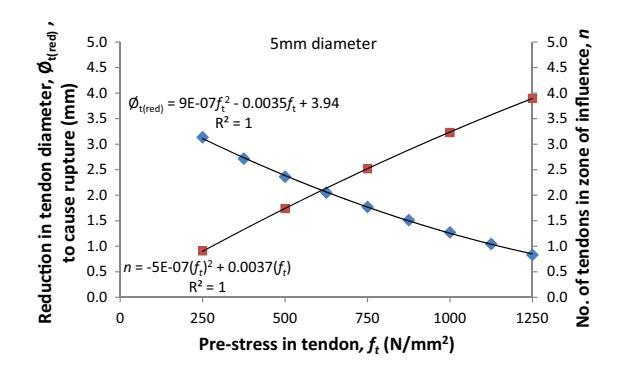
Fig. 11 Determination of: (primary *y*-axis) loss in ruptured tendon diameter for different levels of pre-stress transfer; (secondary *y*-axis) number of 5 mm \emptyset tendons in zone of influence for other levels of pre-stress transfer

The example presented here focuses of a pre-load of 1.5 metric tonnes on the tendon (giving a pre-stress, f_t , of 750 N/mm²). However, if the design pre-stress varies in the ruptured tendon, the loss in diameter to cause failure also varies. This is considered in Fig. 11 where F_t is varied in Eq. 26 to give different levels of pre-load in the tendon (converted to pre-stress, f_t , in Fig. 11). The reduction in tendon diameter, $\emptyset_{t(red)}$ (primary *y*-axis in Fig. 11) can be related to the pre-stress in the tendon by:

Once *n* is known from Eq. 29 for a specific prestress, \emptyset_z can be determined as before from Eq. 15 (or Eq. 20) and the cover, C_t , can be determined from Eq. 25. As an example, if a tendon with a higher prestress of say 1250 N/mm² ruptured, a minimum cover (C_t) of 9.4 mm would be required for the gunite to absorb the compressive stress (as opposed to 6 mm for a pre-stress transfer of 750 N/mm.
