An Experimental Method for Fatigue Testing Cast Iron Water Pipes Using Combined Internal Water Pressure and Bending Loads

RESEARCH PAPER

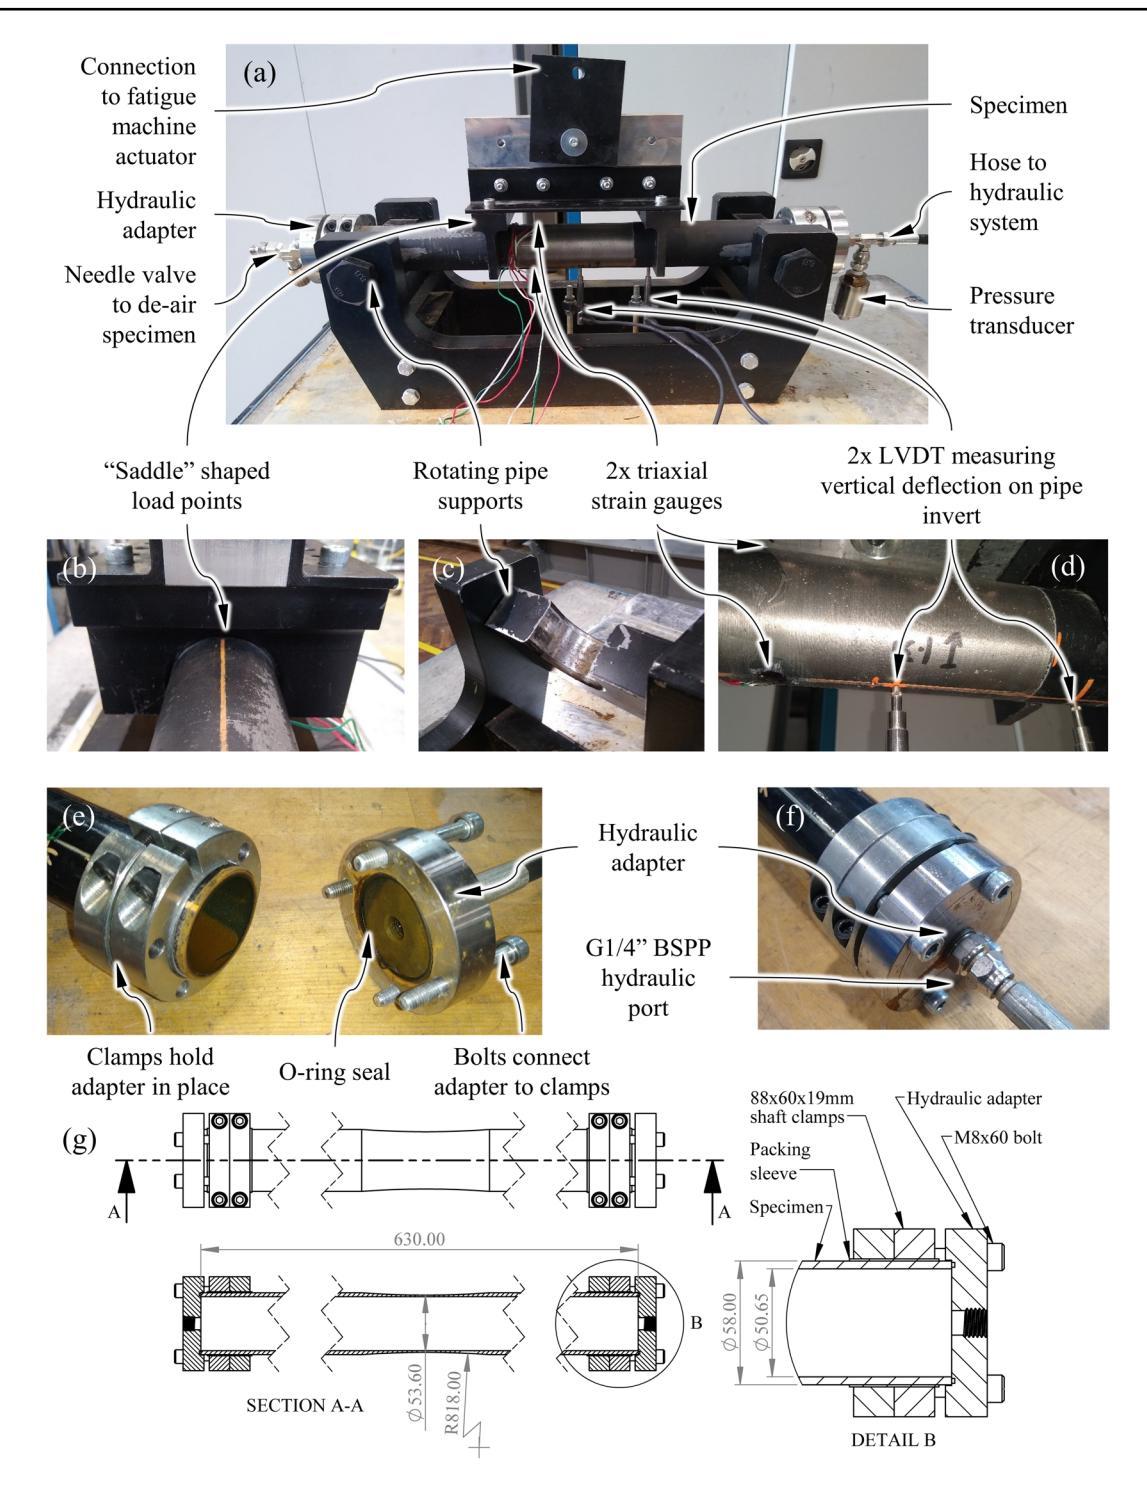
Fig. 1 Labelled photographs and drawings showing the four-point bending apparatus, pipe specimens, and pipe specimen hydraulic adapters

To create a region of constant maximum bending stress in the pipe specimens away from the stress-concentrating influence of the load points a four-point bending arrangement was used. The design of the supports and load points was developed to cause conditions close to an ideal, simply supported, four-point bending case.

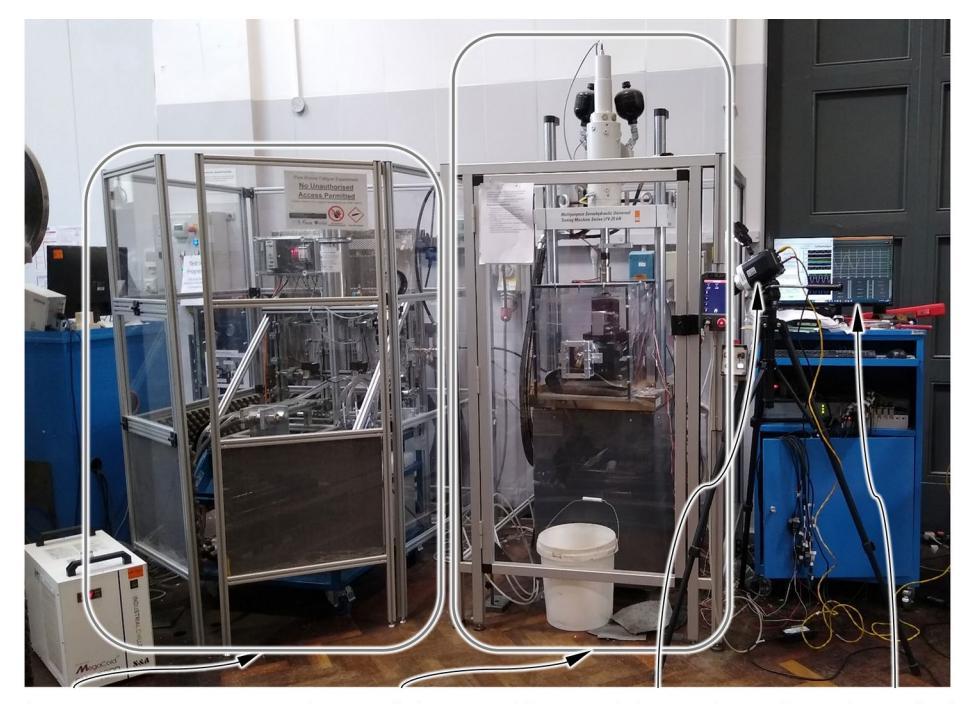
Internal water pressure loading hydraulic system

LFV-25-ME fatigue machine with bending apparatus

ine High-speed camera

PC running LabView and LFV-25-ME software

Fig. 2 Labelled photograph showing the full experimental set-up

So that the stability of leaking fatigue cracks could be observed the system was designed to continue applying internal pressure loading after a small leak had formed. A pump was used to maintain pressure in the high-pressure reservoir before and after a leak formed (Fig. 3, PD1). This pump was supplied as part of a Hydrostatic Test Unit (HTU) as shown by Fig. 3. The high-pressure reservoir was a nitrogen-charged accumulator with a working volume of 2 L (Fig. 3, A2). The bespoke fatigue valve system (see Fig. 3) was mounted on the wheeled HTU frame and positioned within a safety enclosure next to the servo-hydraulic fatigue testing system (see Fig. 2).

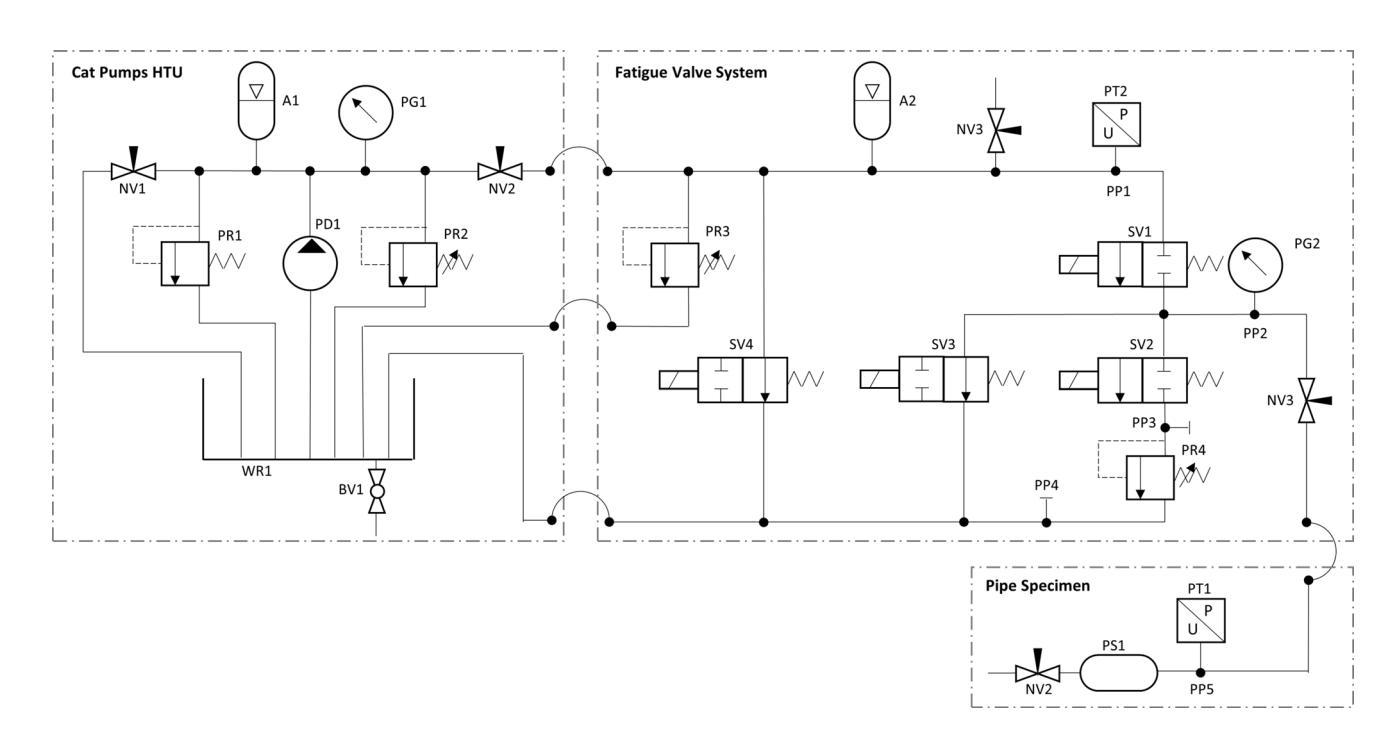
Fig. 3 Full schematic for the hydraulic system used to apply internal water pressure fatigue loading to pipe specimens (see Table 1 for component details)

valve on the hydraulic line to the low-pressure reservoir (Fig. 3, PR4). The maximum cyclic pressure could be set between 3.5 and 20.0 MPa (using PR2 and PR3, Fig. 3),

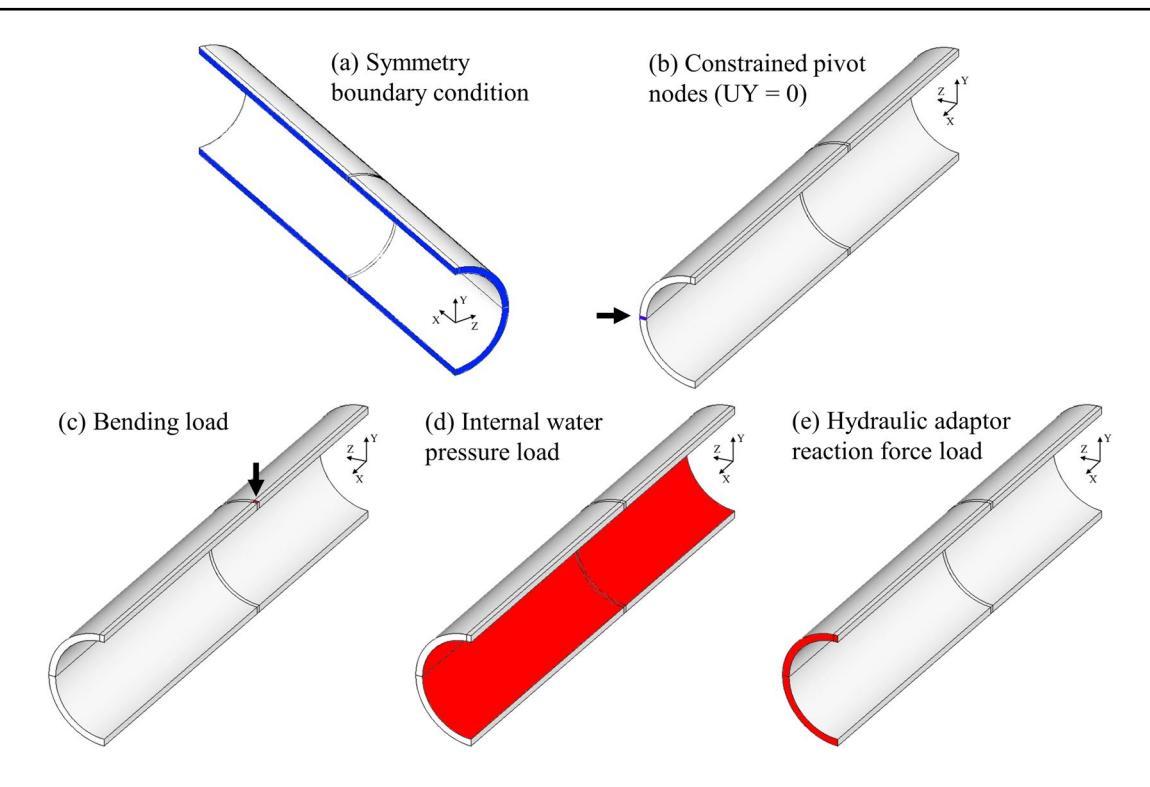
Fig. 4 Diagrams showing the boundary conditions (shaded blue) and loads (shaded red) applied to the four-point bending and internal water pressure load finite element model

To calculate strain and displacement using FEA, a quarter-pipe model was developed which exploited the two planes of symmetry present in the experiment, as shown by Fig. 4(a). The simply-supported aspect of four-point bending was modelled by constraining the vertical movement (UY = 0) of a horizontal row of nodes at the pipe neutral axis (Fig. 4(b)). To approximate the point loads of fourpoint bending, the bending load was applied as a uniformly distributed pressure force over a small 2×2 mm patch (Fig. 4(c)). The internal water pressure load was applied to the inside faces of the specimen model as a uniformly distributed pressure (Fig. 4(d)). To account for the fact that the specimens were subject to an axial load caused by the internal water pressure reaction force on the hydraulic adaptors at each end of the specimen, a uniform pressure load with a negative magnitude was applied to the end face of the specimen model (Fig. 4(e)). A second-order hexahedral element mapped mesh with a 1 mm element size was used to discretise the specimen model. Mesh refinement confirmed that a 1 mm mesh size was sufficiently free from discretisation errors.

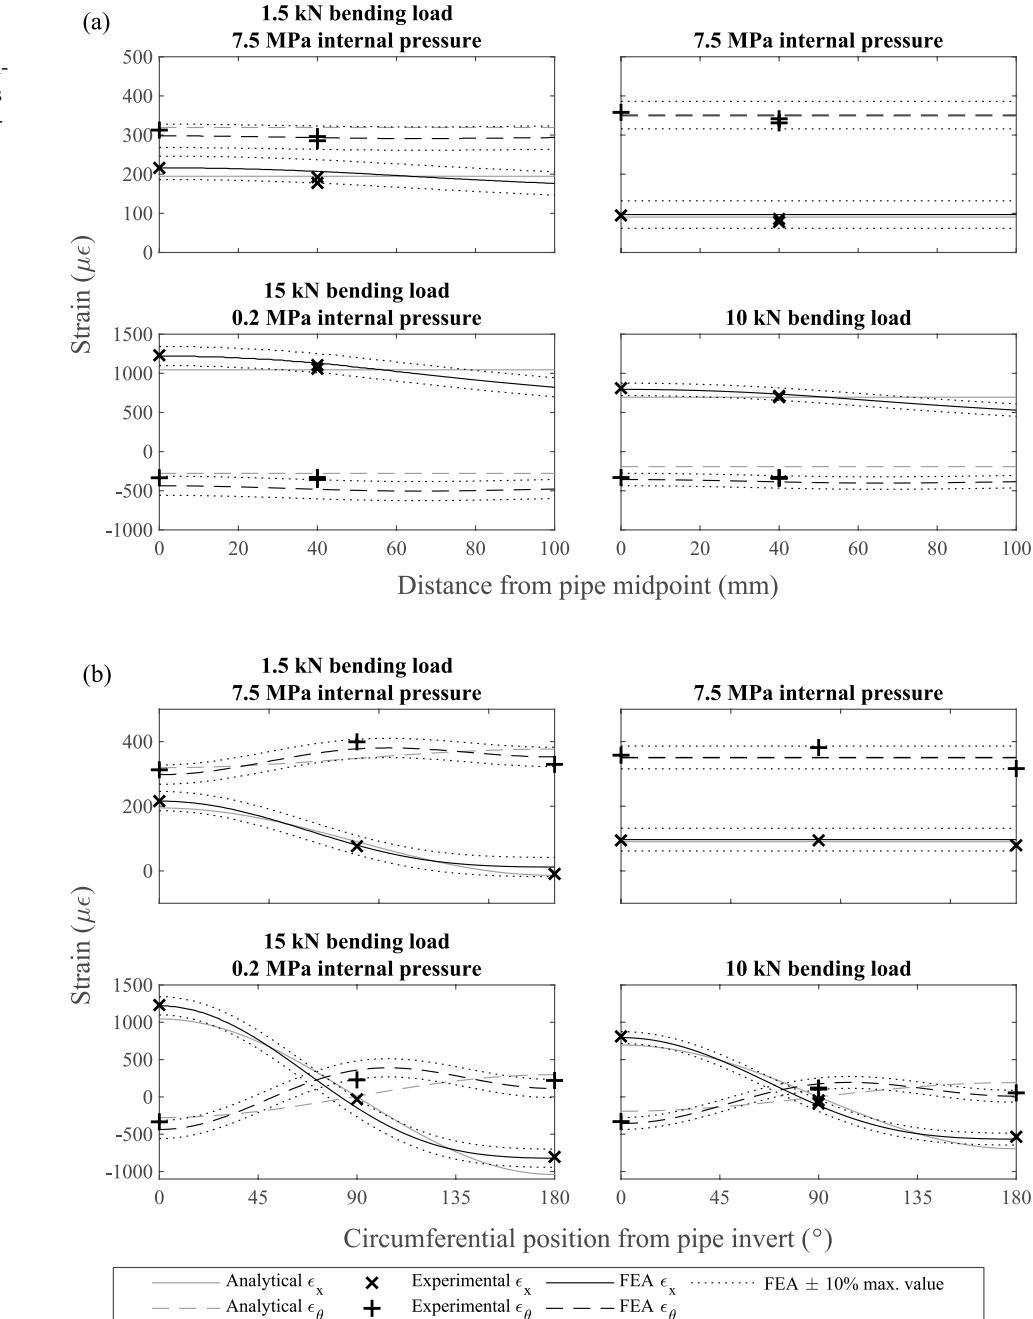
Fig. 5 Measured and predicted strains (**a**) along the invert and (**b**) around the midpoint circumference of one of the specimens used for the strain and displacement validation experiments

All but three invert strain measurements across both specimens fell within $\pm 10\%$ of the maximum predicted strain of the FEA predictions. The greatest invert strain error was 12.4% for a strain measurement of $-330 \ \mu \epsilon$ and all invert strain measurements falling outside the $\pm 10\%$ FEA prediction bands were located 40 mm away from the midpoint. All but one circumference strain measurement fell within $\pm 10\%$ of the maximum predicted strain of the FEA predictions.

The greatest circumference strain error was 10.8% for a strain measurement of 228 $\mu\epsilon$. Only two invert displacement measurements fell outside the \pm 10% FEA prediction bands and these were both for the second pipe under the lowest bending load, meaning the measured displacement was very small (around -0.1 mm). The maximum error was 14.8%.

The strains experienced by pipe specimens subject to only an internal pressure load agreed well with the closed-ends thick-walled pressure vessel relation (equations (5) and (6)) and FEA estimations, as shown by Fig. 5. The FEA model used the same boundary conditions for combined loading and bending-only loading. The good agreement between the experimental strains and FEA estimated strains for both of these loading conditions shows that the application of internal pressure loading did not influence the way in which the specimens interacted with the load points and supports.

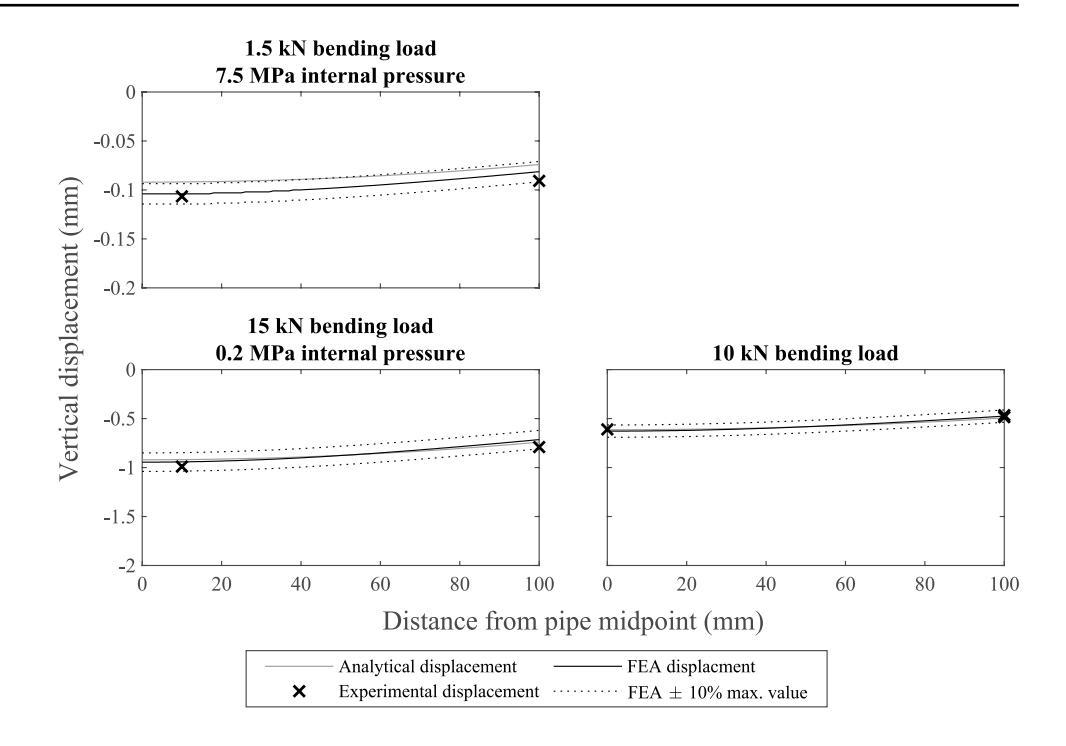
Fig. 6 Measured and predicted vertical displacements along the invert of one of the specimens used for the strain and displacement validation experiments

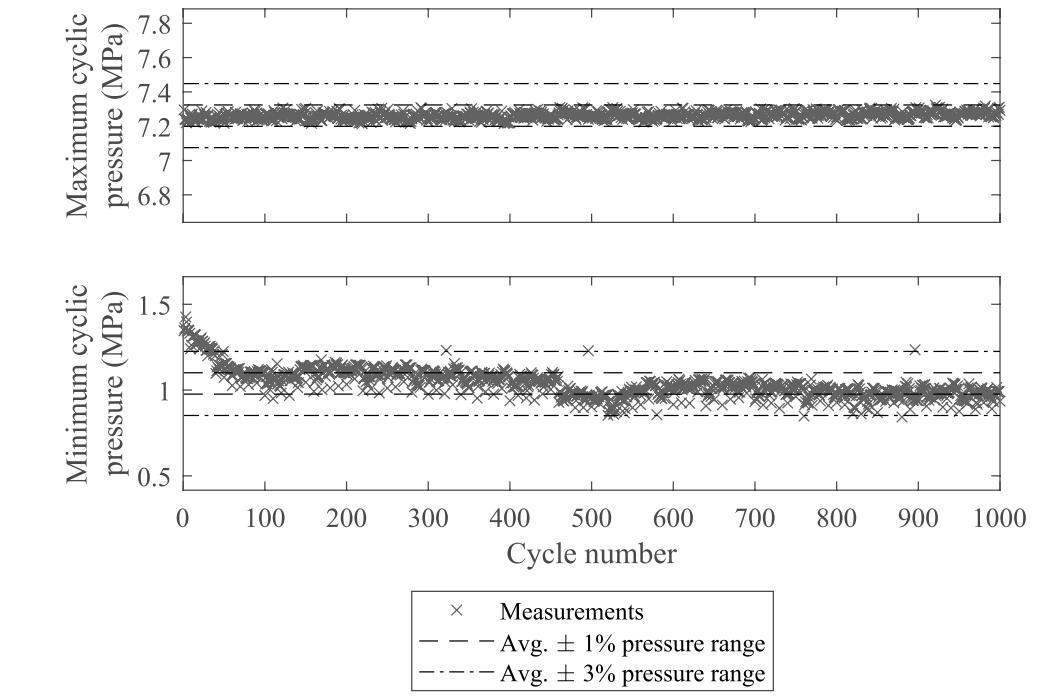
Fig. 9 Plot of measured maximum and minimum cyclic pressures for internal water pressure loading over 10.³ cycles for test 3 from Table 2

amplitudes within $\pm 3\%$ of the average, however, for test 3 95.3% of cycles fell within this range. Figure 9 shows the minimum and maximum cyclic pressures for test 3. The accuracy of the maximum pressure values for test 3 were very good, all falling within $\pm 1\%$ of the average. During the first 100 pressure cycles of test 3 the minimum cyclic pressures gradually stabilised. The final row of Table 2 gives the amplitude error for test 3 excluding the cycles before the hundredth, from which it can be seen that the percentage of cycles with an amplitude error within $\pm 3\%$ was 99.6%.

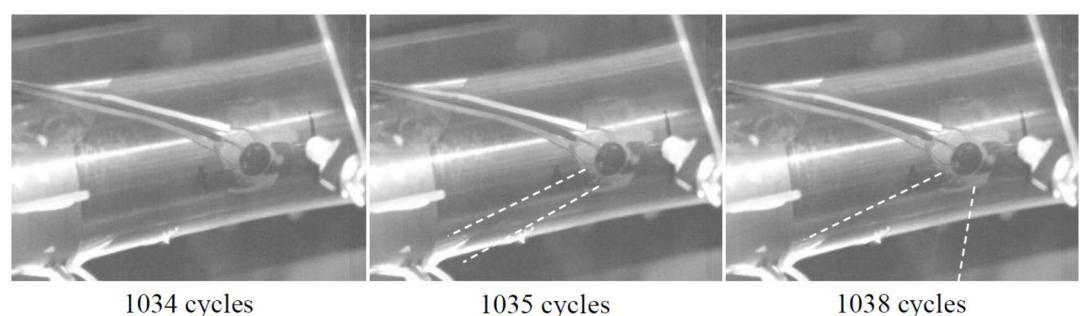
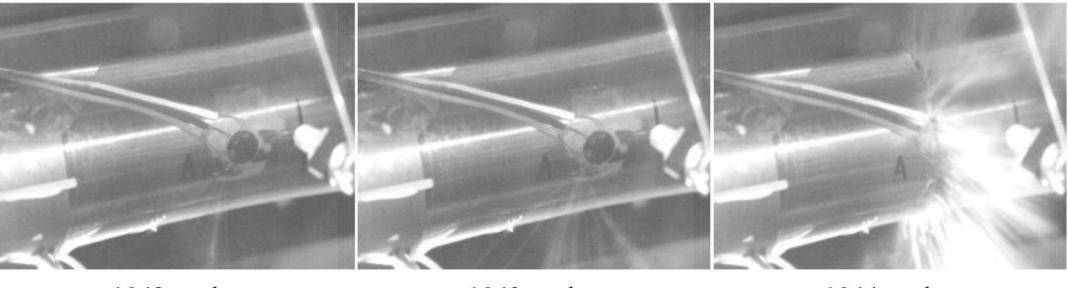
Fig. 12 High-speed video stills showing the evolution of a leak at the invert of a pipe specimen prior to failure under 180° out-of-phase internal water pressure and bending loading (white dashed lines indicate the position of the water jet where this is faint)

Of the three fatigue tests of uniform wall-loss pipe specimens, two pipes developed a leaking crack after 1,035 and 5,900 load cycles then split in two via a full circumferential crack after a further 9 and 19 load cycles, respectively, and one pipe survived 10^5 load cycles without developing a leak. Figure 12 shows stills from the high-speed camera footage of one test illustrating: the first appearance of a leaking crack after 1,035 cycles, the development of the leak over

the following 8 load cycles, and the sudden formation of a full circumferential crack after 1,044 load cycles.

Using high-speed camera footage, leaks were detected in the pipe specimens prior to bursting (see Fig. 12). These leaks persisted for less than 1% of the total cycles-to-burst, indicating that in-service GCI pipes in similar conditions are unlikely to experience prolonged periods of leakage and will instead burst with limited warning.
