## **Relationship between corrosion and element severity score for reinforced concrete beams**

O'FLAHERTY, Fin, BROWNE, Elena, MANGAT, Pal and LAMBERT, Paul (2015). Relationship between corrosion and element severity score for reinforced concrete beams. In: SAHA, Swapan, ZHANG, Y.X., YAZDANI, Siamak and SINGH, Amarjit, (eds.) Implementing Innovative Ideas in structural engineering and project management. ISEC Press, 575-580.

# RELATIONSHIP BETWEEN CORROSION AND ELEMENT SEVERITY SCORE FOR REINFORCED CONCRETE BEAMS

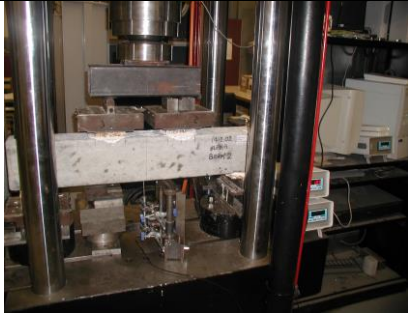
Table 2. Deteriorated beams with corresponding degrees of corrosion

Code	Description	Examples of laboratory beams	Actual degree of corrosion %
1	As new condition, defect has no significant effect on the element (visually or functionally)

0%-4%
2	Early signs of deterioration, minor defect/damage, no reduction in functionality of element	 	  4%-7%
3	Moderate defect/damage, some loss of functionality could be expected	 	  7%-10%

Table 2 shows an example of a deteriorated beam assigned to each of the five severity descriptors from Table 1. The corresponding degrees of corrosion are given as a range as it is more representative of what would be encountered on site. Table 2 shows that a Code Level 5 beam would exhibit a degree of corrosion of the main steel greater than 20% with the other codes 4, 3, 2 and 1 exhibiting degrees of corrosion in the ranges 10%-20%, 7%-10%, 4%-7% and 0%-4% respectively.

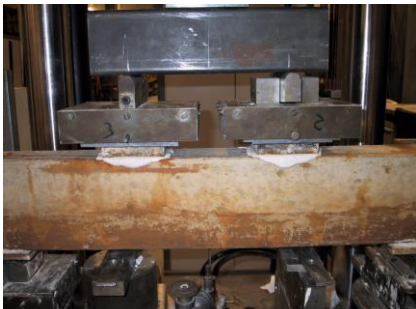
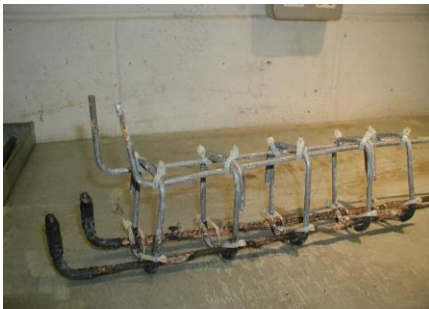
<p>4 Severe damage/defect, element no longer able to entirely fulfil its function and/or is close to failure/collapse</p>

<p>5 The element is non-functional/failed</p>	<p>-</p>	<p>-</p>

10%-20%

>20%

It was reported previously by the authors that beams exhibiting main steel corrosion greater than 10% generally failed in flexure before reaching the service load (O'Flaherty et al, 2008b). Therefore, with safety in mind, beams in practice with main steel corrosion around 10% should be considered as reaching their serviceability limit state and repair and maintenance is required to extend their service life. Referring to Table 2, beams exhibiting 10% corrosion to the main steel would occupy Code Level 3 (Moderate defect/damage, some loss of functionality could be expected) but is not close to failure or collapse. Code Level 3 is the limit for a beam still to be performing in-service, Codes 4 and 5 describe beams which should not be expected to continue to perform in-service, they are either close to collapse or non-functional.
