## **Residual stresses in condition monitoring and repair of thermal power generation components**

JAMES, Malcolm Neil, HATTINGH, Danie, ASQUITH, David, NEWBY, Mark and DOUBELL, Phillip (2017). Residual stresses in condition monitoring and repair of thermal power generation components. *Theoretical and Applied Fracture Mechanics*, 92, 289-297.

# Residual Stresses in Condition Monitoring and Repair of Thermal Power Generation Components

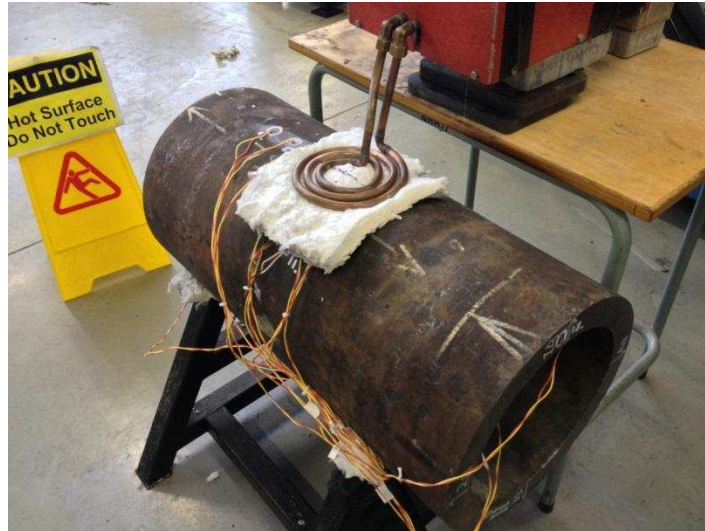
Figure 7 Induction heat treatment of the pipe after completion of the WeldCore® process.

number 1.7380). The PWHT was limited to a maximum surface temperature of 800°C and induction heating was continued until the inner surface of the pipe reached 650°C which was then maintained for a minimum of 15 minutes. Cooling took place in still air conditions in the laboratory.

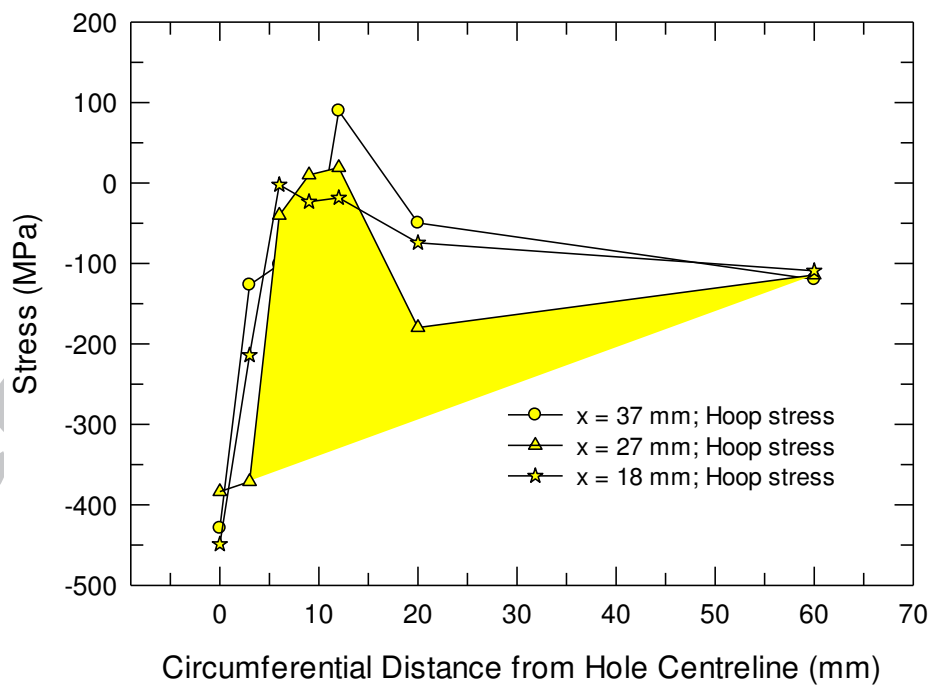
Figure 8a Residual hoop stresses in the as-welded FTHP specimen 1A.

Figure 8b Residual hoop stresses in specimen 2B after local PWHT by inductive coil.

Measurements were made of the residual stresses in the hoop, radial and axial directions of the pipe at three positions through the wall thickness (18 mm, 27 mm and 37 mm from the outer surface) at a number of positions from the weld centreline to a distance of 60 mm. Figure 8 shows the measured residual hoop stresses in specimen 1A (as-welded – Figure 8a) and specimen 2B (PWHT – Figure 8b) while Figure 9 shows the corresponding data in the axial direction. In terms of crack initiation during service, these are the two key coordinate directions. Measurements were able to be made at 5 depths in the PWHT specimen, while data was obtained at only three depths in the as-welded specimen.

Certain observations can be made from these hoop stress data; firstly, that at depths of 18 mm, 27 mm and 37 mm below the surface of the pipe, the large negative peaks that occur around the edge of the weld metal are reduced from peak values in the range 380 MPa to 450 MPa in the as-welded state, to values after PWHT in a range around 275 MPa to 380 MPa. Secondly, the values of peak tensile hoop stress are also reduced at equivalent depths and, thirdly, the stress distribution moves in the tensile direction the closer to the outer surface the measurements are made (e.g. Figure 9b,  $x = 9$  mm and  $x = 4$  mm). In all cases where data was obtained, the level of peak tensile residual hoop stress is  $< 120$  MPa.
